## **Inspection Report**

**Property Address:**  
3002 Wheeler Street  
Georgetown KY 40324

**Talon Home Inspections, LLC**

<b>Date:</b> 8/22/2018	<b>Time:</b> 12:00 PM till 04:00 PM	<b>Report ID:</b> 140822WILLOUGHBY
<b>Property:</b> 3002 Wheeler Street Georgetown KY 40324	<b>Customer:</b> Mr. Mark Stevens	<b>Real Estate Professional:</b>

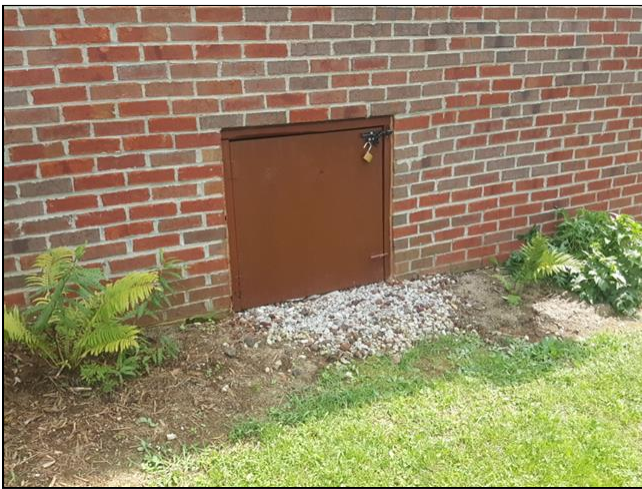
1.0 Item 1(Picture)

**1.0** Access to the crawlspace is located at the left side of the home.

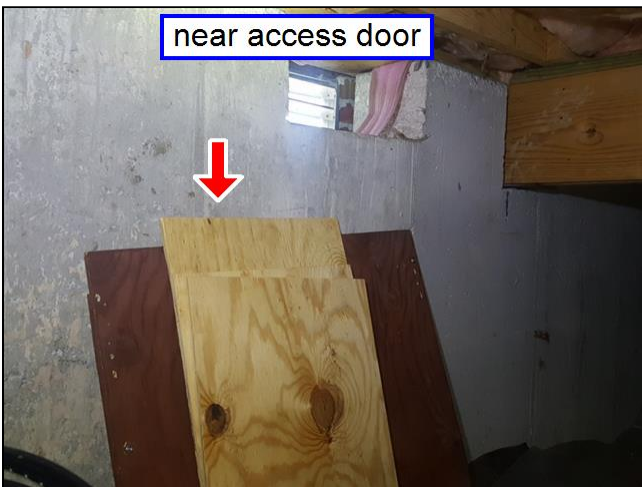
1.2 Item 1(Picture)

**1.2** (1) All wood should be removed from the crawlspace floor. Wood debris risks rotting and can attract wood eating insects into the crawlspace which can lead to more costly repairs later. Recommend all types of debris resting on the crawlspace floor be removed to prevent damage to the wood structure of the home.

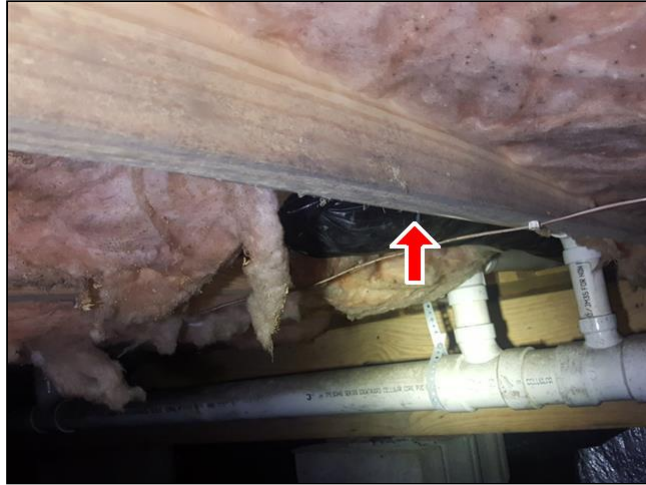
1.4 Item 1(Picture)

**1.4 (1)** Mildew was noted on some of the floor joists in the crawlspace mainly at the rear of the home. This is usually due to excess humidity and/or poor ventilation. Foundation moisture problems should be addressed. Proper ventilation helps control humidity and reduces the risk of rot. This is for your information. Recommend the crawlspace be monitored during the seasons and if condensation occurs, recommend a qualified contractor further investigate to determine cause and correct problem as needed.

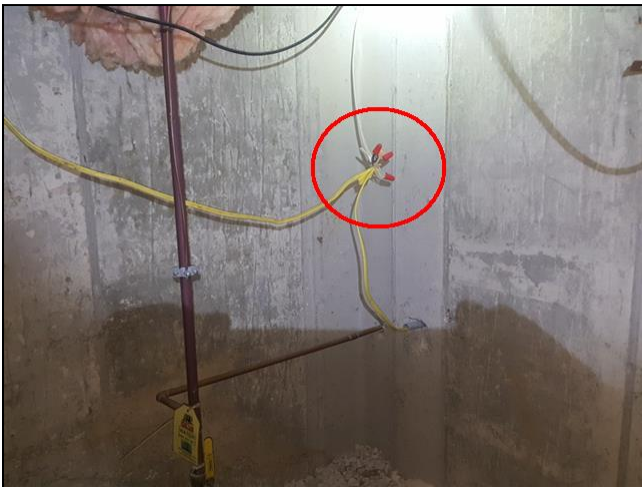
1.9 Item 1(Picture) under 3rd bedroom area

1.9 Wires that are connected with twist caps in a crawlspace need to be placed in a junction box to prevent tampering, protect the wire connections, and for personal protection. This is a safety issue that needs to be corrected. If a leak was to occur it could result in a short then a fire in the home. Recommend a qualified licensed electrician correct as needed.

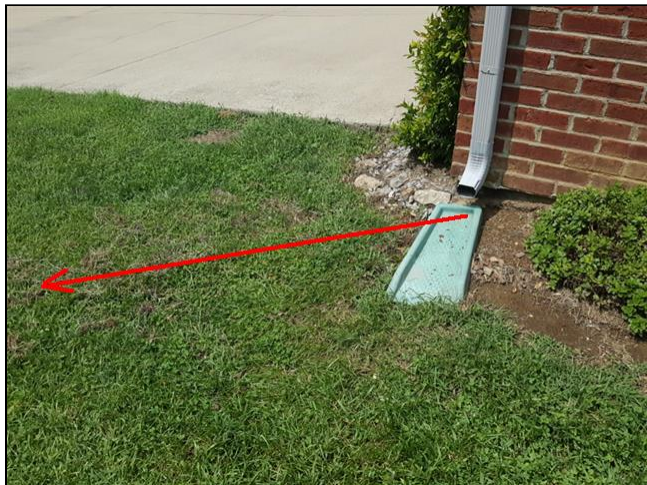
2.3 Item 4(Picture)

**2.3** (2) Recommend the downspout(s) at the front right corner of the garage be re-directed and extended at least 6 feet and flow onto splashblocks so water flows away from the foundation perimeter. This will ensure water is kept away from the foundation perimeter, soil erosion does not occur and water cannot leak under the slab foundation. Also this will prevent settlement from occurring around the foundation perimeter. Recommend repair and replacement as needed.

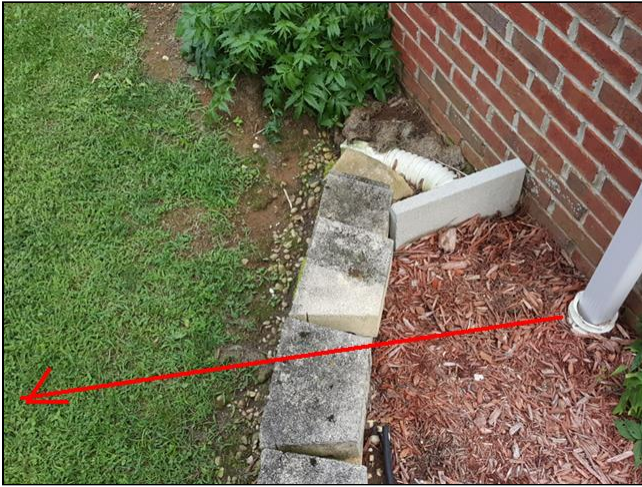
2.3 Item 5(Picture) front left corner of home

**2.3** (3) Recommend the downspout(s) at the home where indicated in the photo(s) be extended at least 6 feet and flow onto splashblocks. This will ensure water is kept away from the foundation perimeter, soil erosion does not occur and water cannot leak into the crawlspace area which may cause settlement of the foundation.

Note: You may wish to consider burying the extension to prevent a tripping hazard. See photos for example.

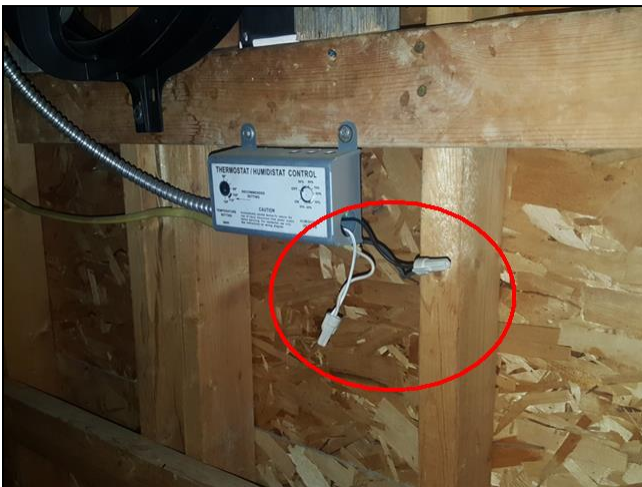
2.9 Item 1(Picture)

2.9 The wiring installation of the power vent in the garage attic is non-standard. It is suspected that an amateur, rather than a licensed electrician or HVAC contractor performed the installation. Splices in electrical wiring should be enclosed in junction boxes and fitted with cover plates. This is a safety issue . Recommend a licensed electrician repair as needed to prevent accidental electric shocks.

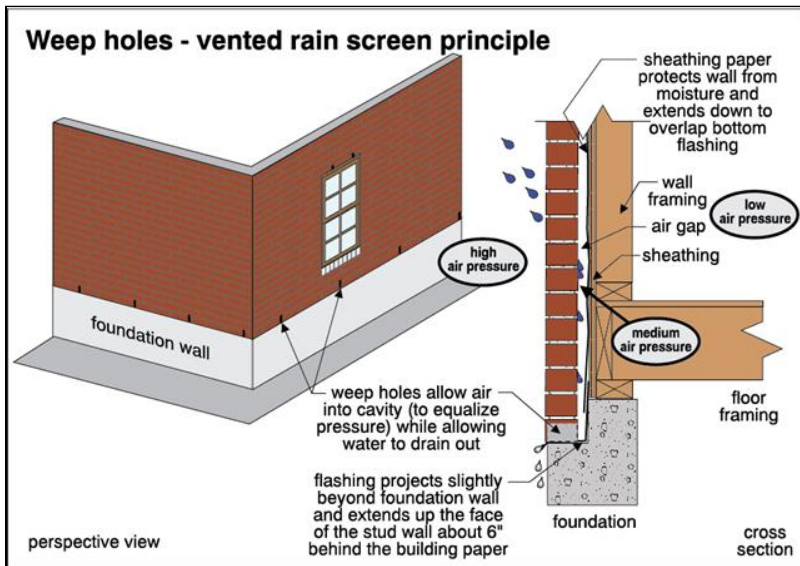
3.0 Item 1(Picture)

**3.0** No weep holes were found on the brick veneer. Weep holes are openings close to the bottom of the brick mortar joints that allow drainage. They are also recommended over door and window openings. Felt paper as well as metal flashing are commonly used for this purpose but cannot be seen without removal of the brick. Any water that might enter behind the brick against wood could cause decay. No visible signs of damage was found during the inspection. It is recommended that these weep holes be installed. A qualified masonry contractor should further investigate and correct if needed.

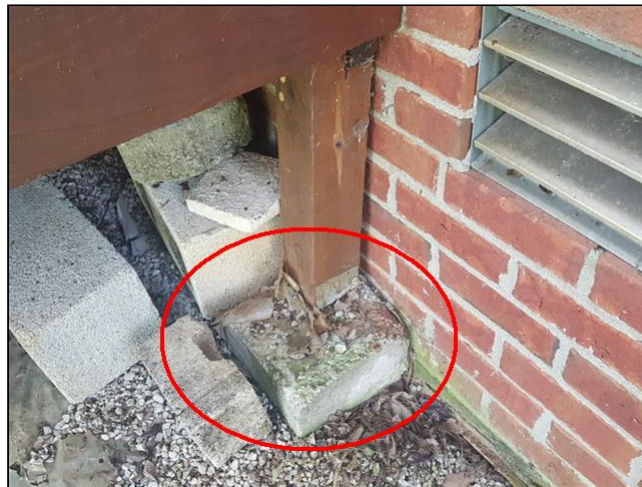
3.5 Item 2(Picture)

**3.5 (1)** Some of the concrete footers have settled creating the post to pull away and tilt from the band board. Over time further settlement of the footers may cause the deck to possibly fail in the future. This is a safety issue. Recommend a qualified contractor repair as needed to ensure structural integrity of the deck and to prevent further settlement or leaning of the posts.

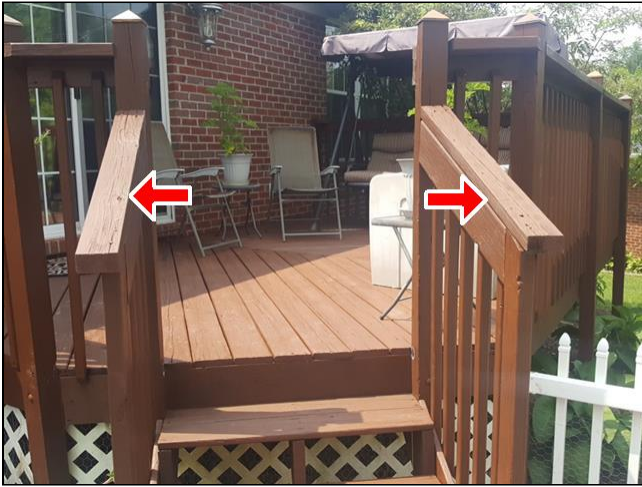
3.5 Item 3(Picture)

**3.5 (2)** 2x4s are installed for handrails for the deck staircase and are not considered "gripable" by industry standards. This is a safety issue and an injury could occur if not corrected. Recommend that a standard approved handrail be installed for safety by a general contractor.

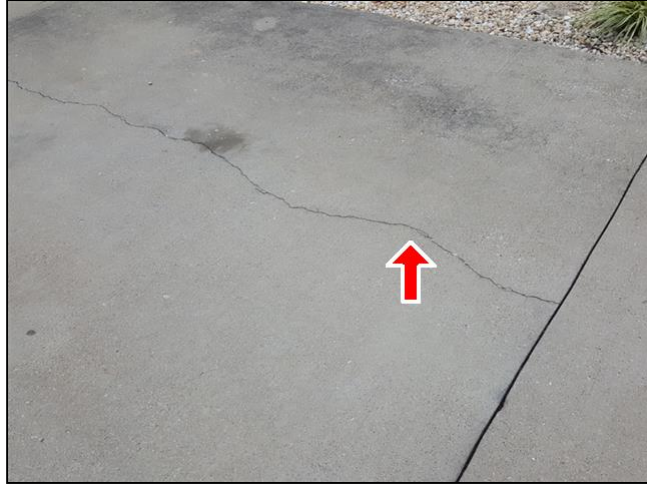
3.6 Item 1(Picture)

**3.6** (1) Common settlement crack(s) were noted at the concrete drive. This is not a tripping hazard as yet at this time. I also do not see these small cracks as an indication of a structural issue. Further deterioration and/or settlement can occur to the driveway via water intrusion if not repaired. Recommend repairs via a masonry caulk as needed then monitor annually. Here is a link for [Sealing Concrete Cracks](#)

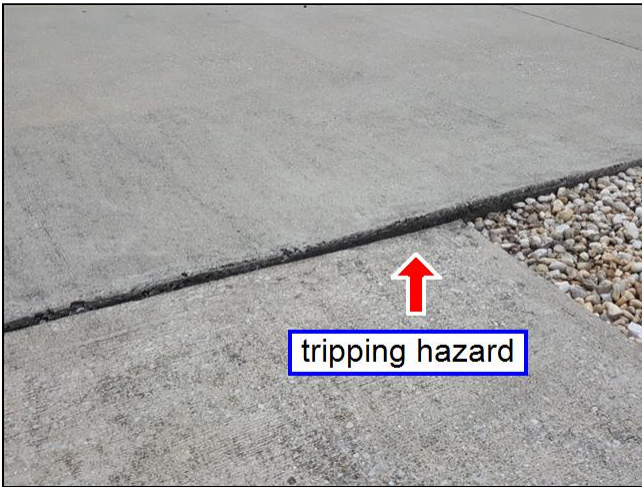
3.6 Item 3(Picture)

**3.6** (2) The front walkway has settled where it butts up to the driveway creating a possible tripping hazard. I do not see this as an indication of a structural issue. However, for safety and to prevent a tripping hazard and a fall or injury from occurring, recommend a qualified masonry contractor repair as needed.

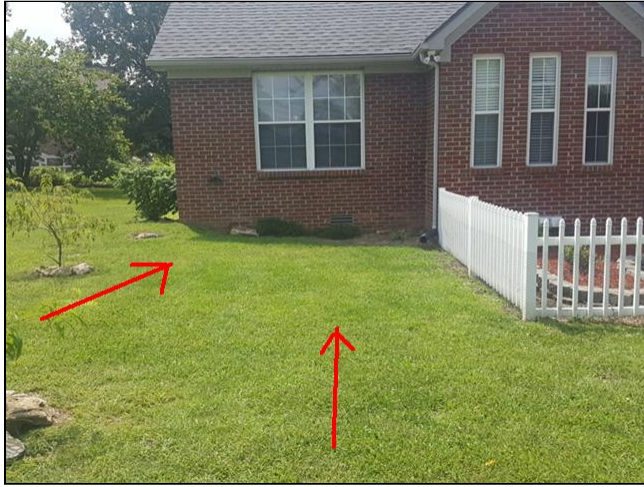
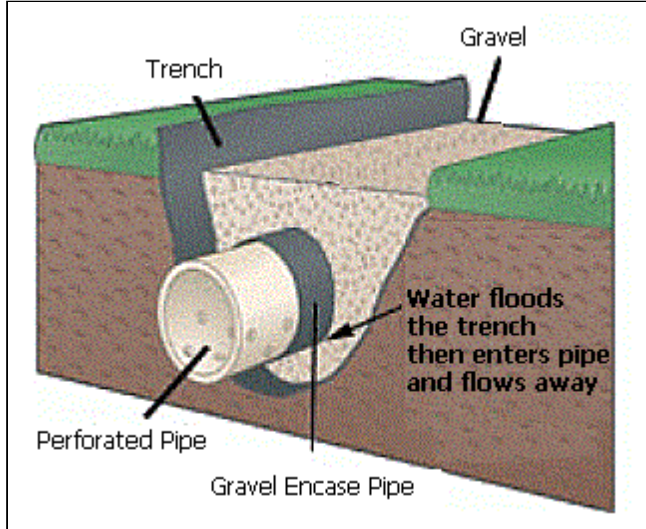
3.8 The grade of soil naturally flows towards the rear left side of the home. Cannot determine if this will cause water pooling against the foundation of the home. Recommend this be monitored when heavy rains are experienced. If water does pool in this area then installing a french drain or a swale by a qualified contractor to prevent water impingement against the foundation wall is strongly recommended. This will avoid moisture and water intrusion in the crawlspace and prevent possible settling of the foundation perimeter of the home.

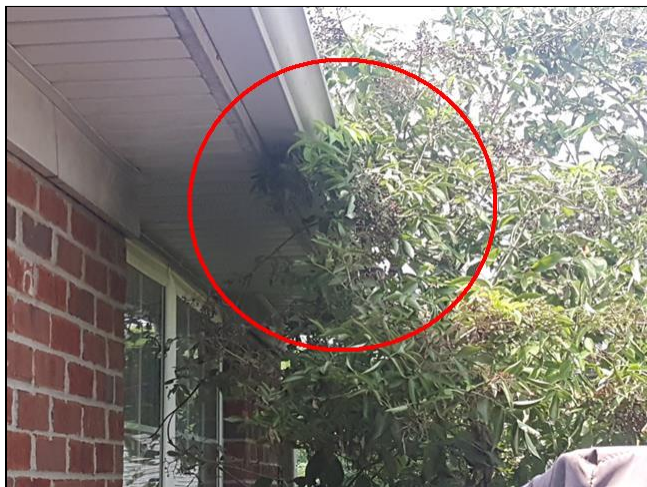
3.9 Item 1(Picture)

**3.9** The shrub at the rear left corner of the home could disrupt gutter, cause mechanical damage to the exterior of home or influence the foundation over time. It would be wise to consider trimming or removal of the shrub. Also recommend that shrubs or bushes be kept neatly trimmed and away from the exterior of home, a minimum of six inches to allow proper venting.

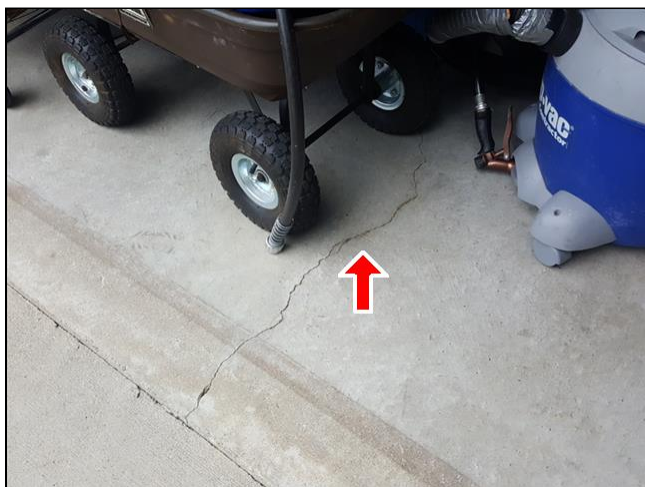
4.2 Item 1(Picture)

**4.2** The garage flooring has typical cracks in areas highlighted in photos. These cracks do not appear significant and seem typical. Cracks that are usually 1/8 inch or wider are need for concern. The cracks are usually the result of shrinkage and/or settling of the slab. Recommend these cracks be sealed then apply an epoxy coating on the floor to ensure water intrusion does not occur. It is recommended that you monitor annually after repairs. If these cracks should reoccur a masonry contractor who is familiar with foundation repair should be consulted. [Caulk for Concrete Cracks](#)

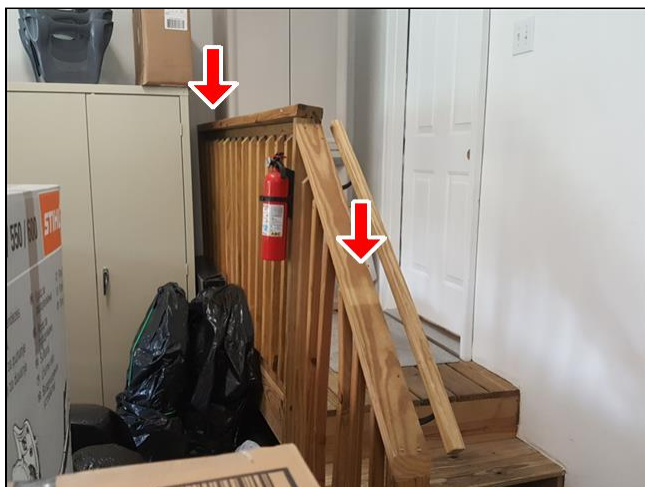
4.5 Item 1(Picture)

**4.5** [The guard rail and stair case rails in the garage are loose, unstable and not secured properly. This is extremely dangerous and is a major safety concern. It may fail under a medium or heavy force or if someone was pushed against or was leaning on the railing. For your safety it should be strengthened and secured. Recommend a qualified contractor repair as needed before closing.](#)

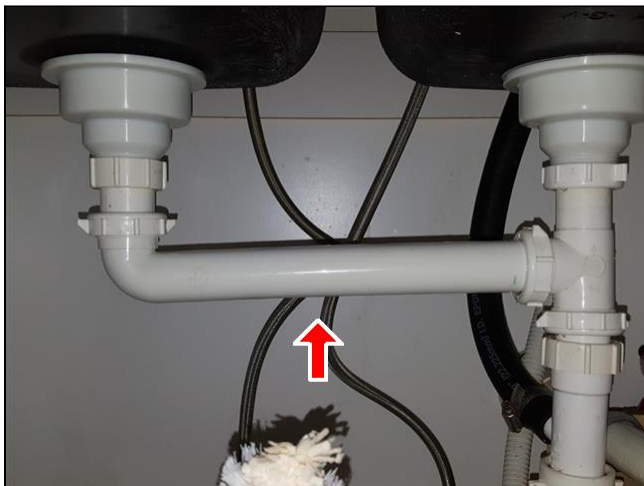
5.1 Item 1(Picture)

**5.1** The disposal drain line is incorrectly pitched to the sink drain line from the disposal unit under the sink in the kitchen. This can cause the drain line to clog. Recommend a qualified plumber correct as needed.

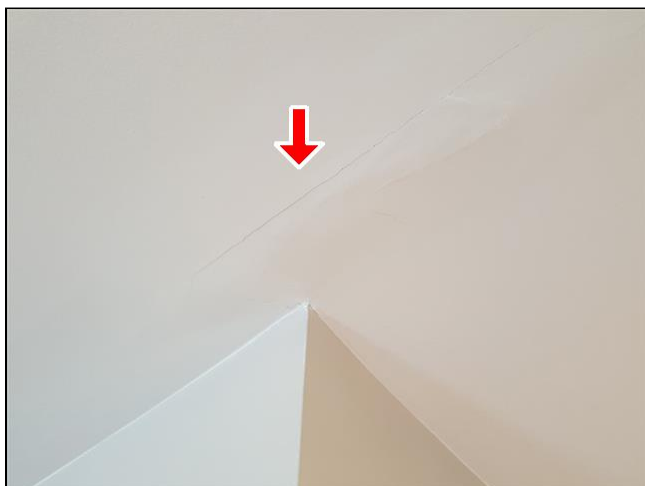
6.0 Item 2(Picture)

**6.0** (2) The drywall has a vertical shrinkage/settlement crack(s) where the ceiling meets in the dining room. Most minor cracking is due to shrinkage of construction materials. The crack is considered to be cosmetic and a small repair issue for your information. Recommend prep prime and paint as needed.

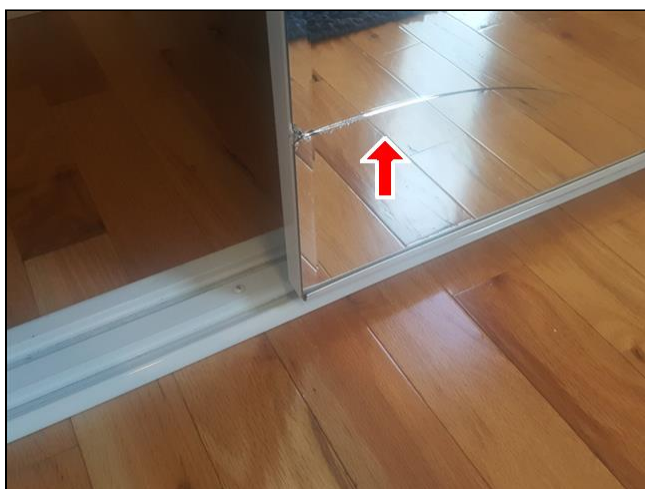
6.6 Item 1(Picture)

**6.6** The mirrored closet door in the 3rd bedroom is cracked. This is a potential safety issue as a person or child could be injured or be cut. Recommend replacement as needed by a general contractor.

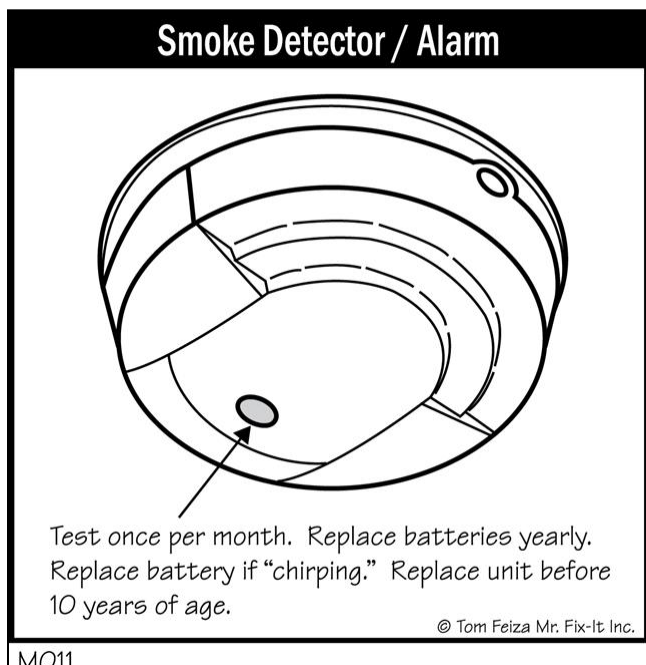
6.8 Item 1(Picture)

**6.8 (1)** Testing of smoke and CO detectors is not part of a home inspection. We do not want to create a false alarm. All detectors in the home exhibit the active green light which indicates they are on and functioning. Recommend the smoke detectors be tested at common hallway to bedrooms upon moving in to home. Note: If the smoke/CO alarm is 10 years old or older, recommend replacement. Ensure the smoke alarm is a photoelectric type. Here is a link explaining type of alarm to use by the [Dept. of Fire and Emergency Services](#)

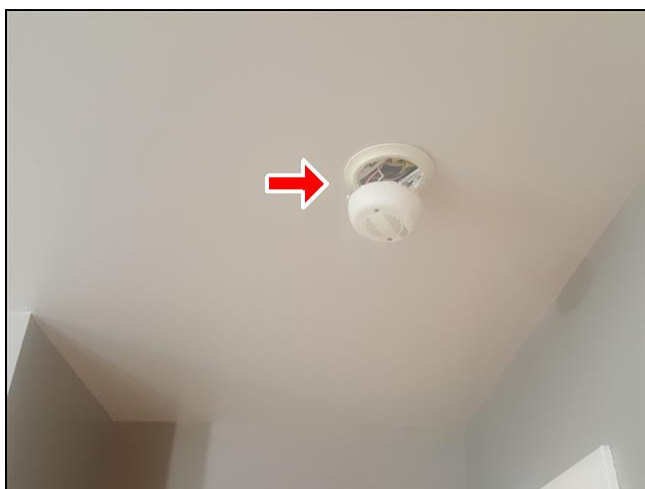
6.8 Item 2(Picture)

**6.8 (2)** The smoke detectors are hanging loose at the ceiling in the 2nd Bedroom. These may not be working due to contacts are not connected correctly. It is also placing strain at the connections which could result in detectors not functioning. Recommend these be secured to the ceiling prior to moving in, then tested to ensure they are working.

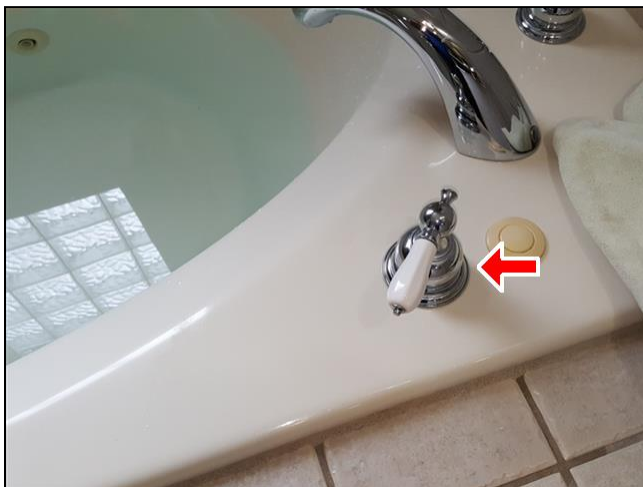
7.4 Item 1(Picture)

**7.4 (1)** The control knob on the cold water faucet leaks at the jacuzzi when moved abruptly in the master bathroom. New seals maybe needed. Recommend a licensed plumber repair or replace as needed.

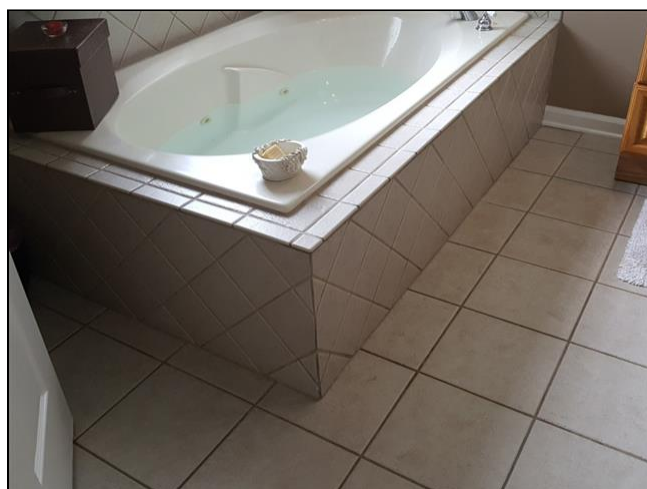
7.8 Item 2(Picture)

**7.8** (2) Access to the pump and drain lines for the jacuzzi tub was not present or could not be found. Could not check for leaks at the pipes or pump. Check with the owner for location. If one is not found would recommend an access point be installed in the event servicing of the pump or pipes need to be worked on.

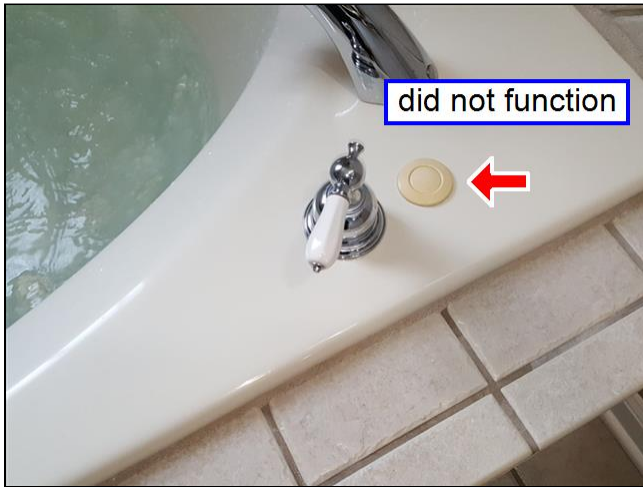
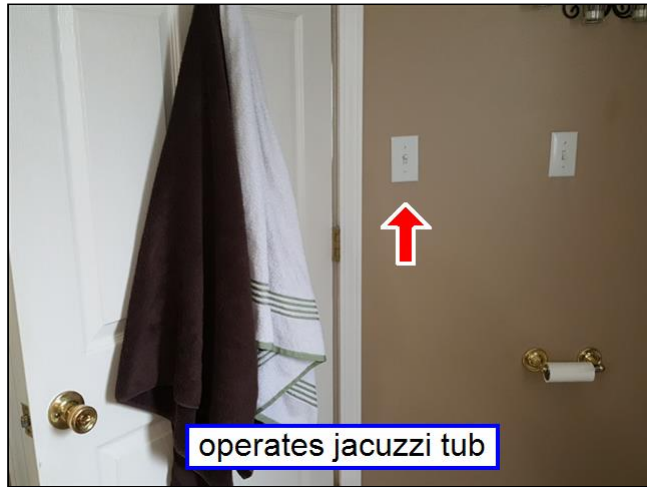
7.8 Item 3(Picture)

7.8 (3) The on/off switch for the operation of the pump for the jacuzzi does not function at the tub. The unit was operated at the wall switch in the bathroom. Recommend an electrician repair or replace switch as needed for ease of use.

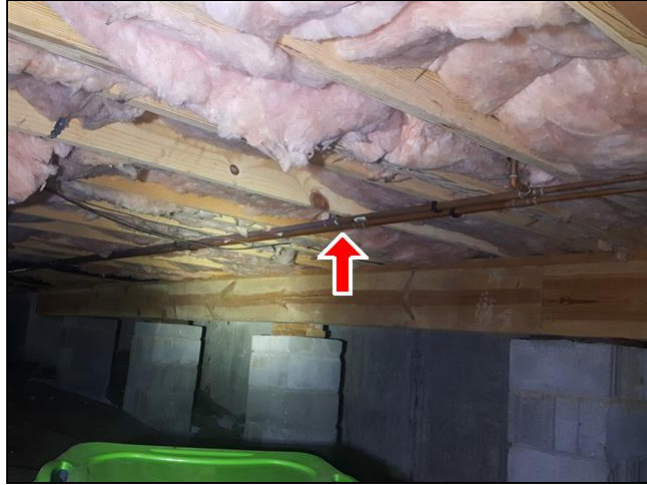
8.1 Item 1(Picture)

8.1 (2) Recommend insulating the water supply pipes underneath in the crawlspace (hot and cold) to ensure pipes do not freeze in winter which may cause a serious plumbing leak in the crawlspace, and to prevent heat loss of water when hot water is flowing into home. This will improve efficiency. This is for your information.

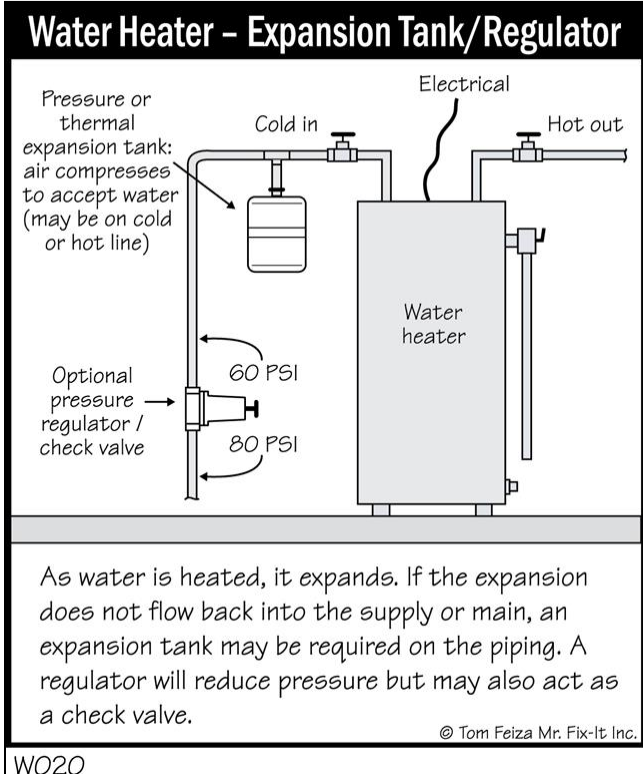
8.2 Item 1(Picture)

**8.2 (2)** Your water heaters do not have a "Thermal Expansion tank" installed to prevent a possible leak at the TPR or "pop-off" valve. If the water pressure gets high enough it can damage valves in the plumbing fixtures, joints in the supply pipes and even the water heater. Thermal expansion always occurs in water heaters. Like most substances, water expands as it is heated. There were no visible leaks or drips at the TPR valve during the inspection. If your water heater does begin to drip or leak, then a thermal expansion tank may be needed. This is for your information.

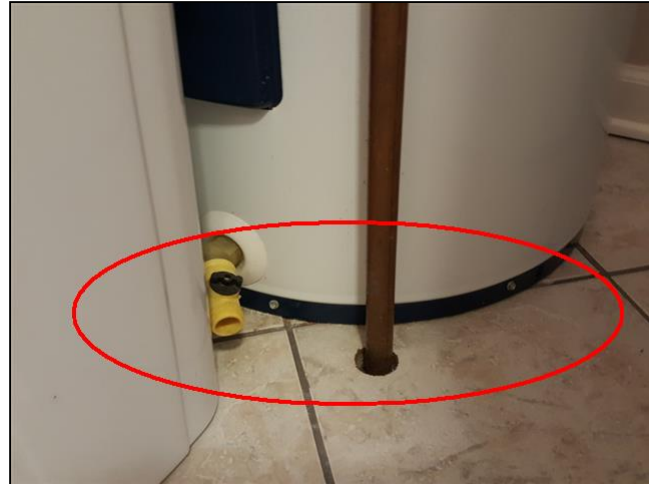
8.2 Item 2(Picture) right unit

8.2 (3) The water heater on a finished floor has the potential to cause severe damage if a leak should develop. Consider installing a drain pan under the water heater to prevent damage to the home if a leak develops. This will allow any water leaks to safely drain without damaging the finished materials, floor or furnishings. A qualified plumber could examine and install the drainage pan and drain line, but may need to install a drain line with a trap to the current drainage system. As an inexpensive safe-guard a drain pan with a moisture alarm can easily be installed as another option. Recommend a qualified plumber make the necessary corrections if desired.

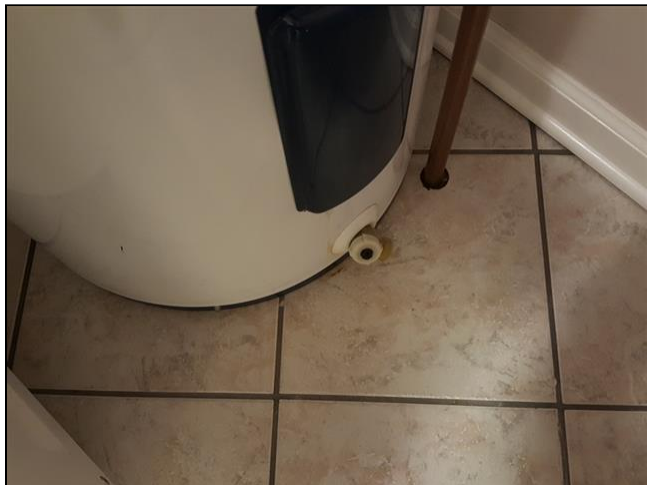
8.3 Item 1(Picture) right unit

**8.3** (1) Could not identify or visibly see where the drainage for the TPR line for both water heaters is draining to the exterior. Recommend contacting the owner for location. The TPR drain line maybe located in the crawlspace. Water should not be dumped in a crawlspace as it can lead to mildew or mold on building materials and perhaps deterioration of the wood floor structure. The drain line(s) should exit to the exterior of the home and kept away from the foundation structure. Recommend a licensed plumber correct if needed.

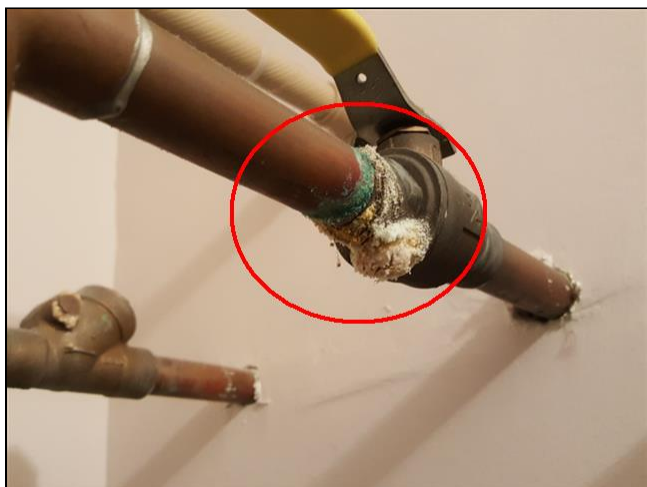
8.3 Item 3(Picture)

**8.3** (2) The stop-valve has corrosion at the cold water line above the water heater in the Washer/Dryer room. There was no leaking of water at the time of the inspection. However recommend this be monitored for leakage and if it does replacement of the shutoff valve is recommended to prevent damage to the top of the water heater. Would also strongly recommend this valve be replaced when a new water heater is installed. A qualified licensed plumber should repair or correct as needed.

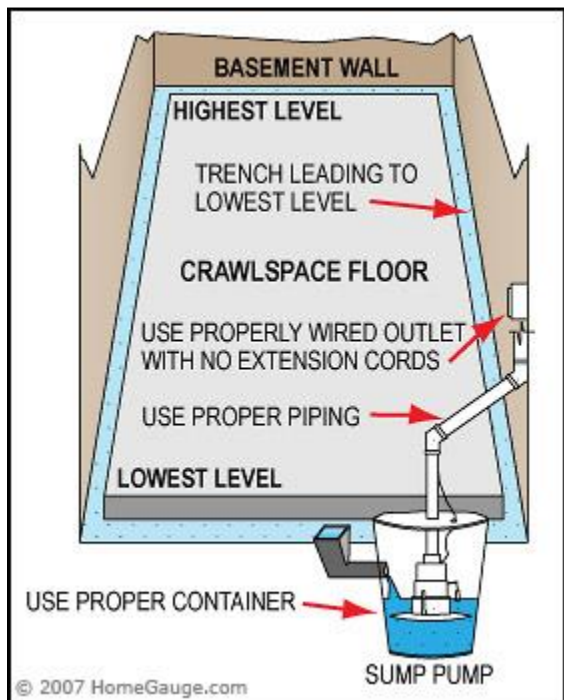
#### 8.5 Item 1(Picture)

**8.5** You may wish to consider installing a sump pump in the crawlspace in the event that if a serious plumbing leak occurs due to freezing water pipes or an elevated water table to prevent possible damage in the crawlspace which can lead to costly repairs. This is for your information.

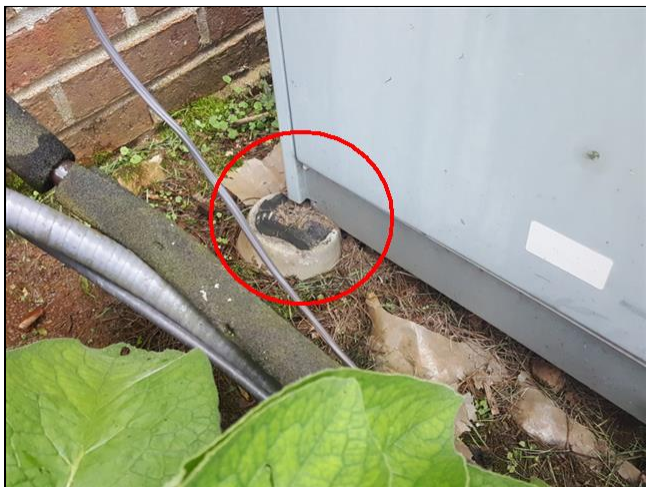
10.0 Item 3(Picture)

**10.0** (3) The plat form foot for the Heat Pump unit is not supporting the corner of the unit correctly. Over time this may settle further causing the unit to fall of it's support which could result in a leak at the large suction line. It could also result in the unit to be unstable. Recommend a qualified HVAC contractor correct as needed to avoid this in the future.

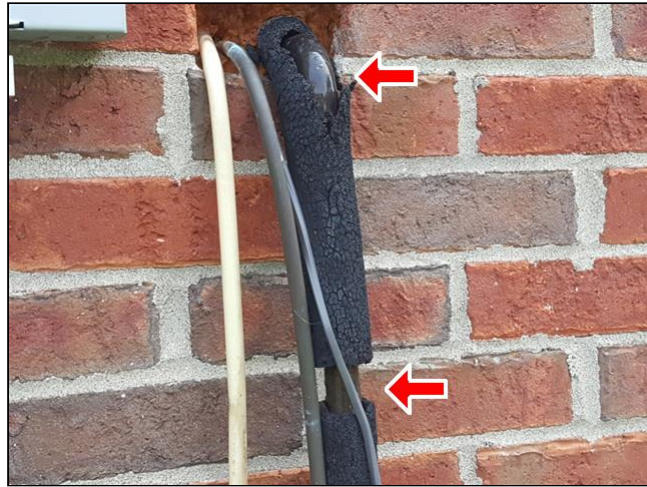
10.3 Item 4(Picture)

**10.3 (2)** The foam sleeve on the large suction line for the outside Heat Pump is deteriorated and missing at areas. This can cause condensation and increased system operating costs via the unit not operating efficiently. This is a small repair. This insulation is to maintain or stabilize the temperature of the gas used in the system. The outside temperature can influence this gas and cause efficiency fluctuations of the unit. Recommend installing a new sleeve, this will help maintain efficiency of the compressor.

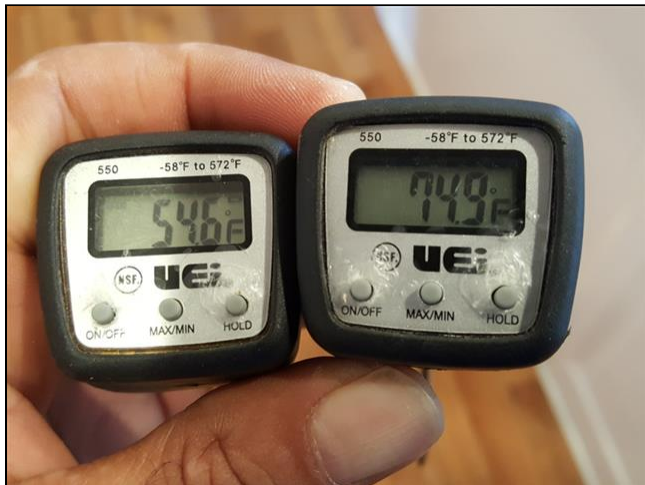
10.7 Item 1(Picture)

**10.7** The ambient air test was performed by using thermometers at the registers closest to the blower to determine if the difference in temperatures of the supply and return air are between 14 degrees and 22 degrees which indicates that the unit is cooling as intended. The supply air temperature on your system read 54 degrees, and the return air temperature was 74 degrees. This indicates the range in temperature drop is normal.

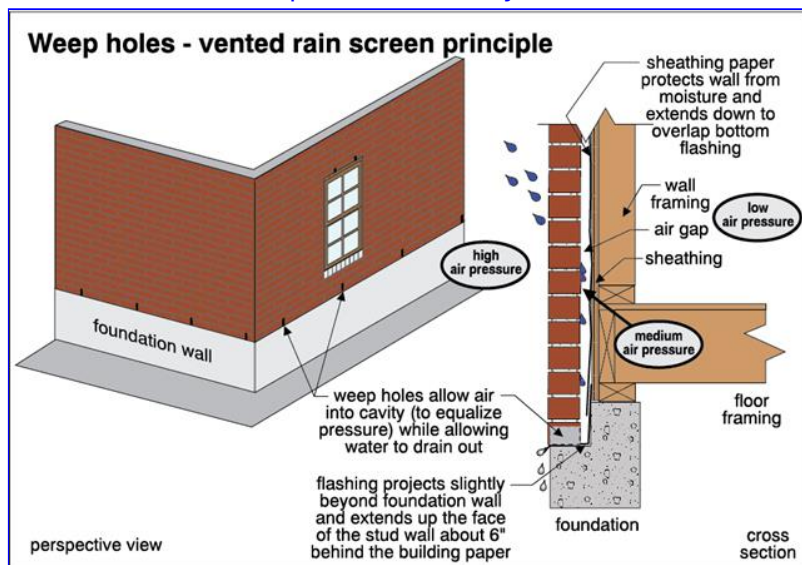
3.0 Item 1(Picture)

No weep holes were found on the brick veneer. Weep holes are openings close to the bottom of the brick mortar joints that allow drainage. They are also recommended over door and window openings. Felt paper as well as metal flashing are commonly used for this purpose but cannot be seen without removal of the brick. Any water that might enter behind the brick against wood could cause decay. No visible signs of damage was found during the inspection. It is recommended that these weep holes be installed. A qualified masonry contractor should further investigate and correct if needed.

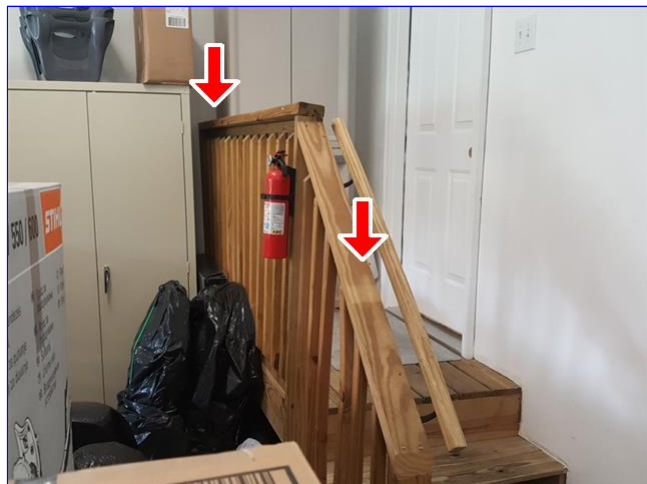
4.5 Item 1(Picture)

The guard rail and stair case rails in the garage are loose, unstable and not secured properly. This is extremely dangerous and is a major safety concern. It may fail under a medium or heavy force or if someone was pushed against or was leaning on the railing. For your safety it should be strengthened and secured. Recommend a qualified contractor repair as needed before closing.

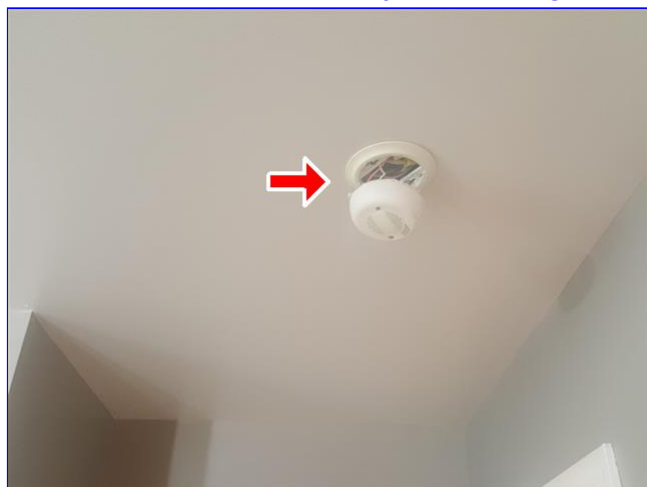
6.8 Item 2(Picture)

could result in detectors not functioning. Recommend these be secured to the ceiling prior to moving in, then tested to ensure they are working.

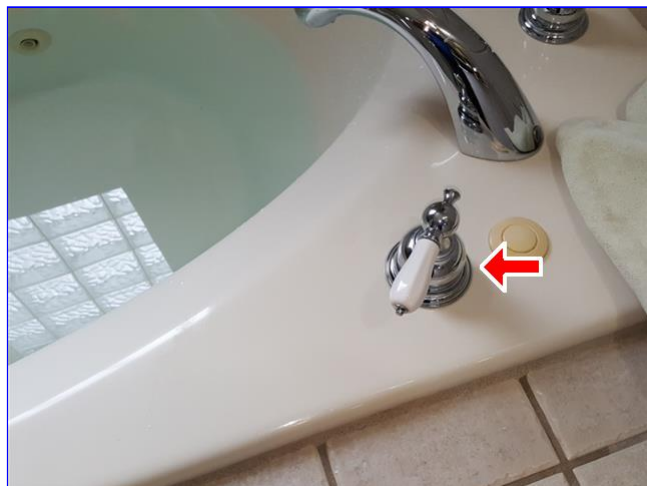
7.4 Item 1(Picture)

(1) The control knob on the cold water faucet leaks at the jacuzzi when moved abruptly in the master bathroom. New seals maybe needed. Recommend a licensed plumber repair or replace as needed.

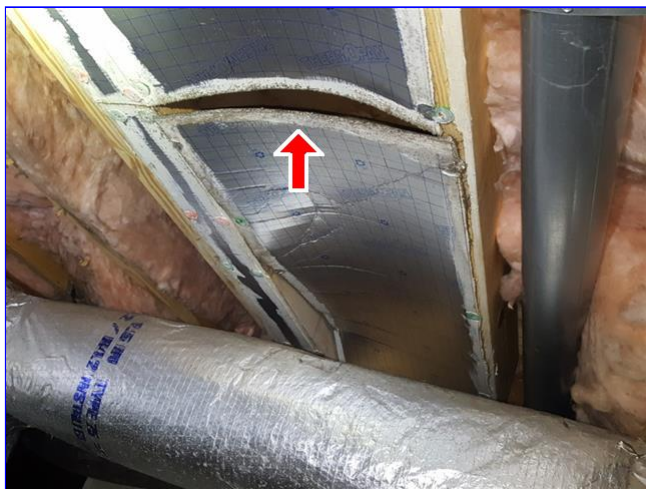
10.4 Item 1(Picture)

(2) The return air duct is not sealed at the plenum at the Air Handler in the crawlspace. This is allowing unfiltered air in the crawlspace to enter the home via the blower which is allowing contaminants to enter the unit. This is a health issue. This can also cause damage to the unit and blower, increase heating/cooling costs. Recommend a qualified HVAC repair ductwork where necessary.

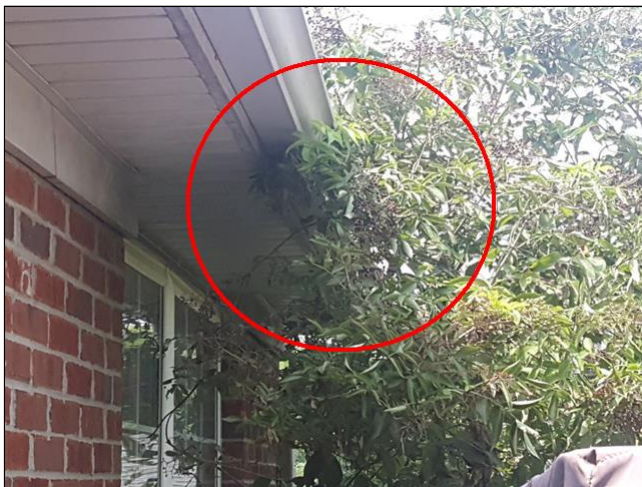
3.9 Item 1(Picture)

The shrub at the rear left corner of the home could disrupt gutter, cause mechanical damage to the exterior of home or influence the foundation over time. It would be wise to consider trimming or removal of the shrub. Also recommend that shrubs or bushes be kept neatly trimmed and away from the exterior of home, a minimum of six inches to allow proper venting.
