# RIO GRANDE DIVERSION INFRASTRUCTURE INVENTORY

**Structure Name:** SAN JOSE OR LUCERO D

**Date:** April 1, 2019

PHOTO LOG

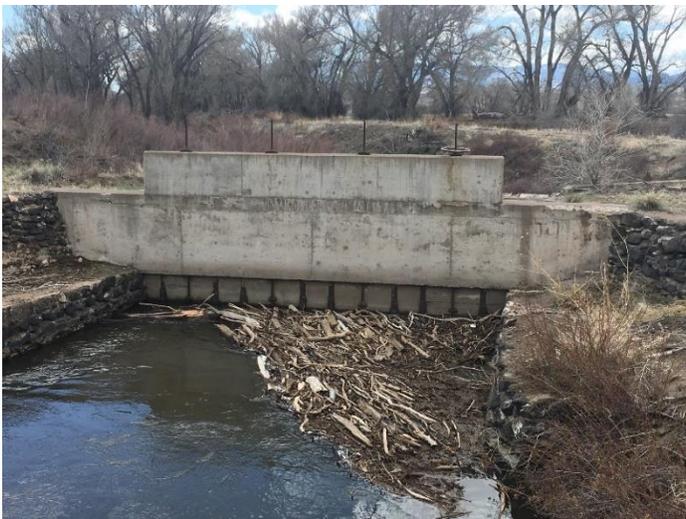
River headgate

**Repair(s) or Improvement(s) Currently Needed:** The main headgate functions well. Significant Woody debris accumulates at the river headgate. This could be mitigated with an improved trash rack. The river headgate is also aging and may need significant repairs in the near future. To improve efficiency and decrease annual maintenance, this ditch's diversion and river headgate could be combined with Monte Vista Canal. The flume has heaved and needs to be reset. Additionally, significant erosion has occurred downstream of flume, which needs to be mitigated. Fish and boat passage, as well as riparian restoration should be considered as part of any repairs or improvements to this structure's diversion dam on the Rio Grande.
