DEPARTMENT OF REGULATORY
AND ECONOMIC RESOURCES

MINIMUM INSPECTION PROCEDURAL GUIDELINES
FOR BUILDING ELECTRICAL RECERTIFICATION

- a. Name on Title: Village at Dadeland Condominiums (E)
- b. Street Address: 7360 SW 82nd St. Miami, Florida 33143
- c. Legal Description: Village at Dadeland Condominiums
- d. Owner's Name: Village at Dadeland Condominiums
- e. Owner's Mailing Address: 7360 SW 82nd St. Miami, Florida 33143
- f. Folio Number of Property on which Building is Located: 30-4035-047-XXXX
- g. Building Code Occupancy Classification: R2 - Residential
- h. Present Use: Condominium, Residential
- i. General Description, Type of Construction, Size, Number of Stories, and Special Features

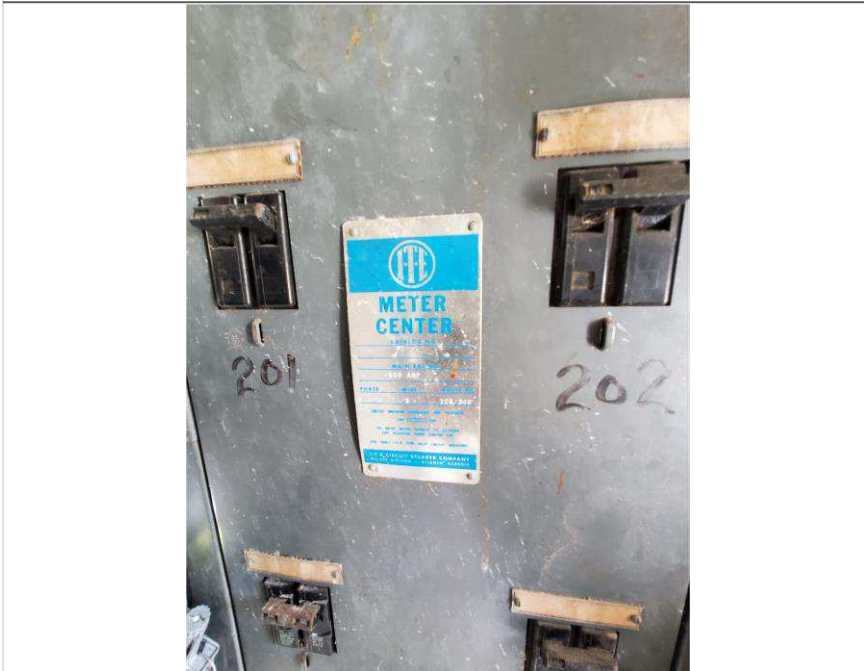
Photo 9 – Village of Dadeland Condominium Association

Existing Electrical Room - 1st FL
Apartment Meters and Main
Switches

Old and oxidized meter stacks.

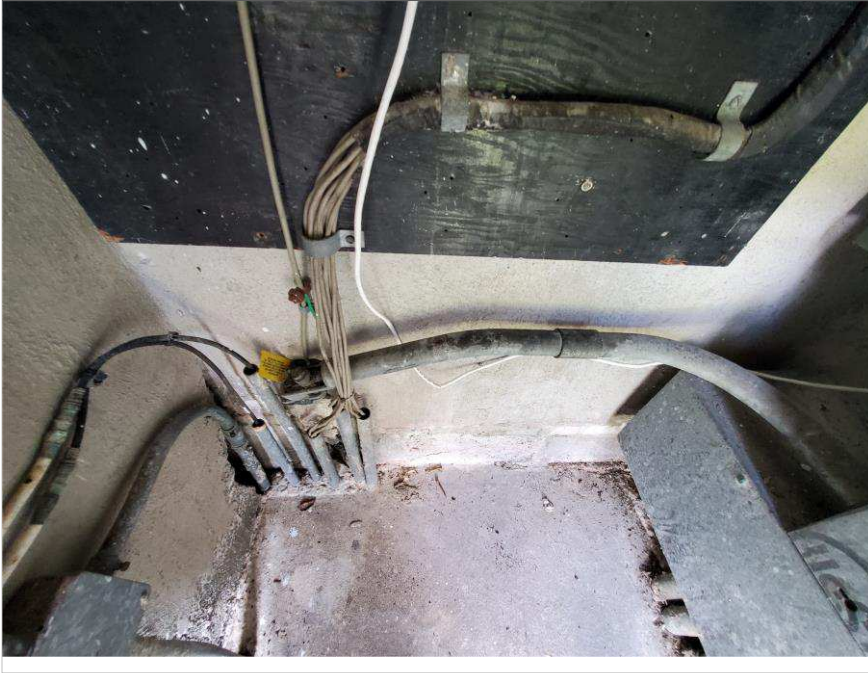
Photo 11 – Village of Dadeland Condominium Association

Existing Electrical Room - 1st FL
Main Service - Grounding

Grounding resistance to be tested to determine if repairs and/or maintenance are required.

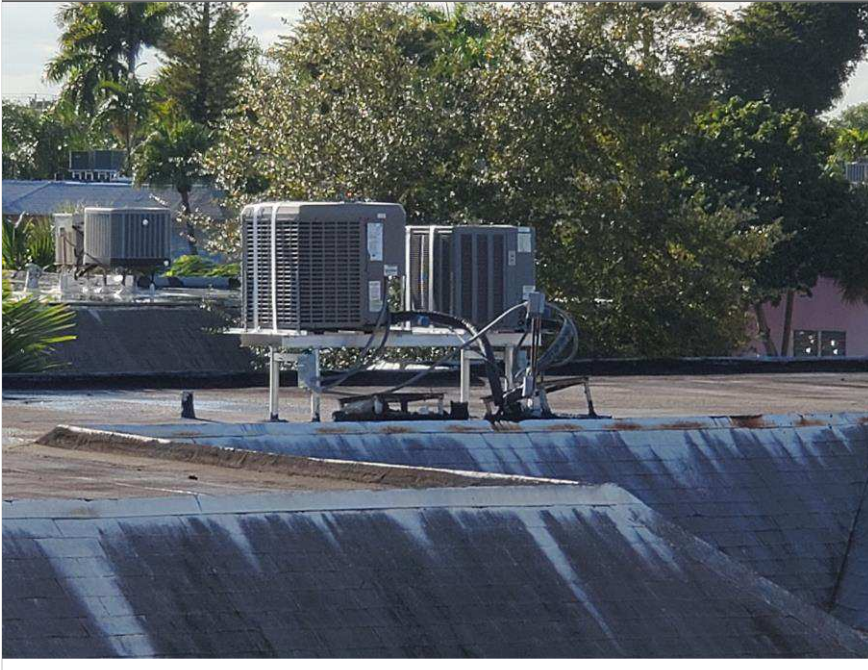
Photo 12 – Village of Dadeland Condominium Association

Rooftop -
Rooftop Condenser Units -

Junction boxes not properly supported.

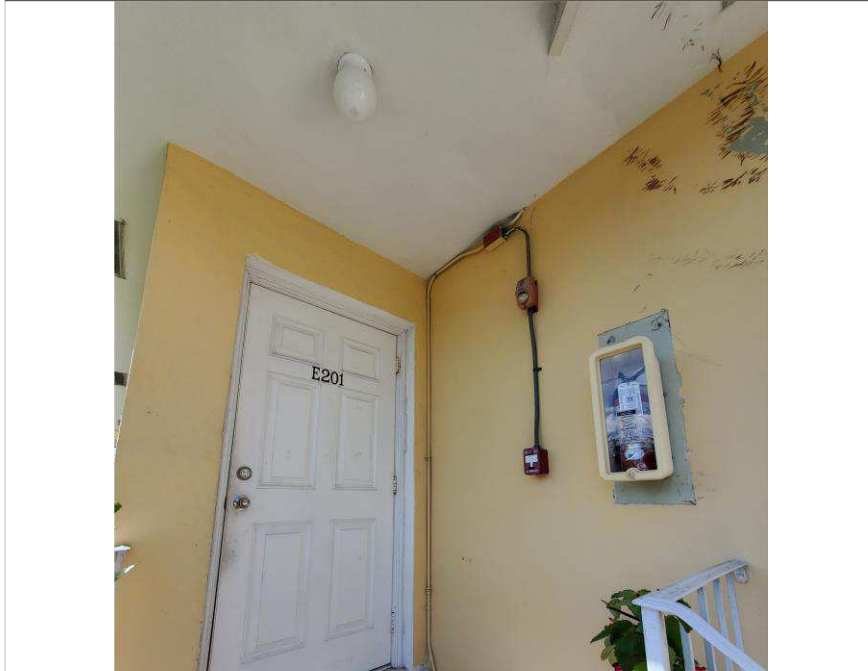
Photo 15 – Village of Dadeland Condominium Association

Level 2

Fire Alarm - Old and Weathered
Fire Alarm Devices and Control
Center

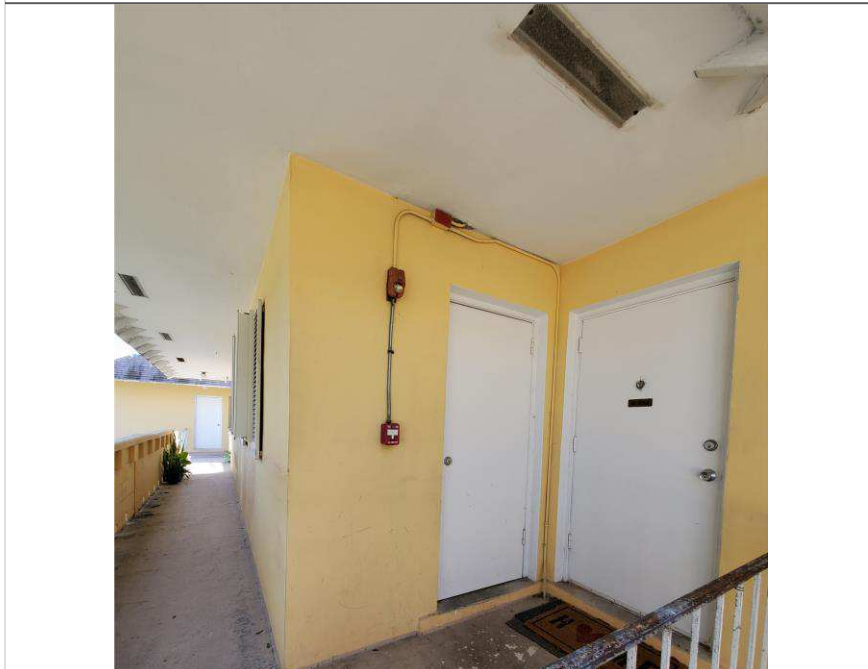
Photo 16 – Village of Dadeland Condominium Association

Level 2

Fire Alarm - Old and Weathered
Fire Alarm Devices and Control
Center

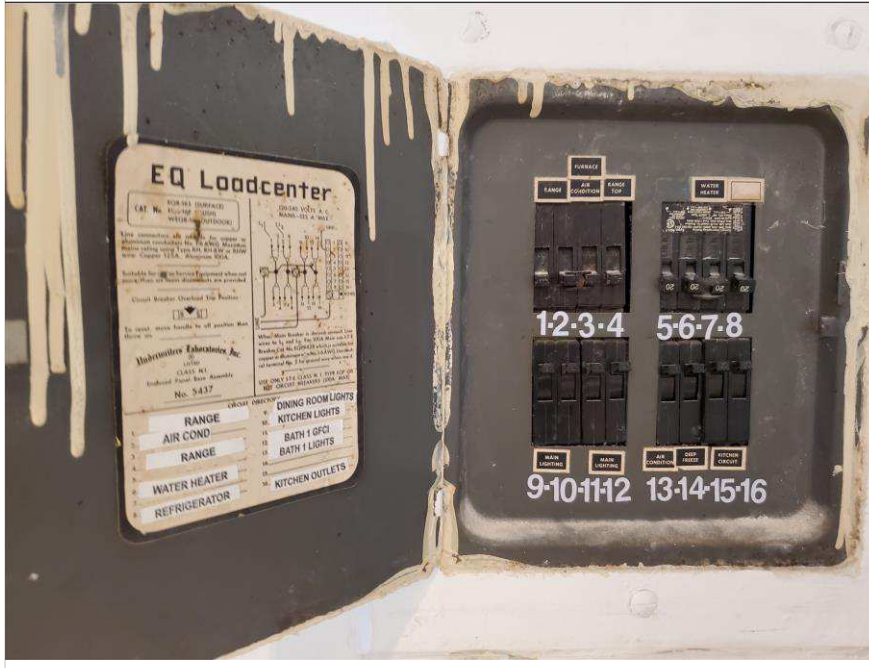
Photo 17 – Village of Dadeland Condominium Association

Apartments - Old Electrical Panels

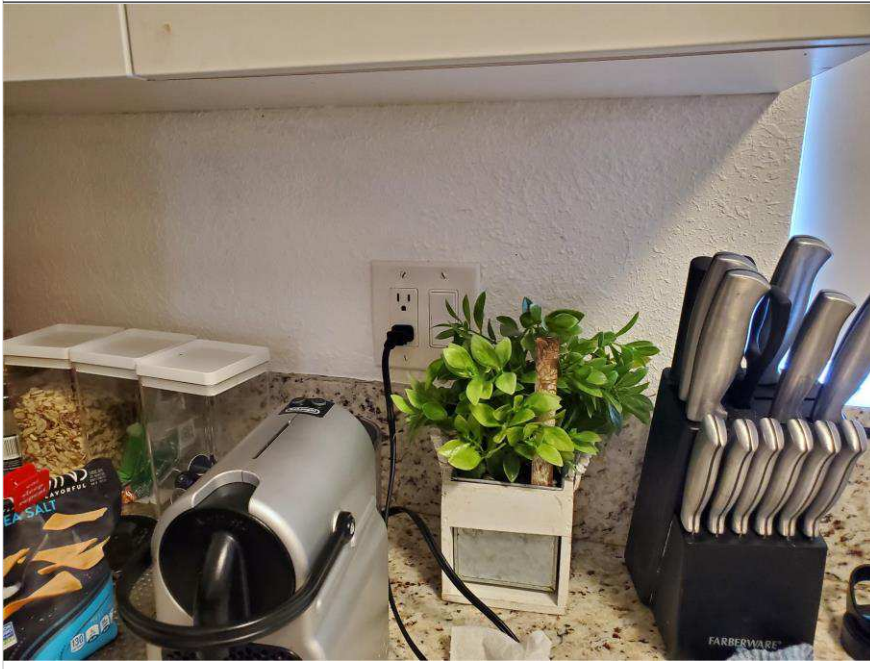
Photo 19 – Village of Dadeland Condominium Association

Apartments - Kitchen outlets

Kitchen outlet to be GFCI type
and properly wired.

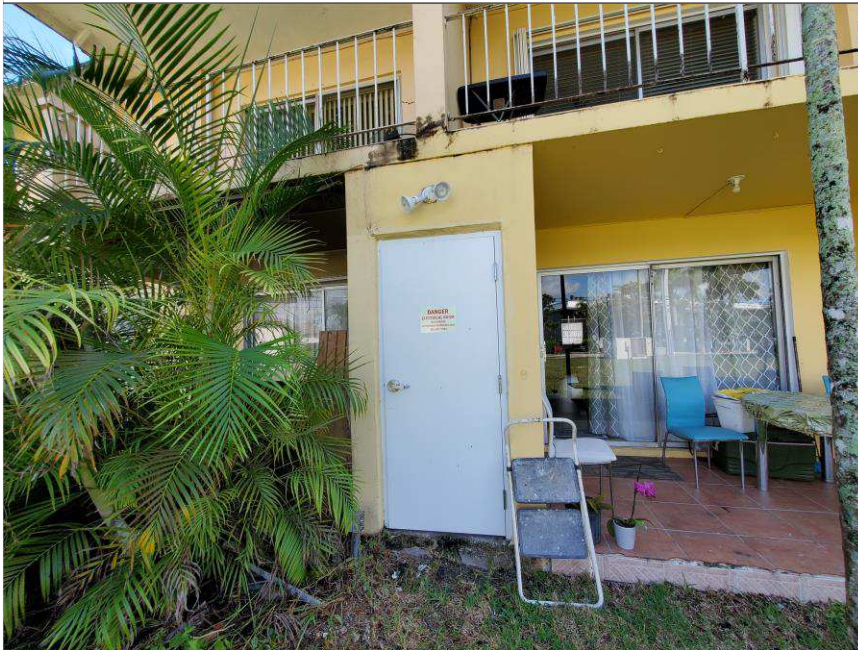
Photo 1 – Village of Dadeland Condominium Association

Existing Electrical Room - 1st FL
No Storage Permitted

Building Number sign is missing.

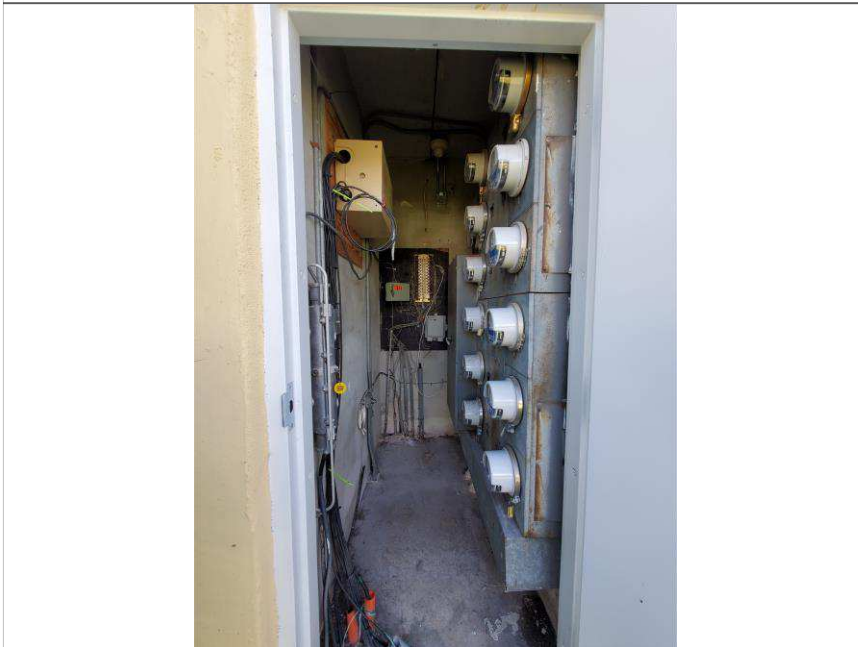
Photo 2 – Village of Dadeland Condominium Association

Existing Electrical Room - 1st FL
Main Switches for Apartments,
Meters, and Gutter.

Insufficient clearance in front of
electrical components.

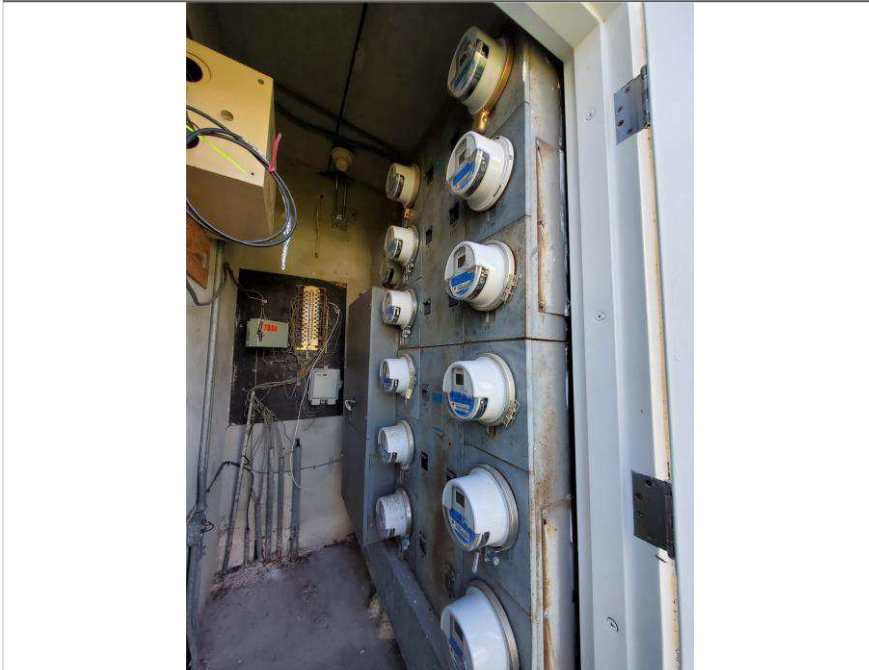
Photo 8 – Village of Dadeland Condominium Association

Existing Electrical Room - 1st FL
Main Switches for Apartments,
Meters, and Gutter.

Old and oxidized meter stacks.

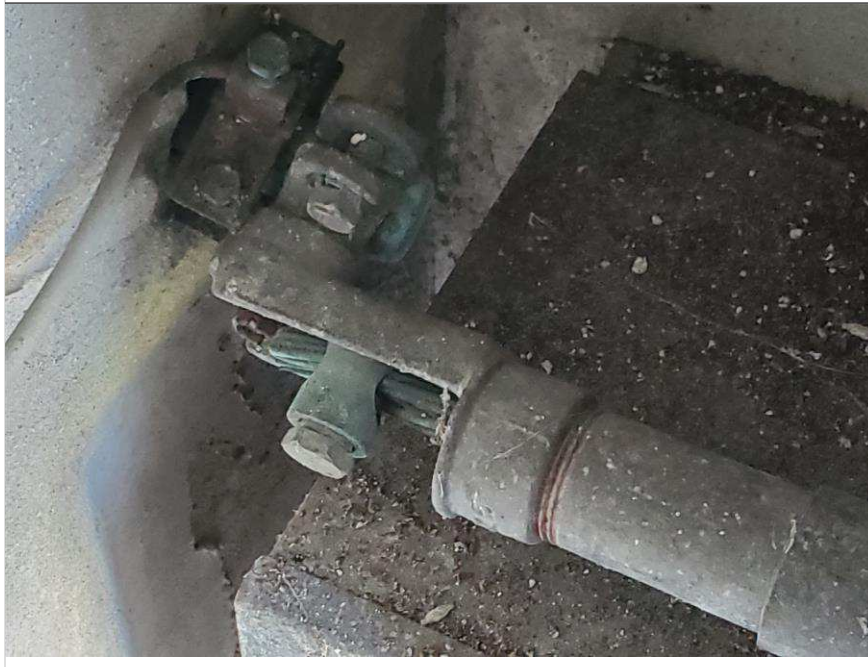
Photo 12 – Village of Dadeland Condominium Association

Existing Electrical Room - 1st FL
Main Service – Grounding

Grounding resistance to be
tested to determine if repairs
and/or maintenance are
required.

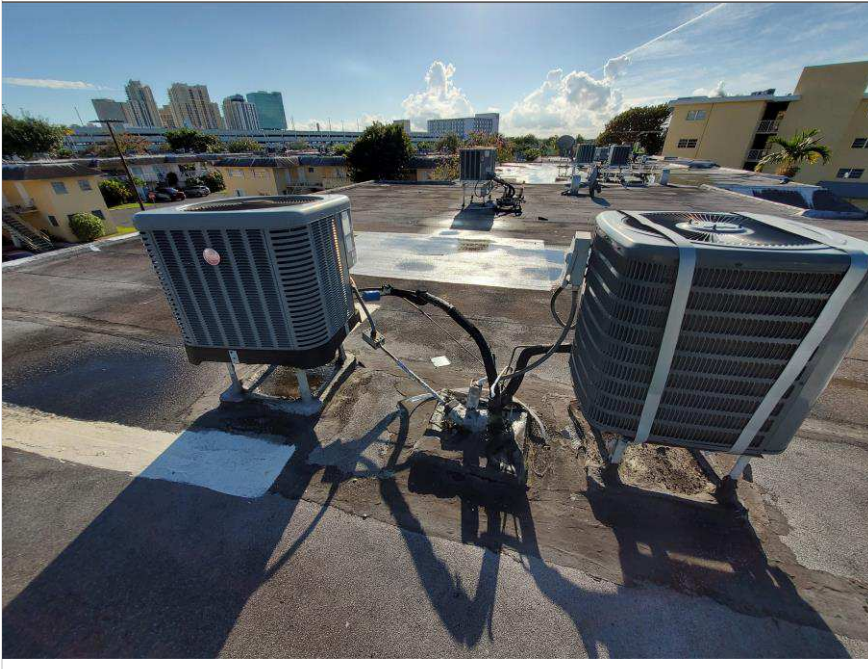
Photo 13 – Village of Dadeland Condominium Association

Rooftop Condenser Units -
Oxidized junction boxes and
conduits.

Junction boxes not properly
supported.

Missing disconnect switches.

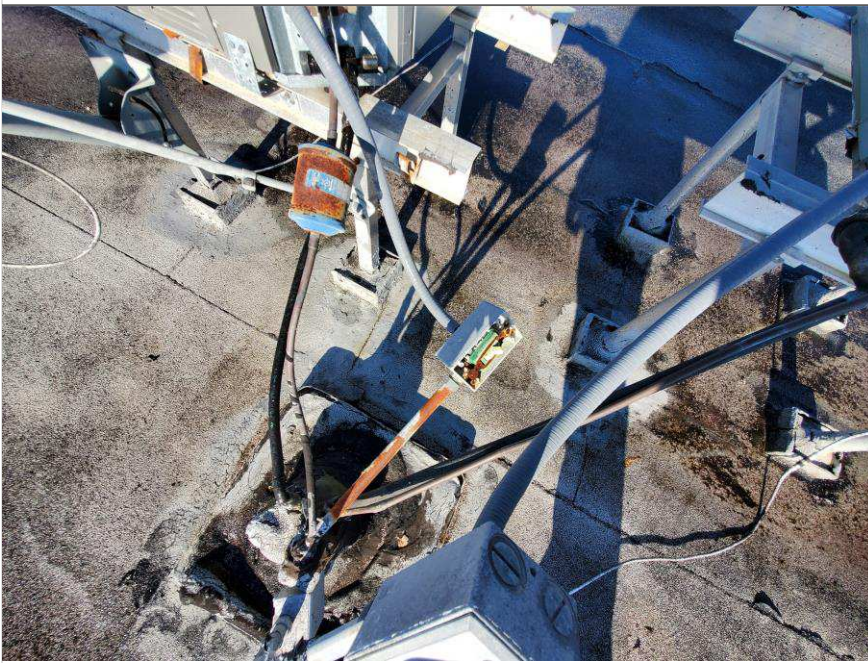
Photo 14 – Village of Dadeland Condominium Association

Rooftop Condenser Units -
Oxidized junction boxes and
conduits.

Junction boxes not properly
supported.

Missing disconnect switches.

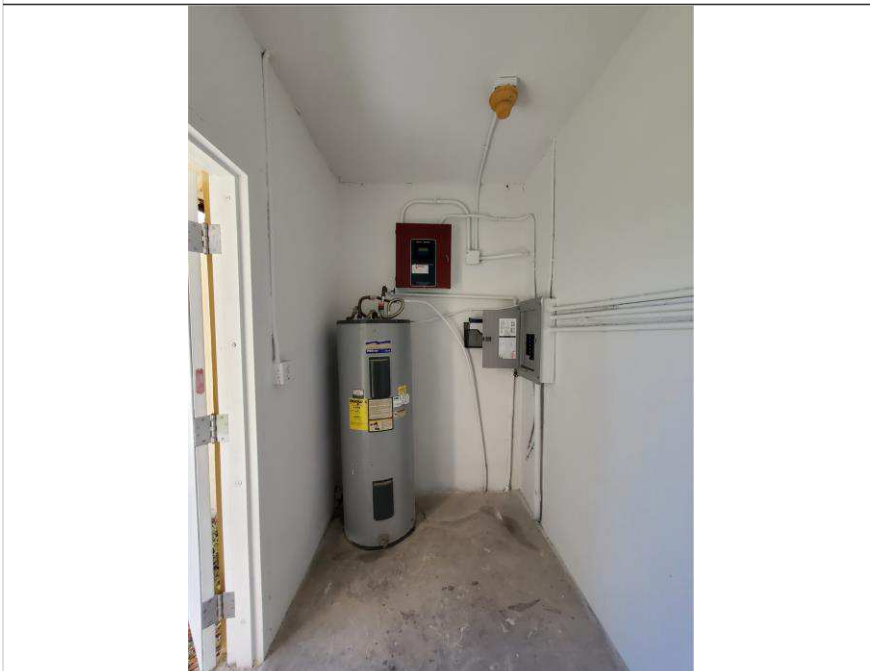
Photo 16 – Village of Dadeland Condominium Association

1st floor - Laundry/Water Heater
Room:

Fire Alarm - Old and Weathered
Fire Alarm Devices and Control
Center

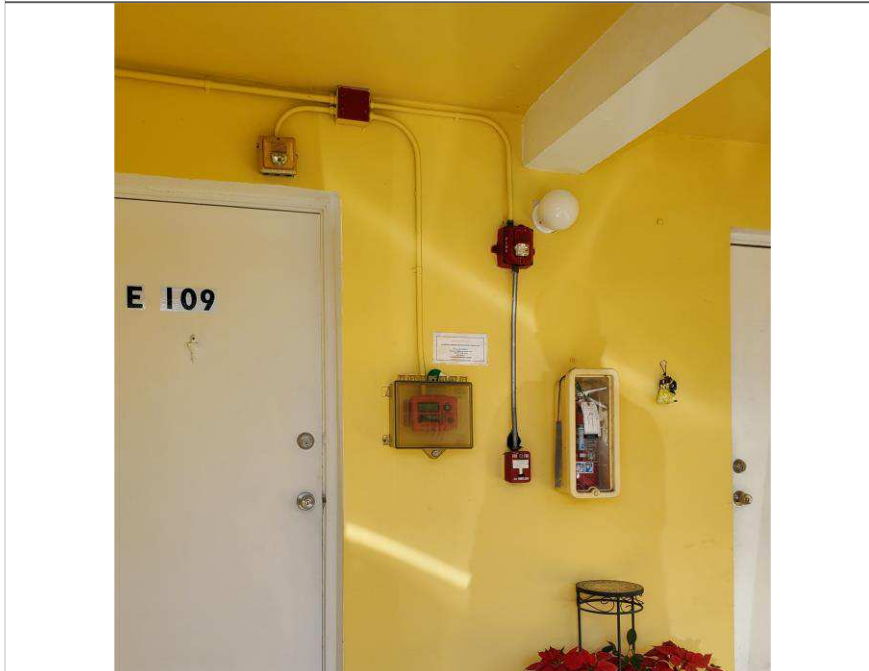
Photo 17 – Village of Dadeland Condominium Association

Level 1

Fire Alarm - Old and Weathered
Fire Alarm Devices and Control
Center

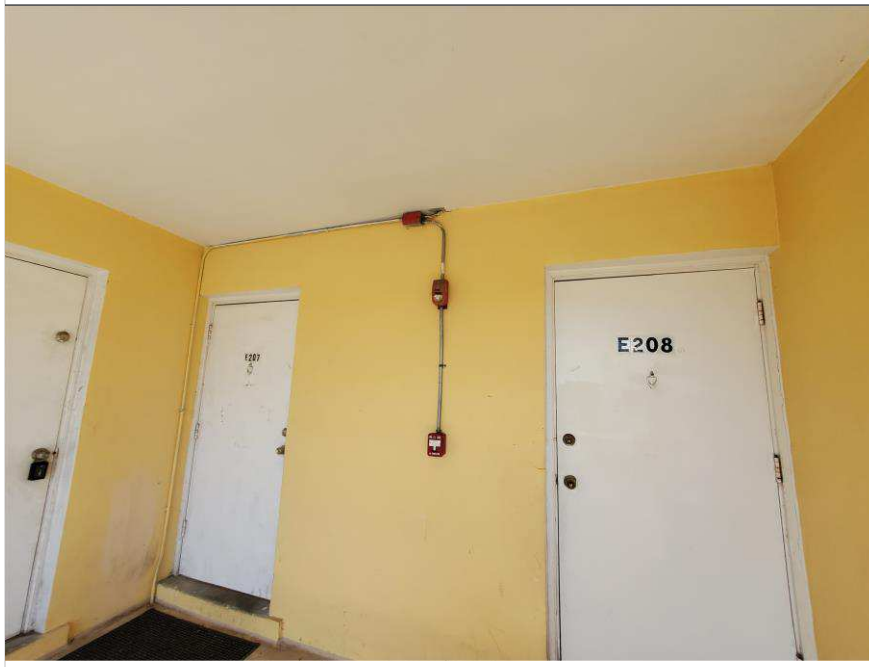
Photo 18 – Village of Dadeland Condominium Association

Level 2

Fire Alarm - Old and Weathered
Fire Alarm Devices and Control
Center

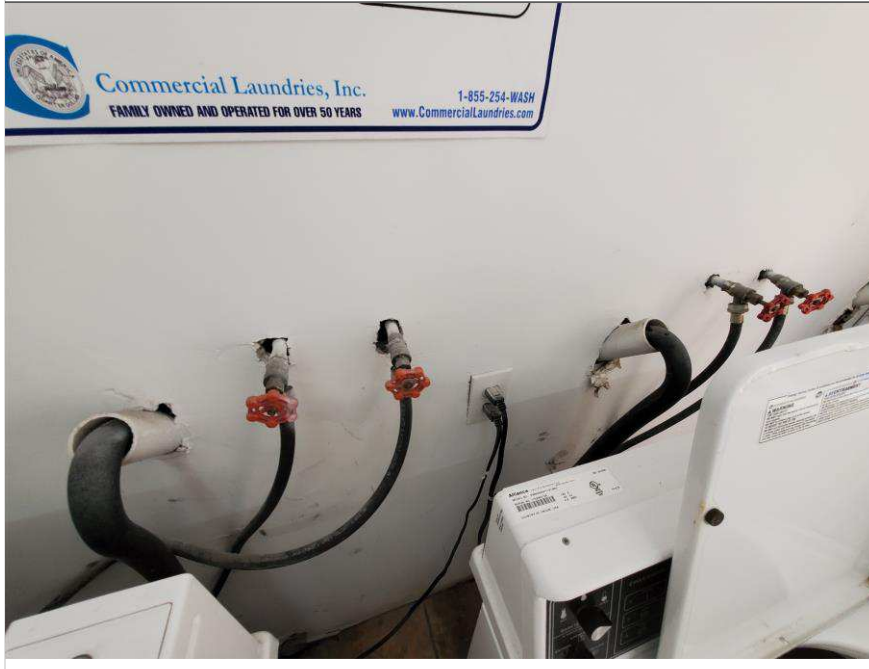
Photo 19 – Village of Dadeland Condominium Association

Laundry Room -
Outlets are not GFCI type.

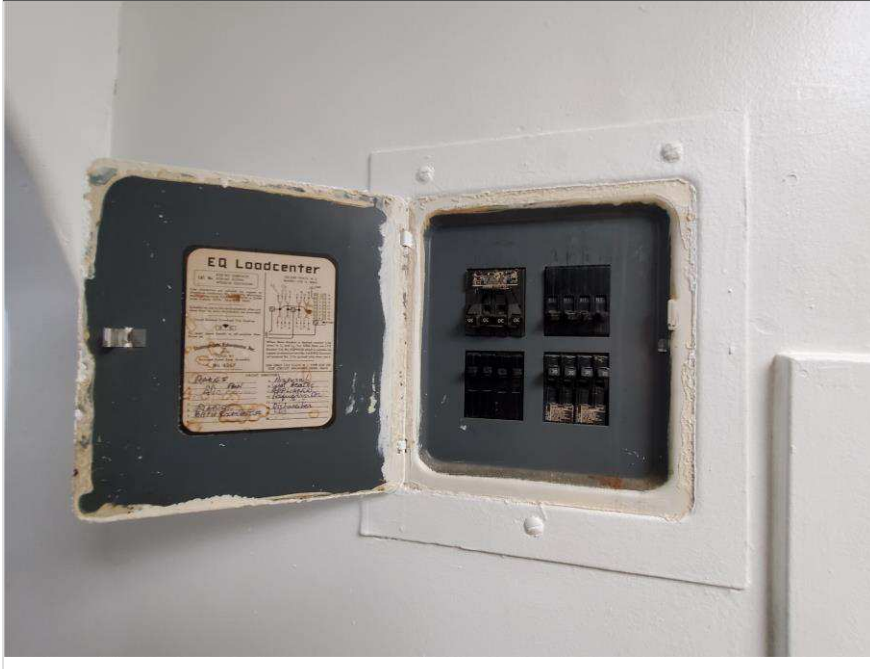
Photo 21 – Village of Dadeland Condominium Association

Apartments - Old Electrical
Panels

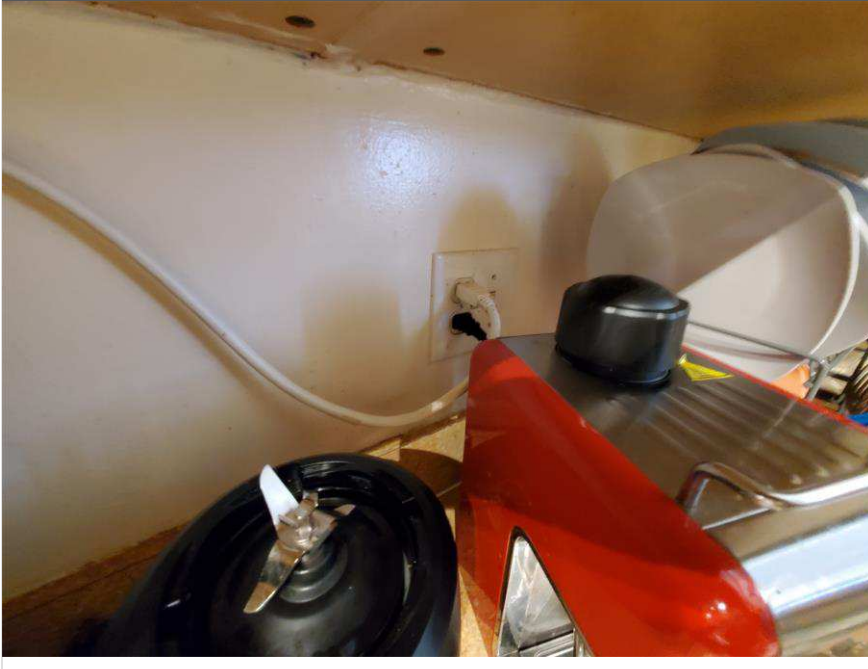
Photo 23 – Village of Dadeland Condominium Association

Apartments - Kitchen outlets
not GFCI type.

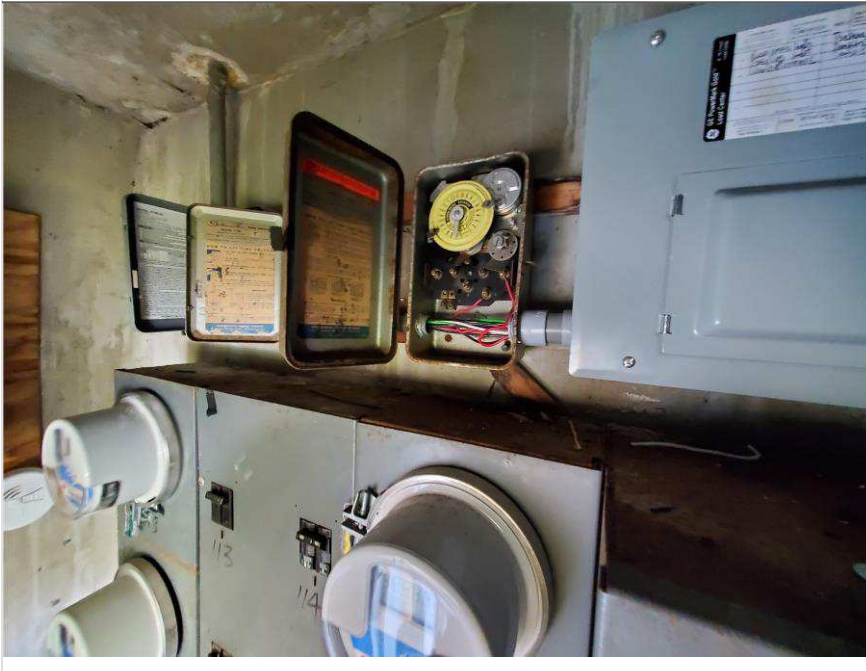
Photo 9 – Village of Dadeland Condominium Association

Existing Electrical Room - 1st FL
Apartment Meters, Main
Switches.

Time clocks installed very high.

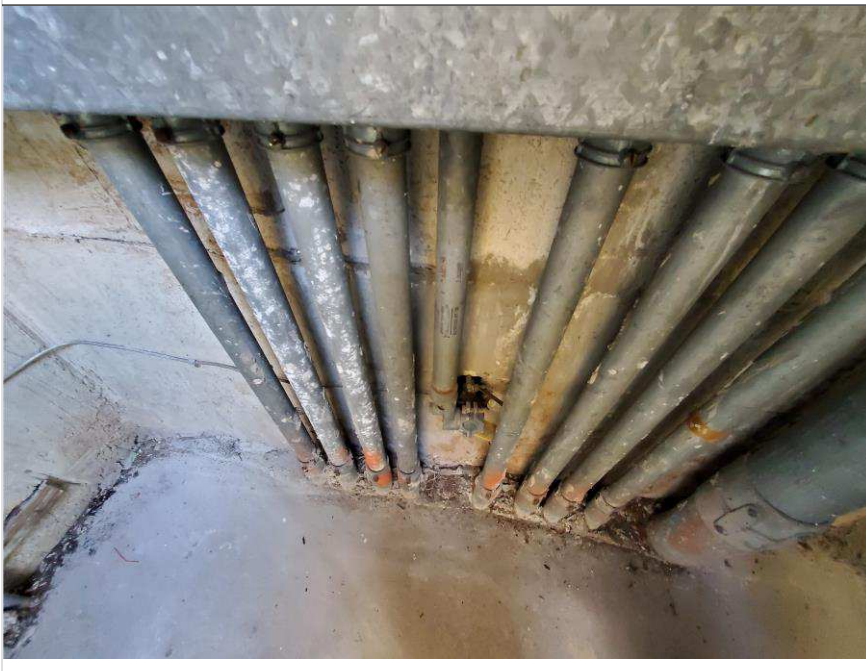
Photo 10 – Village of Dadeland Condominium Association

Existing Electrical Room - 1st FL
Main Service - Grounding

Grounding resistance to be
tested to determine if repairs
and/or maintenance are
required.

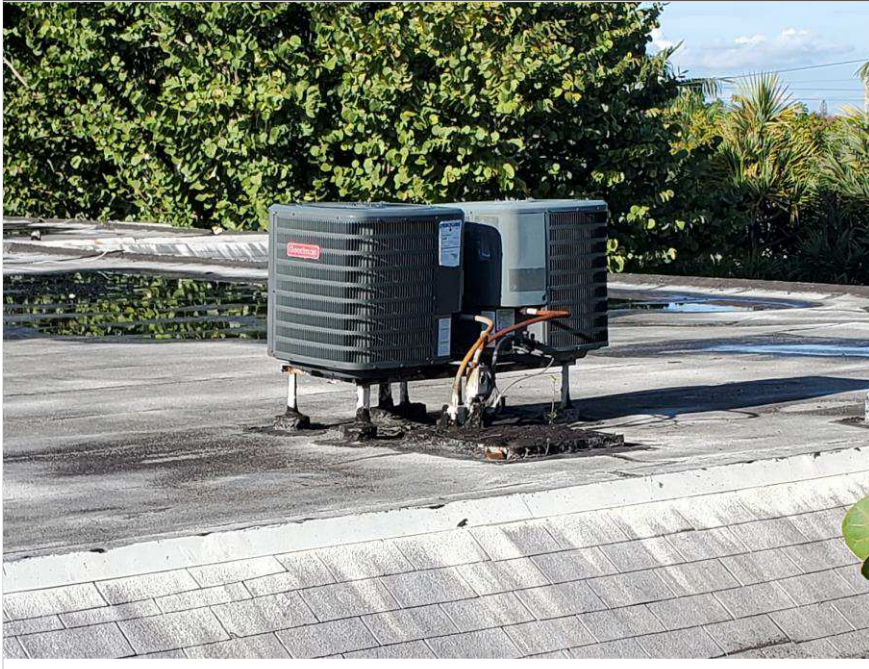
Photo 11 – Village of Dadeland Condominium Association

Rooftop Condenser Units -
Oxidized junction boxes and
conduits.

Junction boxes not properly
supported.

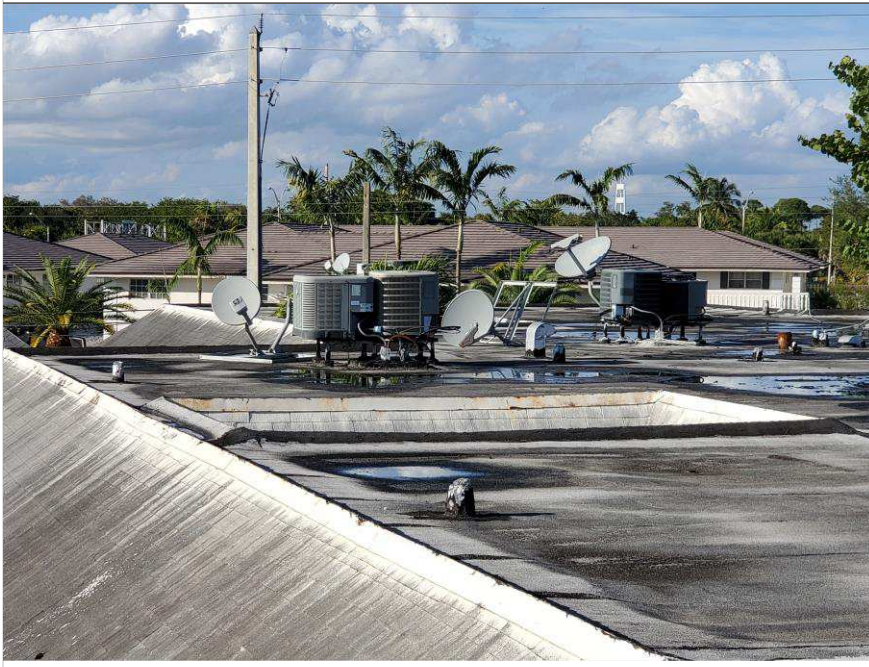
Photo 12 – Village of Dadeland Condominium Association

Rooftop Condenser Units -
Oxidized junction boxes and
conduits.

Junction boxes not properly
supported.

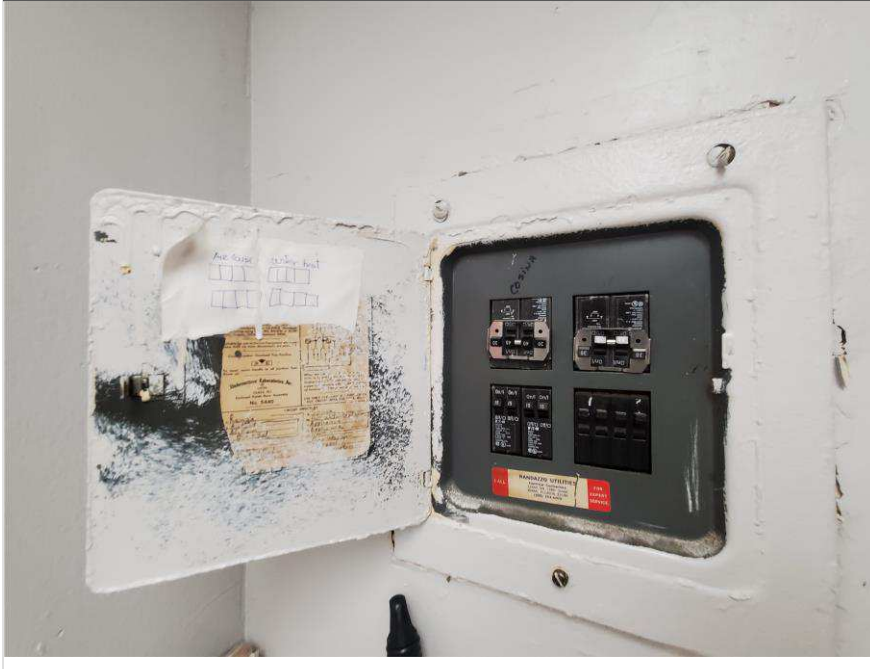
Photo 13 – Village of Dadeland Condominium Association

Apartments - Old Electrical Panels

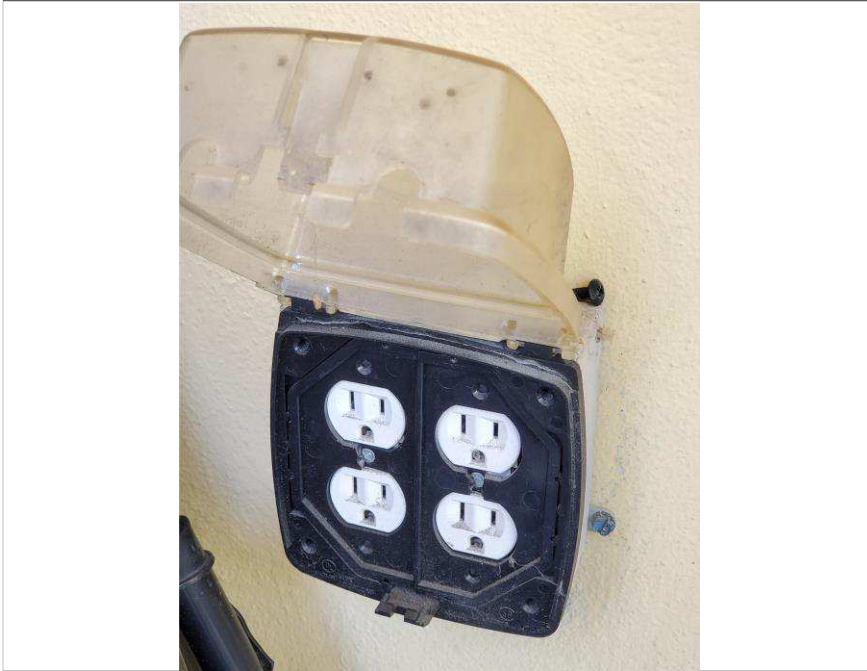
Photo 17 – Village of Dadeland Condominium Association

Apartments - Balcony/Patio
outlets not GFCI type

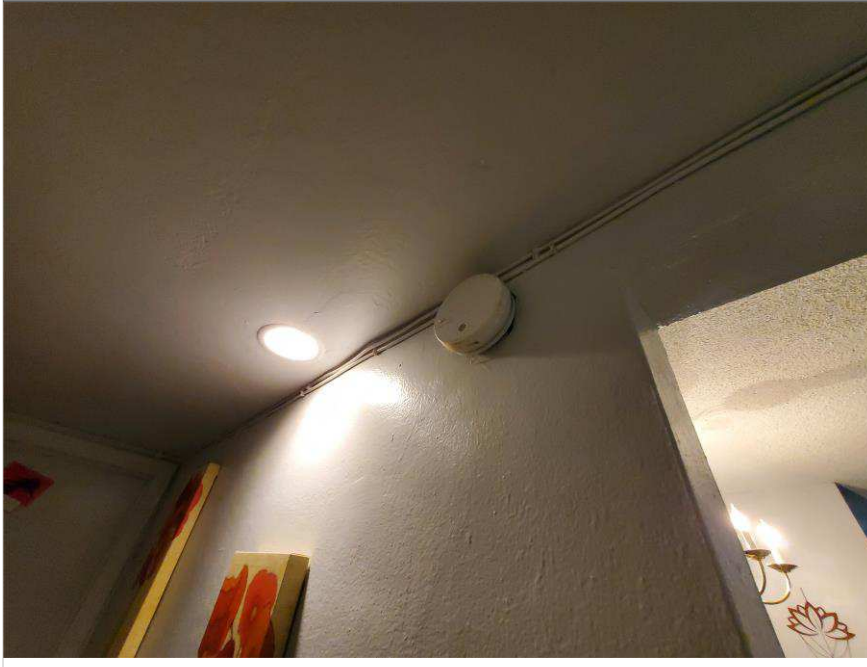
Photo 18 – Village of Dadeland Condominium Association

Apartments - Old Smoke
Detectors

Old Smoke Detectors to be
replaced (typical).

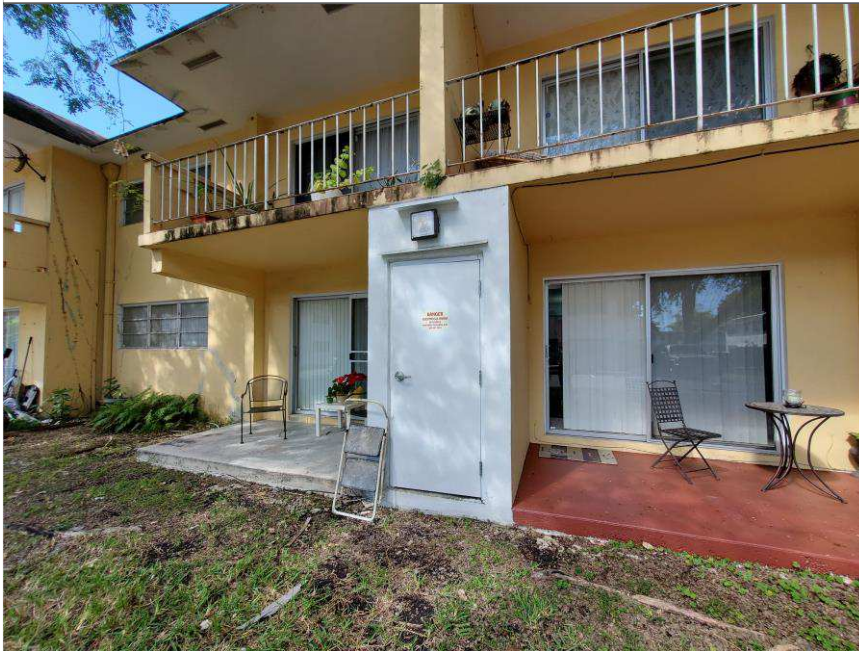
Photo 1 – Village of Dadeland Condominium Association

Existing Electrical Room - 1st FL
No Storage Permitted

Missing sign with Room name
and Building number.

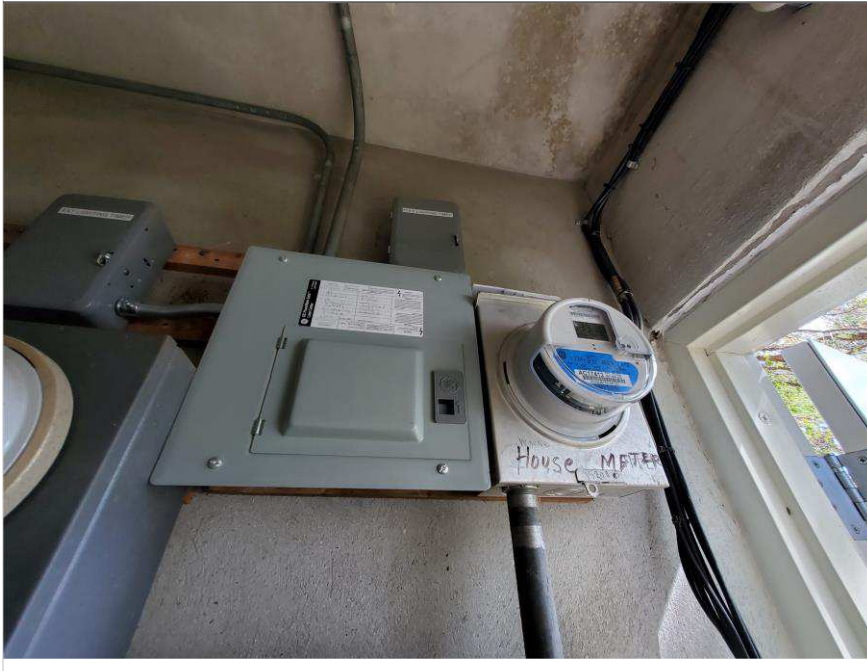
Photo 5 – Village of Dadeland Condominium Association

Existing Electrical Room - 1st FL
House Panel Board and Meter.

Time clocks installed too high.

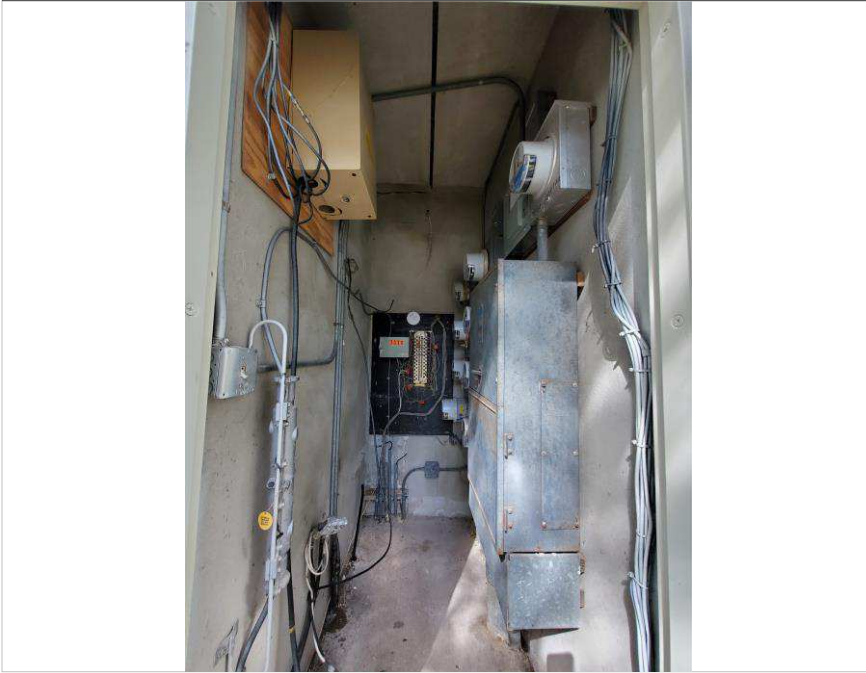
Photo 9 – Village of Dadeland Condominium Association

Existing Electrical Room - 1st FL
Main Switches for Apartments,
Meters, and Gutter.

Insufficient Clearance at
electrical components.

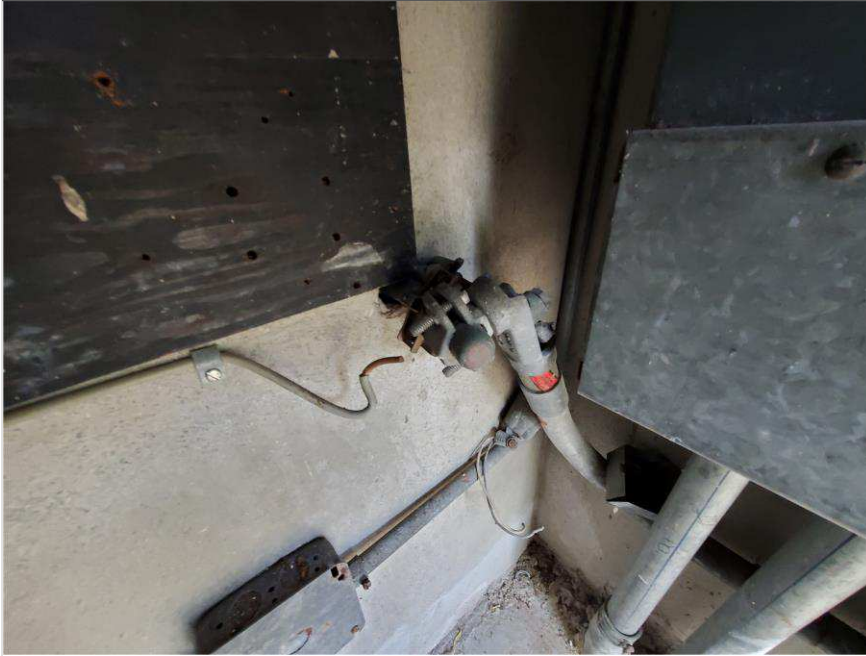
Photo 10 – Village of Dadeland Condominium Association

Existing Electrical Room - 1st FL
Main Distribution – Grounding

Grounding resistance to be
tested to determine if repairs
and/or maintenance are
required.

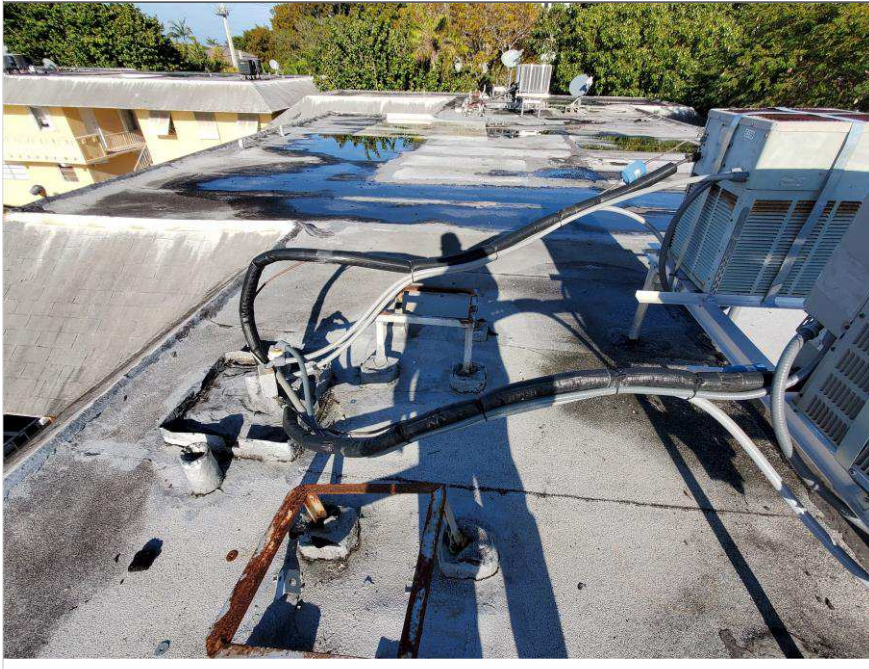
Photo 11 – Village of Dadeland Condominium Association

Rooftop Condenser Units -
Oxidized junction boxes and
conduits.

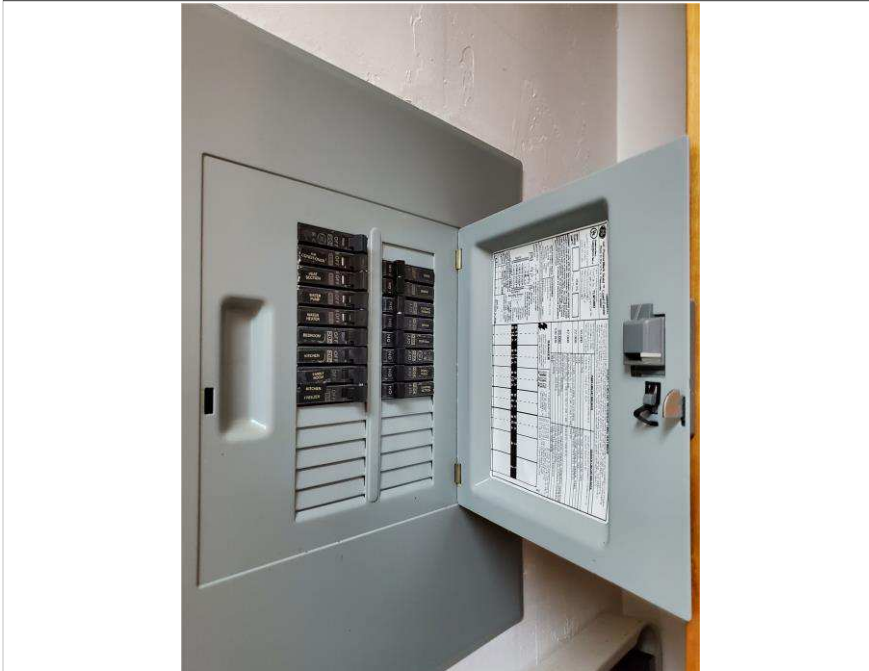
Photo 15 – Village of Dadeland Condominium Association

Apartments - Electrical Panels

Missing panel directory.

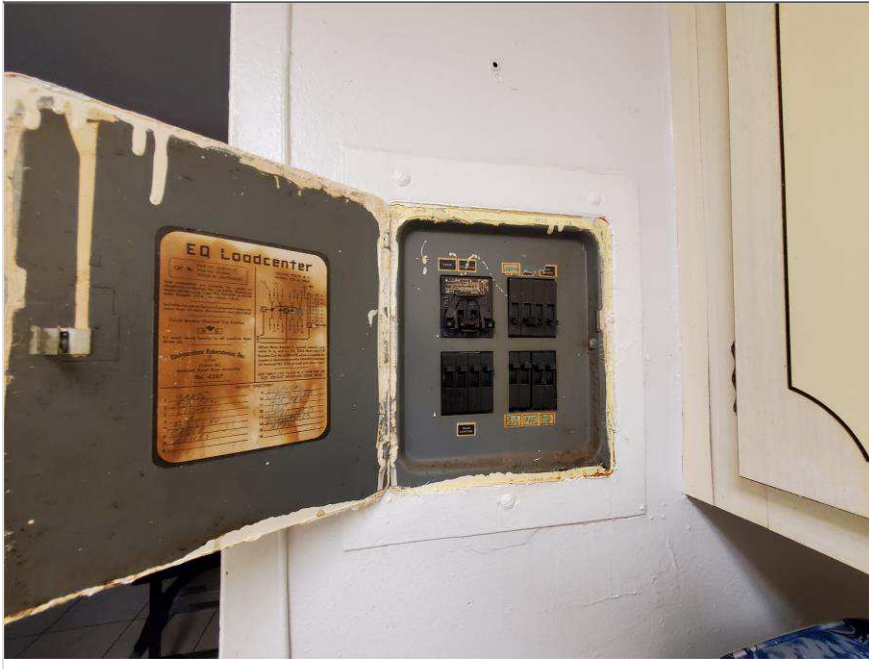
Photo 16 – Village of Dadeland Condominium Association

Apartments -

Old, oxidized breaker to be replaced.

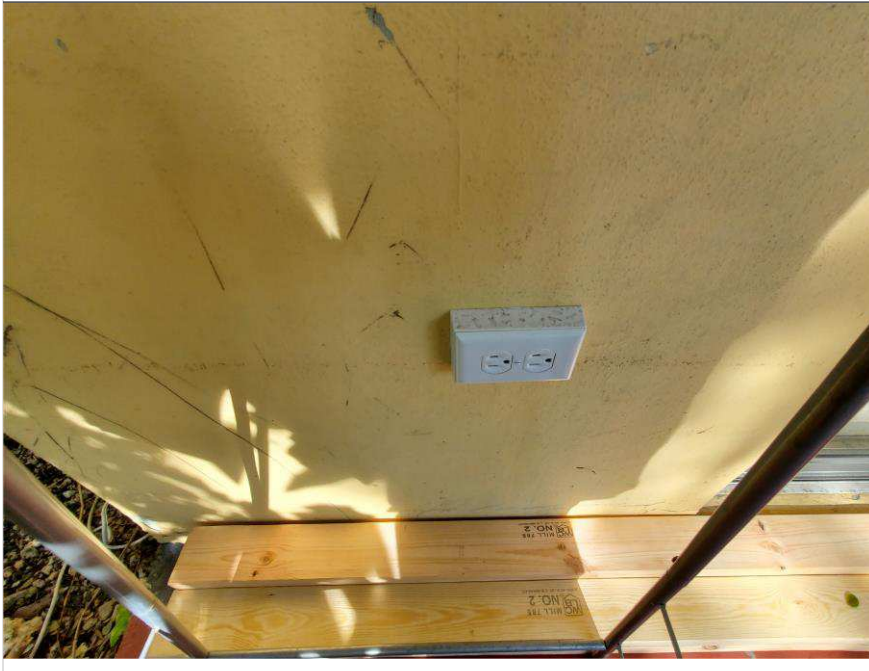
Photo 17 – Village of Dadeland Condominium Association

Apartments - Balcony outlet is not GFCI type.

No weatherproof cover.

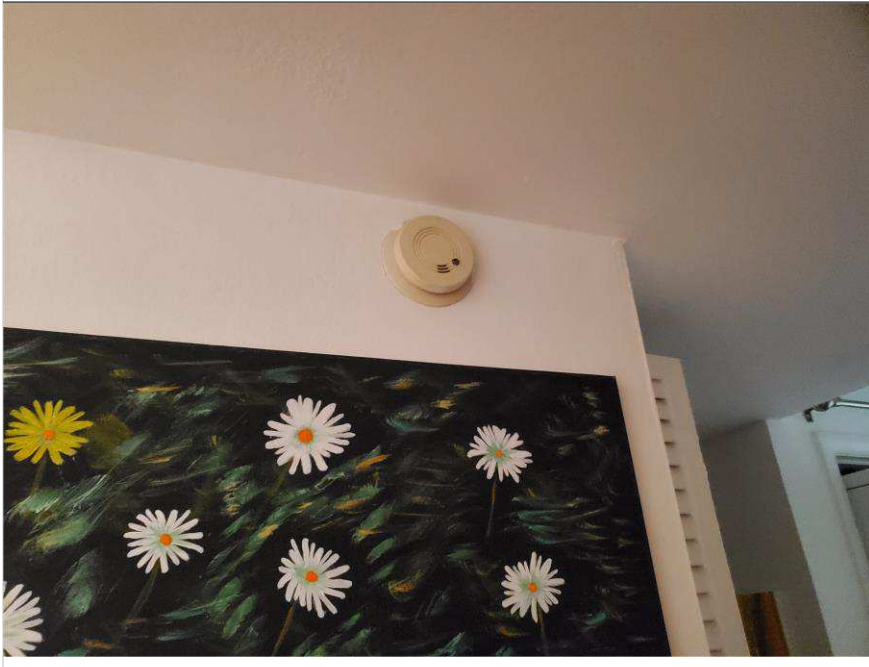
Photo 18 – Village of Dadeland Condominium Association

Apartments - Old Smoke Detectors

Old Smoke Detectors to be replaced.

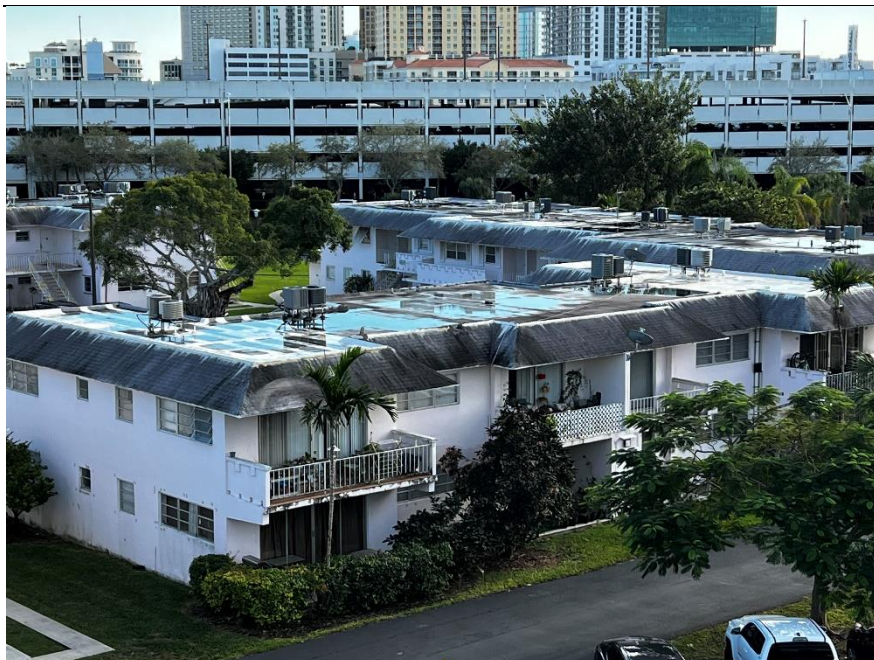
Photo #2:

Water ponding stains observed on the roof.

The bituminous roof membrane was deemed to be in fair condition, but sign of weathering/distress are evident.

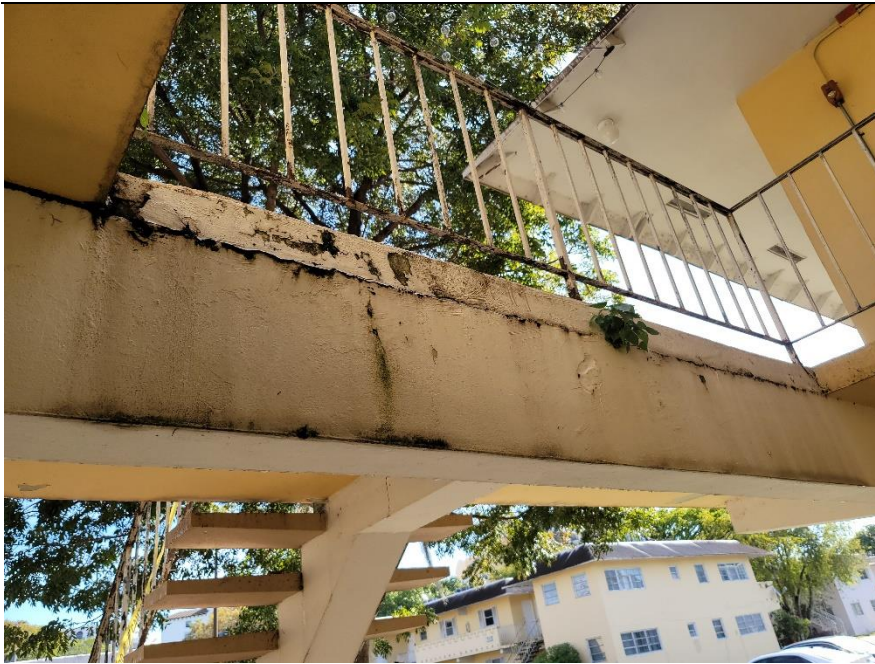
Photo #3:

Staining and vegetation growth was observed at the exposed surfaces of the concrete beams supporting the catwalks. Remediation of the unsound surface areas are required to prevent deterioration of the concrete.
