DEPARTMENT OF REGULATORY
AND ECONOMIC RESOURCES

MINIMUM INSPECTION PROCEDURAL GUIDELINES
FOR BUILDING ELECTRICAL RECERTIFICATION

- a. Name on Title: Village at Dadeland Condominiums (E)
- b. Street Address: 7360 SW 82nd St. Miami, Florida 33143
- c. Legal Description: Village at Dadeland Condominiums
- d. Owner's Name: Village at Dadeland Condominiums
- e. Owner's Mailing Address: 7360 SW 82nd St. Miami, Florida 33143
- f. Folio Number of Property on which Building is Located: 30-4035-047-XXXX
- g. Building Code Occupancy Classification: R2 - Residential
- h. Present Use: Condominium, Residential
- i. General Description, Type of Construction, Size, Number of Stories, and Special Features

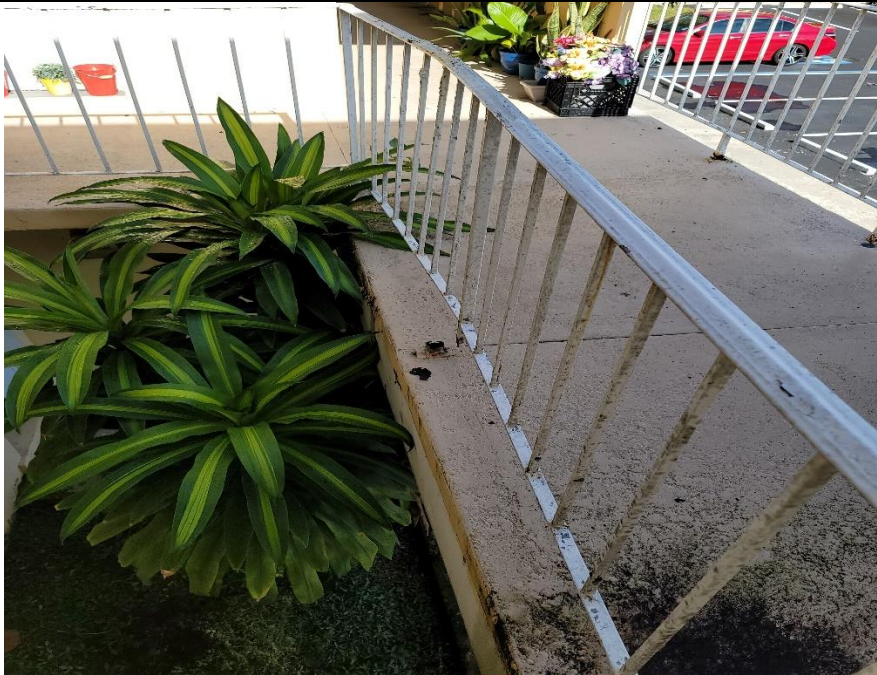
Photo #5:

Replacement of the steel picket rails is mandatory due to the extent of corrosion at the base of the rail posts.

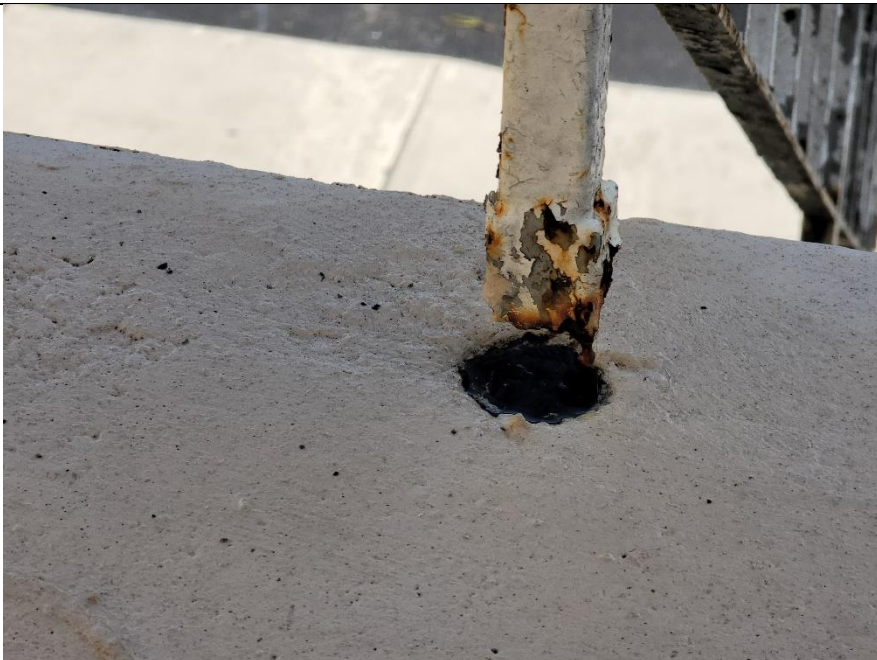
Photo #6:

Replacement of the steel picket rails is mandatory due to the extent of corrosion at the base of the rail posts.

The concrete at the rail post pockets will need to be cleaned and remediated appropriately.

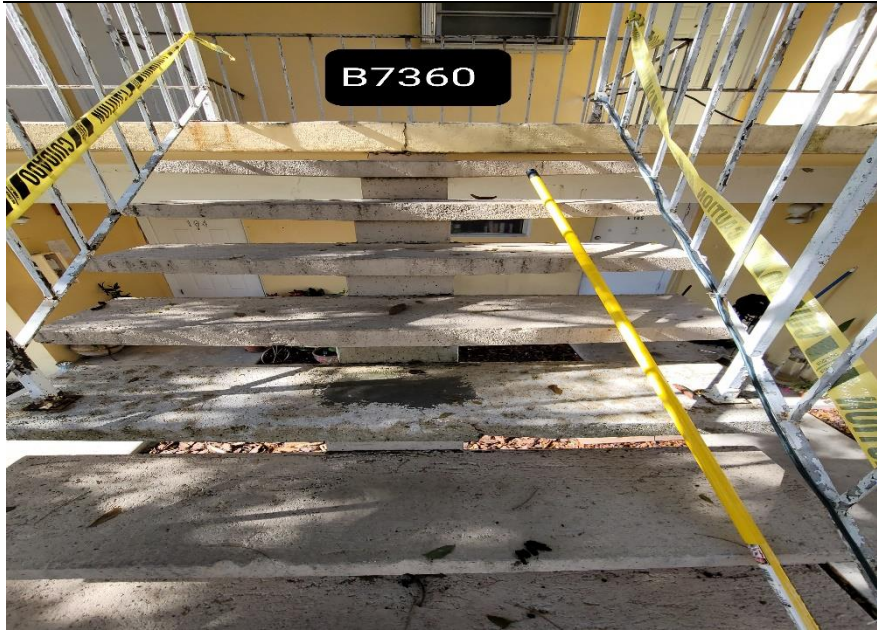
Photo #7:

No protective membrane was observed on the precast steps making them susceptible to the elements and faster deterioration.

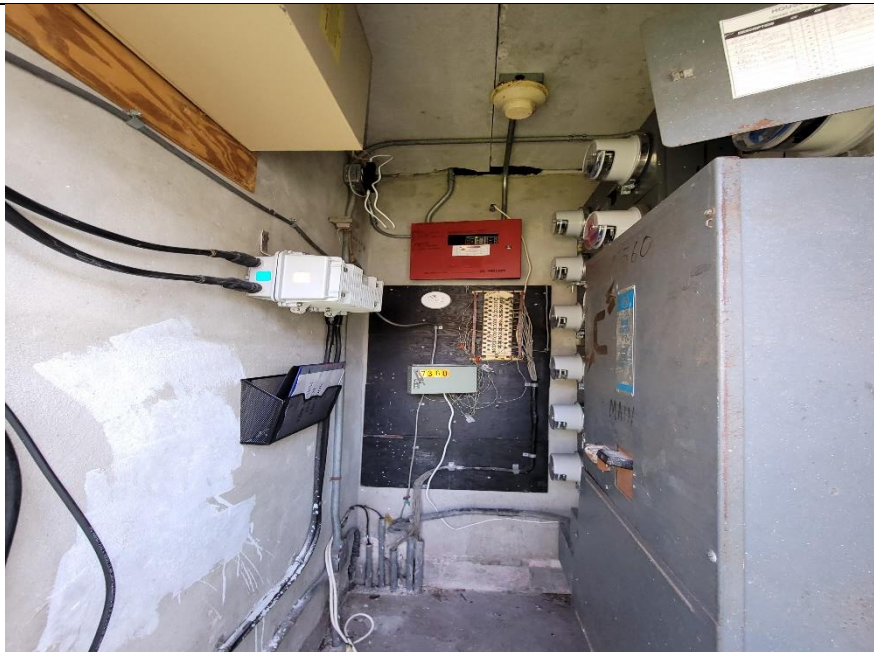
Photo #8:

The mechanical room was observed to be in good condition. Wall/ceiling penetration should be sealed.

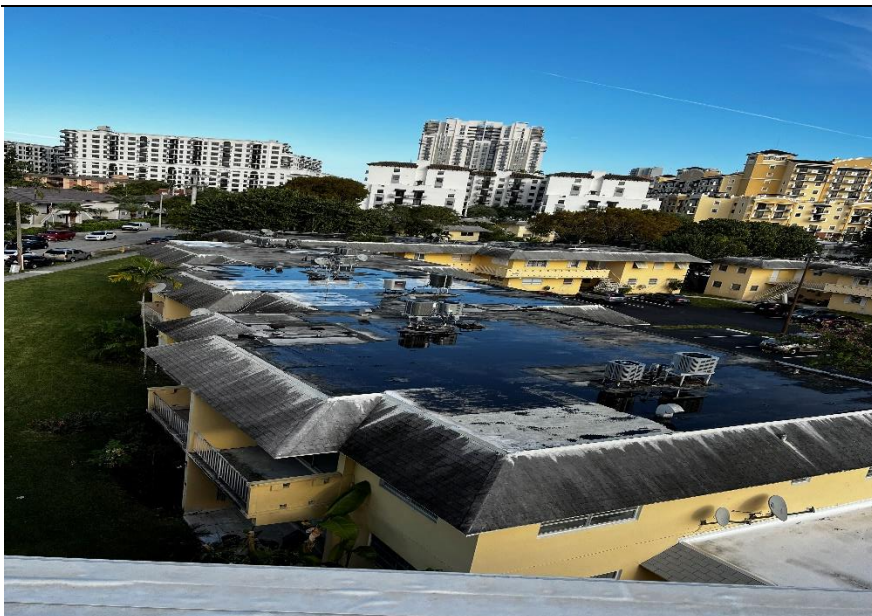
Photo #2:

Water ponding stains observed on the roof.

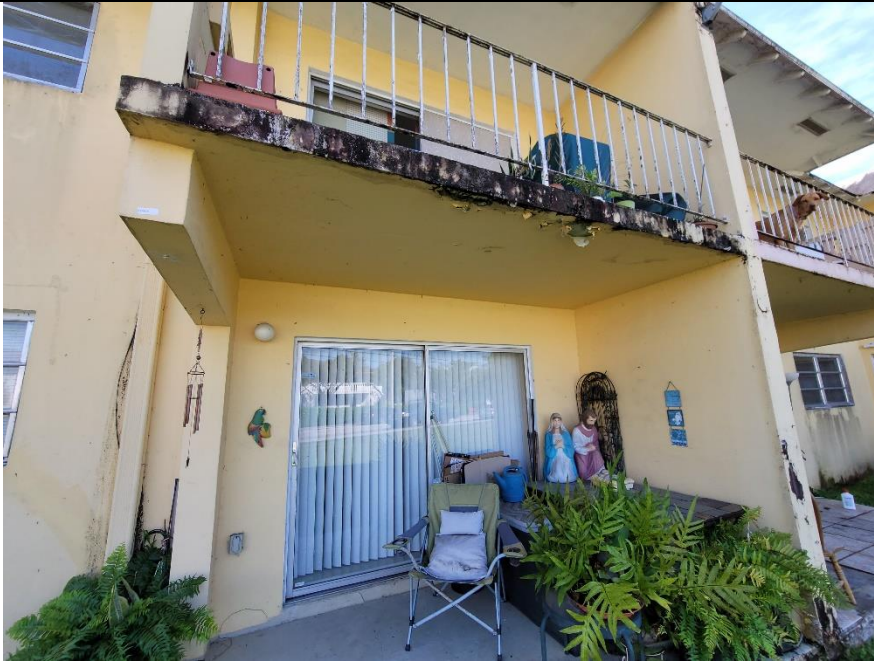
Photo #3:

Heavily stained concrete surfaces, or areas of vegetation growth typically promote the deterioration of the concrete substrate. Areas should be cleaned and appropriately painted/stuccoed.

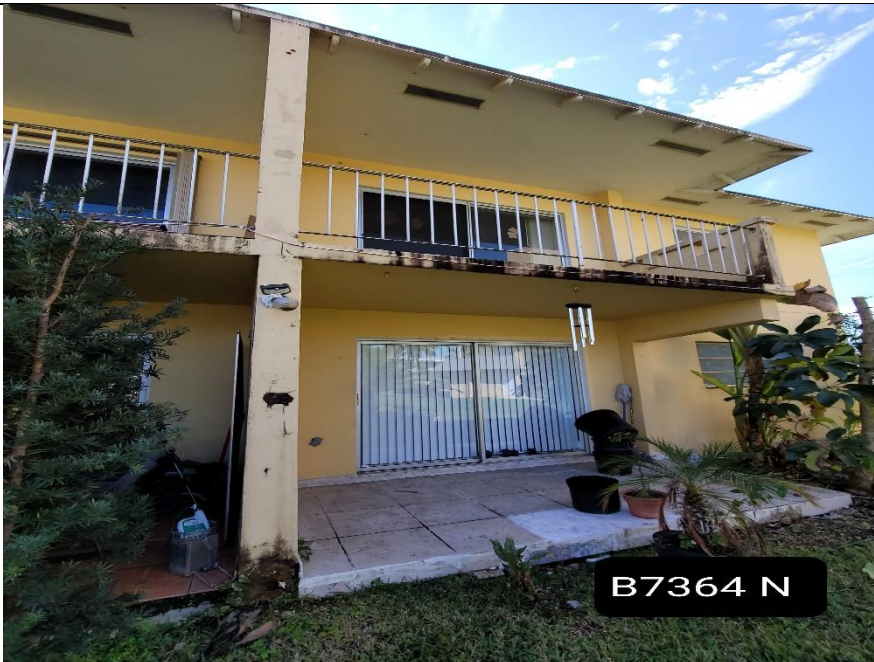
Photo #4:

Heavily stained concrete surfaces, or areas of vegetation growth typically promote the deterioration of the concrete substrate. Areas should be cleaned and appropriately painted/stuccoed.

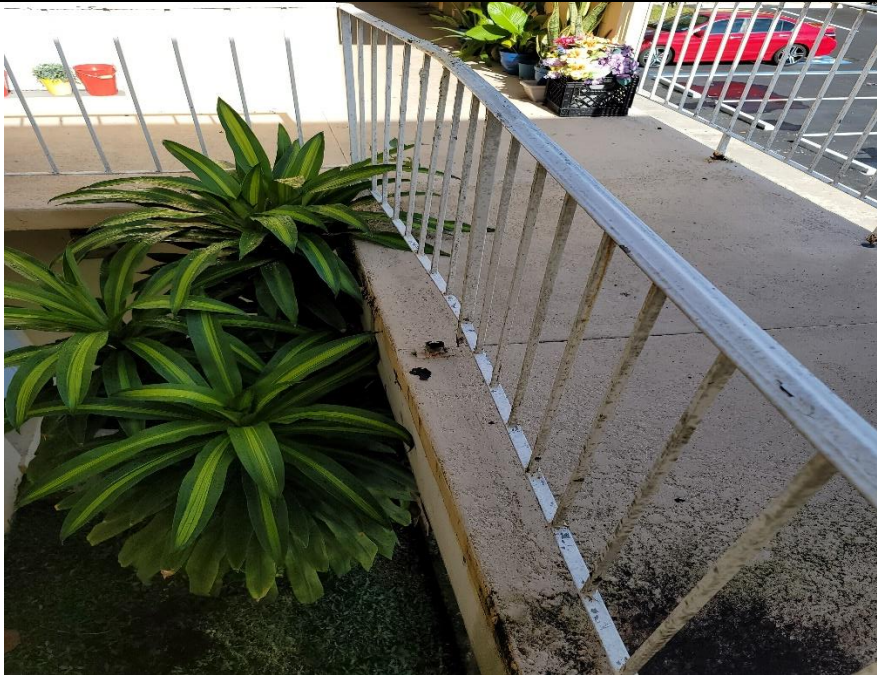
Photo #5:

Replacement of the steel picket rails is mandatory due to the extent of corrosion at the base of the rail posts.

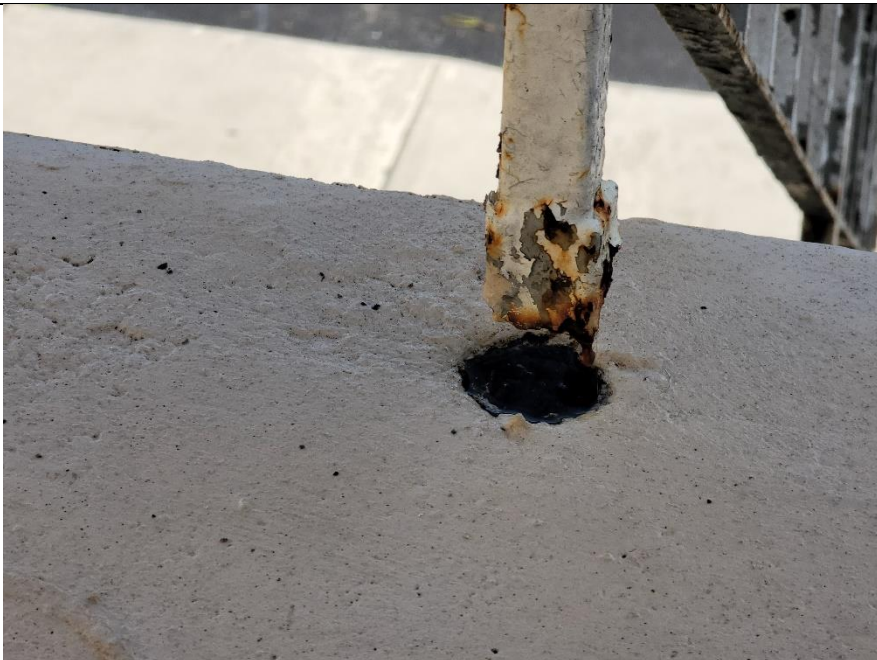
Photo #6:

Replacement of the steel picket rails is mandatory due to the extent of corrosion at the base of the rail posts.

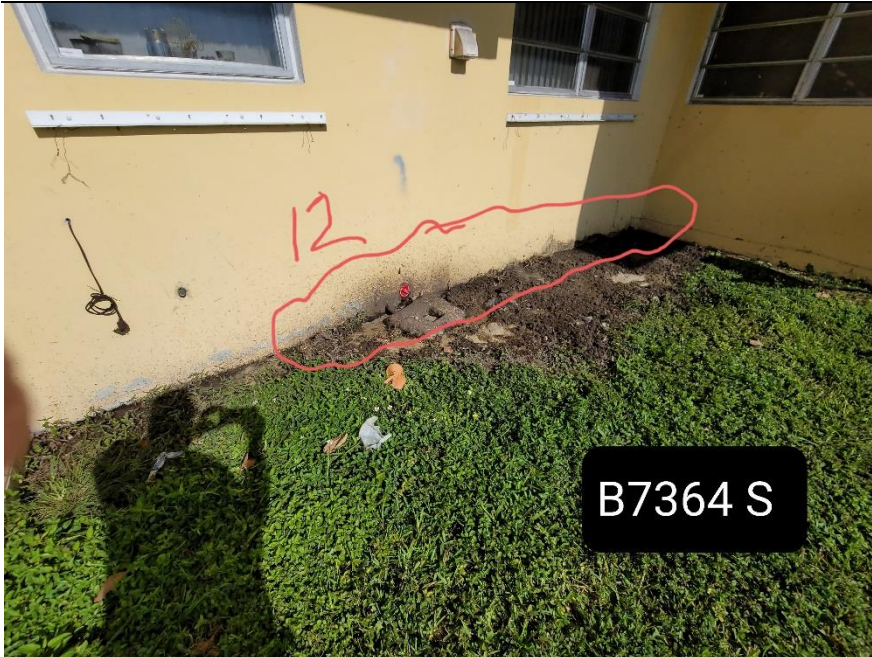
Photo #7:

Miscellaneous wall penetrations should be properly sealed to prevent water infiltration into the building, and/or surface decay of the stucco membrane in the vicinity of the penetration.

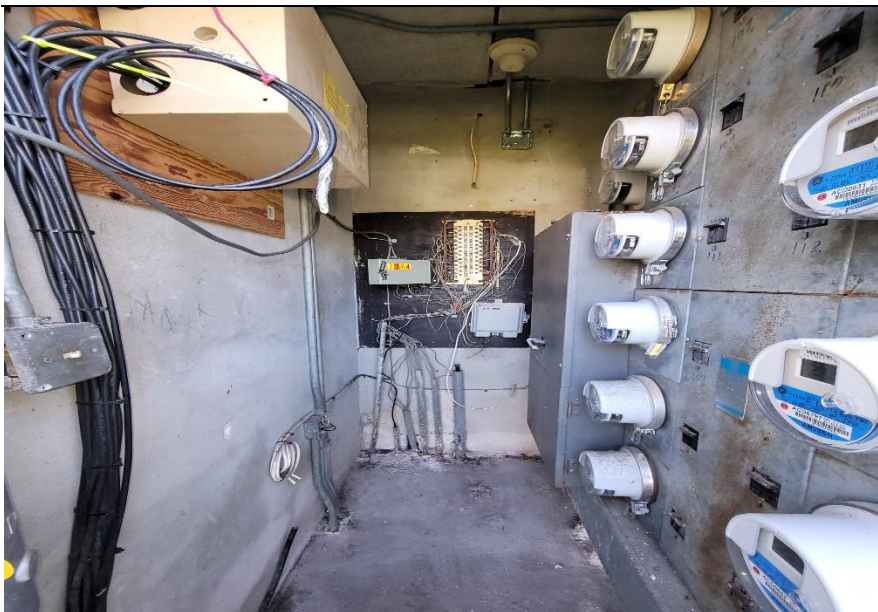
Photo #8:

The mechanical room was observed to be in good condition. Wall/ceiling penetration should be sealed.

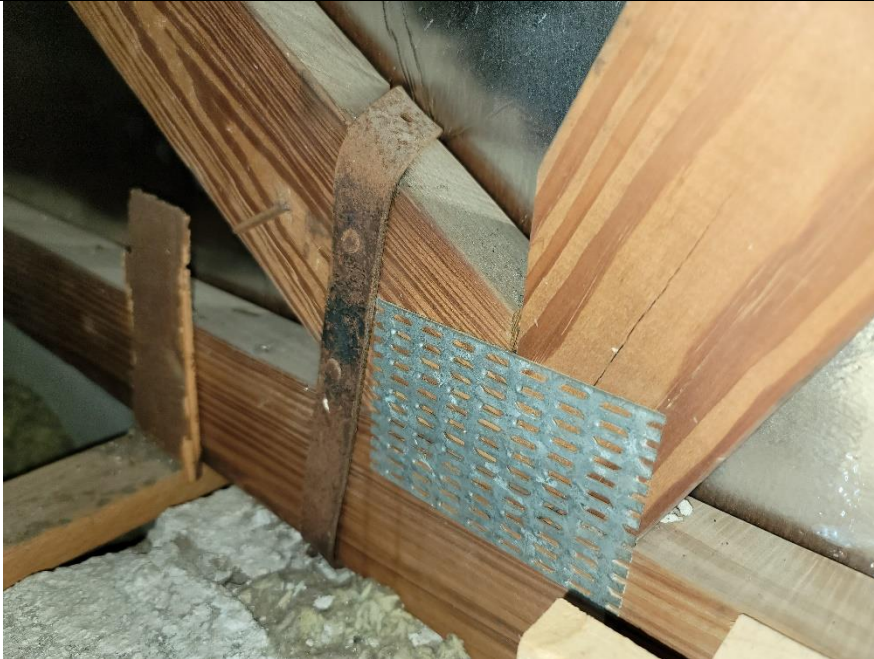
Photo #7:

Where accessible the roof structure was observed and found to be in fair condition.

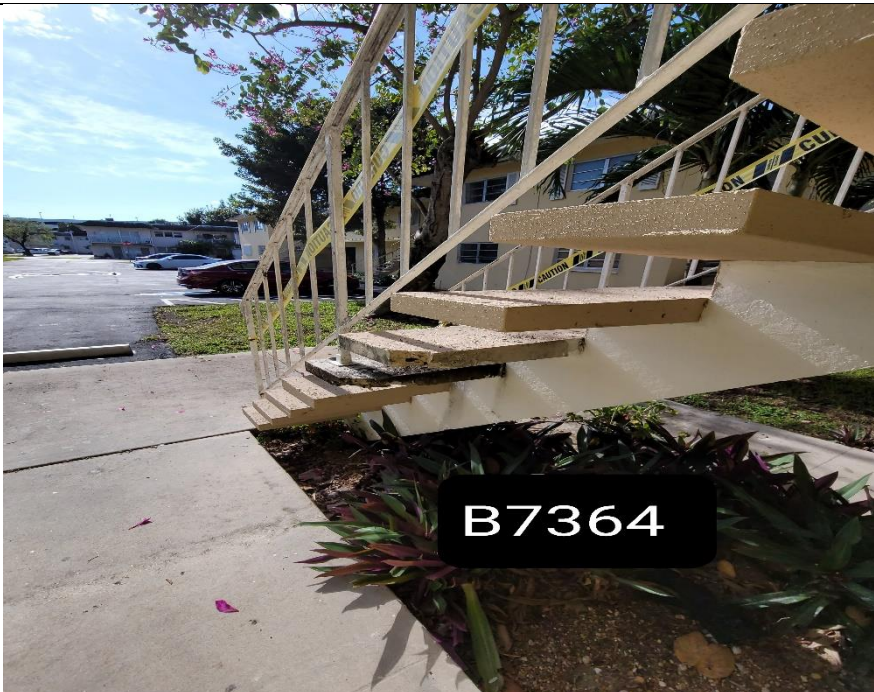
Photo #8:

Chipped or deteriorated precast steps should be replaced

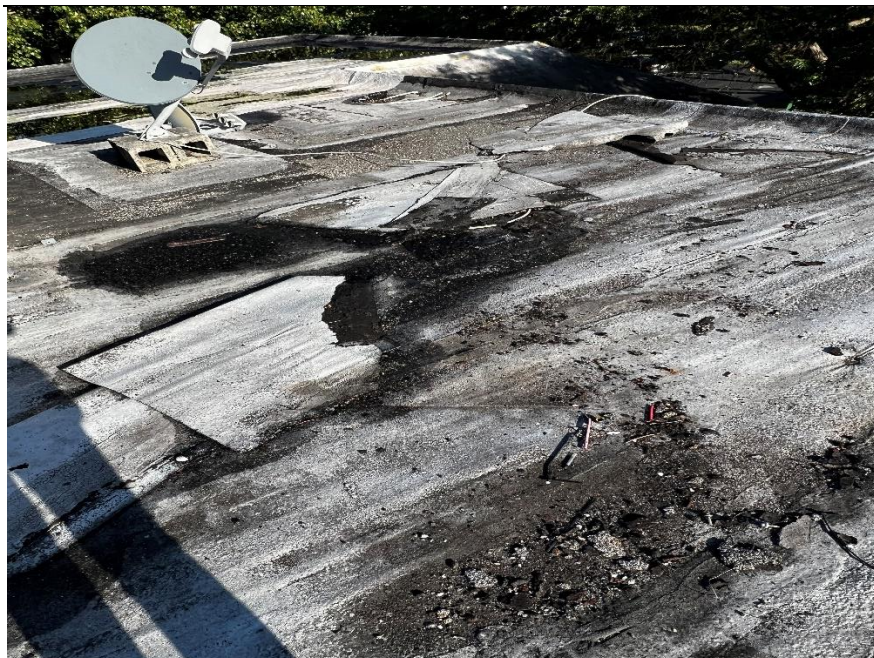
Photo #2:

Water ponding stains observed on the roof.

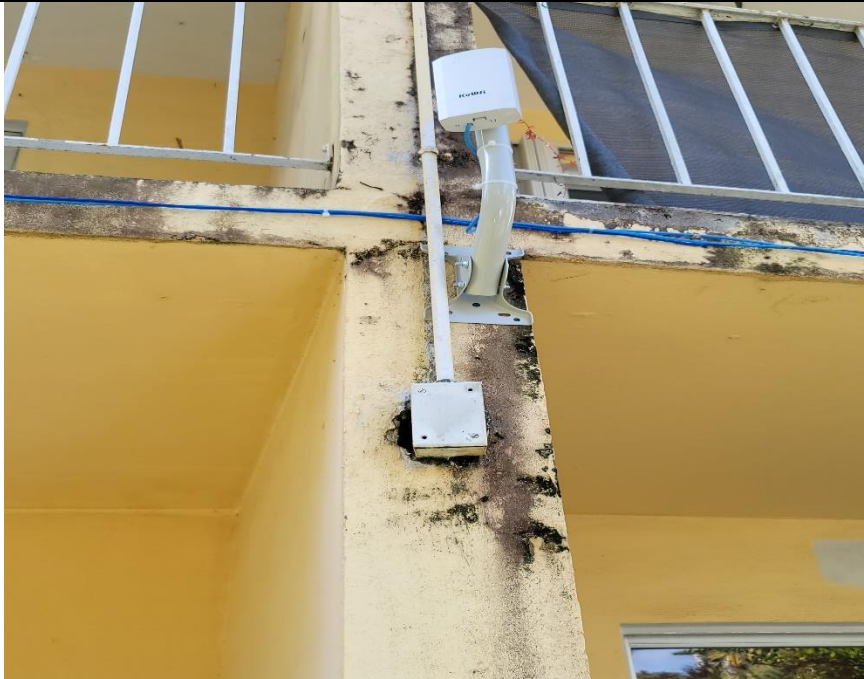
Photo #3:

Heavily stained concrete surfaces, or areas of vegetation growth typically promote the deterioration of the concrete substrate. Areas should be cleaned and appropriately painted/stuccoed and sealed as required.

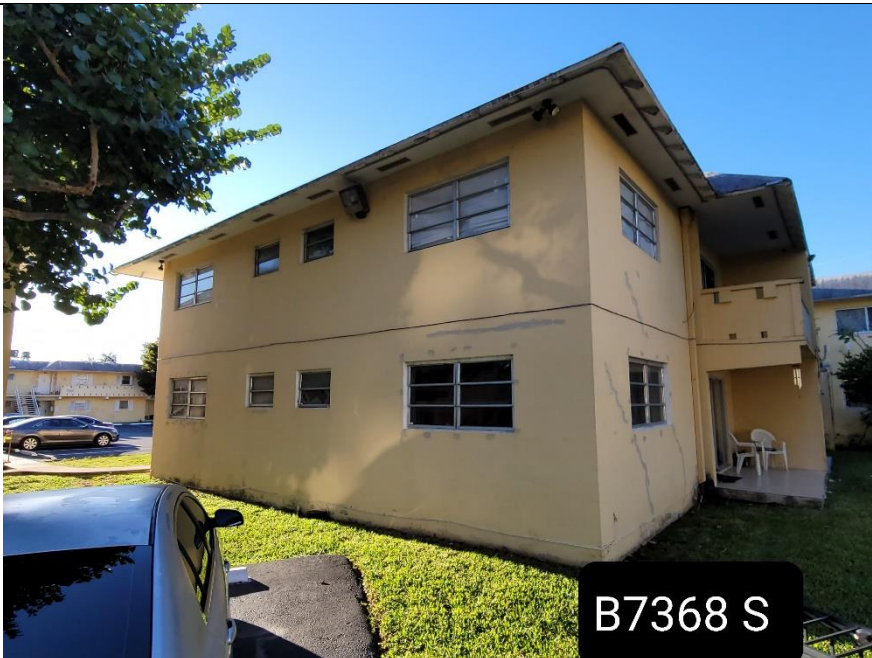
Photo #4:

The stuccoed envelope requires maintenance of the stucco exterior surfaces at many locations.

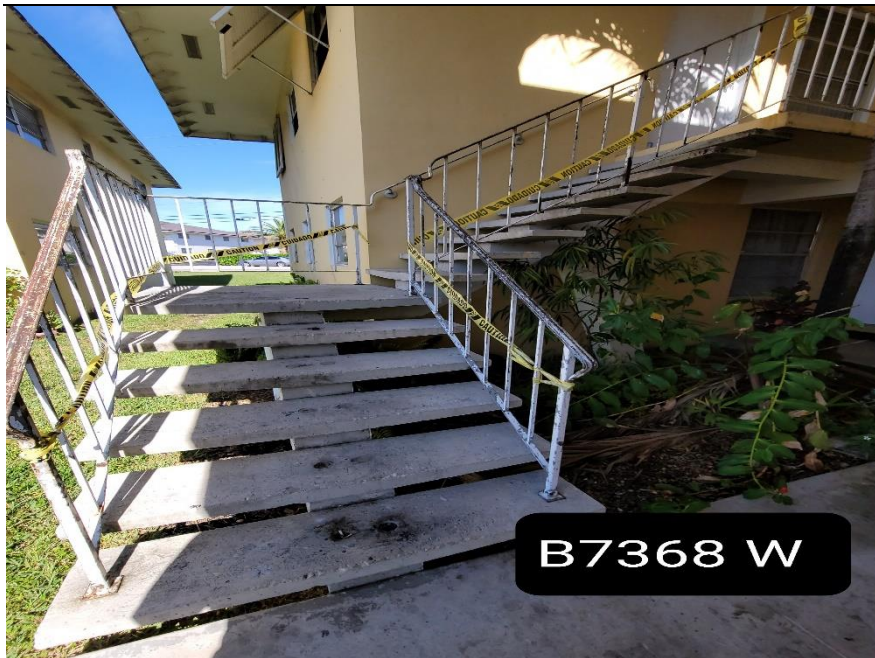
Photo #5:

Replacement of the steel picket rails is mandatory due to the extent of corrosion at the base of the rail posts.

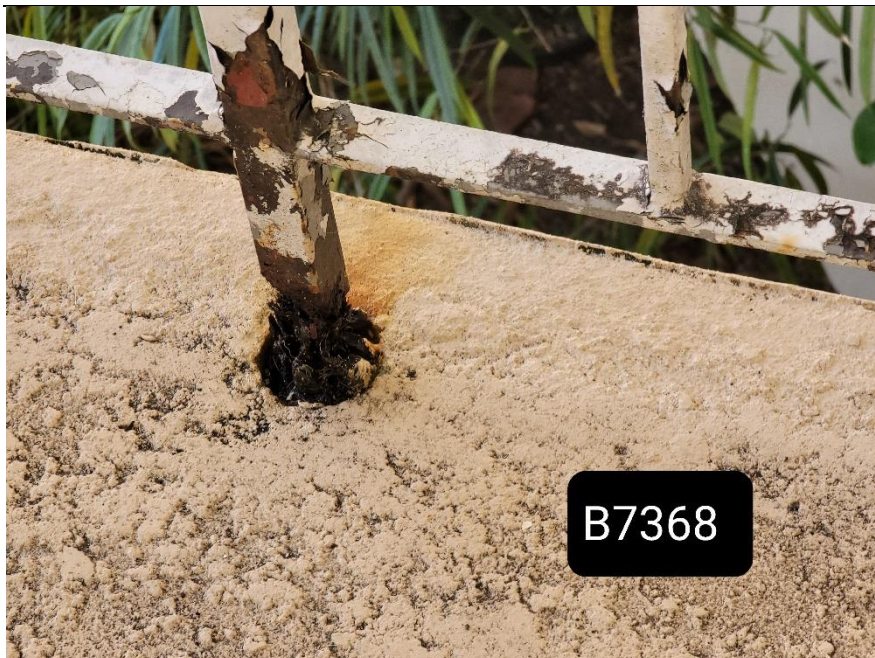
Photo #6:

Replacement of the steel picket rails is mandatory due to the extent of corrosion at the base of the rail posts.

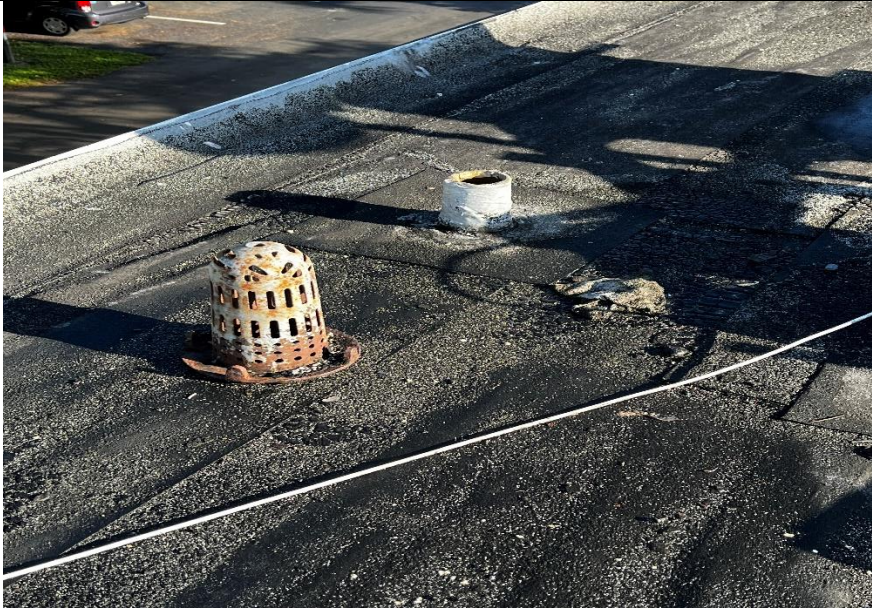
Photo #7:

The strainers for the interior drain lines were found to be rusted or non-functional since many of them are missing or not in their proper position. Others need maintenance to remove debris.

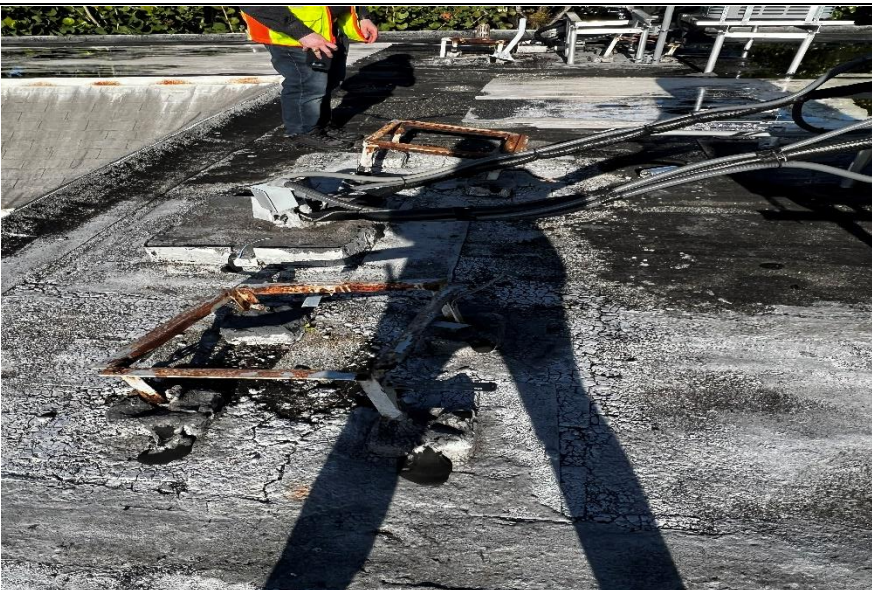
Photo #8:

All abandoned metal strainers and corroded steel dunnage systems should be removed from the roof to prevent potential loose metal elements from falling off the roof during strong wind events.

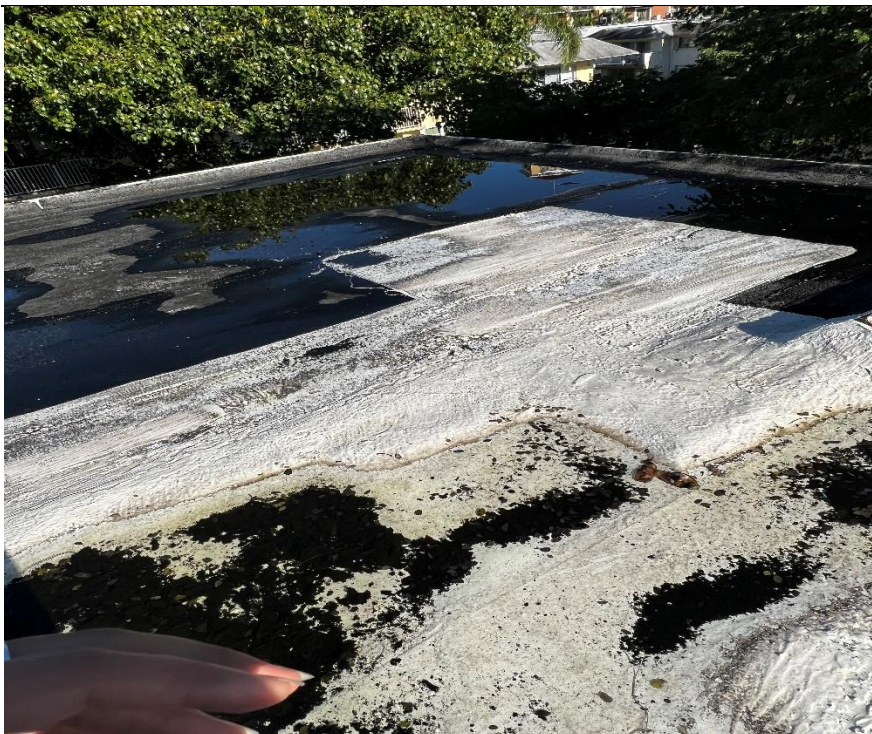
Photo #2:

Water ponding stains observed on the roof.

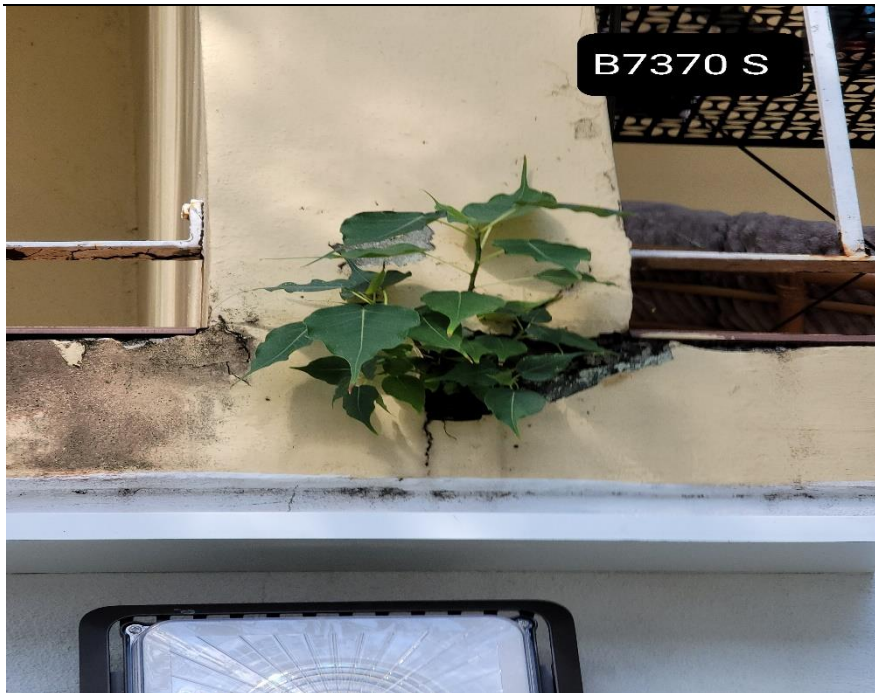
Photo #3:

Heavily stained concrete surfaces, or areas of vegetation growth typically promote the deterioration of the concrete substrate. Areas should be cleaned and appropriately painted/stuccoed and sealed as required.

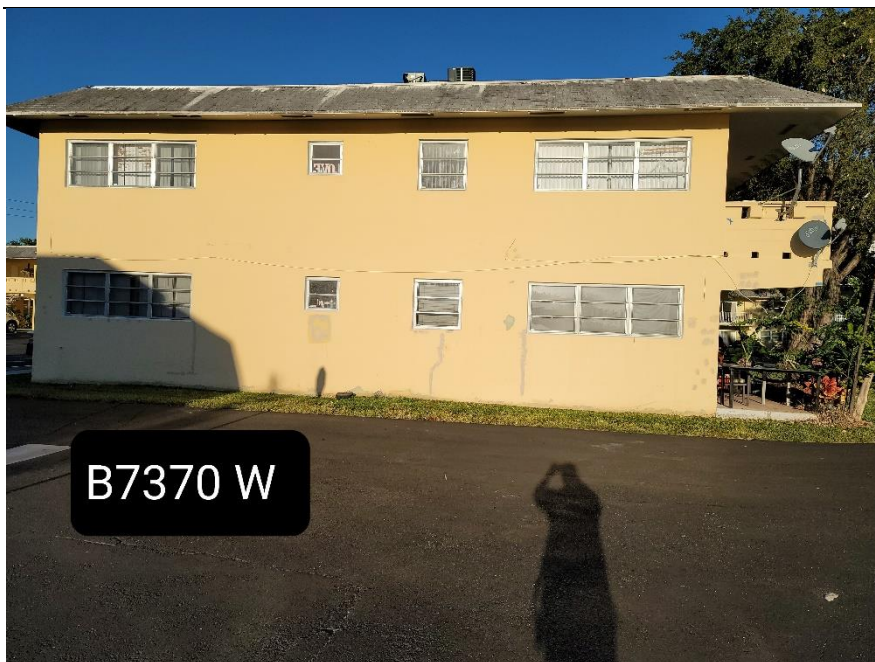
Photo #4:

The stuccoed envelope requires maintenance of the stucco exterior surfaces at many locations.

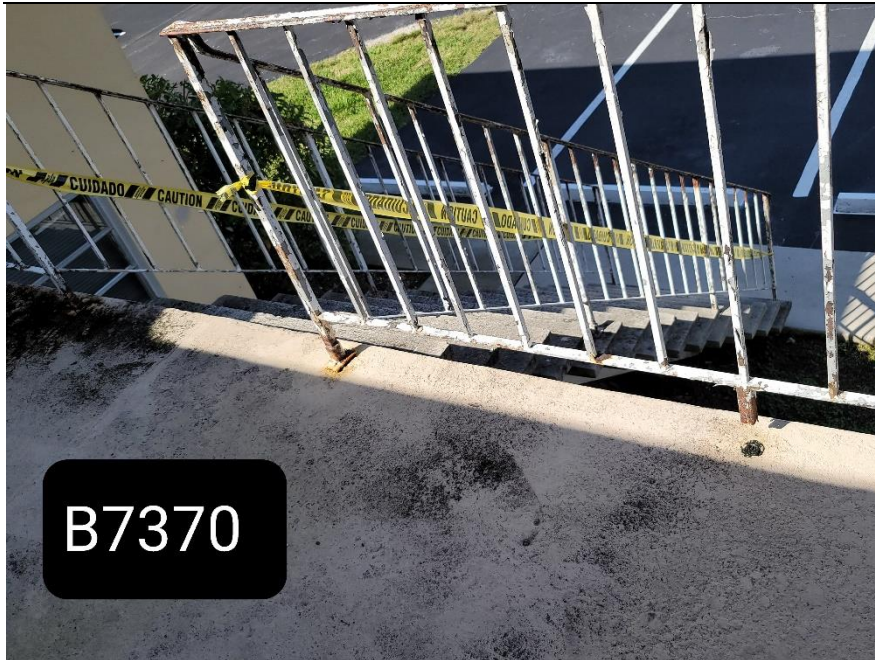
Photo #5:

Replacement of the steel picket rails is mandatory due to the extent of corrosion at the base of the rail posts.

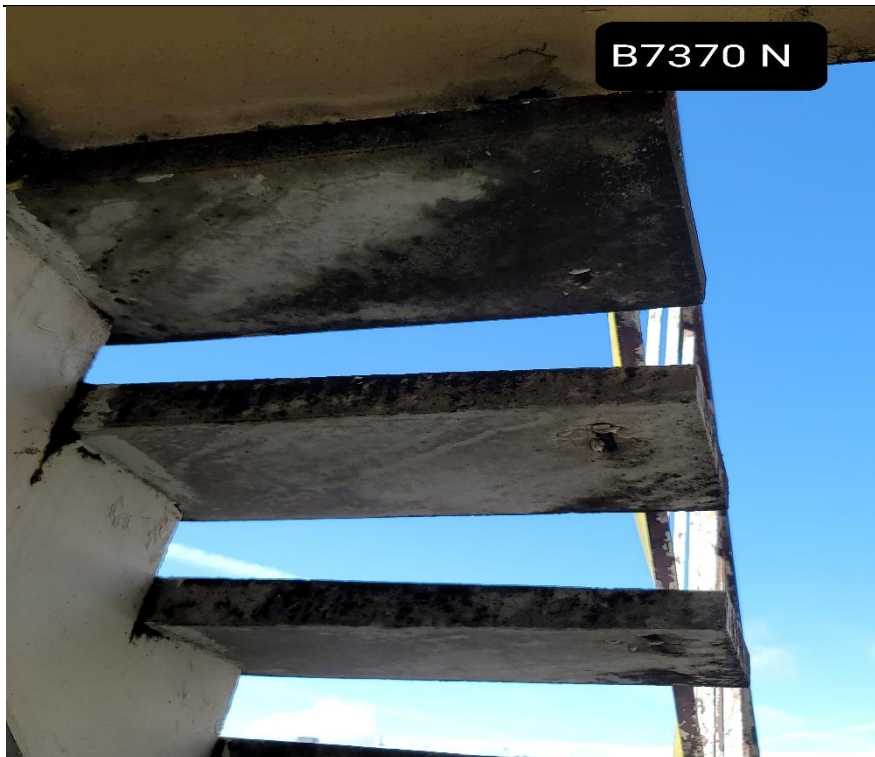
Photo #6:

Chipped or deteriorated precast steps should be replaced

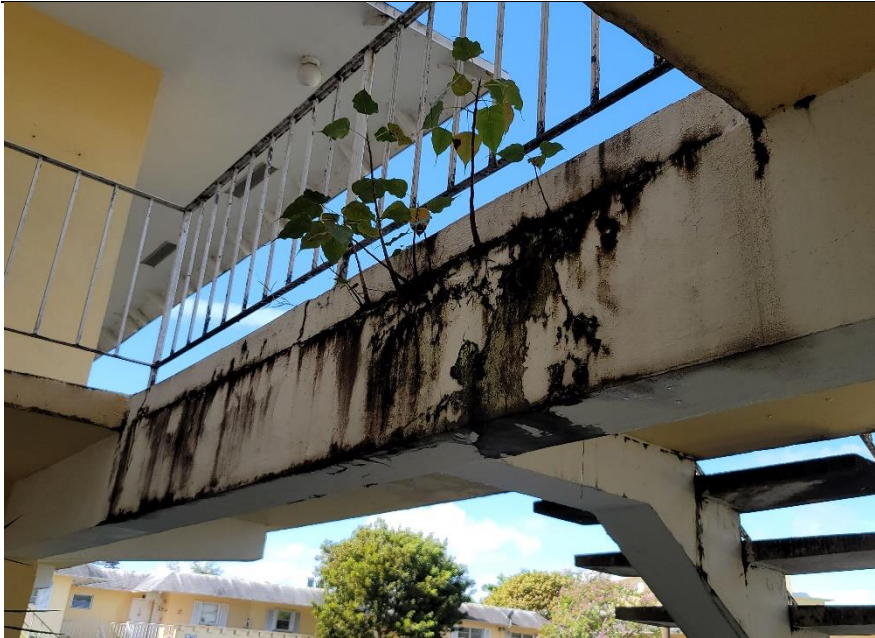
Photo #7:

Staining and vegetation growth was observed at the exposed surfaces of the concrete beams supporting the catwalks. Remediation of the unsound surface areas are required to prevent deterioration of the concrete.

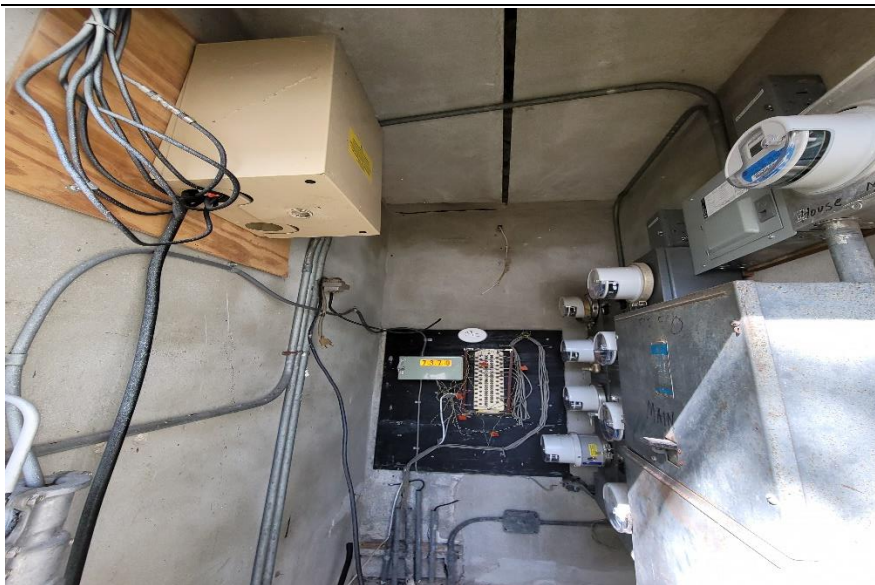
Photo #8:

The mechanical room was observed to be in good condition. Wall/ceiling penetration should be sealed.
