# RIO GRANDE DIVERSION INFRASTRUCTURE INVENTORY

**Structure Name:** CONSOLIDATED SLOUGH WEIR

Rio Grande Stream  
Management Plan

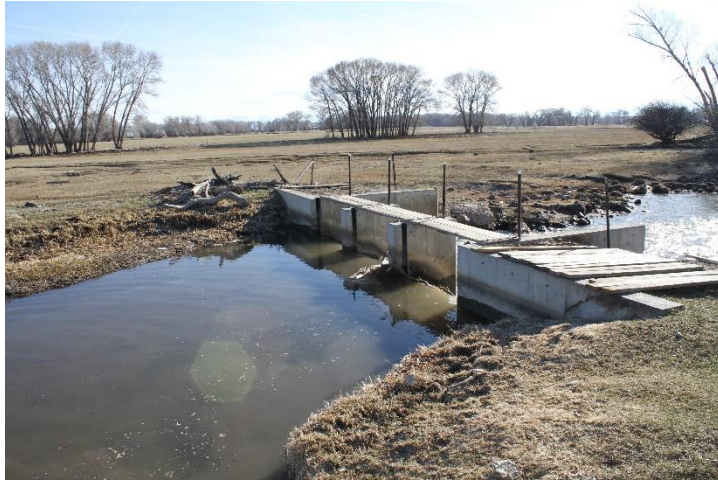
Weir looking downstream

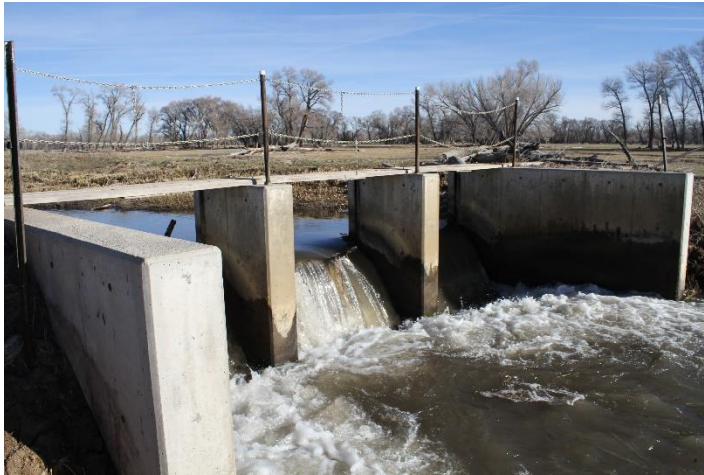
Weir looking upstream

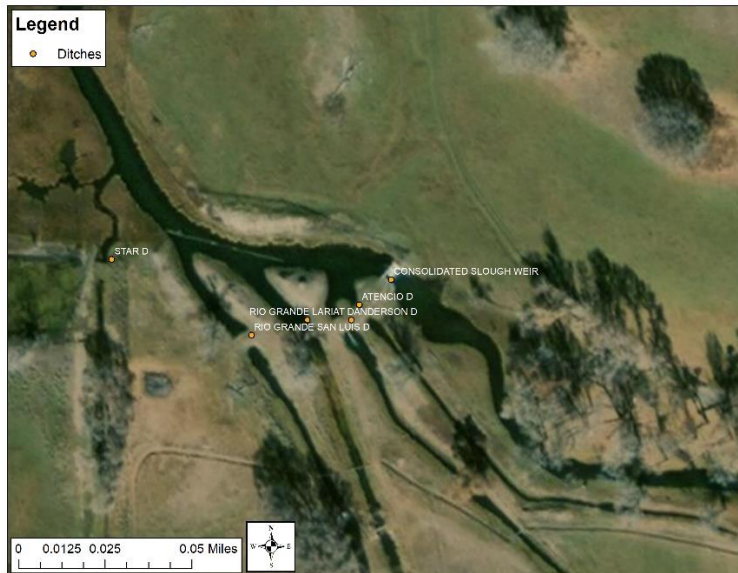
Aerial view of structure
