MINIMUM INSPECTION PROCEDURAL GUIDELINES FOR BUILDING ELECTRICAL RECERTIFICATION

Table with 1 column and 13 rows containing structure details: a. Name on Title: Village at Dadeland Condominiums (D), b. Street Address: 7420 SW 82nd St. Miami, Florida 33143, c. Legal Description: Village at Dadeland Condominiums, d. Owner's Name: Village at Dadeland Condominiums, e. Owner's Mailing Address: 7420 SW 82nd St. Miami, Florida 33143, f. Folio Number of Property on which Building is Located: 30-4035-047-XXXX, g. Building Code Occupancy Classification: R2 - Residential, h. Present Use: Condominium, Residential, i. General Description, Type of Construction, Size, Number of Stories, and Special Features. Additional Comments: The condominium building was built in 1968. Is a two story building comprised of concrete slab on compacted grade and stucco covered cmu exterior load bearing wall. The second floor catwalk consists of pre-cast concrete slabs, concrete tie columns and tie beams along exterior walls up to the roof level. The roof is a low slope roof and comprised of timber trusses and plywood decking covered with a bituminous asphalt membrane. At the perimeter of the roof there are timber

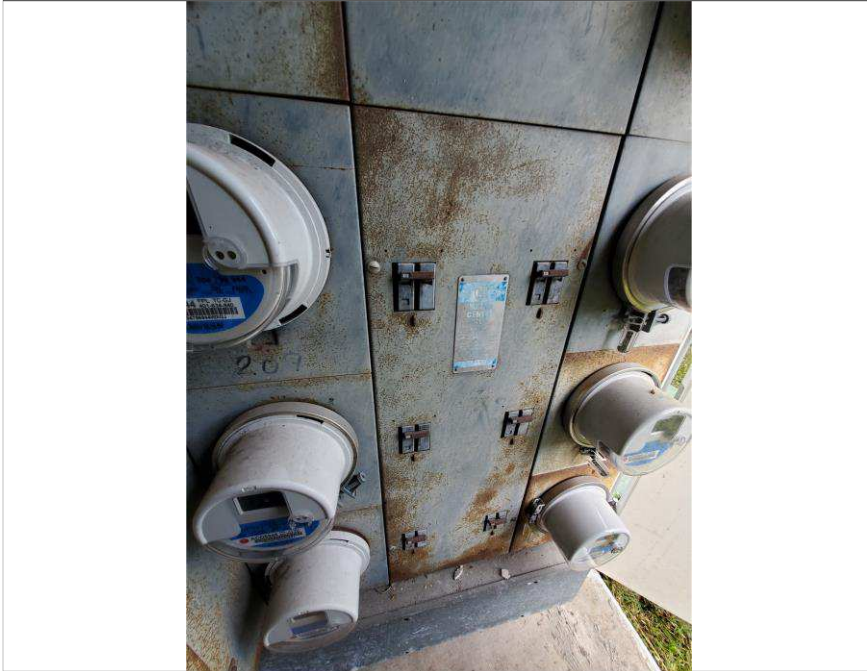
Photo 9 – Village of Dadeland Condominium Association

Existing Electrical Room - 1st FL  
Apartment Meters and Main  
Switches

Old and oxidized meter stacks.

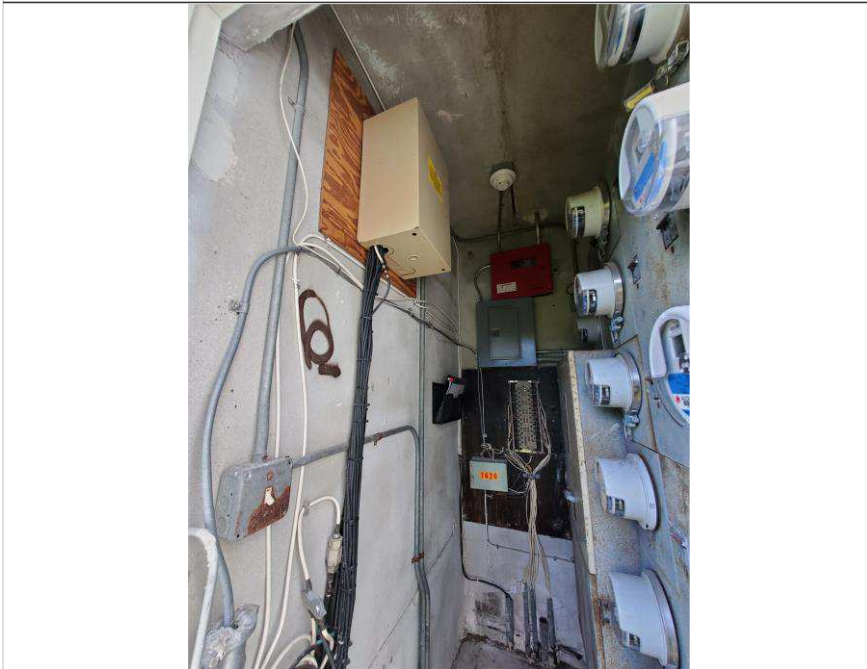
Photo 10 – Village of Dadeland Condominium Association

Existing Electric Room - 1<sup>st</sup> FL  
Main Service Disconnect has  
insufficient clearance.

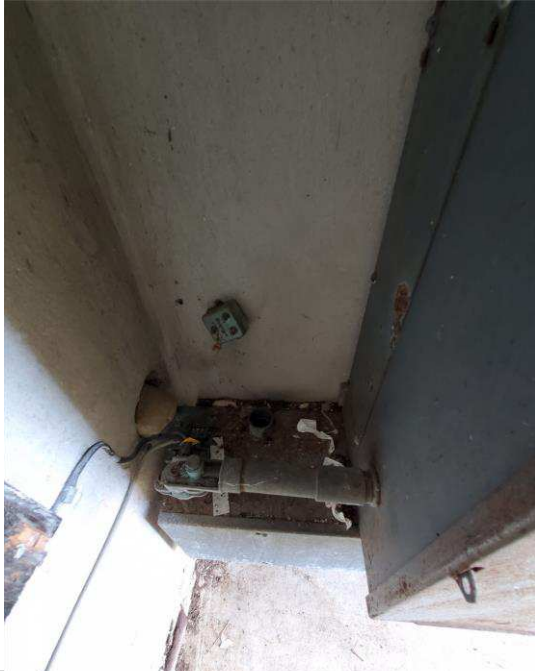
Photo 11 – Village of Dadeland Condominium Association

Existing Electrical Room - 1st FL  
Main Service - Grounding

Grounding resistance to be tested to determine if repairs and /or maintenance are required.

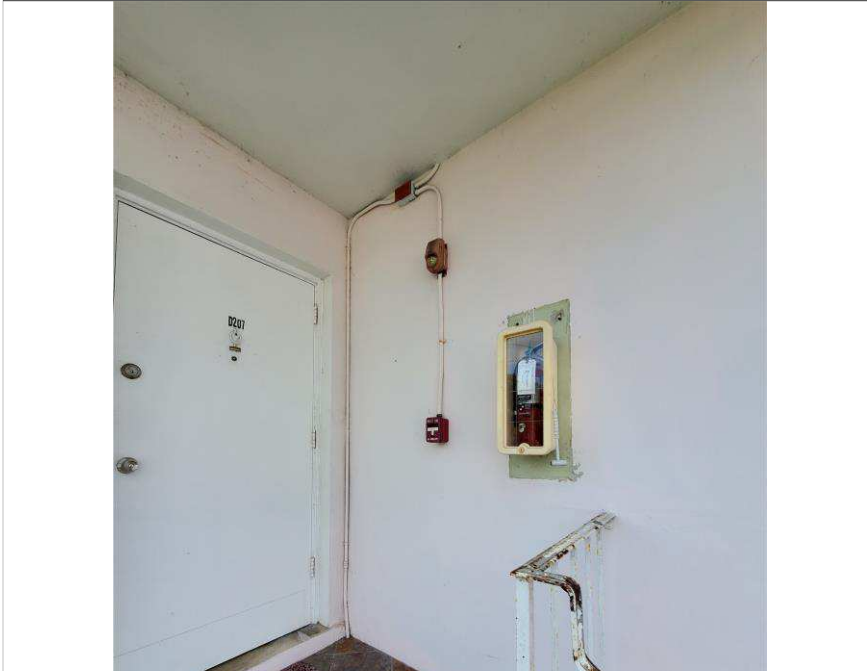
Photo 15 – Village of Dadeland Condominium Association

Level 2  
Fire Alarm Devices and Control  
Center  
Fire Alarm - Old and Weathered

Old Strobe Horn/Strobe Device  
and Pull Stations

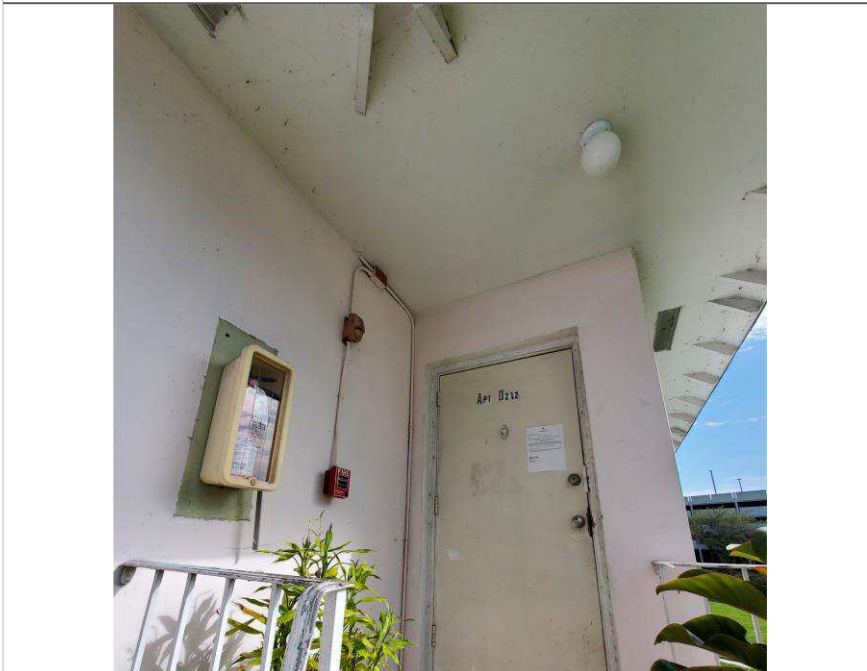
Photo 16 – Village of Dadeland Condominium Association

Level 2  
Fire Alarm Devices and Control  
Center  
Fire Alarm - Old and Weathered

Old Strobe Horn/Strobe Device  
and Pull Stations

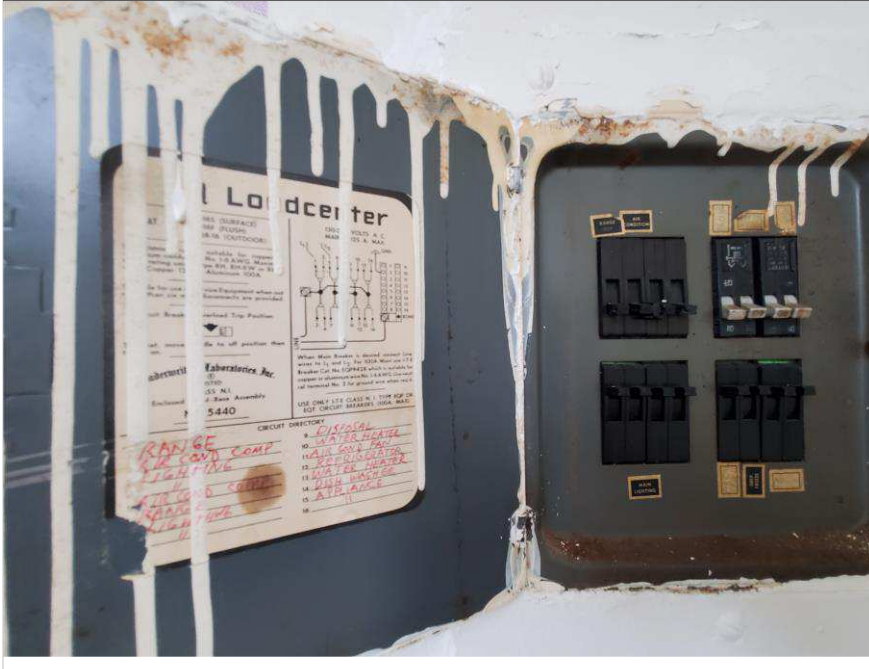
Photo 19 – Village of Dadeland Condominium Association

Apartments - Old Electrical Panels

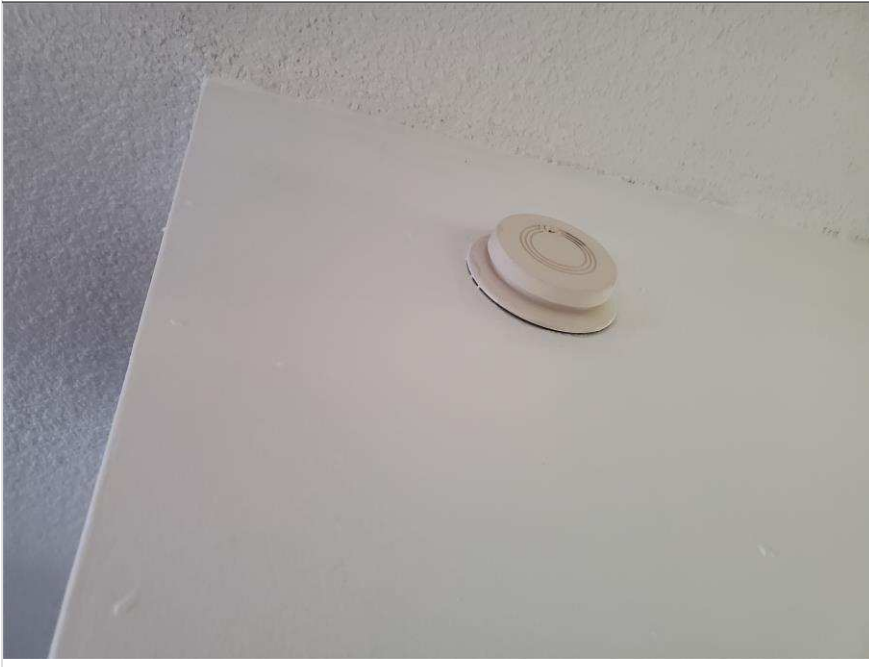
Photo 22 – Village of Dadeland Condominium Association

Apartments - Old Smoke  
Detectors

Old Smoke Detectors to be  
replaced.

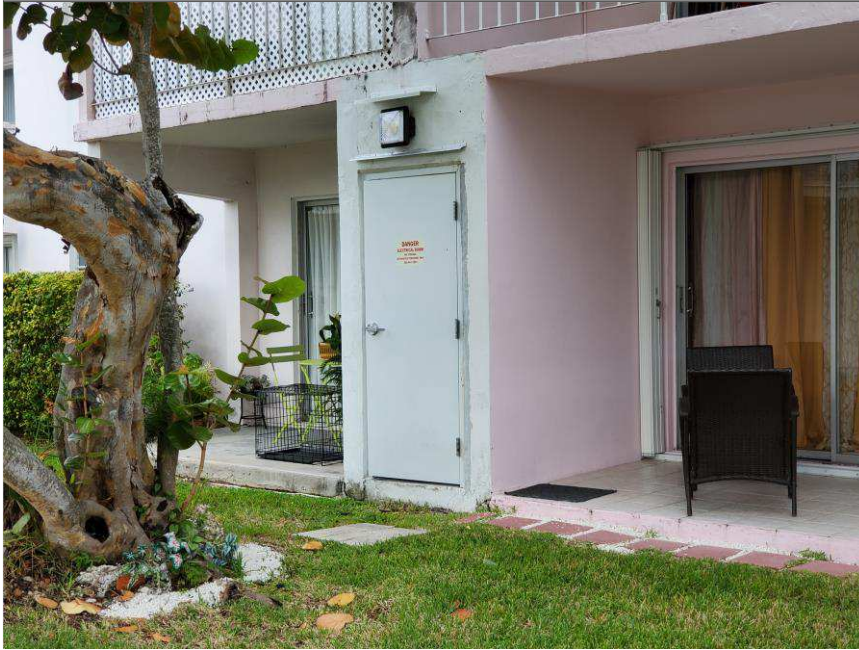
Photo 1 – Village of Dadeland Condominium Association

Existing Electrical Room - 1st FL  
No Storage Permitted

Building Number sign is missing.

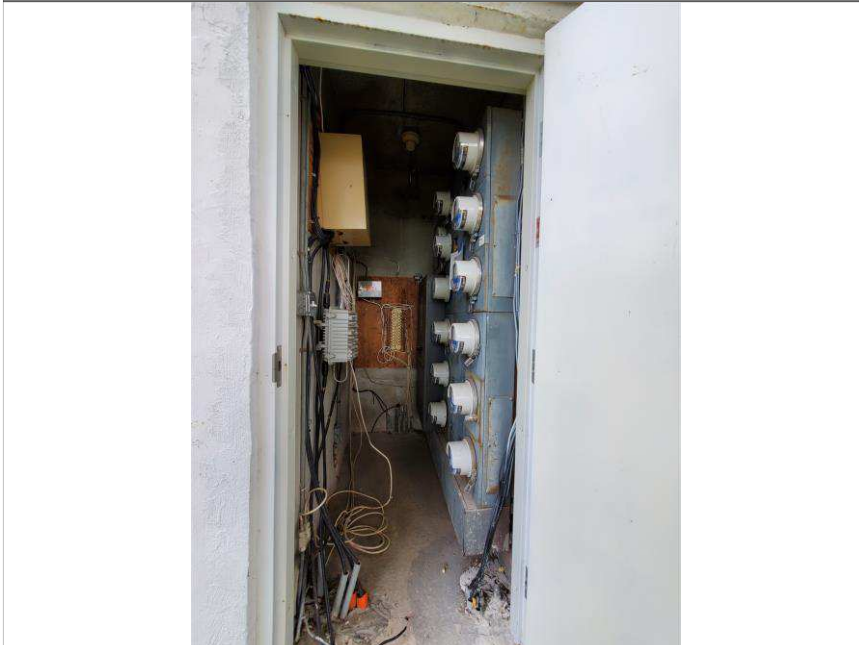
Photo 2 – Village of Dadeland Condominium Association

Existing Electrical Room - 1<sup>st</sup> FL  
Main Switches for Apartments,  
Meters, and Gutter.

Insufficient clearance in front of  
electrical components.

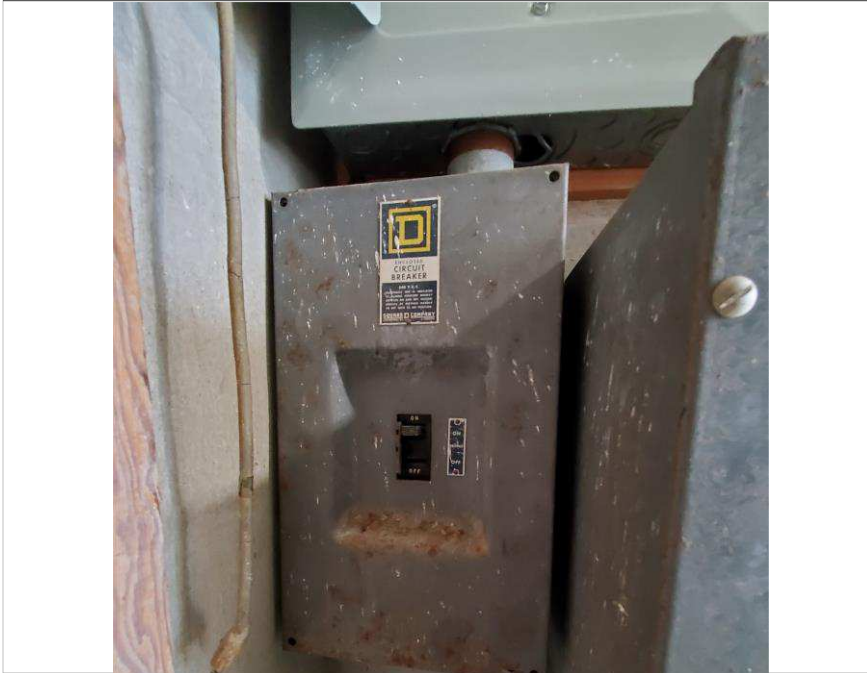
Photo 7 – Village of Dadeland Condominium Association

Existing Electrical Room - 1st FL

Old House Main Circuit Breaker

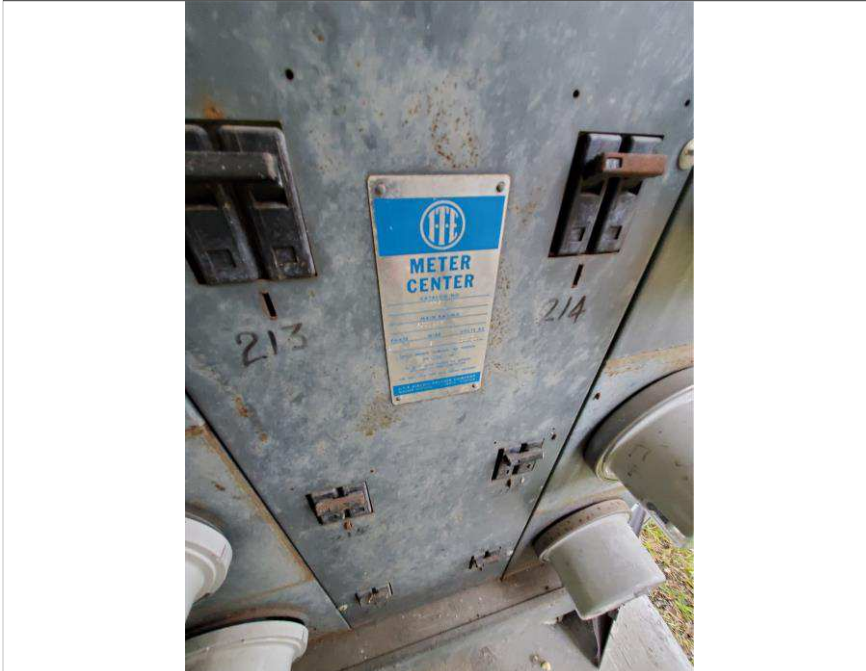
Photo 11 – Village of Dadeland Condominium Association

Existing Electrical Room - 1st FL  
Main Switches for Apartments,  
Meters, and Gutter.

Old and oxidized meter stacks  
and gutter.

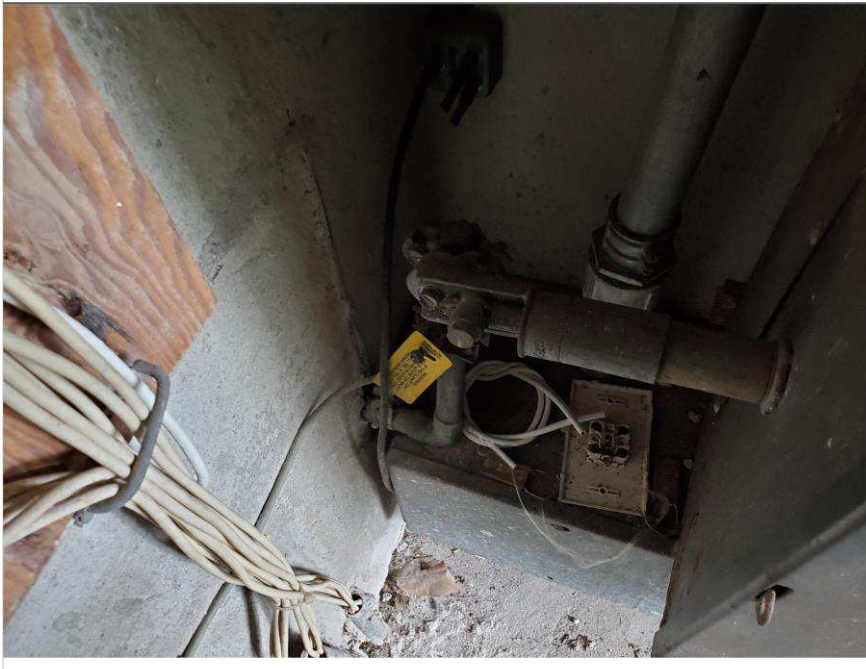
Photo 12 – Village of Dadeland Condominium Association

Existing Electrical Room - 1st FL  
Main Service - Grounding

Grounding resistance to be  
tested to determine if repairs  
and /or maintenance are  
required.

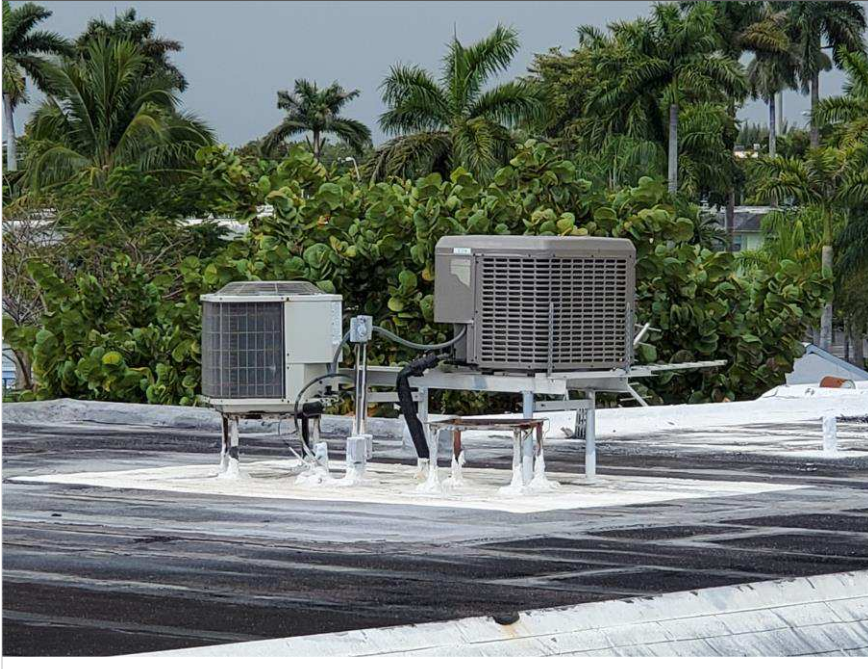
Photo 13 – Village of Dadeland Condominium Association

Rooftop Condenser Units -  
Oxidized junction boxes and  
conduits.

Junction boxes not properly  
supported.

Missing disconnect switches.

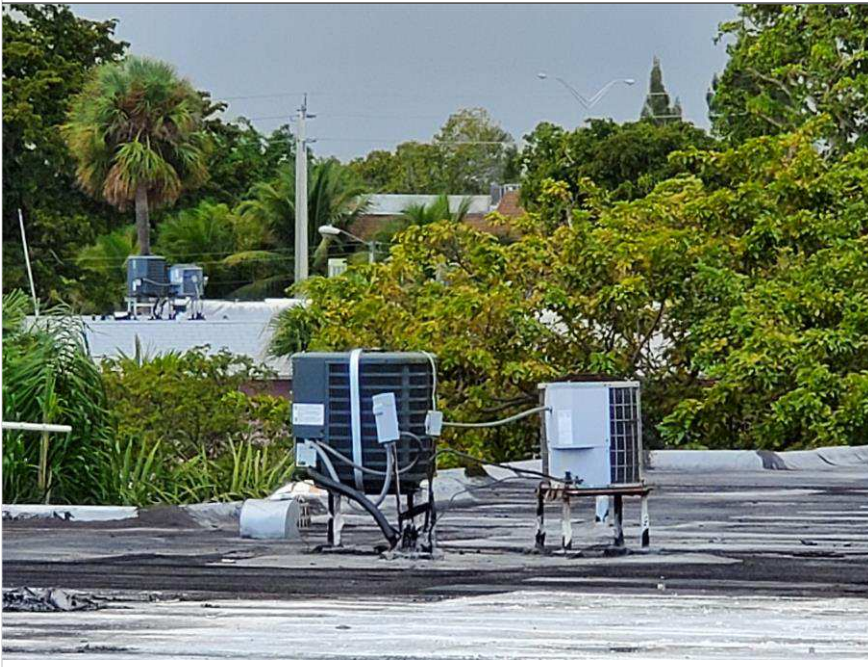
Photo 14 – Village of Dadeland Condominium Association

Rooftop Condenser Units -  
Oxidized junction boxes and  
conduits.

Junction boxes not properly  
supported.

Missing disconnect switches.

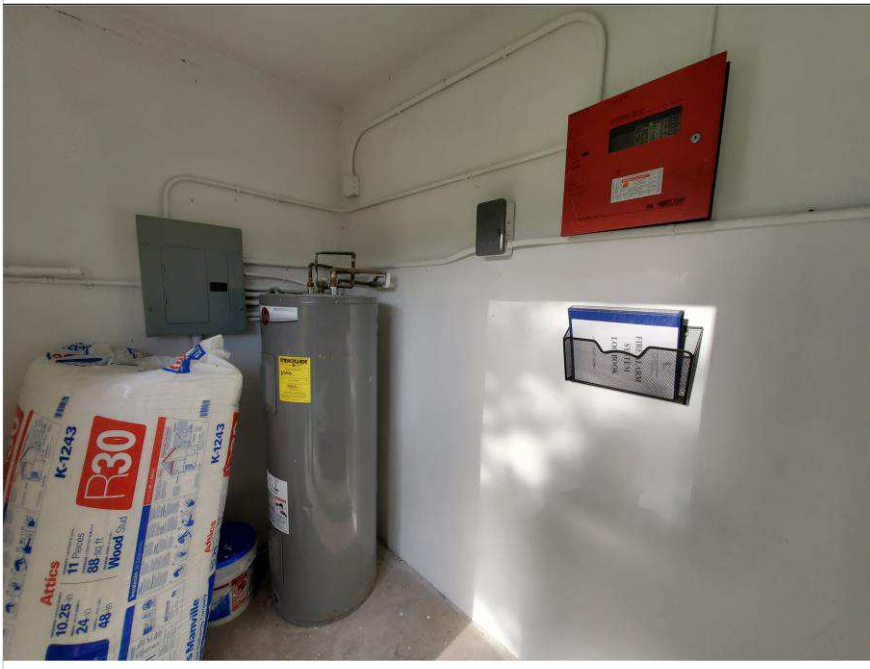
Photo 16 – Village of Dadeland Condominium Association

1st FL - Laundry/Water Heater Room

Fire Alarm – Old and Weathered  
Fire Alarm Devices and Control  
Center

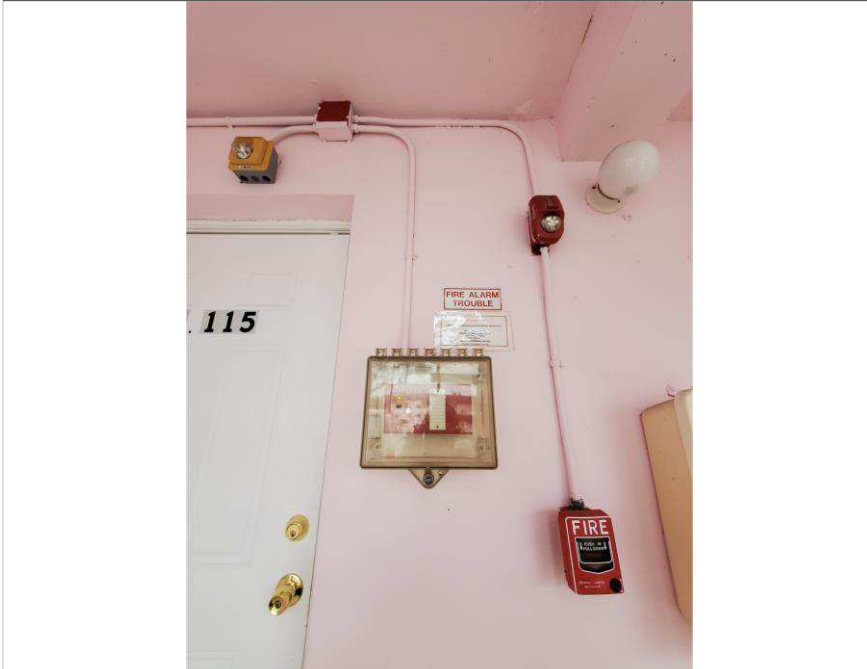
Photo 17 – Village of Dadeland Condominium Association

Level 1  
Fire Alarm - Old and Weathered  
Fire Alarm Devices and Control  
Center

Old Strobe Horn/Strobe Device  
and Pull Stations

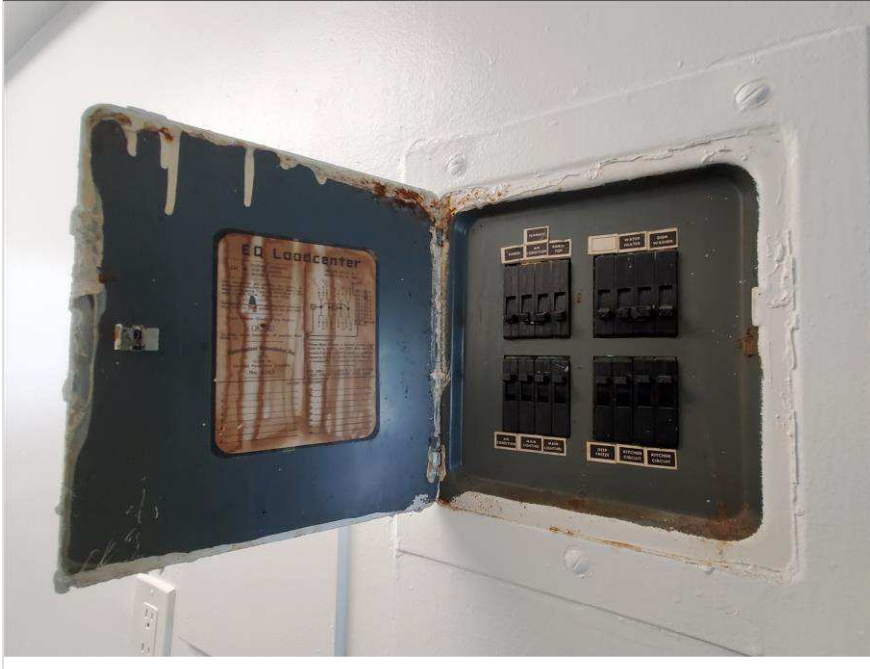
Photo 23 – Village of Dadeland Condominium Association

Apartments – Old Electrical Panels

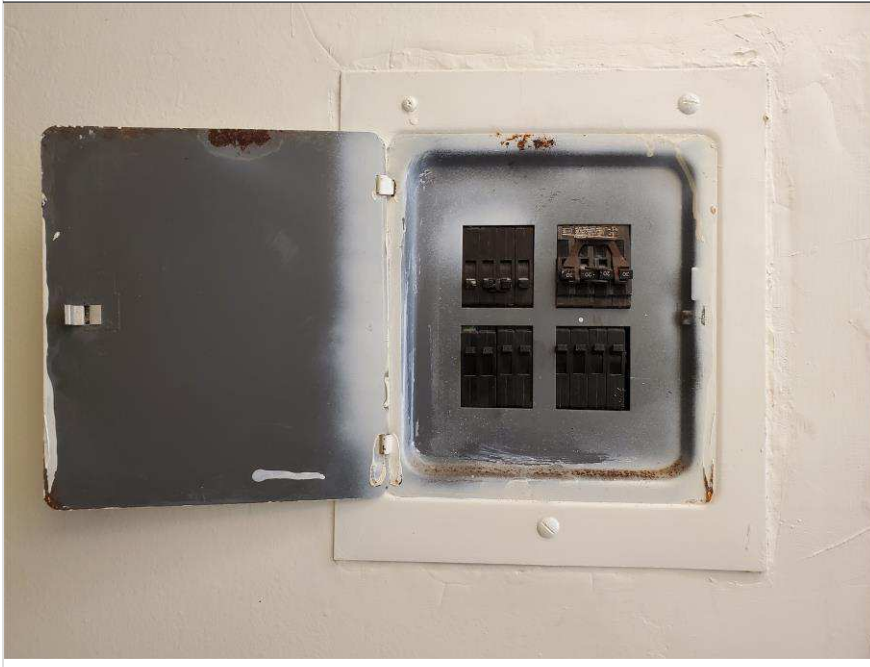
Photo 24 – Village of Dadeland Condominium Association

Apartments – Old Electrical Panels

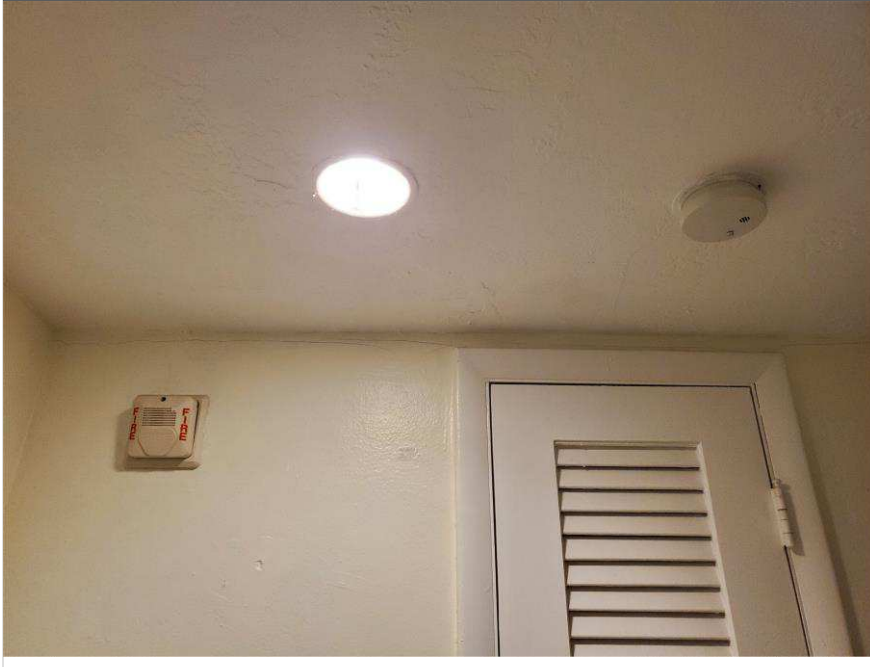
Photo 27 – Village of Dadeland Condominium Association

Apartments - Old Smoke  
Detectors

Old Smoke Detectors to be  
replaced.

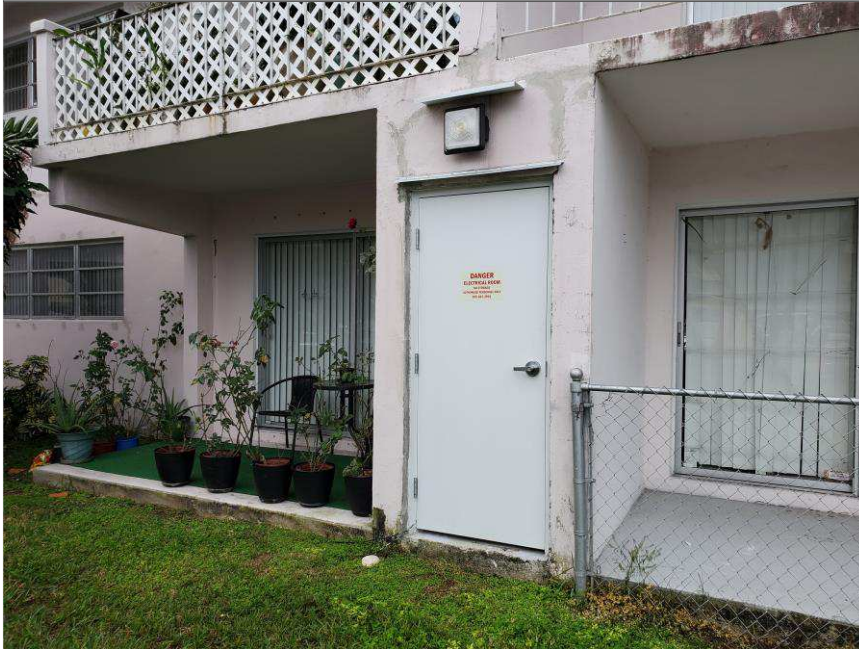
Photo 1 – Village of Dadeland Condominium Association

Existing Electrical Room - 1st FL  
No Storage Permitted

Missing sign with Room name  
and Building number.

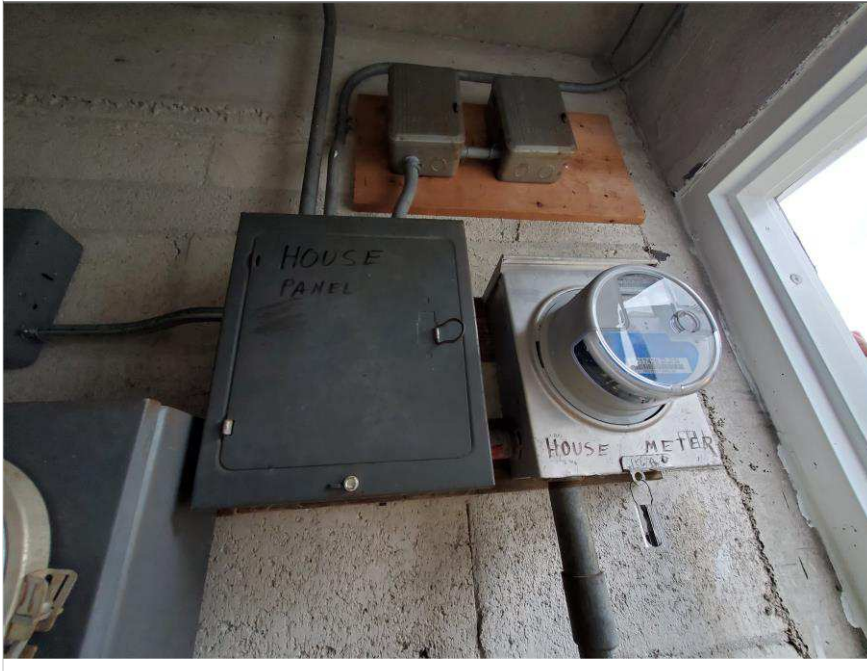
Photo 5 – Village of Dadeland Condominium Association

Existing Electrical Room - 1st FL  
 House Panel Board and Meter.

Time clocks installed too high.

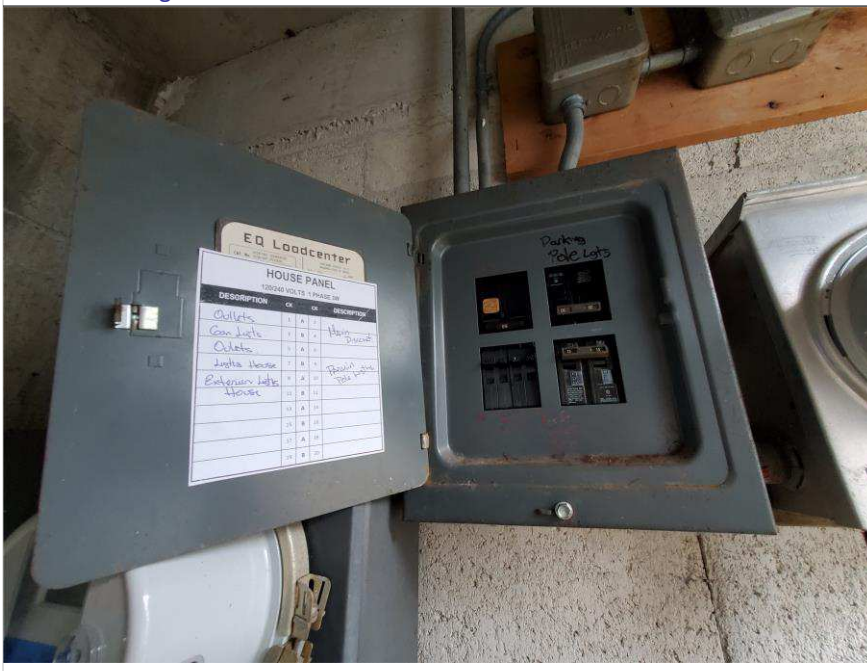
Photo 6 – Village of Dadeland Condominium Association

Existing Electrical Room - 1st FL  
 House Panel Board and breakers  
 are oxidized.

50 year old electrical  
 components.

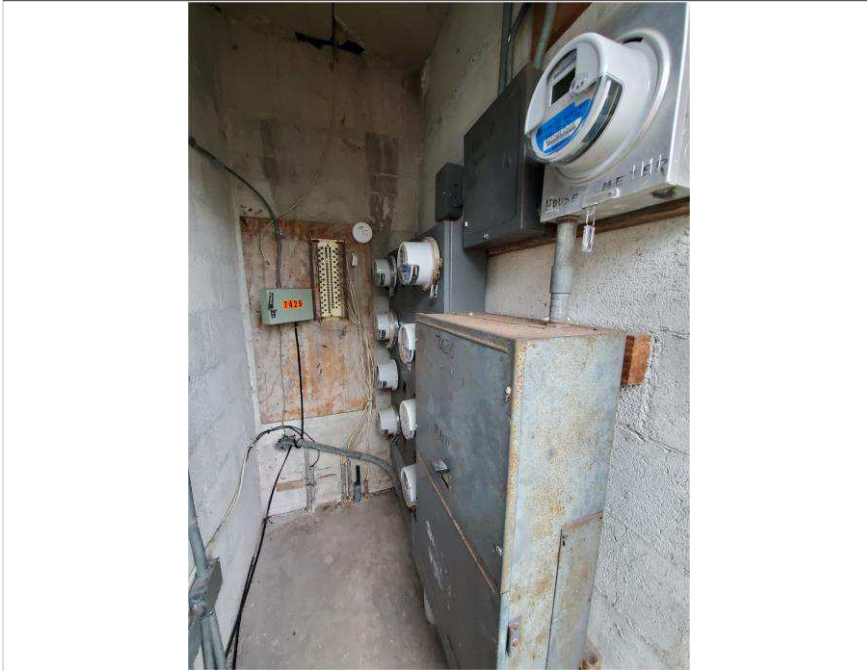
Photo 9 – Village of Dadeland Condominium Association

Existing Electrical Room - 1st FL  
Apartment Meters and Main  
Gutter and Main Disconnect  
Switch

Insufficient Clearance at  
electrical components.

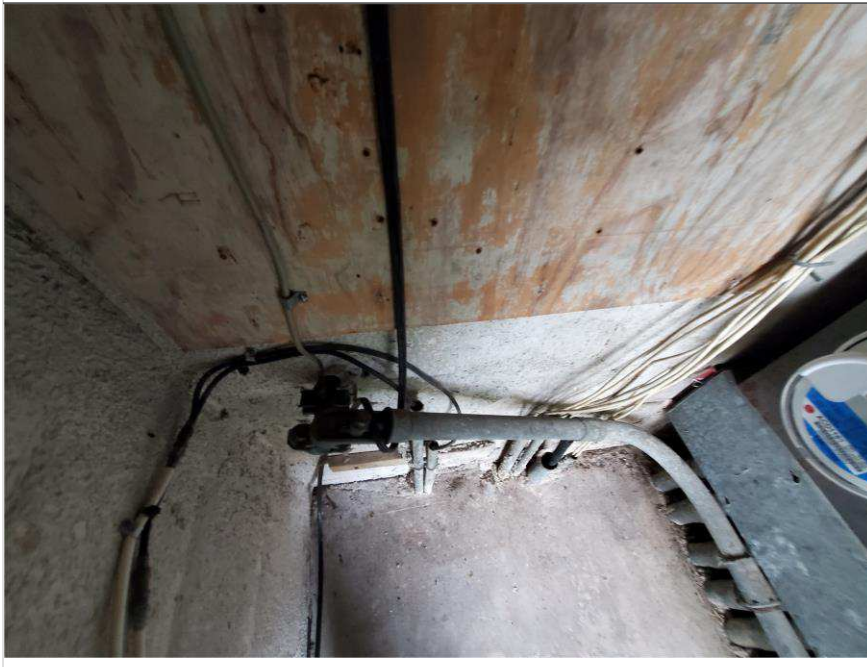
Photo 10 – Village of Dadeland Condominium Association

Existing Electrical Room - 1st FL  
Main Service - Grounding

Grounding resistance to be  
tested to determine if repairs  
and /or maintenance are  
required.

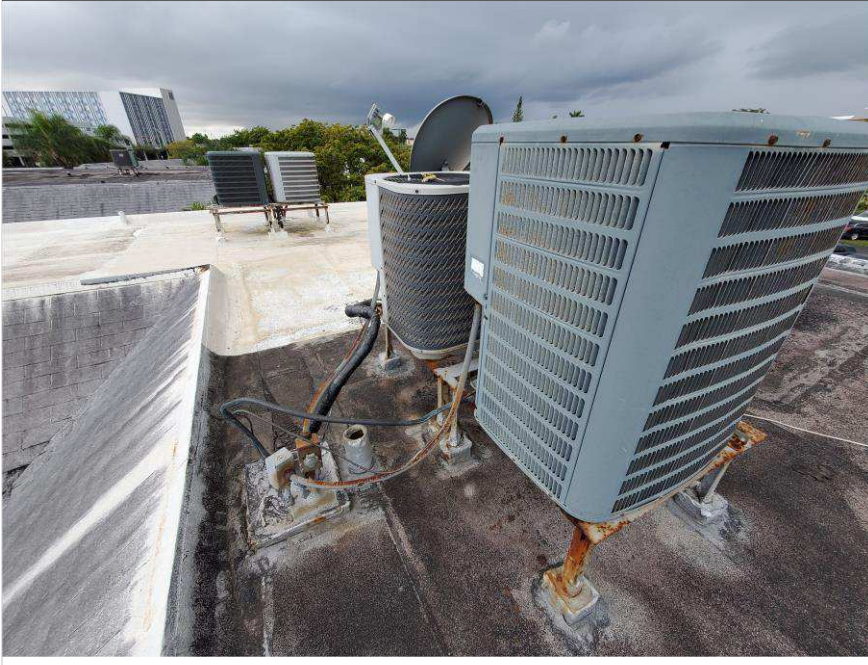
Photo 11 – Village of Dadeland Condominium Association

Rooftop Condenser Units -  
Oxidized junction boxes and  
conduits.

Junction boxes not properly  
supported.

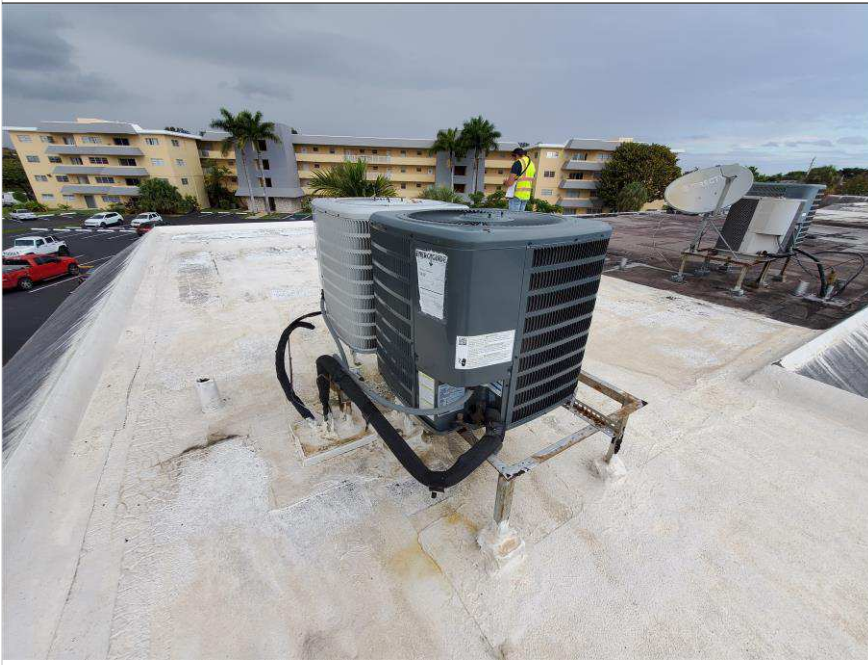
Photo 12 – Village of Dadeland Condominium Association

Rooftop Condenser Units -  
Oxidized junction boxes and  
conduits.

Junction boxes not properly  
supported.

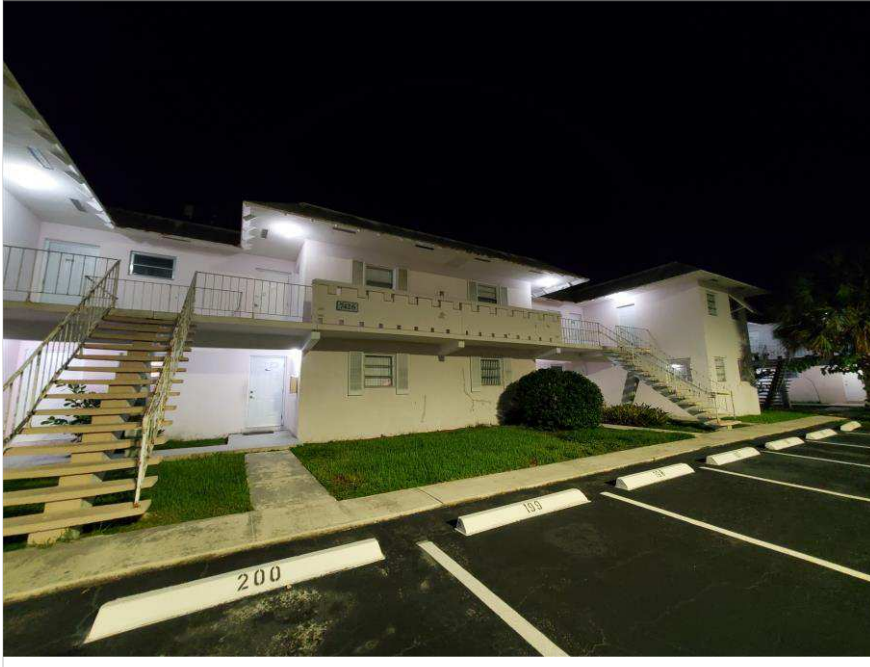
Photo 13 – Village of Dadeland Condominium Association

Catwalks -  
Poorly illuminated catwalks  
Exterior light not functional.

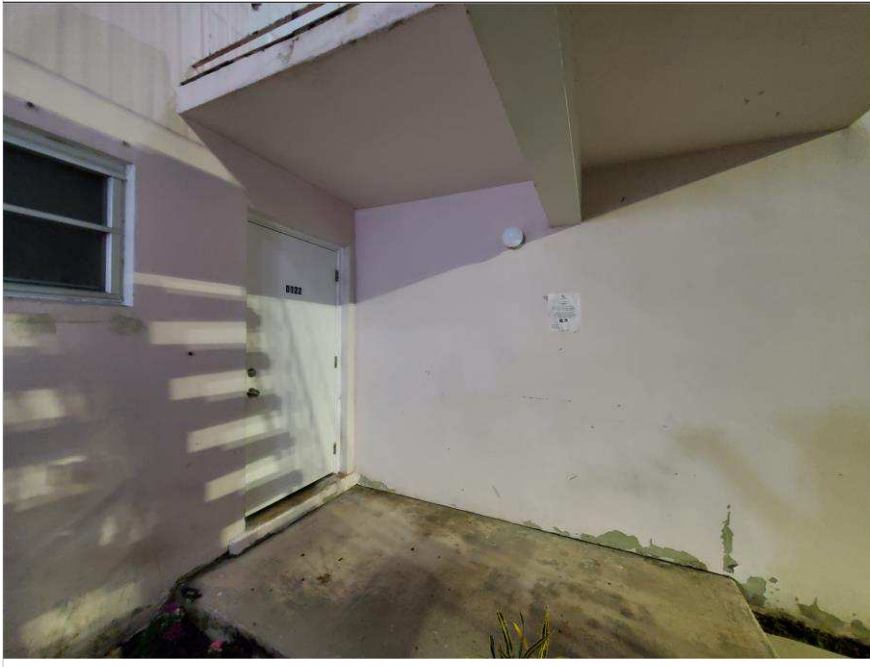
Photo 14 – Village of Dadeland Condominium Association

Catwalks -  
Poorly illuminated catwalks  
Exterior lights not functional.

Light out at point of egress.

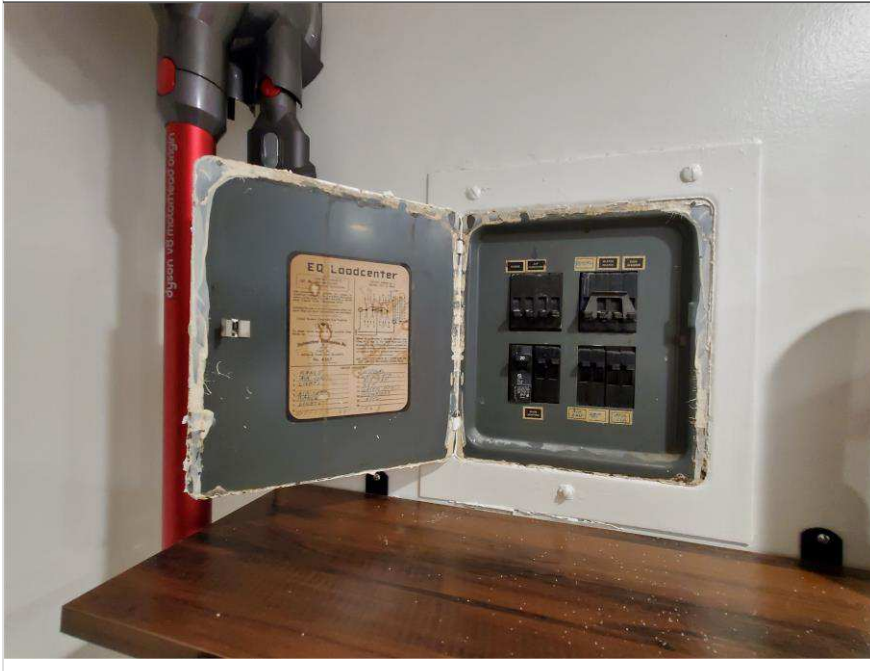
Photo 15 – Village of Dadeland Condominium Association

Apartments - Old Electrical Panels

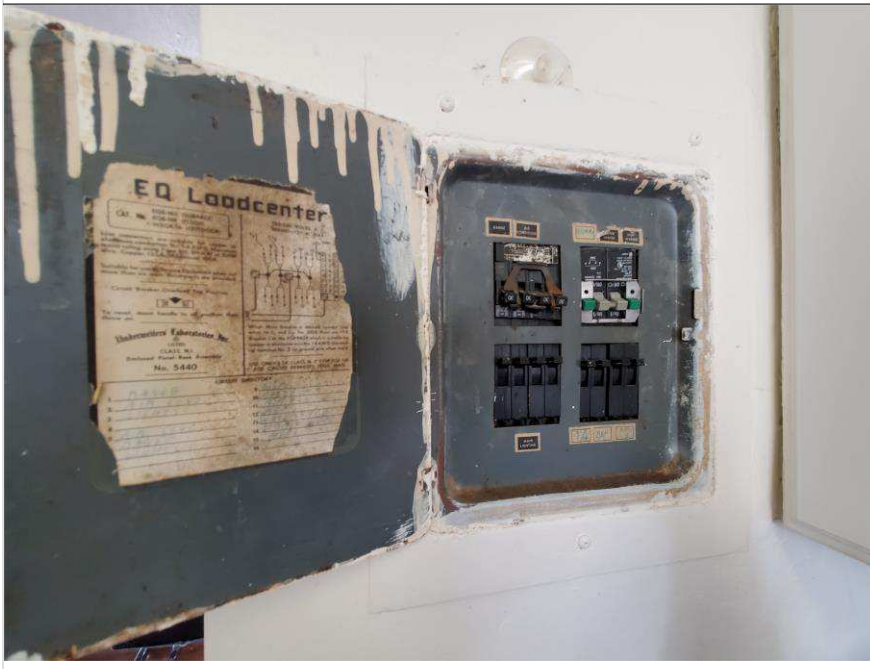
Photo 16 – Village of Dadeland Condominium Association

Apartments - Old Electrical Panels

Old, oxidized breaker to be replaced.

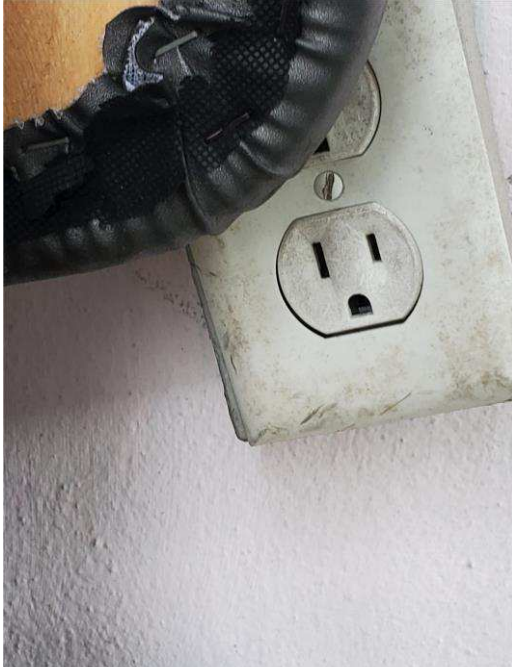
Photo 17 – Village of Dadeland Condominium Association

Apartments - Balcony outlet is not GFCI type.

No weatherproof cover.

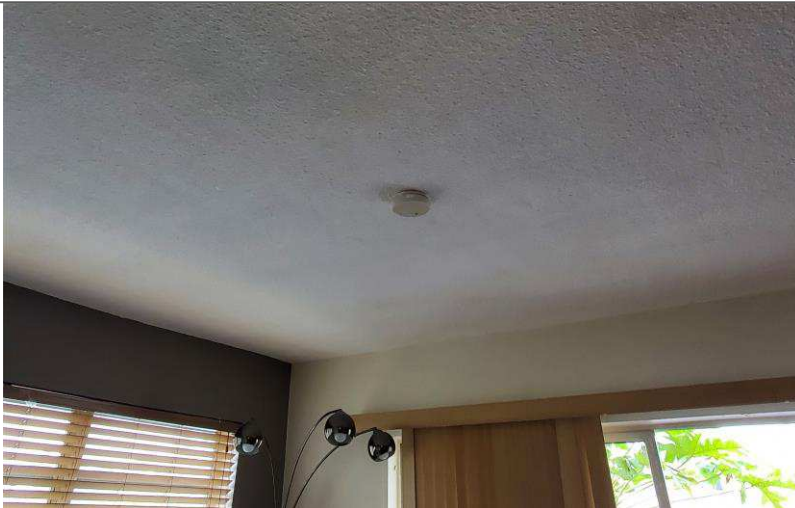
Photo 18 – Village of Dadeland Condominium Association

Apartments - Old Smoke Detectors

Old Smoke Detectors to be replaced.

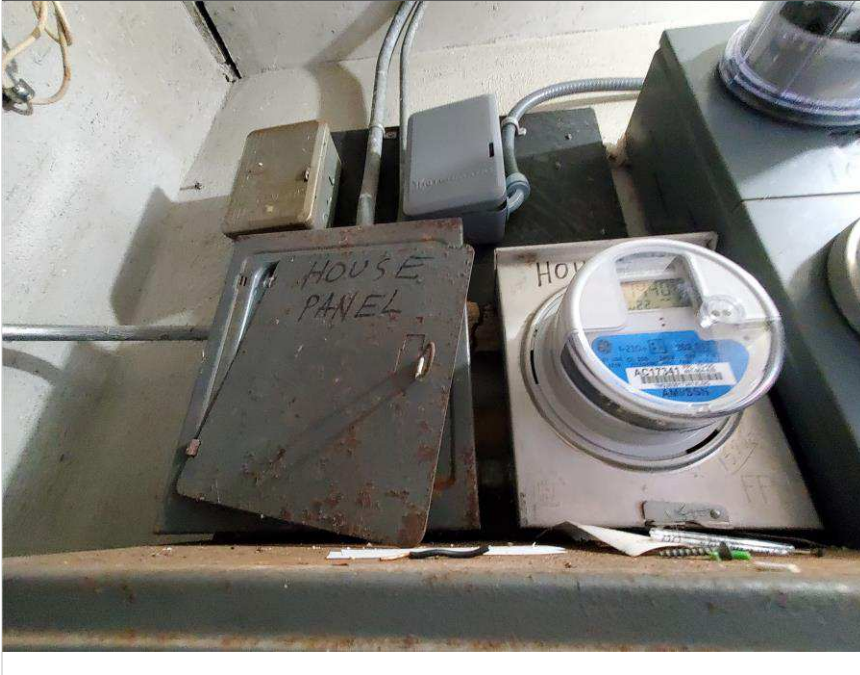
Photo 5 – Village of Dadeland Condominium Association

Existing Electrical Room - 1st FL  
House Panel and Meter.

Time Clocks installed too high.

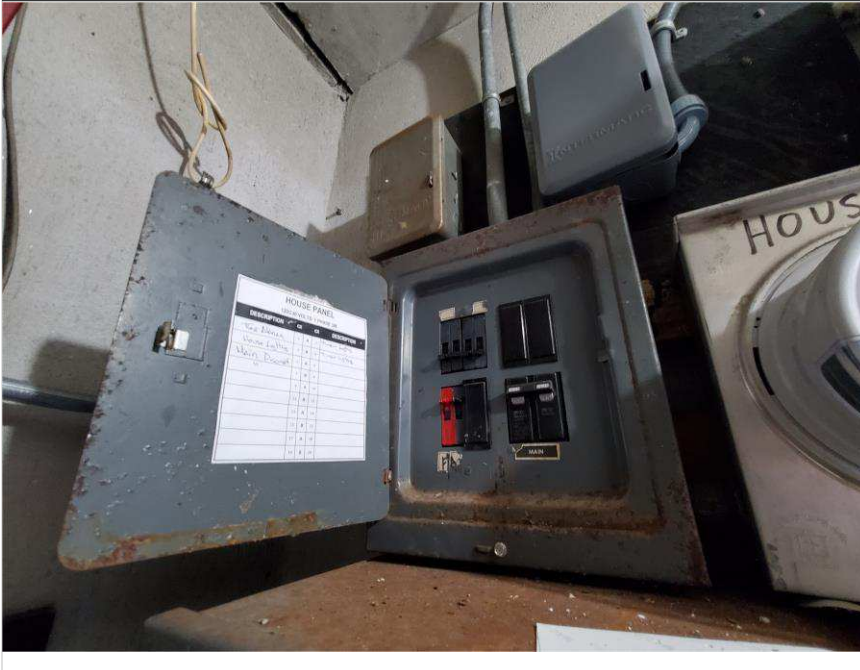
Photo 6 – Village of Dadeland Condominium Association

Existing Electrical Room - 1st FL  
House Panel Board and  
breakers are oxidized.  
50 year old electrical  
components.

Covered Name Plate Rating.

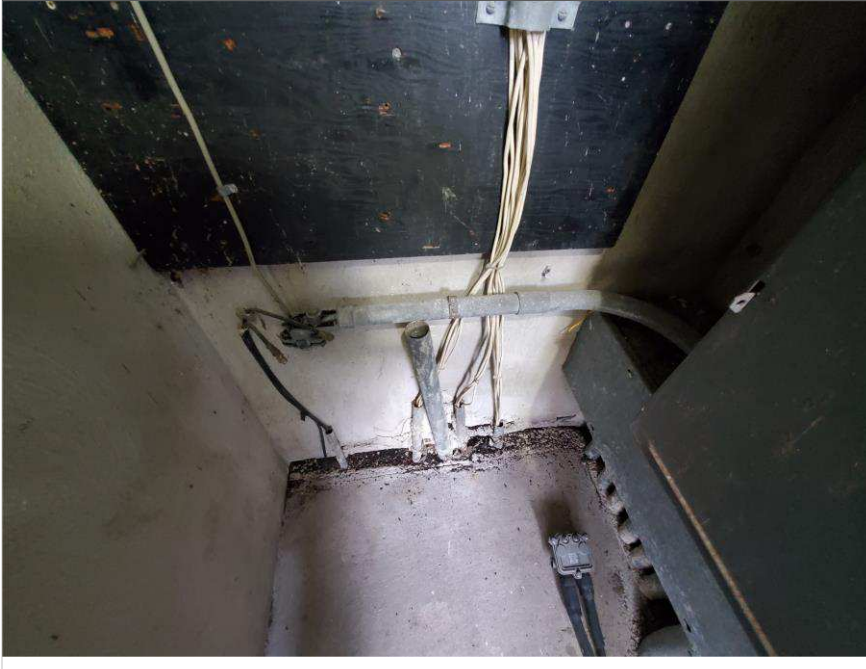
Photo 11 – Village of Dadeland Condominium Association

Existing Electrical Room - 1st FL  
Main Service - Grounding

Grounding resistance to be tested to determine if repairs and/or maintenance are required.

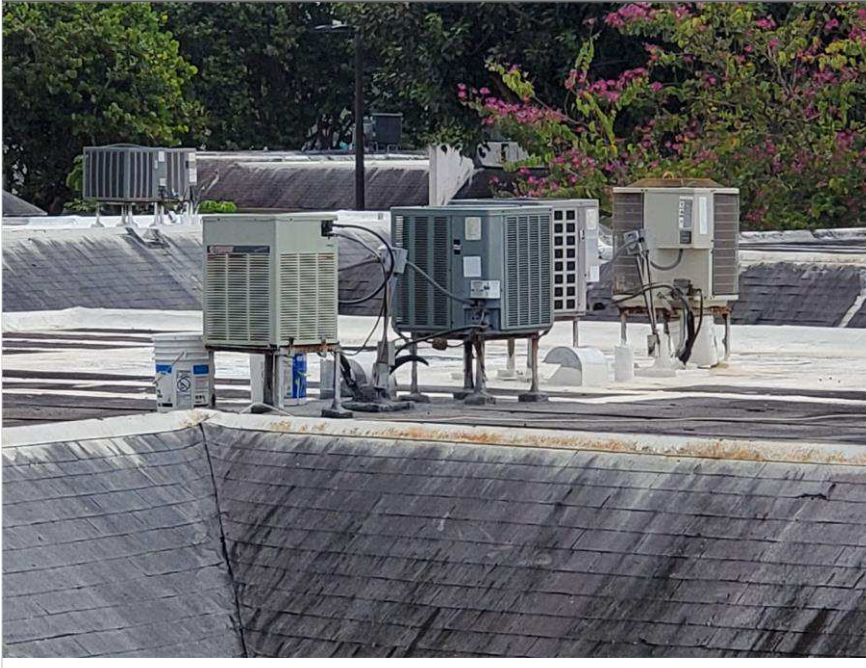
Photo 12 – Village of Dadeland Condominium Association

Rooftop -  
Rooftop Condenser Units -

Junction boxes not properly supported.

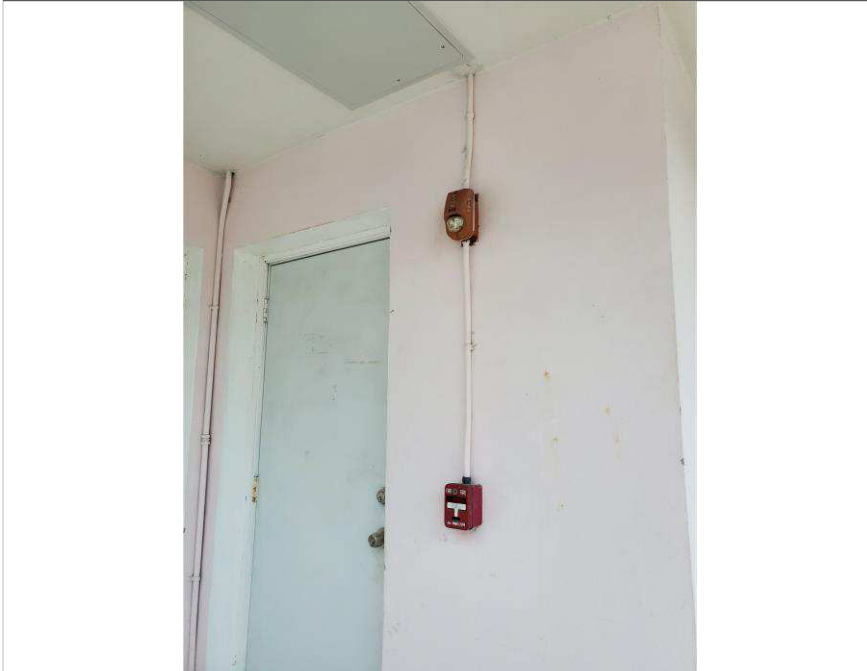
Photo 15 – Village of Dadeland Condominium Association

Level 2

Fire Alarm - Old and Weathered  
Fire Alarm Devices and Control  
Center
