MINIMUM INSPECTION PROCEDURAL GUIDELINES FOR BUILDING ELECTRICAL RECERTIFICATION

Table with 1 column and 13 rows containing structure details: a. Name on Title: Village at Dadeland Condominiums (D), b. Street Address: 7420 SW 82nd St. Miami, Florida 33143, c. Legal Description: Village at Dadeland Condominiums, d. Owner's Name: Village at Dadeland Condominiums, e. Owner's Mailing Address: 7420 SW 82nd St. Miami, Florida 33143, f. Folio Number of Property on which Building is Located: 30-4035-047-XXXX, g. Building Code Occupancy Classification: R2 - Residential, h. Present Use: Condominium, Residential, i. General Description, Type of Construction, Size, Number of Stories, and Special Features. Additional Comments: The condominium building was built in 1968. Is a two story building comprised of concrete slab on compacted grade and stucco covered cmu exterior load bearing wall. The second floor catwalk consists of pre-cast concrete slabs, concrete tie columns and tie beams along exterior walls up to the roof level. The roof is a low slope roof and comprised of timber trusses and plywood decking covered with a bituminous asphalt membrane. At the perimeter of the roof there are timber

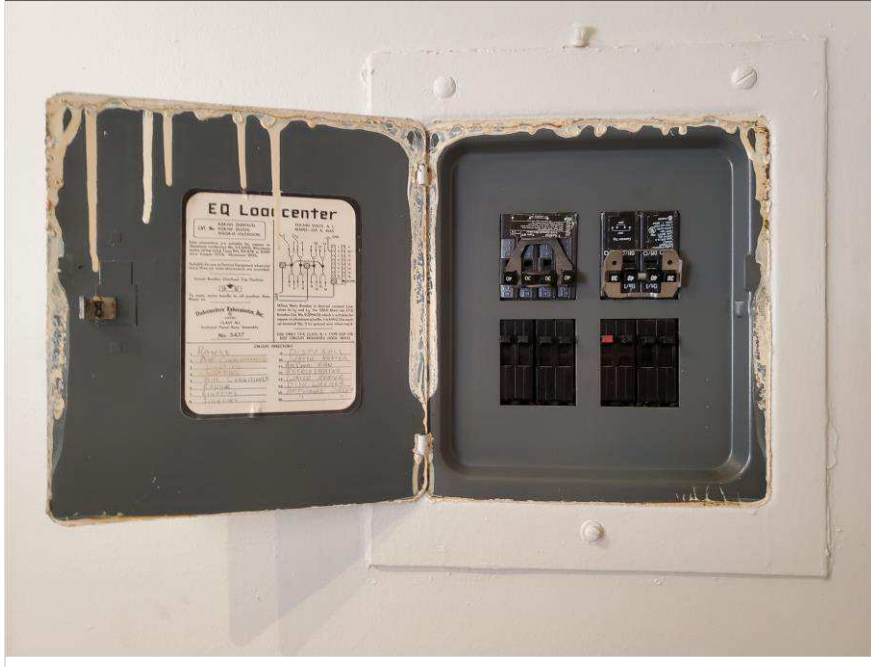
Photo 19 – Village of Dadeland Condominium Association

Apartments - Old Electrical Panels

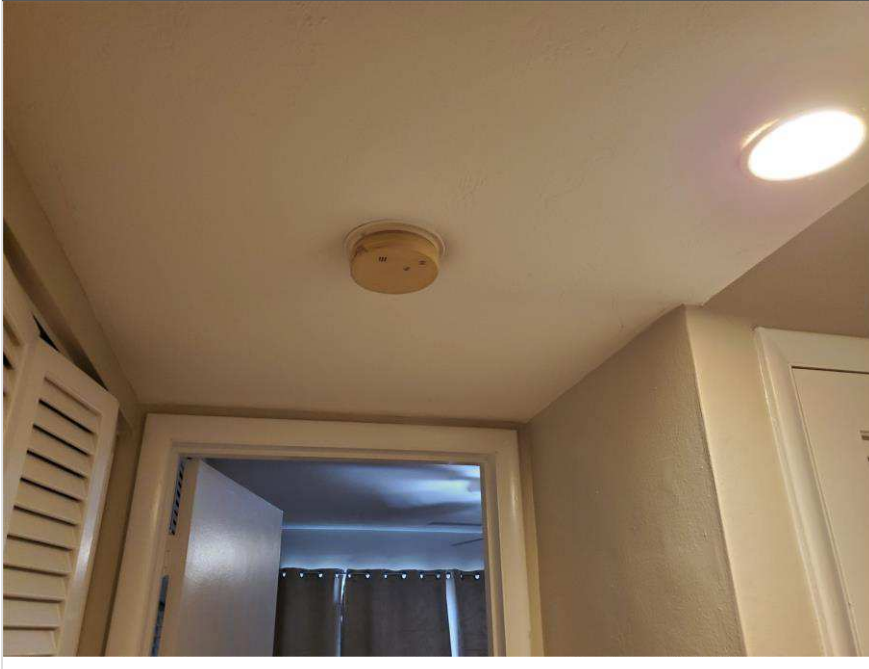
Photo 21 – Village of Dadeland Condominium Association

Apartments - Old Smoke Detectors

Old Smoke Detectors to be replaced.

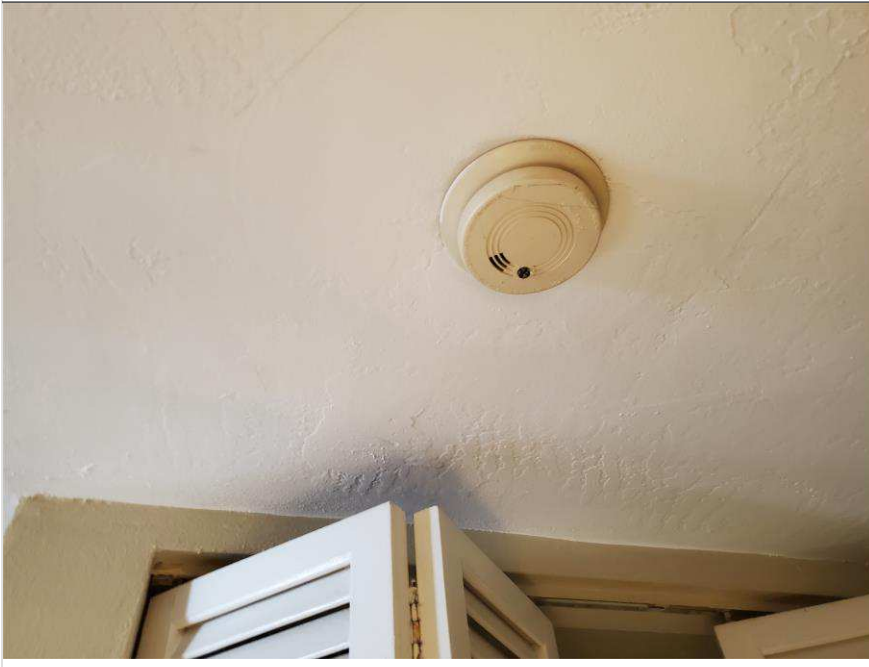
Photo 22 – Village of Dadeland Condominium Association

Apartments - Old Smoke Detectors

Old Smoke Detectors to be replaced.

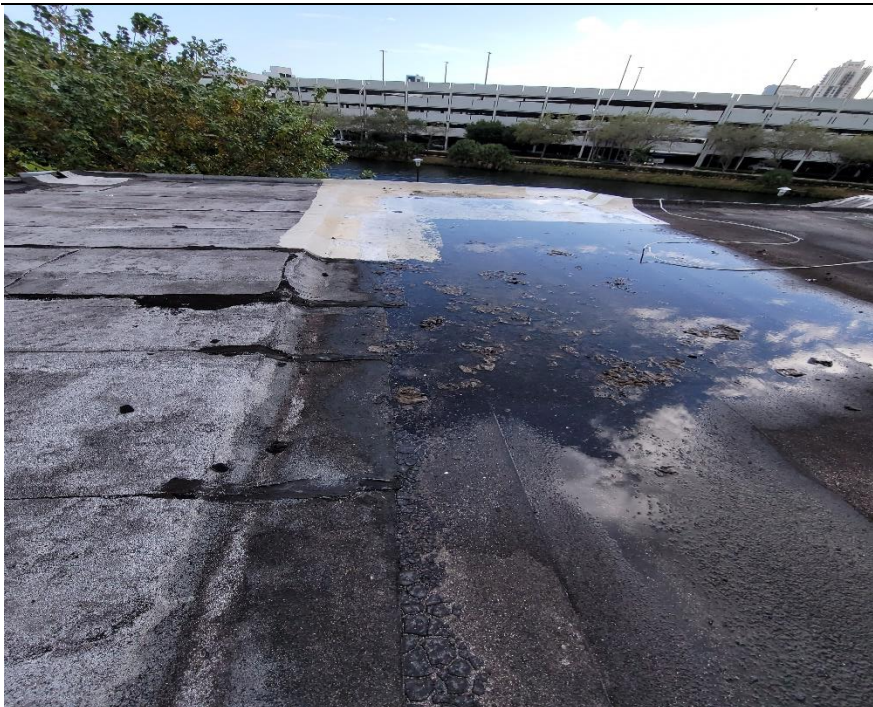
Photo #2:

Water ponding stains observed on the roof.

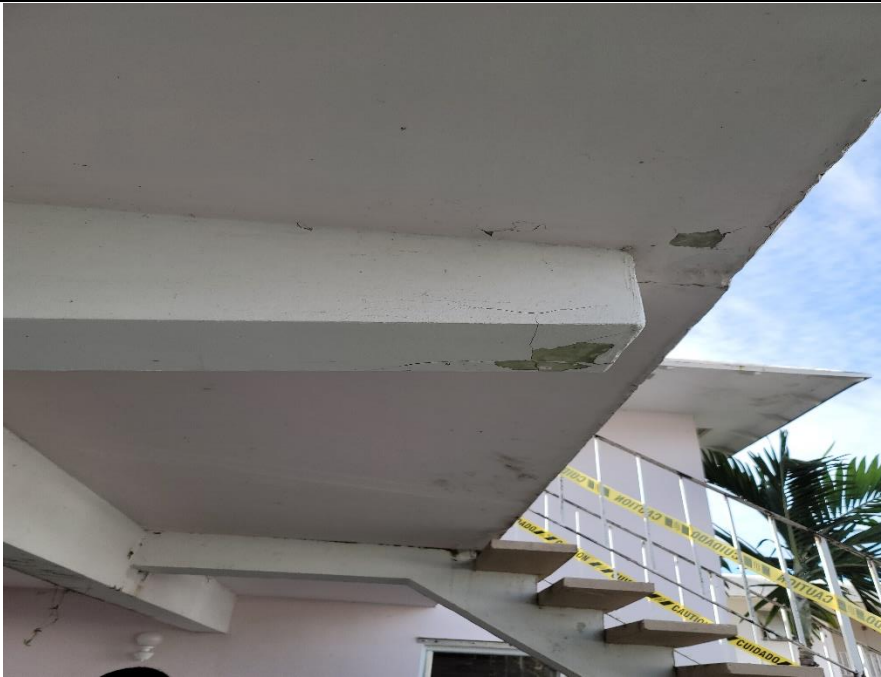
Photo #3:

Unsound concrete surfaces detected at the cantilevered beams of the front catwalks.

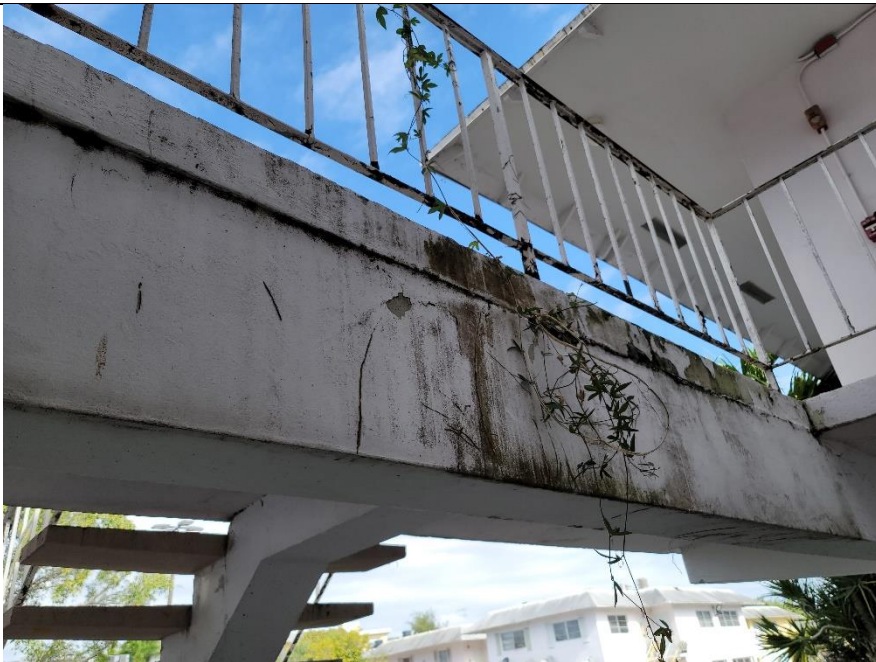
Photo #4:

Staining and vegetation growth was observed at the exposed edges of the concrete beams supporting the catwalks. The members are still sound but maintenance of the paint/waterproofing is required to prevent deterioration of the concrete.

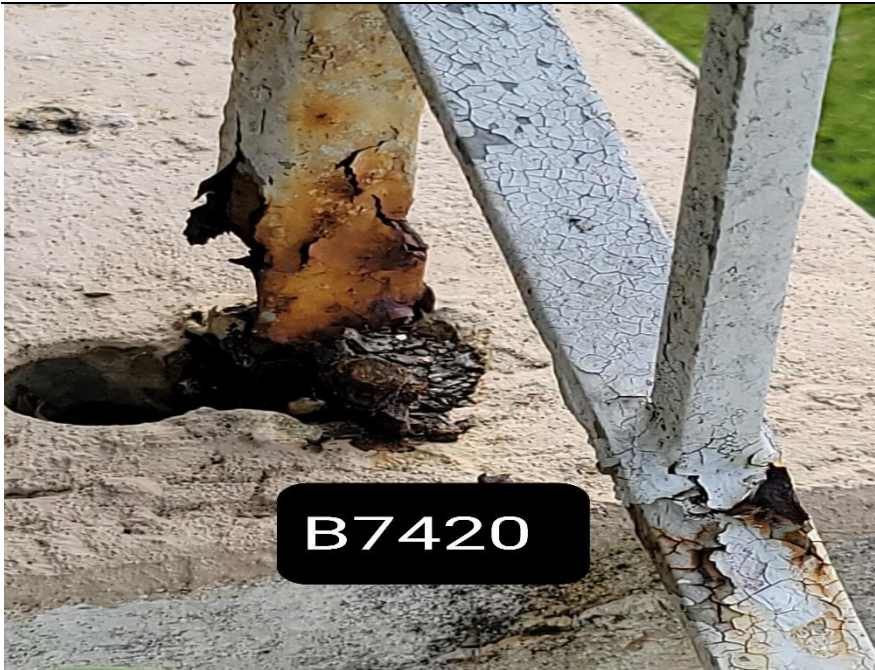
Photo #5:

Replacement of the steel picket rails is mandatory due to the extent of corrosion at the base of the rail posts.

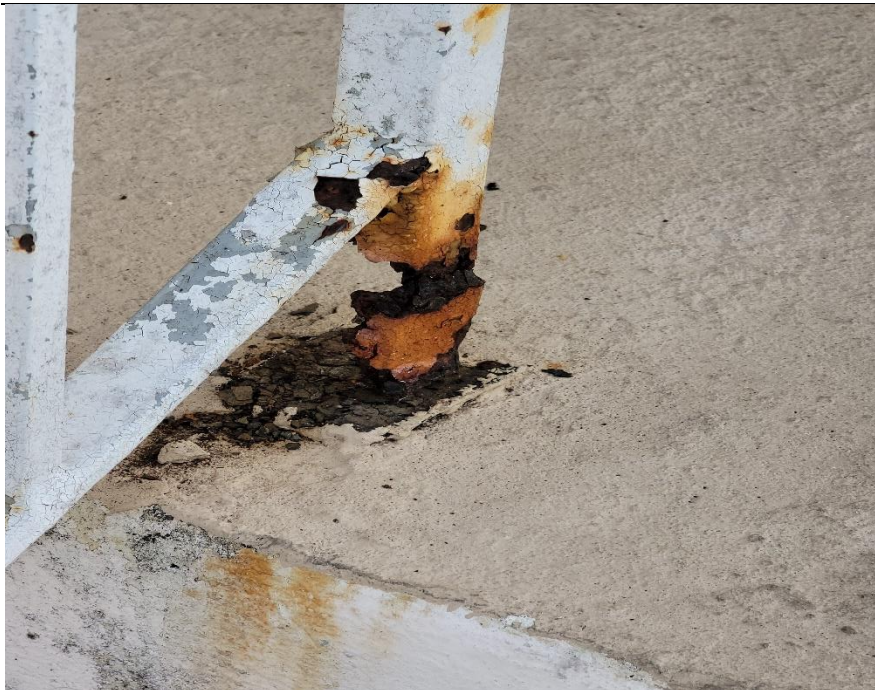
Photo #6:

Replacement of the steel picket rails is mandatory due to the extent of corrosion at the base of the rail posts.

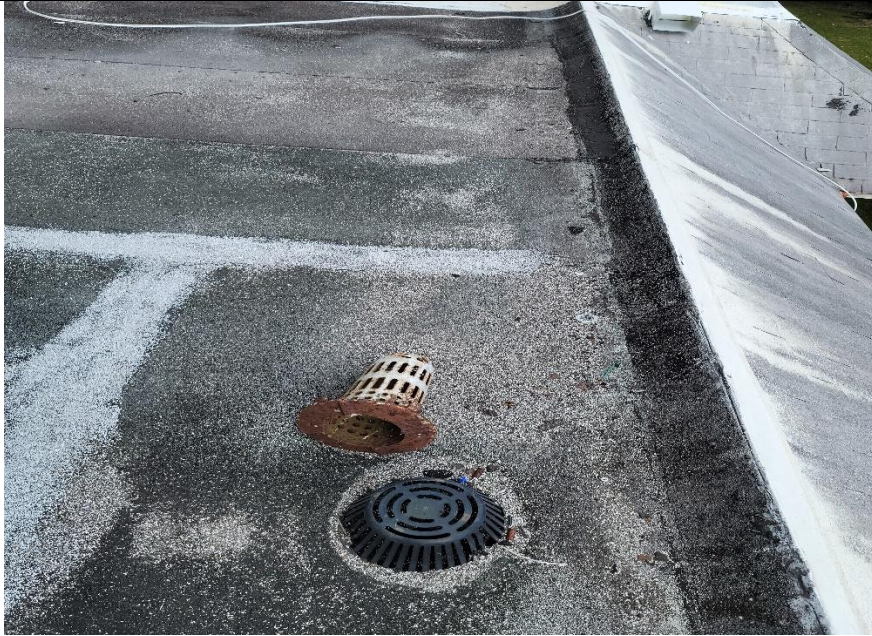
Photo #7:

All abandoned metal strainers and corroded steel dunnage systems should be removed from the roof to prevent potential loose metal elements from falling off the roof during strong wind events.

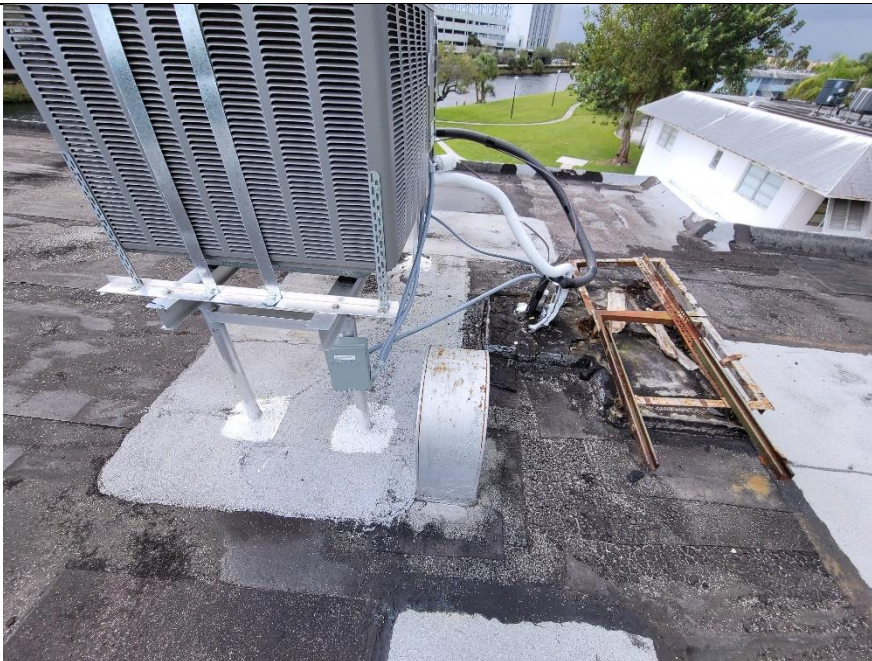
Photo #8:

All abandoned metal strainers and corroded steel dunnage systems should be removed from the roof to prevent potential loose metal elements from falling off the roof during strong wind events.

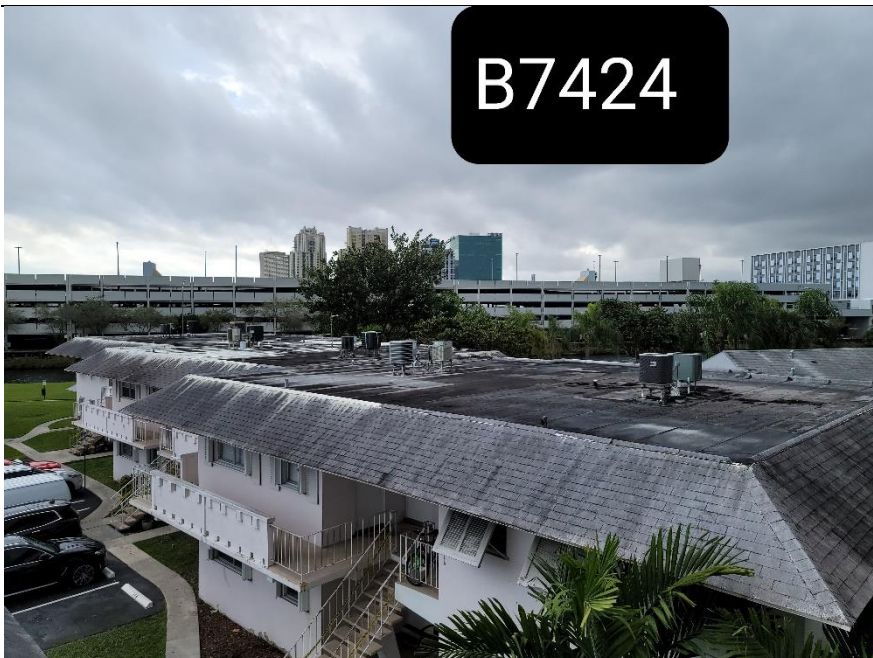
Photo #2:

Water ponding stains observed on the roof.

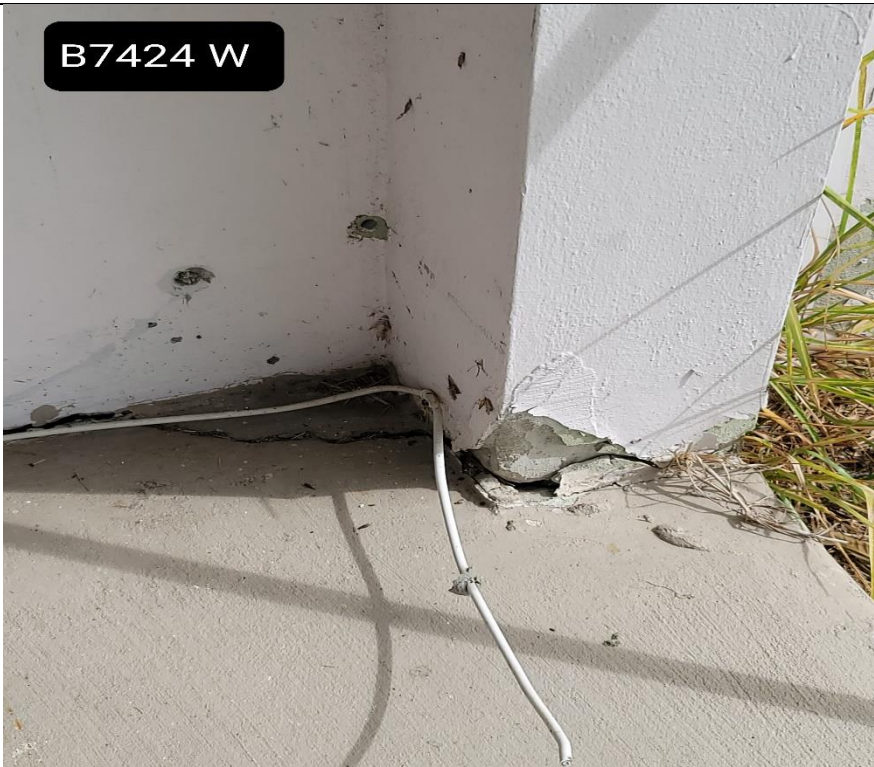
Photo #4:

Deterioration of the rear patio slabs observed near the front corners/edges.

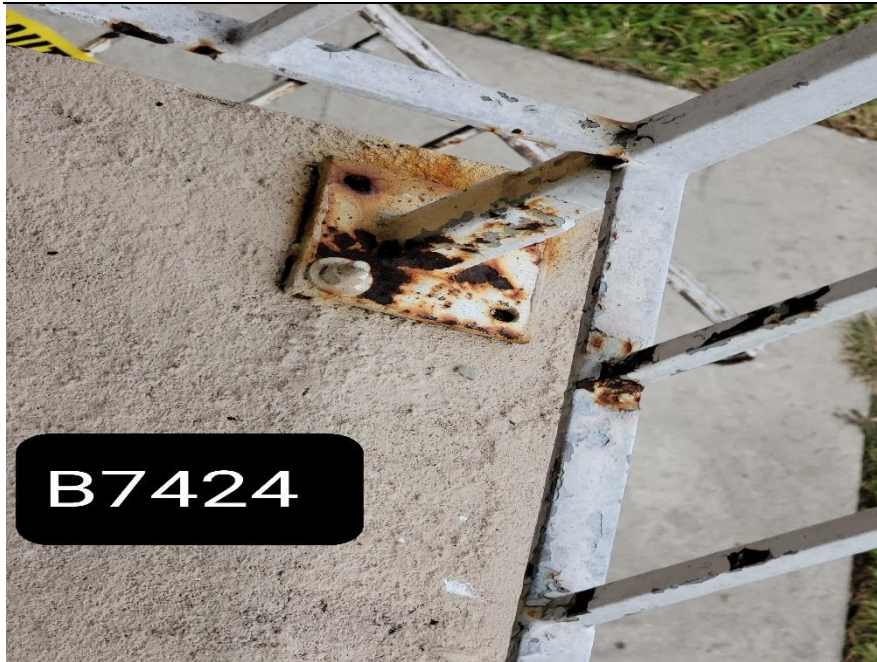
Photo #5:

Replacement of the steel picket rails is mandatory due to the extent of corrosion at the base of the rail posts.

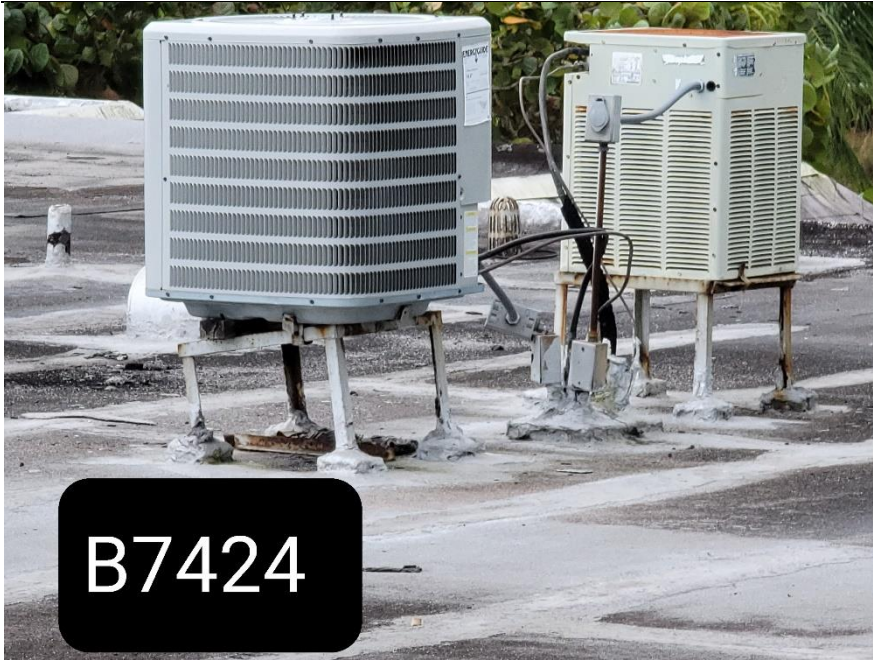
Photo #7:

The structural integrity of the roof dunnage systems are compromised. The dunnage systems should be replaced to prevent the mechanical units from falling onto the roof and endangering the residents below.

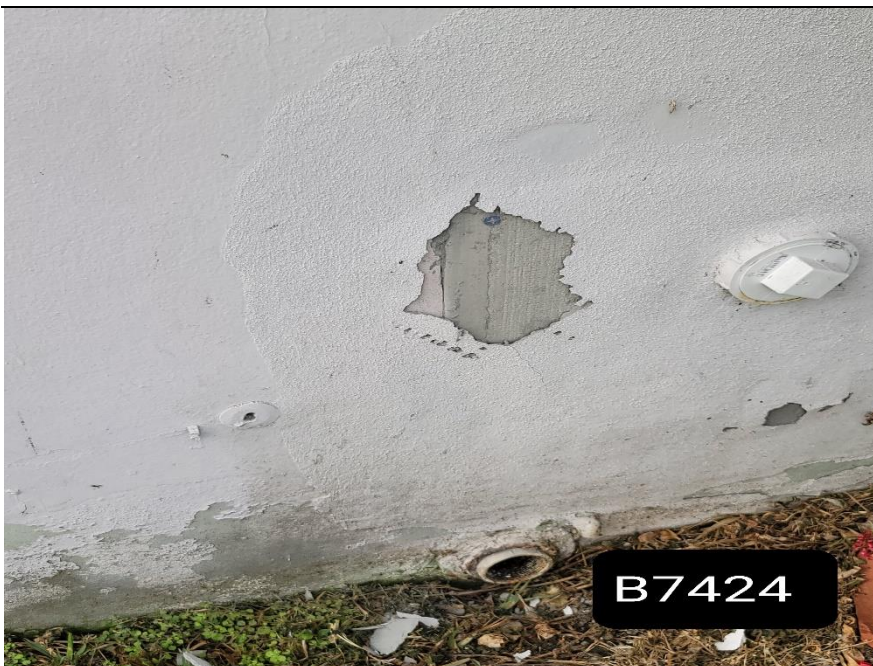
Photo #8:

Previous exterior wall repair/patches observed in the front elevation. The stucco has begun to fall off exposing the cement board beneath. Areas need to be properly repaired to maintain water tightness of the exterior envelope.

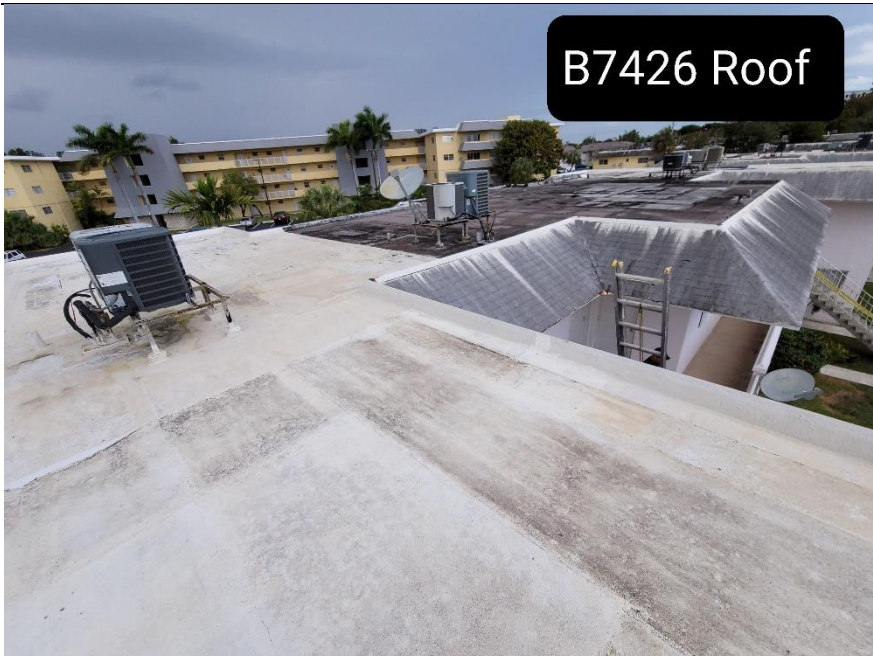
Photo #2:

Water ponding stains observed on the roof.

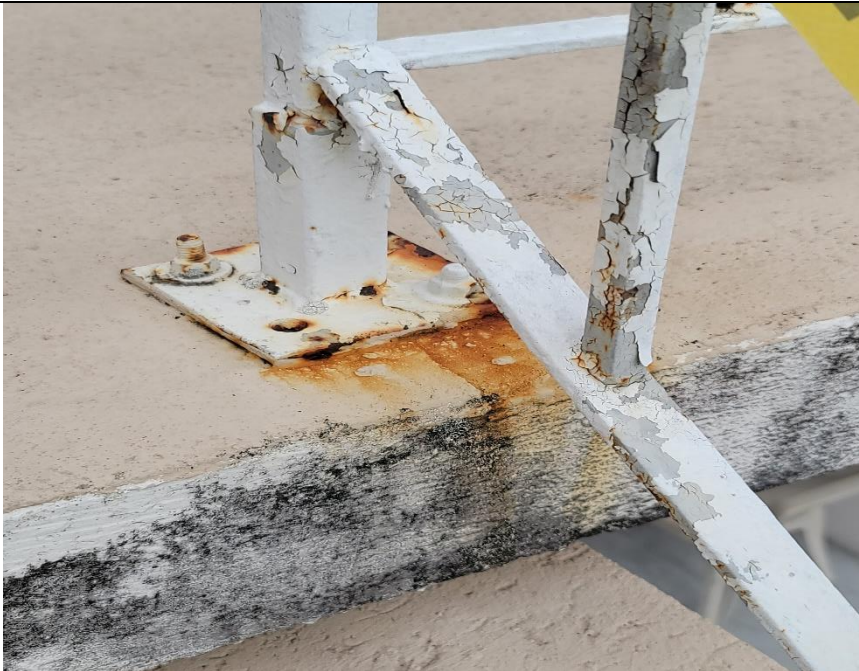
Photo #4:

Replacement of the steel picket rails is mandatory due to the extent of corrosion at the base of the rail posts.

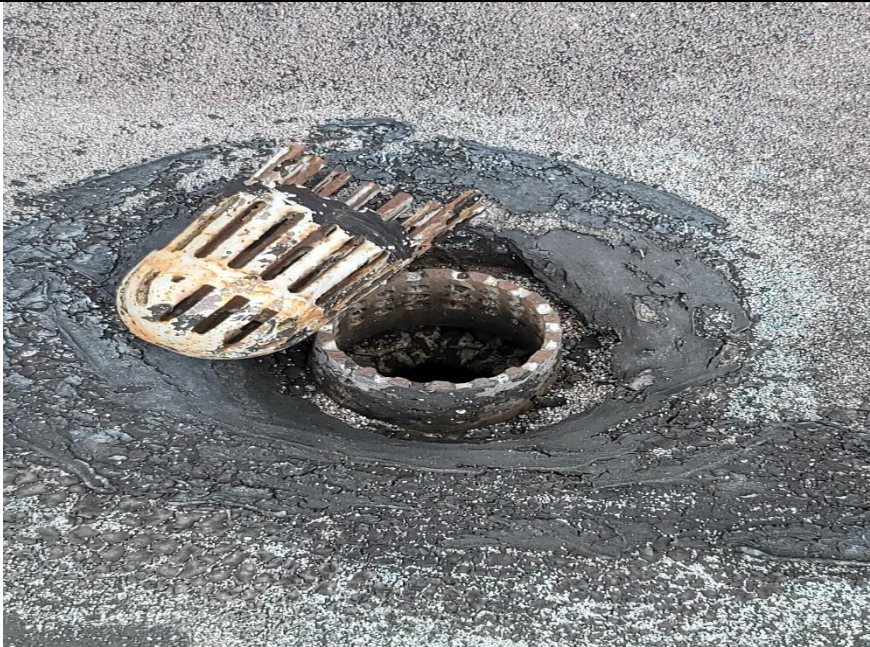
Photo #5:

The strainers for the interior drain lines were found to be rusted or non-functional since many of them are missing or not in their proper position. Others need maintenance to remove debris.

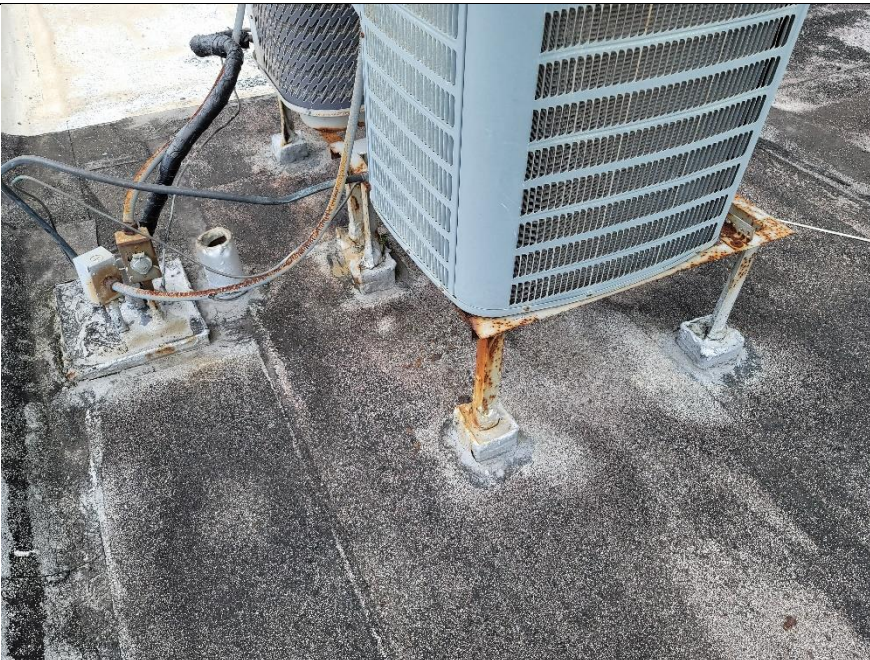
Photo #6:

The structural integrity of the roof dunnage systems are compromised. The dunnage systems should be replaced/maintained to prevent the mechanical units from falling onto the roof and endangering the residents below.

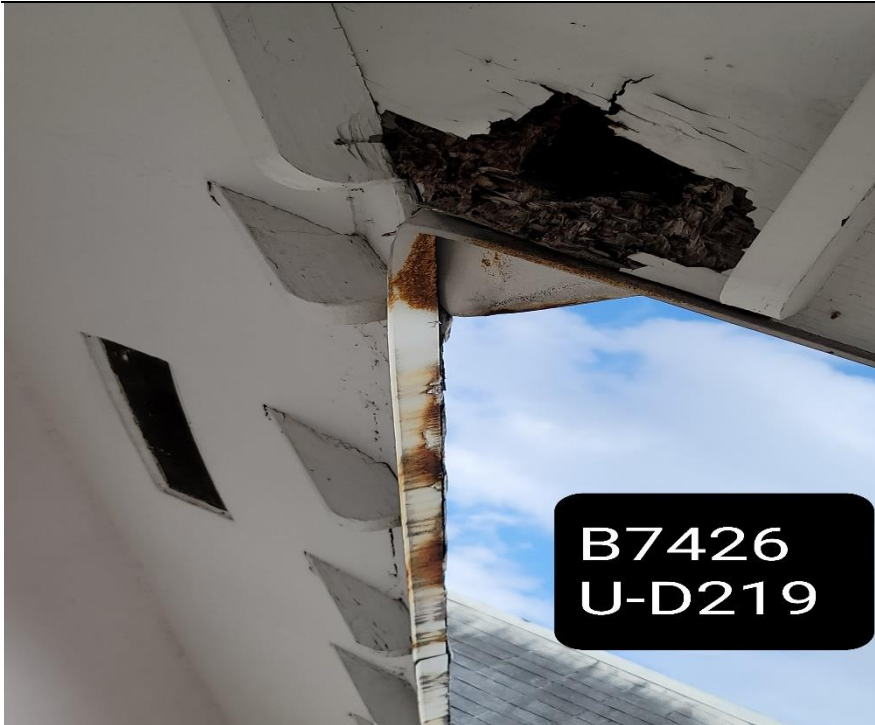
Photo #7:

Areas of the wood soffit of the mansard roof need to be repaired. The wood sheathing has decomposed exposing the interior portions of the roof to the elements, insects and rodents.

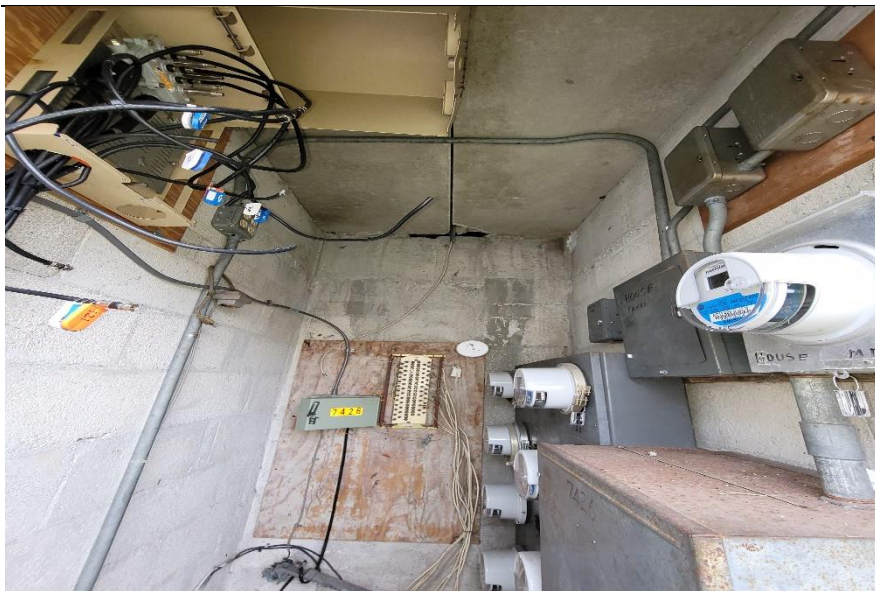
Photo #8:

The mechanical room was observed to be in good condition. Wall/ceiling penetration should be sealed.

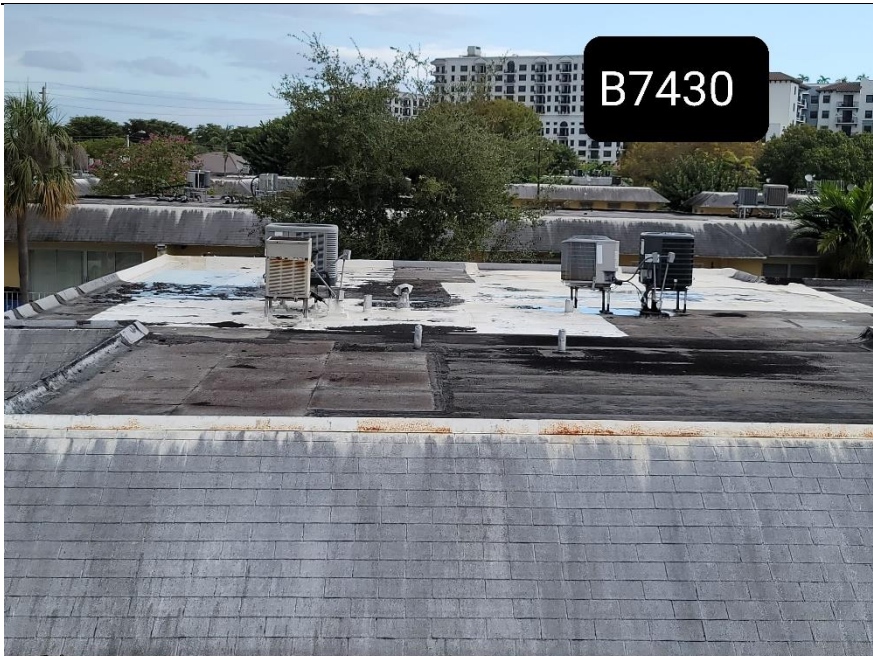
Photo #2:

Water ponding stains observed on the roof.

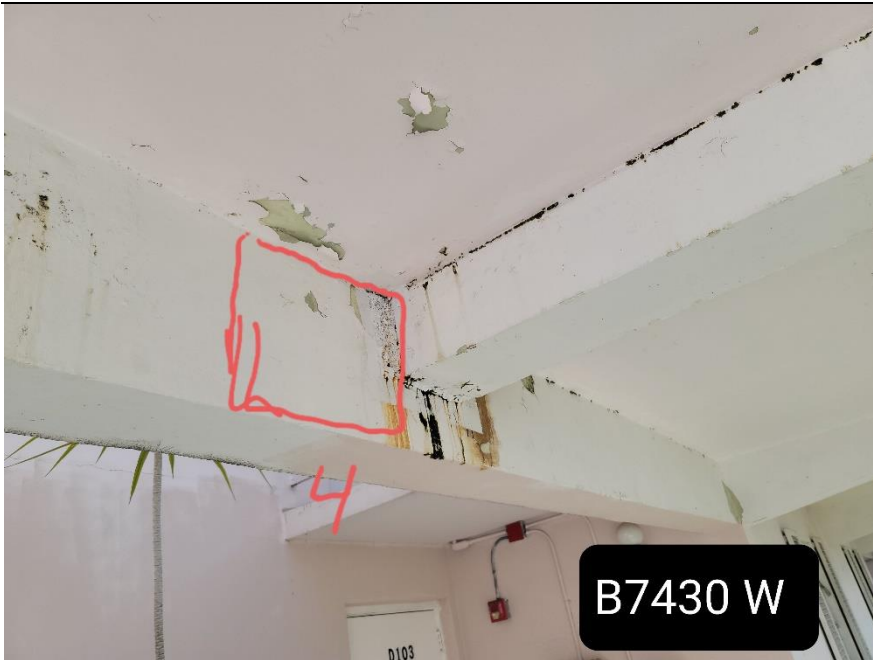
Photo #3:

Staining and vegetation growth was observed at the exposed edges of the concrete beams supporting the catwalks. Remediation of the unsound surface areas are required to prevent deterioration of the concrete.

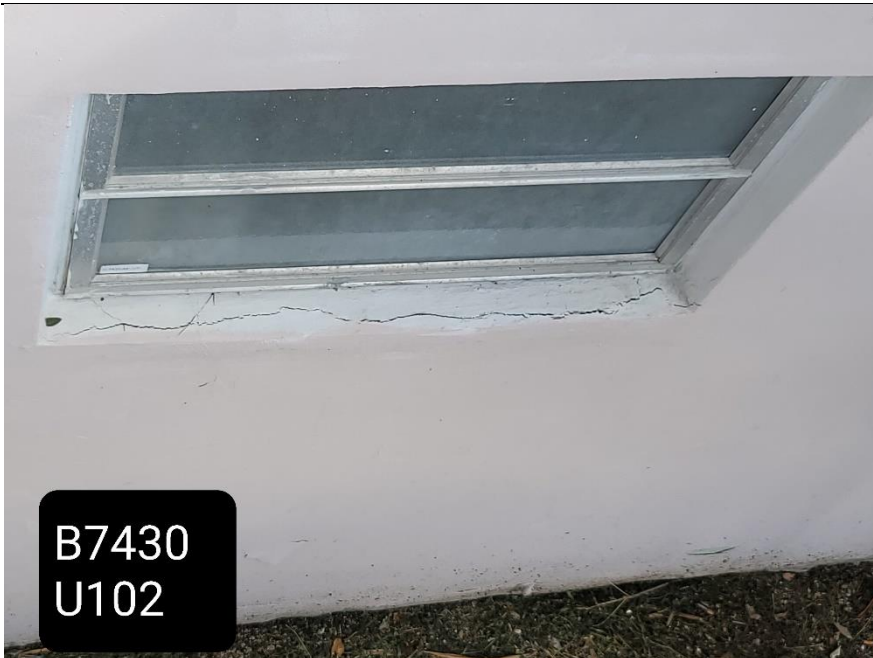
Photo #4:

Spalled and cracked surfaces observed at the window sills.

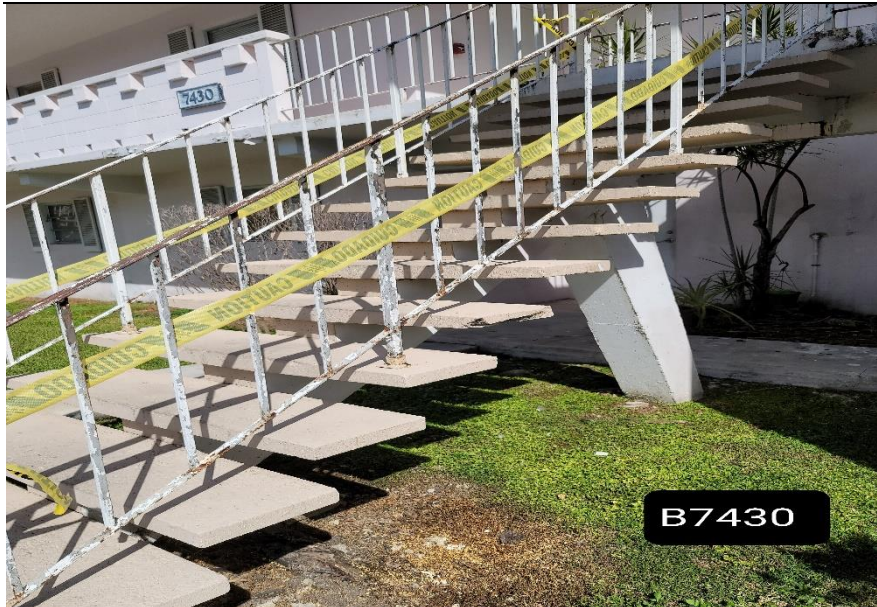
Photo #5:

Replacement of the steel picket rails is mandatory due to the extent of corrosion at the base of the rail posts.

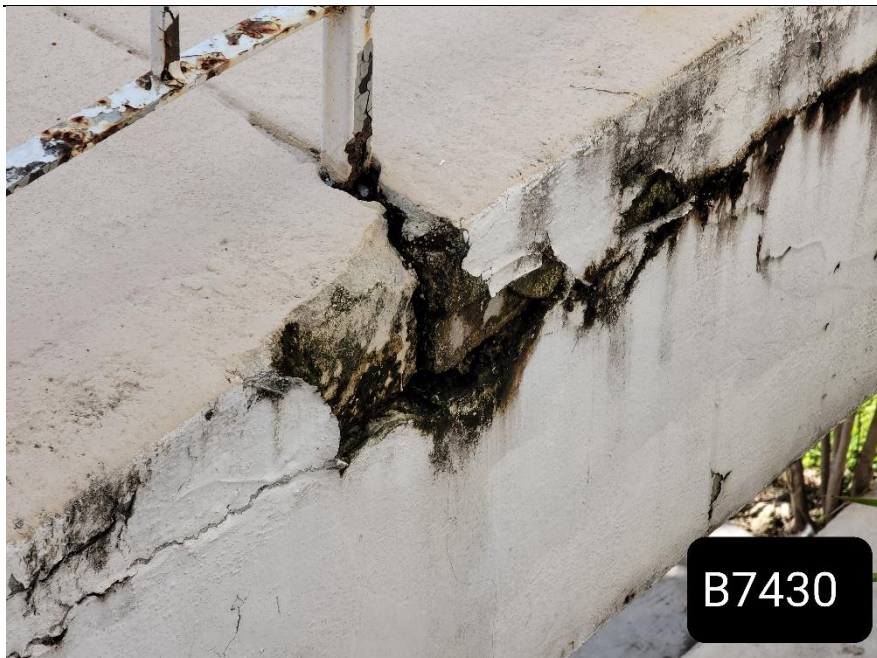
Photo #6:

Replacement of the steel picket rails is mandatory due to the extent of corrosion at the base of the rail posts.

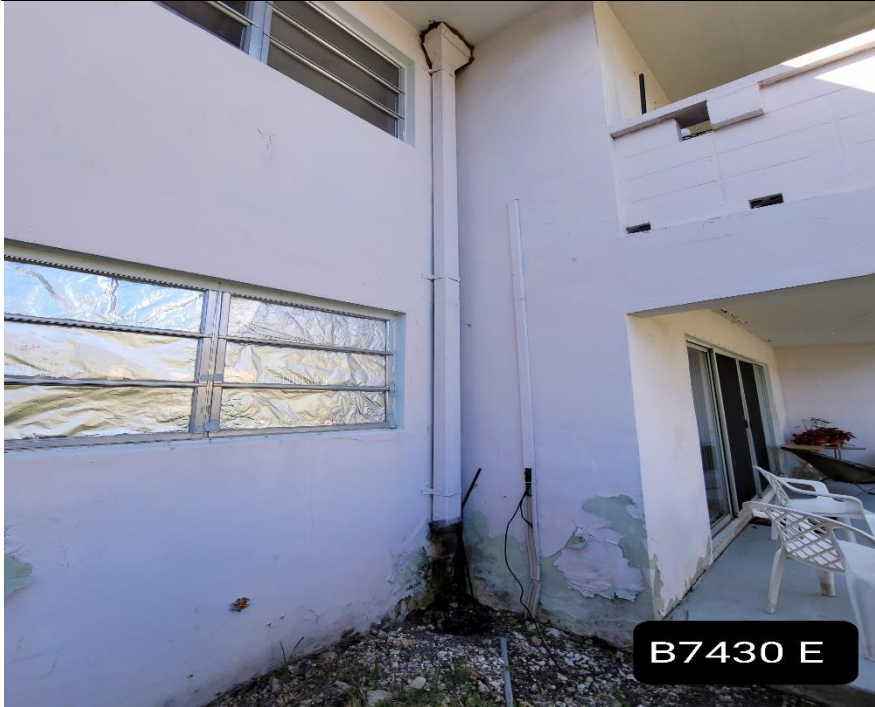
Photo #7:

No downspout diverters observed allowing water to accumulate near the base of the walls. The water accumulation has allowed vegetation growth and decay of the base of the walls.

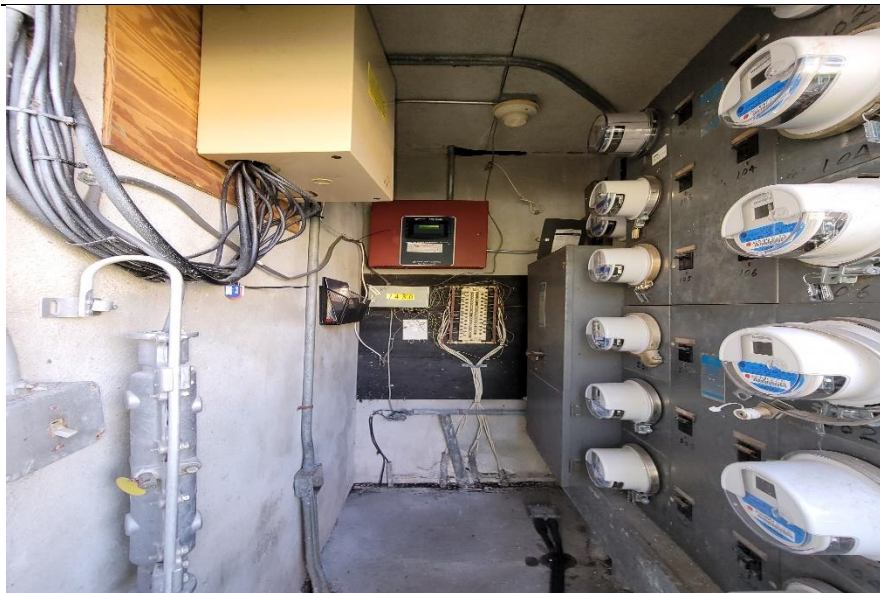
Photo #8:

The mechanical room was observed to be in good condition. Wall/ceiling penetration should be sealed.
