**TEST REPORT**  
**ROOF MOISTURE SURVEY**  
**Test Protocol TAS 126-95**  
**Florida Building Code 2014**

ACRC #: **16-0172 MSELD**

Project Name: **Palm Beach Shores Condo.**

Deck: **East Lower Deck**

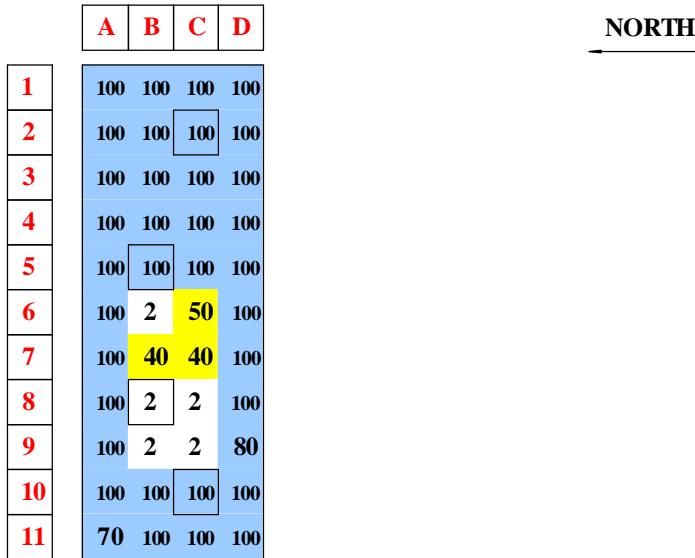
TAS-126  
GRAPHIC MOISTURE PLOT

**Over 25% of the roof area was found to have unacceptable levels of moisture. Per Section 611.1.1 of the Florida Building Code, High Velocity Hurricane Zone; this roof will need to be removed.**

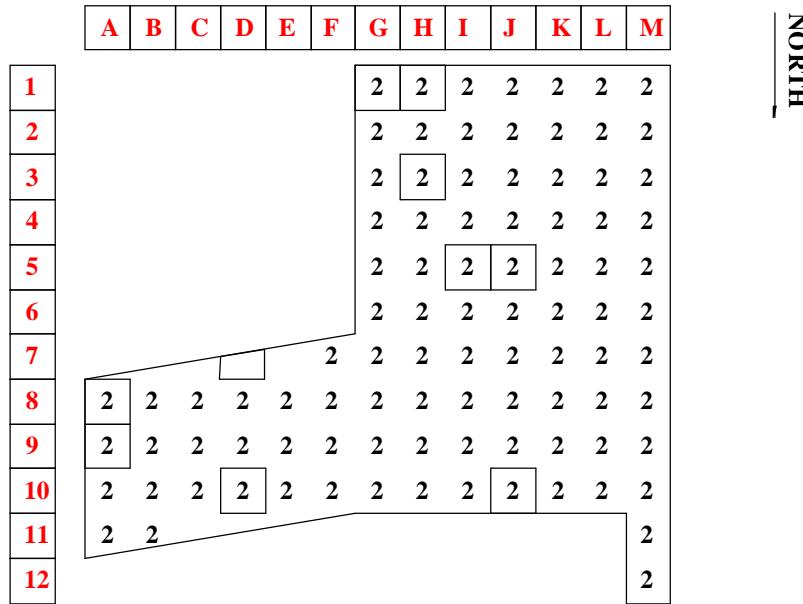
TAS-126  
GRAPHIC MOISTURE PLOT

**The roof is within acceptable moisture ranges and is suitable to re-roof or recover.**

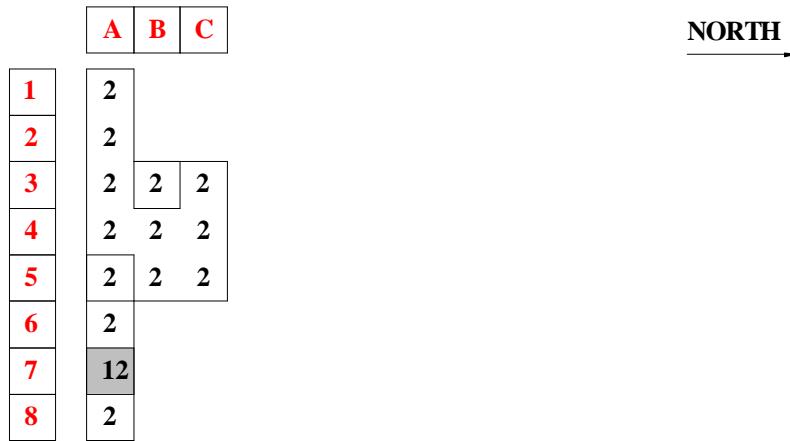
TAS-126  
GRAPHIC MOISTURE PLOT

**The majority of this roof system is within the acceptable range of moisture content. Small areas, (approximately twenty-five (25) square feet), are in the unacceptable range and will need to be removed.**

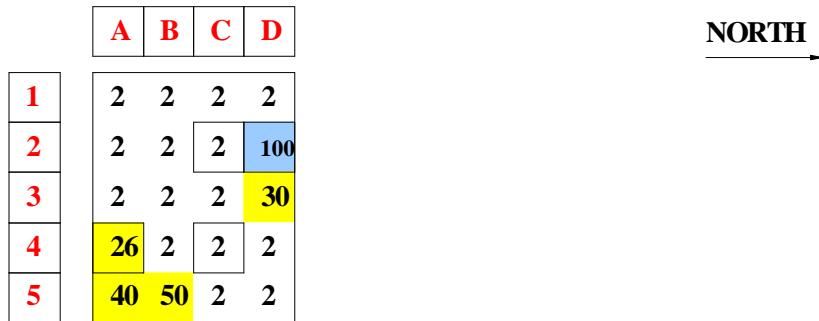
TAS-126  
GRAPHIC MOISTURE PLOT

**Twenty Five percent of the roof area (approximately 500 sq. ft.) contains unacceptable levels of moisture trapped within the roof system. Current Code requires the entire roof to be replaced if over 25 % of the roof contains unacceptable levels of moisture.**

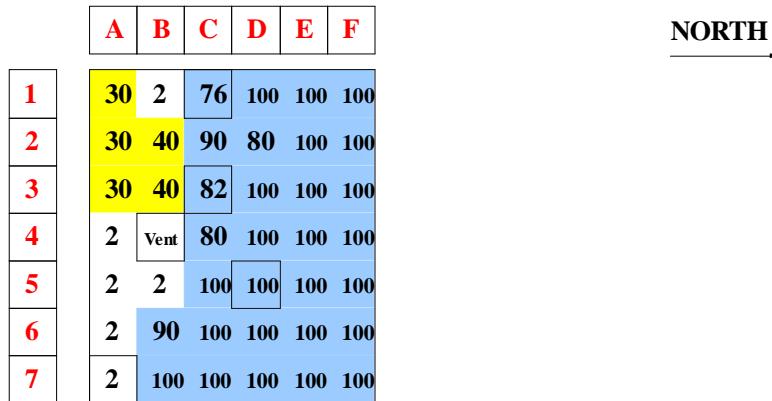
TAS-126  
GRAPHIC MOISTURE PLOT

**Over 25% of the roof area was found to have unacceptable levels of moisture. Per Section 611.1.1 of the Florida Building Code, High Velocity Hurricane Zone; this roof will need to be removed.**
