SAGUACHE CREEK DIVERSION INFRASTRUCTURE INVENTORY

Structure Name: FULLERTON D 1

Date: July 3, 2019

Saguache Creek Stream Management Plan

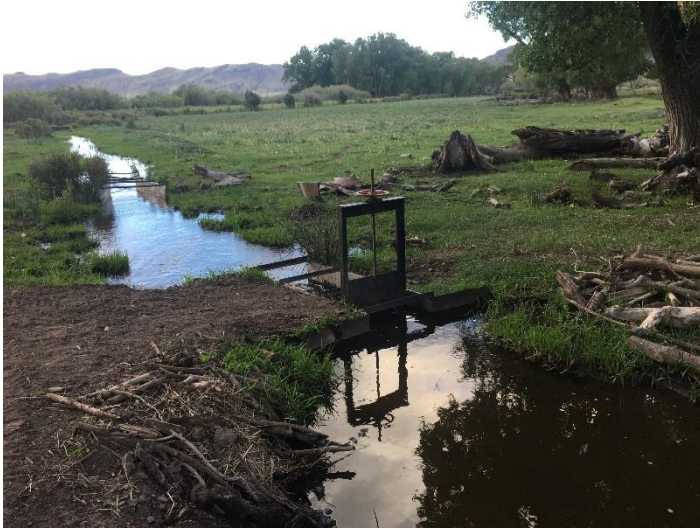
Headgate looking downstream

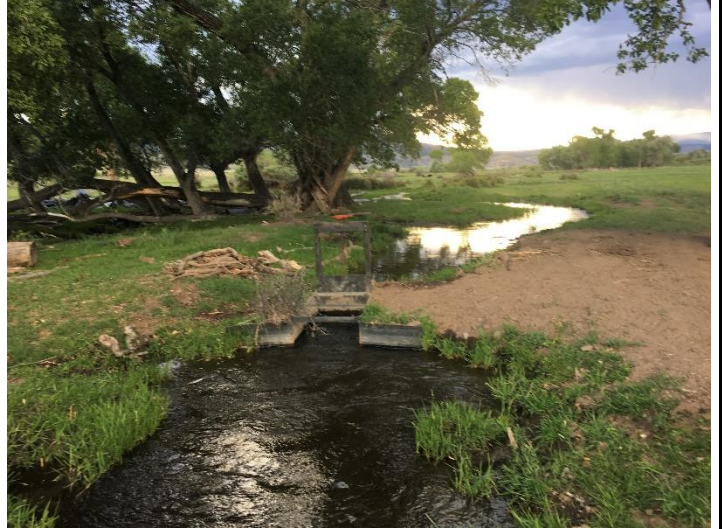
Headgate outlet

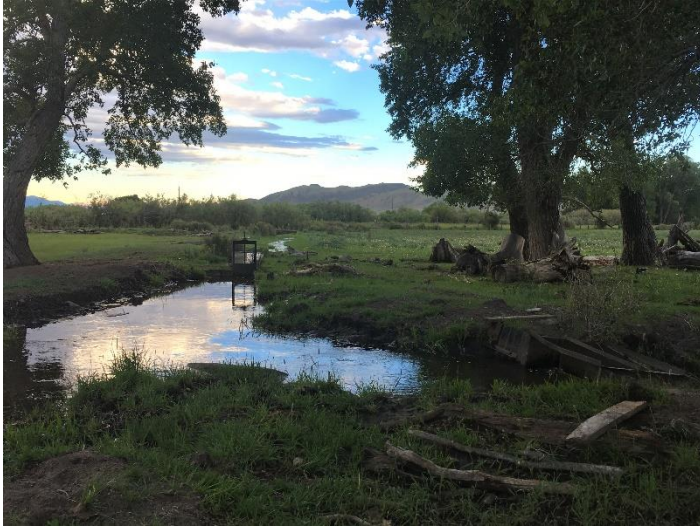
Headgate and diversion dam

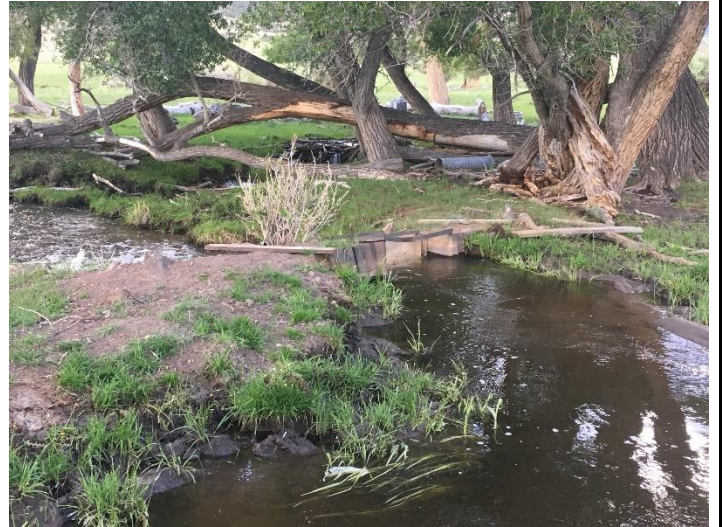
Diversion dam

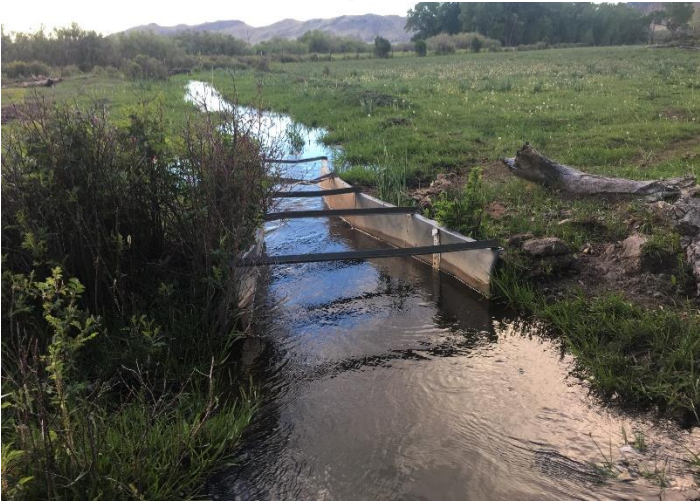
Flume looking downstream

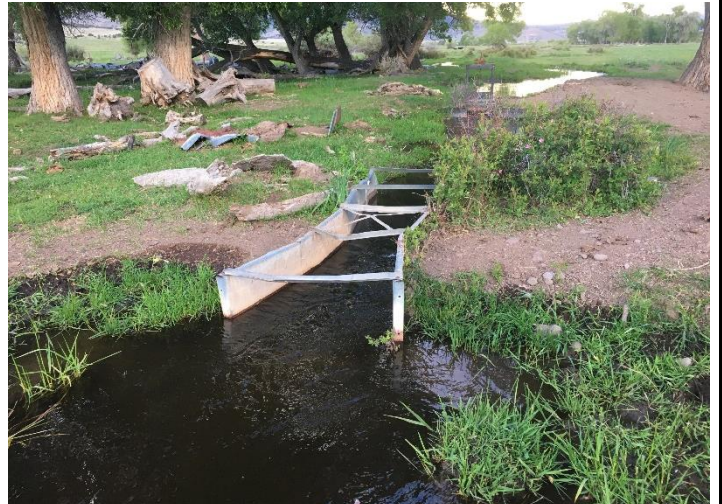
Flume looking upstream
