Home Inspection Report

358 Waddy Drive, Weems, Va.

Report Number: 3421 Temperature: 60's Conditions: dry Year constructed: 1994
Present during Inspection: seller/agent State of Occupancy: occupied

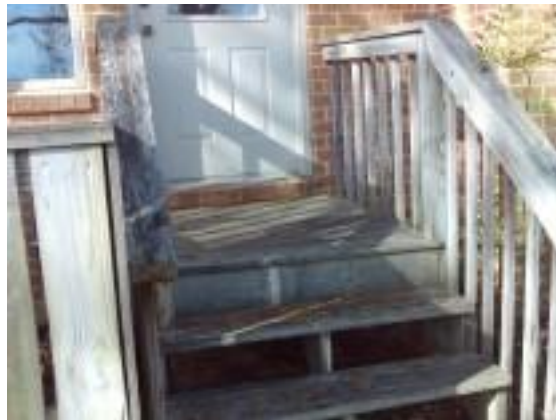
The treated decks need cleaning.

The treated decks and stairs need cleaning and treatment.

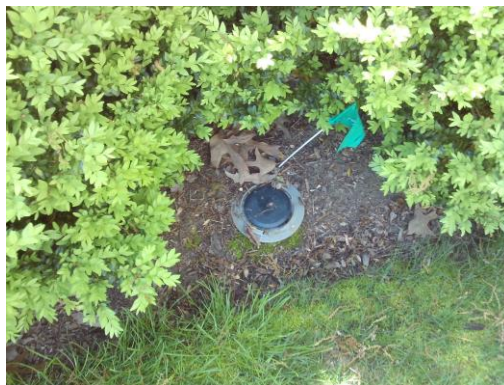
There are termite traps surrounding the perimeter of the house. A diagram is presently located in the garage.

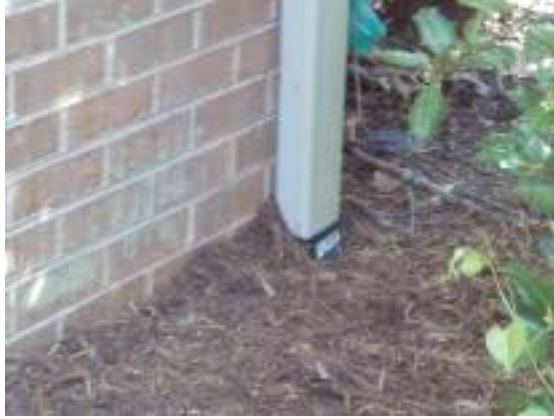
Underground downspout drains are being utilized.No indication of back-up is present but the drains were not tested for flowage.

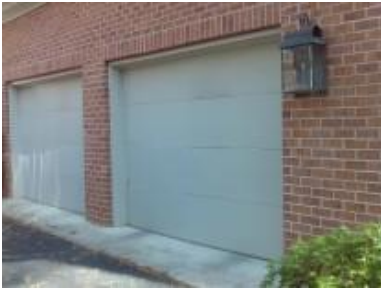
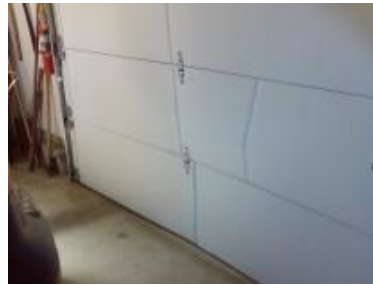
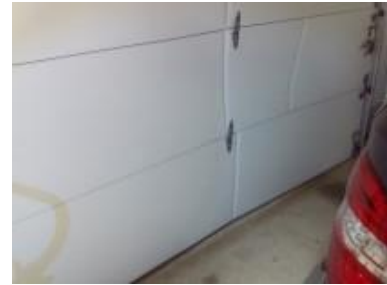
The garage doors are damaged but operate properly. Replacement is recommended.

The garage door are damaged but are operational. Replacement should be considered.

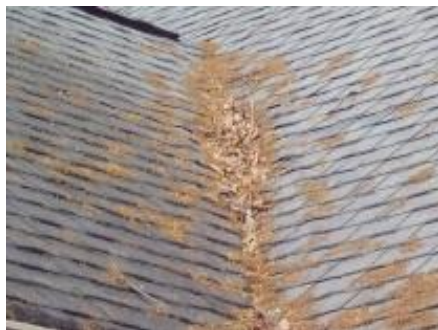
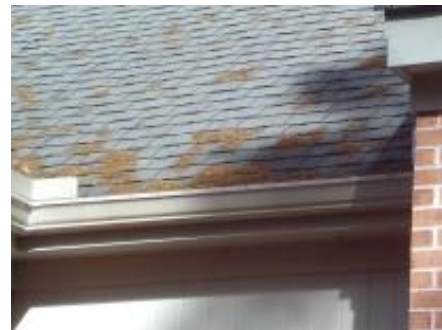
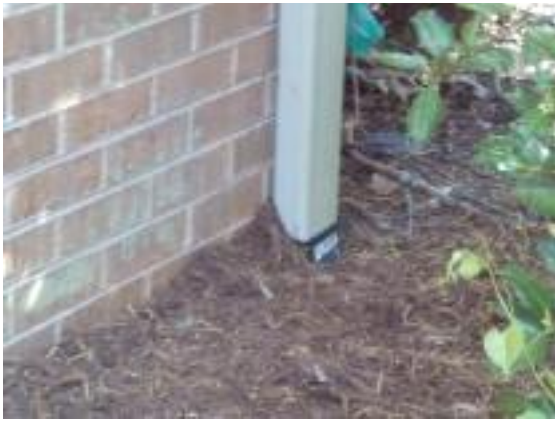
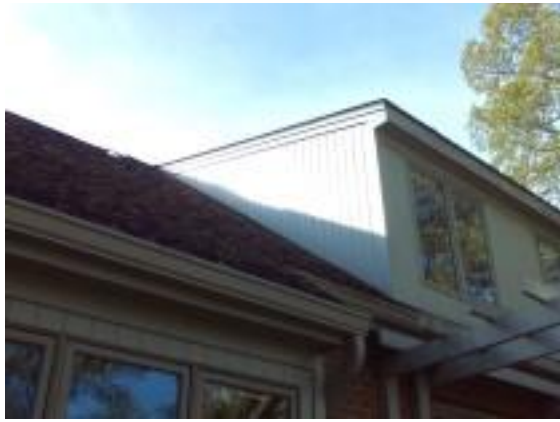
The roof is original but is in serviceable condition overall. Anticipate roof replacement within the next few years. No interior leakage was observed. The gutters are full of debris and need cleaning.

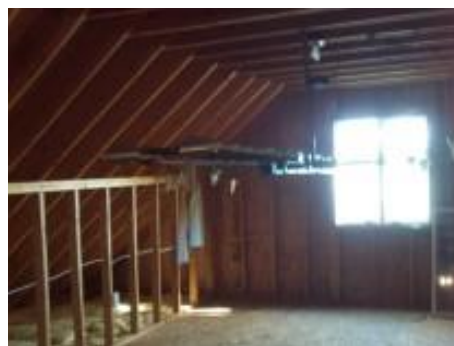
A large FM antenna is mounted in the attic.

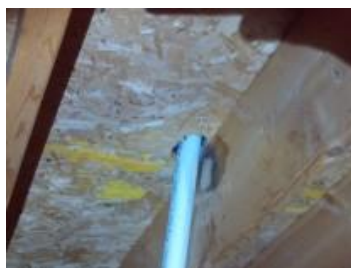
Stains at pipe vent. The moisture meter indicated the area was dry.

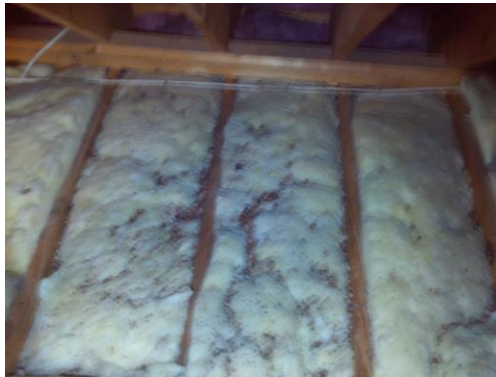
There is minor evidence of squirrel activity in the attic, acorn shells on insulation, which should be further investigated.

A small section indicated squirrel activity at one time.

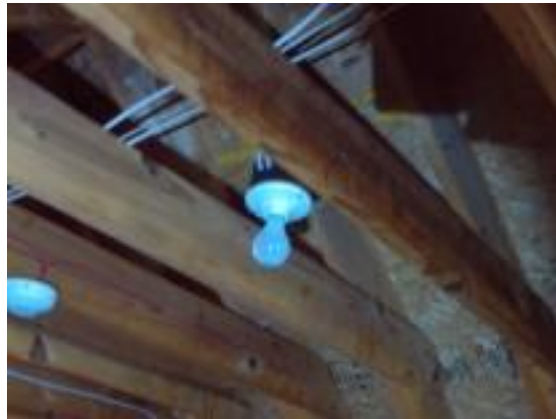
Two light fixtures in the attic did not function, likely the bulbs.

Two attic light bulbs were burnt out.

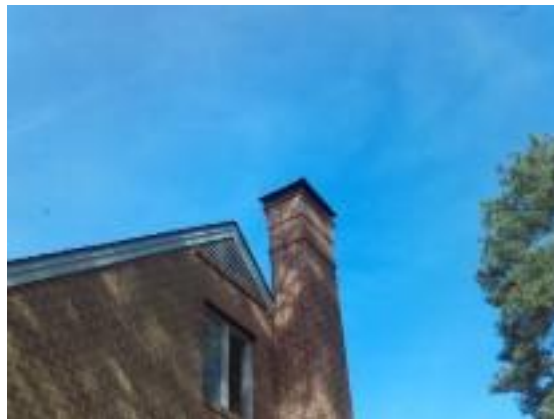
The chimneys should be cleaned prior to use and have spark arrestors on top. The dampers are functional.

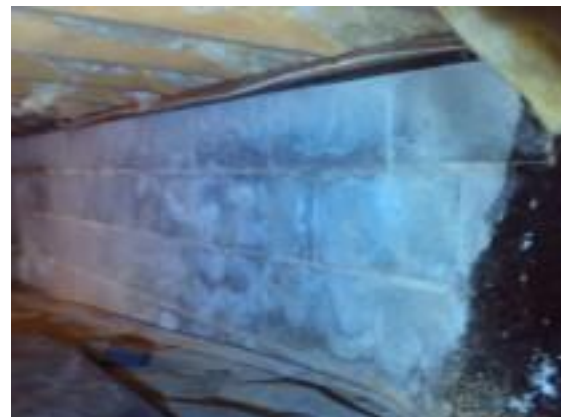
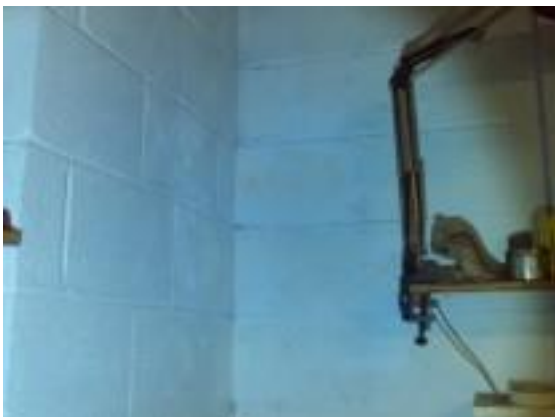
A few stains were present on the rear wall in the crawl space and the basement block walls. The moisture meter indicated that the stains were likely old.

Stains were observed in the block wall in the basement and crawl space along the back of the house. The moisture meter indicated that the stains were old.

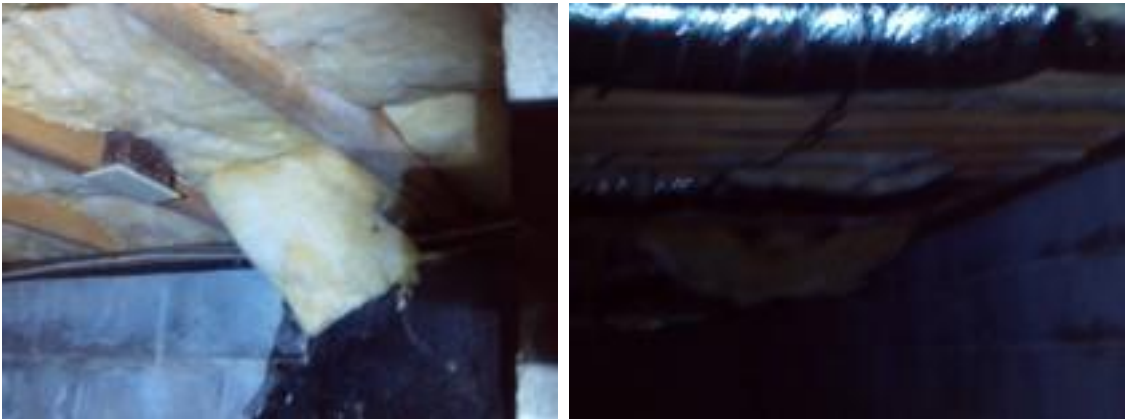
Two pieces of insulation are loose and falling in the crawl space and need to be properly attached.

Two pieces of insulation are loose and need to be reattached.
