## **Inspection Report**

**Property Address:**  
211 Mangini Street  
Nicholasville KY 40356

<b>Date:</b> 9/12/2018	<b>Time:</b> 10:00 AM till 02:30 PM	<b>Report ID:</b> 180912PETERS
<b>Property:</b> 211 Mangini Street Nicholasville KY 40356	<b>Customer:</b> Mr. Trevor Peters	<b>Real Estate Professional:</b>

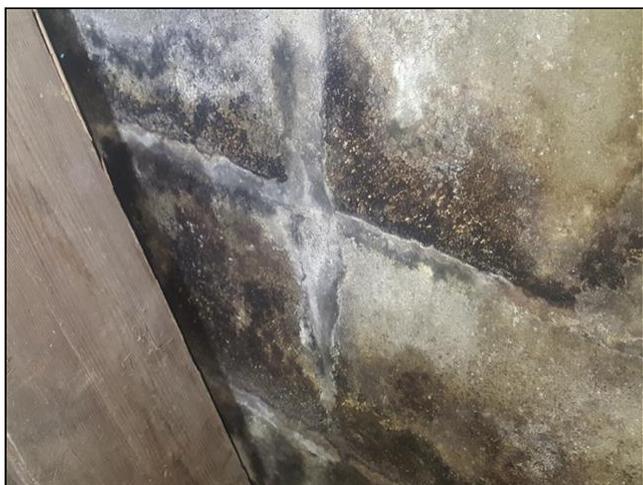
1.0 Item 1(Picture)

1.0 (1) Fungi growth, black stains on the masonry block walls and mildew where located in various areas in the basement, especially under the kitchen, dining room and 2nd bathroom areas in the home. When entering the basement in this area a very strong odor (musty smell) was experienced. This could be mold. Only lab testing of the mold/mildew can determine the type or if it is considered to be dangerous. Recommend a certified mold expert further evaluate and conduct testing and sampling before closing. They will be able to best advise you how to clean up, remove and/or treat areas affected. EPA guidelines state that homeowners can clean areas less than 100 square feet with water using laundry detergent. Due to the amount of mold/mildew found **I do not recommend** this, have a qualified contractor do this after mold expert has advised remedies for cleanup.

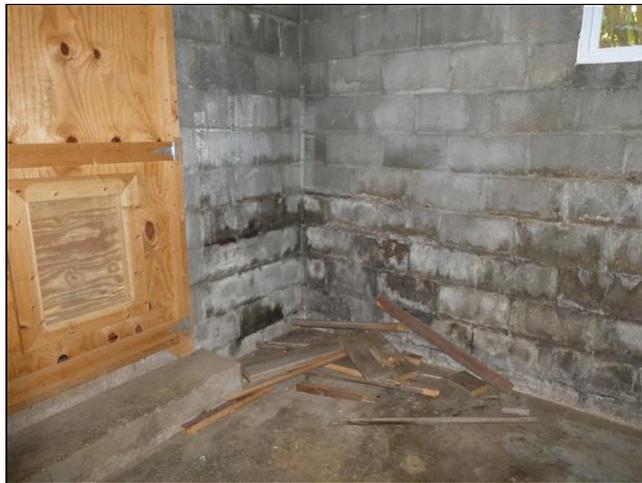
1.0 Item 13(Picture)

**1.0** (4) Visible signs of water intrusion/stains in the basement walls at the rear of the home. 90% of water entry into the foundation walls has been found to be caused by improper grading or defective gutter/ drainage systems. Refer to Roofing and Exterior of this report for improvements and recommendations. However I would recommend consulting a qualified basement foundation contractor to determine what other corrections maybe needed to prevent future water penetration in the masonry block walls due to this appears to be an ongoing problem and due to the fungi growth on the walls.

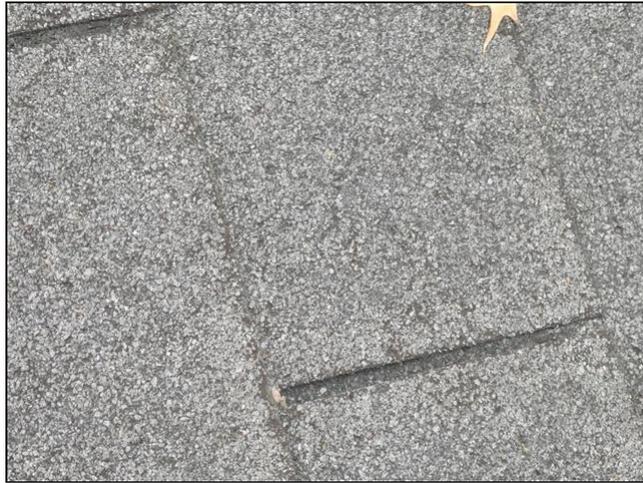
2.0 Item 1(Picture) above kitchen area

2.0 (1) Signs of loss of protective granules, drying and fibers exposed of the roof shingles are starting to appear especially at the front of the home. This indicates that the roof is close to the end of its life span. This usually increases the potential for ultraviolet damage to the membrane. Recommend a qualified roofing contractor further evaluate the roof to determine if replacement is required now before roof leaks start to develop. If the roof is not to be replaced it should be closely watched and repaired or replaced at the first sign of leaking to prevent damage to the interior finishes or roof framing in the attic.

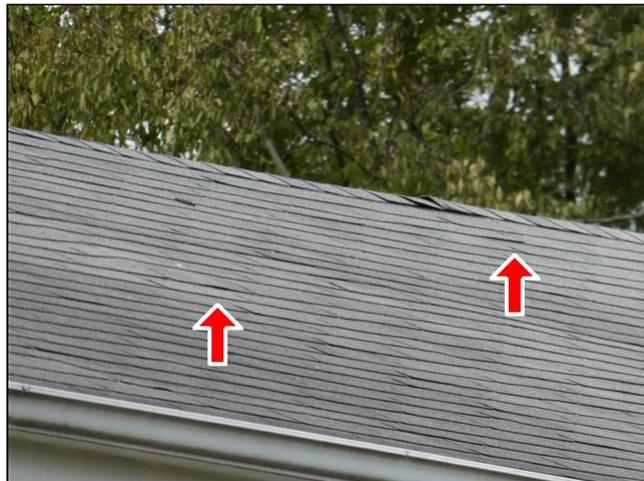
2.0 Item 17(Picture) right side of home

**2.0** (3) Some of the shingles are starting to lift on the roof in various places, (see photos for location) This is probably due to a lack of ventilation or age of the covering. Generally, lifting shingles are caused by ventilation issues and the shingles are baked from the inside out. Over time, this heat causes the sealants on the back of the shingles to detach from the course underneath and the shingles start to lift. The shingles are less resistant to the action of ice and wind. Recommend a qualified roofing contractor further evaluate the roof to determine if replacement is needed now and repair lifting shingles where needed. Consideration for a new roof is expected in the near future.

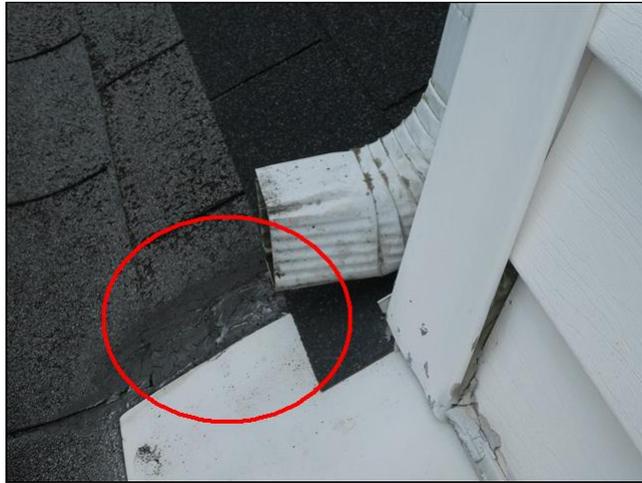
2.1 Item 1(Picture) above kitchen area

2.1 (2) The step flashing and wall/roof intersection has been tarred all around the metal flashing. The flashing is suspected to be in poor condition. Tar is a temporary patch and will eventually fail. Deteriorated or leaking flashing should be replaced. This indicates that previous water leaks had existed. This type of repair is not recommended as it is prone to further leaking due to direct sunlight on the sealant which can cause cracks. The cracking can allowing water to enter. Recommend a qualified roofing contractor further inspect and make the necessary repairs if needed.

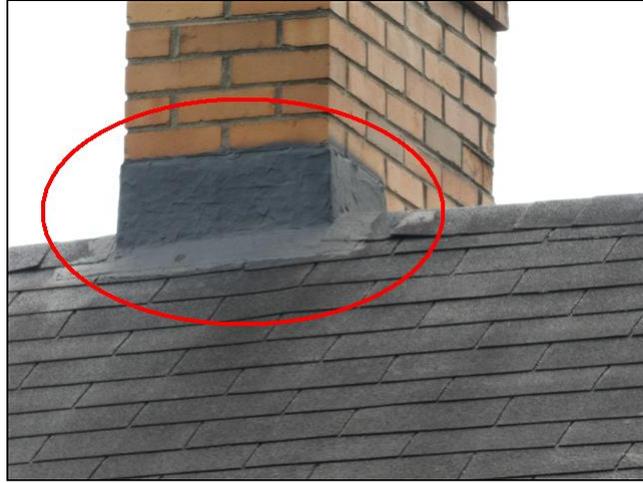
2.2 Item 1(Picture)

2.2 (2) The chimney has been tarred all around the metal flashing. The flashing is suspected to be in poor condition. Tar is a temporary patch and will eventually fail. Deteriorated or leaking flashing should be replaced. This indicates that previous water leaks had existed. This type of repair is not recommended as it is prone to further leaking due to direct sunlight on the sealant which can cause cracks. The cracking can allow water to enter. Recommend a qualified roofing contractor further inspect and make the necessary repairs as needed.

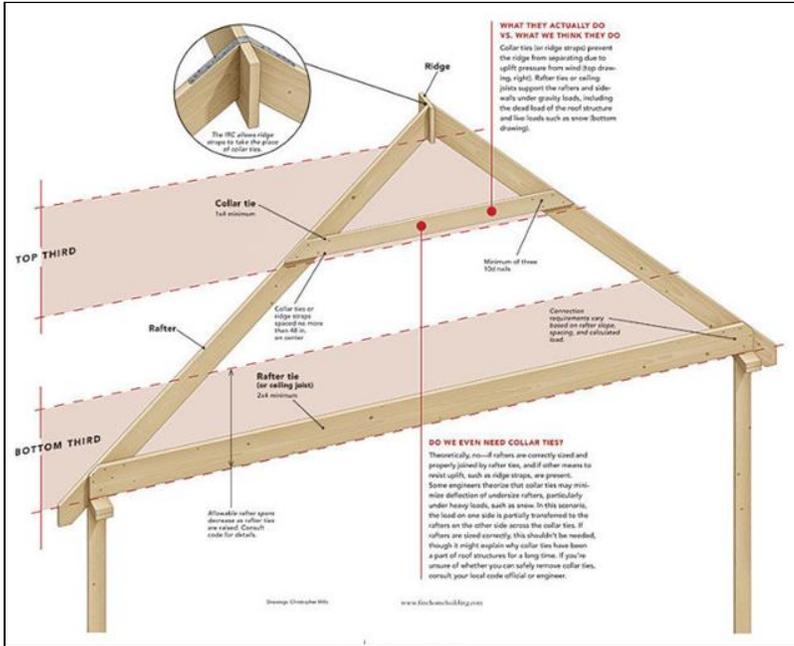
2.6 Item 5(Picture)

2.6 (3) Recommend additional collar ties (horizontal members running between each rafter, near their mid span) to add extra support to the roof structure and to resist rafters from sagging and/or pulling away in the future. Heavy loads such as snow may cause the roof to sag, cracked rafters appearing or the roof to develop leaks near these areas from stress. There are no gusset plates between the rafters to support current roof structure. Recommend a qualified roof framing contractor further evaluate the roof structure and make the necessary repairs as needed.

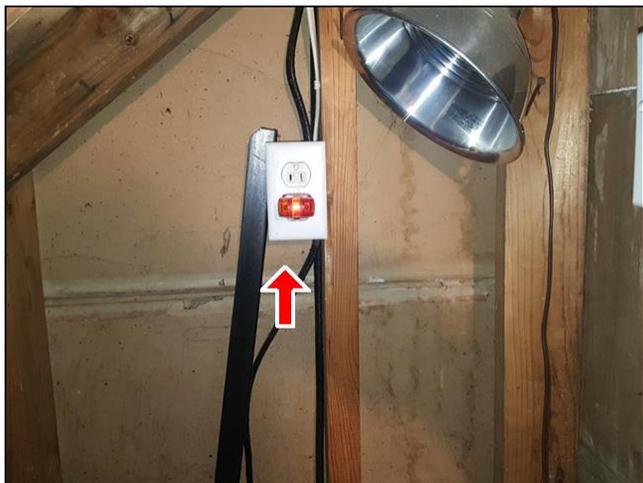
2.9 Item 1(Picture)

**2.9** The receptacle(s) in the Master Bedroom attic where indicated in the photo(s) is showing an open ground. This is a safety issue. Major appliances using three prong cords should never be connected to these two slot receptacles unless the appliance manufacturer allows the connection. Many lamps and other small appliances do not have or require the three slot electrical receptacles. This is for your information. Recommend a licensed qualified electrician repair as needed.

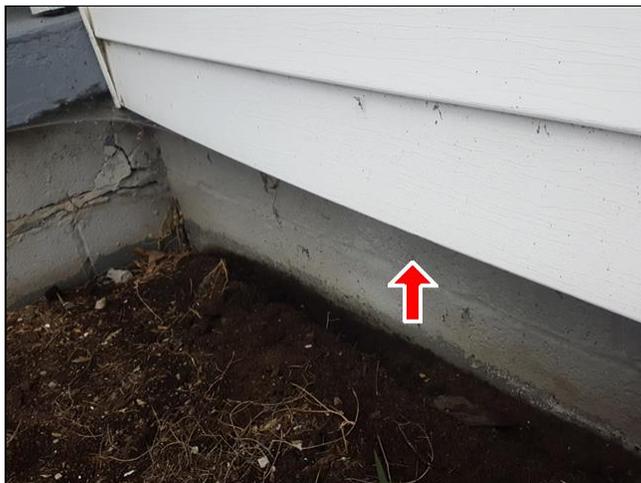
3.0 Item 4(Picture) front right side of home

3.0 (3) The vinyl siding around the entire perimeter of the home from the bottom is not secured to the home. The loose siding should be re-secured to prevent it from being blown off and to protect the building from weather entry. It may not have been installed correctly due to the original wood siding behind. Recommend a qualified siding installer further investigate and correct as needed.

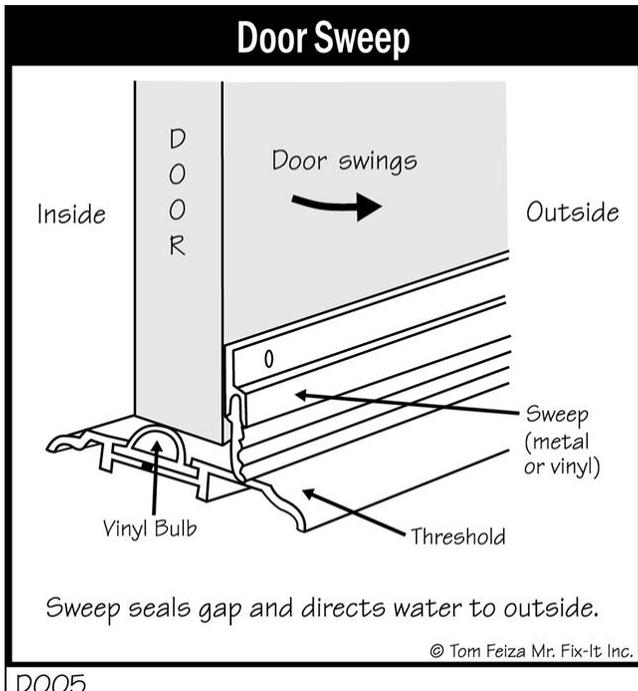
3.2 Item 1(Picture)

3.2 I would recommend a door sweep be installed at the rear basement door of the home to ensure water intrusion does not occur especially in winter when it snows. This is for your information

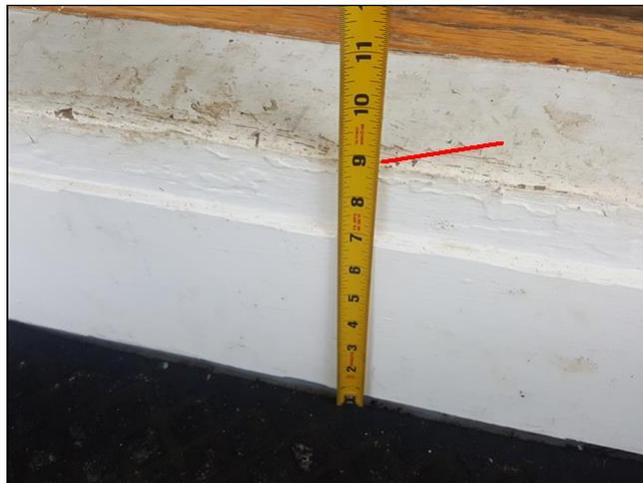
3.4 Item 2(Picture)

3.4 (2) The front step at the porch is higher than the recommended height of 8 and 3/4 inches. This is a potential safety issue and a fall or injury could occur if not corrected. The front porch has dropped at the front of the home causing this to occur. Recommend a qualified masonry contractor correct and repair as needed. Also, recommend filling cracks to prevent water intrusion to prevent further settlement. Then further monitor for more movement after repairs. If such movement occurs in the future, you may need to investigate cause and rectify using a qualified masonry contractor.

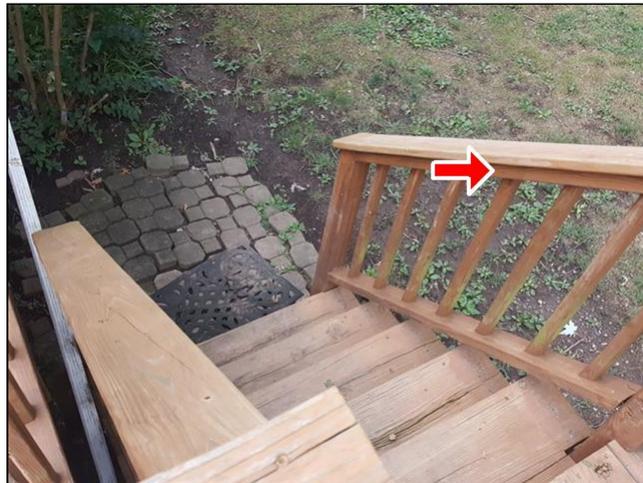
3.5 Item 1(Picture)

3.5 (1) 2x6s are installed for handrails for the deck staircases and are not considered "gripable" by industry standards. This is a safety issue and an injury could occur if not corrected. Recommend that a standard approved handrail be installed for safety by a general contractor.

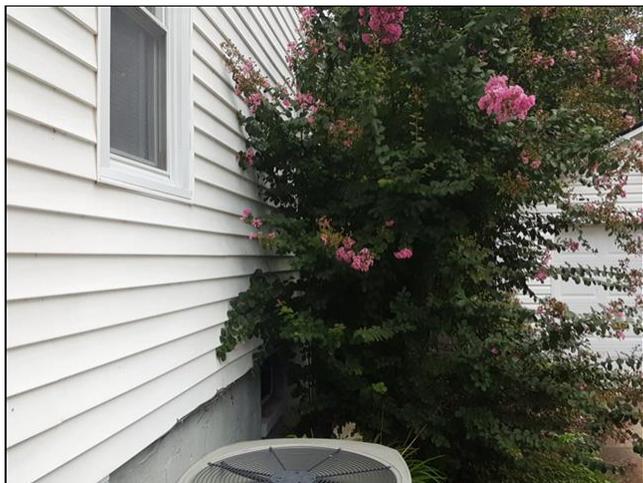
3.9 Item 1(Picture) right side of home

**3.9** (1) The vegetation is overgrown where indicated in the photos. Recommend that all bushes, shrubs and trees where applicable be kept neatly trimmed and away from the foundation, wall siding, and window frames to prevent damage to the home and allow proper venting and inspection of house. A 6" clearance is recommended.

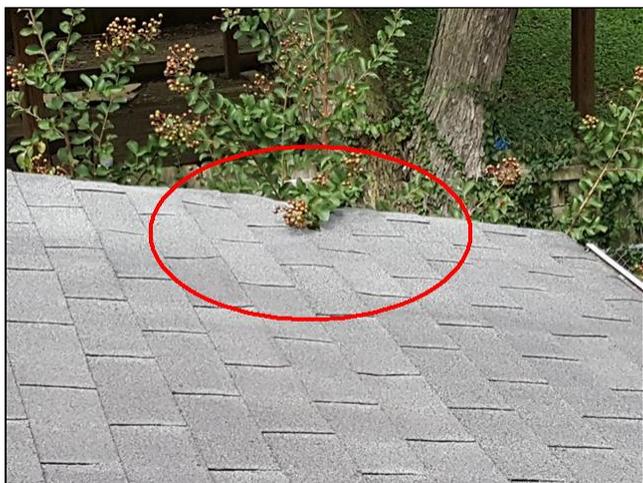
3.9 Item 3(Picture)

**3.9** (2) The tree limbs that are in contact or hanging near the roof at the rear right corner of the home should be trimmed to prevent damage to the shingles and from scraping on the roof surface. They will also clog gutters which will cause water run off problems around the home. Recommend cutting back tree branches as needed.

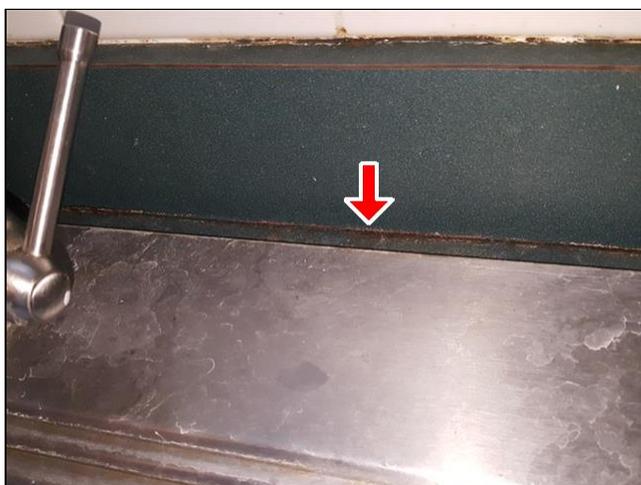
4.8 Item 1(Picture)

**4.8** Recommend caulking around the counter top in the kitchen to seal the gap/crack. Water may enter which can cause damage to the drywall and cabinets, then result in possible mold forming. Repair using a quality caulk that is resistant to moisture and is expandable. Here is a link on [How to Choose the right Caulk](#)

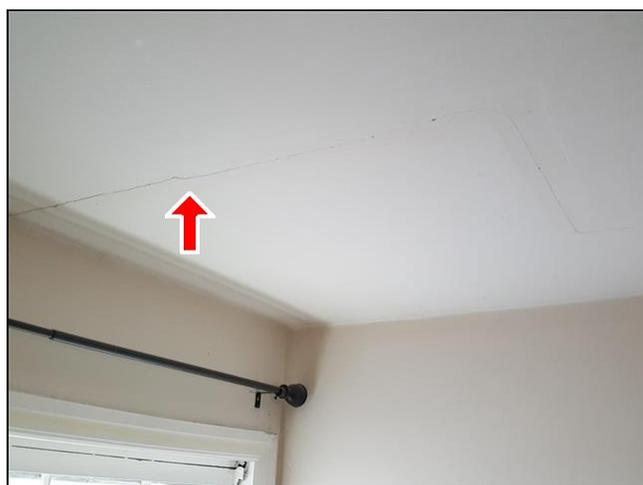
5.0 Item 1(Picture) family room

**5.0** The cracks in the ceiling in the (upstairs) family room and 2nd bedroom (see photos for location) appear to be common settlement cracks. Cracks larger than 1/16" are of concern only. Minor settlement of the home has occurred due to the age of the home and from perhaps framing shrinkage. Cracks of this nature are also caused by moisture, changing temperature, or framing shrinkage due to a lack of ventilation. Recommend repairing cracks then paint and monitor. If cracks reappear and become larger than 1/16" then would recommend a structural engineer further investigate to determine cause and suggest repairs.

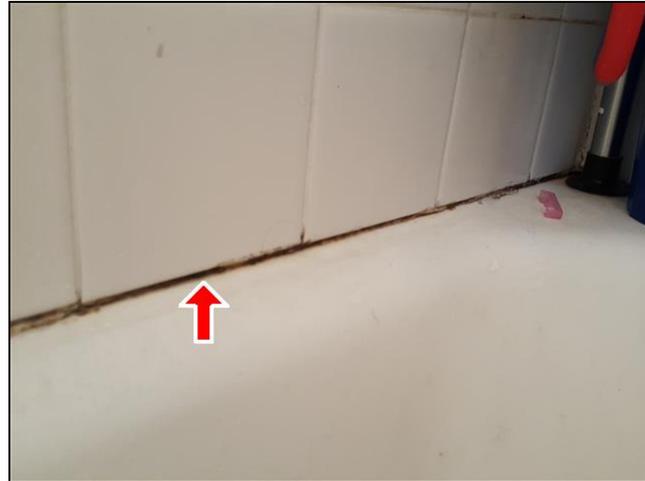
6.7 Item 1(Picture)

6.7 Old, shrinking, or dirty caulk with cracks was seen in the master bathroom shower enclosure. All of the caulk should be kept in perfect condition to prevent further cracking or more holes appearing to reduce the possibility of water leaking underneath the shower enclosure and tiled wall. If not corrected mold and/or deterioration of the floor/wall framing can occur beneath the shower enclosure. Recommend re-caulking where needed to seal openings and deteriorated caulk. Use a quality silicone caulk that is expandable and moisture resistant. [Choosing the right caulk](#) Would recommend a qualified general contractor repair as needed.

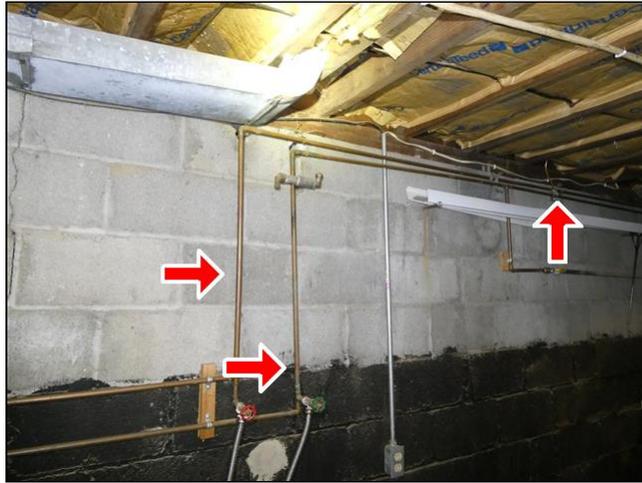
7.1 Item 1(Picture)

7.1 (2) Recommend insulating the water supply pipes in the basement (hot and cold) to ensure pipes do not freeze in winter which may cause a serious plumbing leak in the basement, and to prevent heat loss of water when hot water is flowing into home. This will improve efficiency. This is for your information.

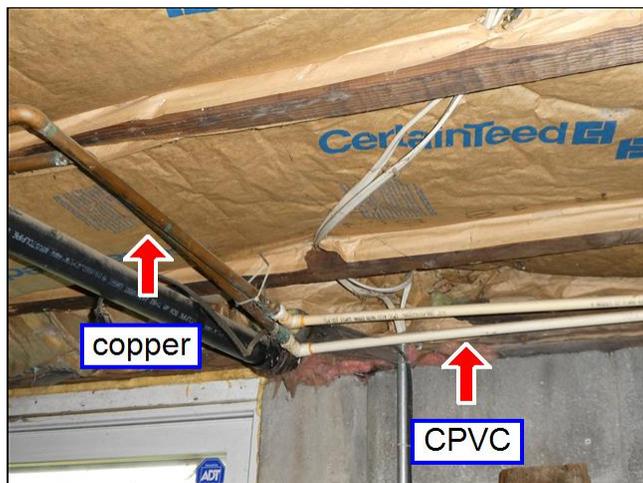
7.9 Item 1(Picture)

**7.9** Older homes have usually had various system changes and improvements as noted in this home. Sometimes these improvements were not made professionally. Be aware that older systems may develop problems which could not be seen during this type of inspection. If an exhaustive inspection of the plumbing system is desired a licensed plumber should be contacted. Please note that the water supply lines in the basement are a combination of copper and cpvc pipes combined "Our inspection of the Drain, Vent, and Water supply lines is limited to the readily visible portions only. The pipes in the walls are inaccessible. A qualified plumbing contractor may use specialized tools, testing procedures, mirrors or video cameras as needed to evaluate the plumbing system. The waste flow was satisfactory during this inspection except for the 2nd bathroom at the sink. (see note 7.5(2) ). Be aware that older systems can develop problems that cannot be seen until leaks appear. Watch for any signs of failure and have the lines repaired or replaced before they become major problems.

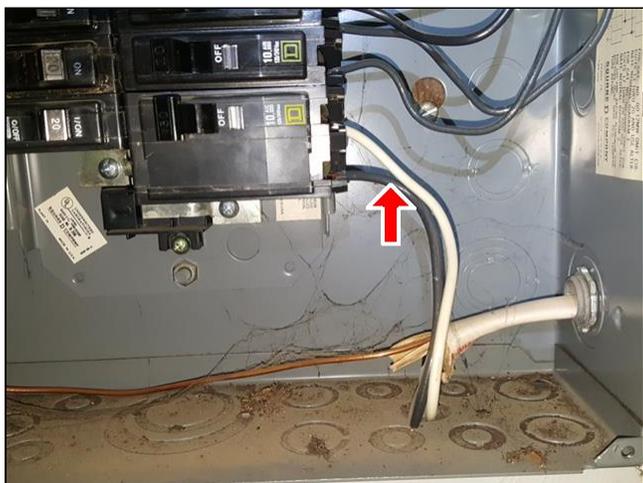
8.3 Item 10(Picture)

**8.3 (7)** The white wire(s) that are connected to the circuit breaker(s) should be marked black to indicate that they are live (hot wires) and are being used for the flow of electricity to travel. Recommend an electrician correct due to safety.

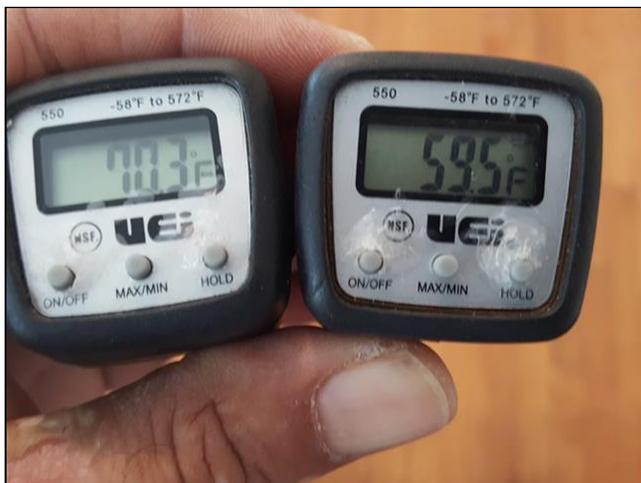
9.9 Item 1(Picture)

**9.9** The ambient air test was performed by using thermometers at the registers closest to the blower to determine if the difference in temperatures of the supply and return air are between 14 degrees and 22 degrees which indicates that the unit is cooling as intended. The supply air temperature on your system read 59 degrees, and the return air temperature was 70 degrees. This indicates that the unit is **not** cooling properly and a qualified licensed Heat/Air contractor should inspect for cause or problem. Note: There maybe a leak in the refrigerant line or the refrigerant levels need topping up.

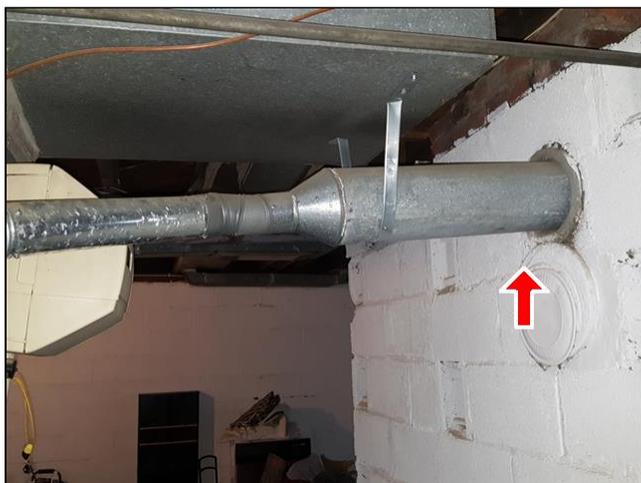
9.10 Item 1(Picture)

**9.10** The chimney is being used for venting a gas furnace. A stainless steel vent pipe should be installed and properly sized for the gas appliance to prevent damage to the interior of the chimney mortar joints, possible entry of CO (carbon monoxide) gases into the home, and sized to promote good drafting of the gas appliance. Clay flue tile is usually to large to allow proper drafting. A cap should be installed at the same time. Strongly recommend that a qualified licensed plumber examine the chimney to determine if the chimney or flues have been damaged and require repairs to prevent CO entry into the home and to verify that the flue or clay liner is properly sized to provide good drafting of the gasses.

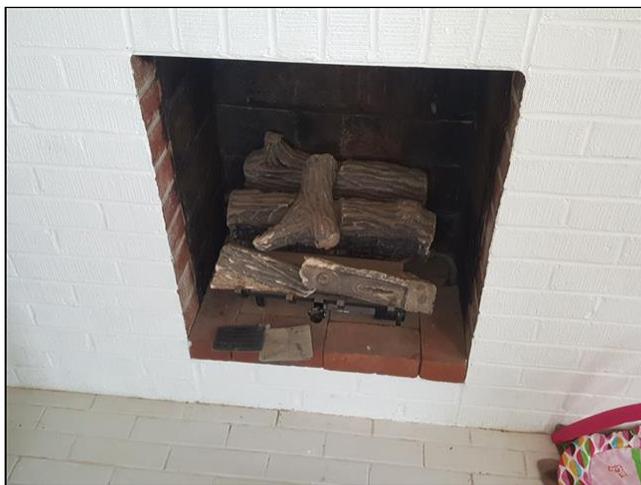
9.11 Item 1(Picture)

**9.11** (1) The non vented gas fireplace at the living room was not inspected for operation. There was no pilot light lit. The inspector is **NOT** required to light pilot lights and operate these fixtures. Reason why we do not light pilot lights is for safety. As such we suggest that the pilot be lit and the fireplace operation be verified with the current owner during the final walk-through to insure continued good operating conditions. If owner is unsure or gas fireplace has not been used for some time, we strongly recommend a qualified fireplace contractor further evaluate and inspect to ensure safety and operation of the gas fireplace prior to moving in.

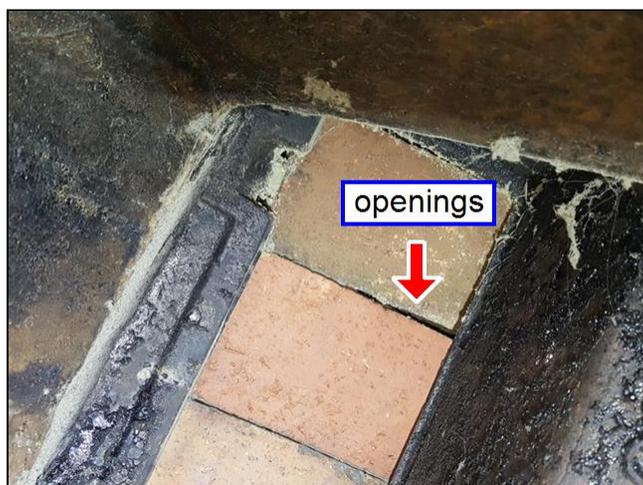
9.11 Item 2(Picture)

**9.11** (3) Because the home is equipped with a vent less gas fireplace, The burn area needs to be sealed. The missing damper has been replaced with bricks, however there are slight openings. This can effect the gas fireplace and creates partial venting of a vent less gas log fireplace. This could cause carbon monoxide to be produced. Before using the gas fireplace in the living room, **strongly** recommend a qualified fireplace contractor further inspect the fireplace burn area and correct or repair if needed for safety of occupants in the home.

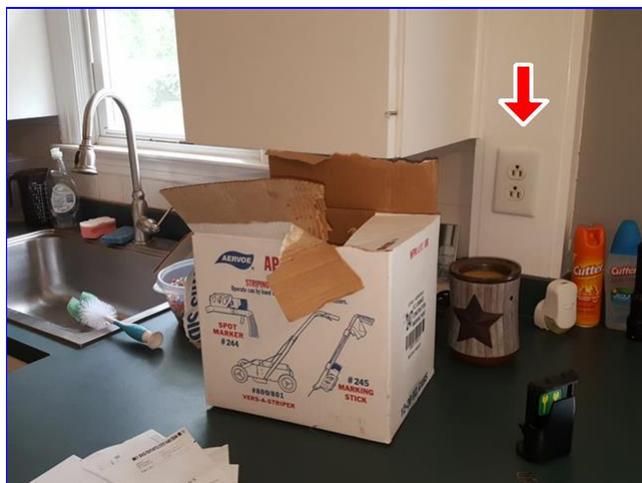
4.9 Item 2(Picture)

(3) The outlet(s) is not GFCI protected in the kitchen in the home where indicated in the photo. Although GFCIs may not have been required at the time that this house was built, these are now required and recommended for safety within any water source as a safety feature when any changes to the outlets are made. GFCI outlet offers protection from shock or electrocution. Recommend a licensed electrician correct as needed.

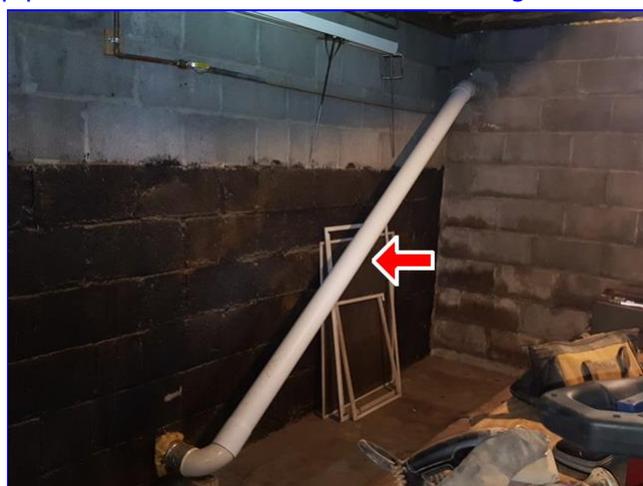
4.10 Item 6(Picture)

(3) The dryer vent in the basement is made of PVC pipe. This is a safety issue. Manufacturers state that "To reduce the risk of fire, DO NOT use plastic pipe or flexible plastic pipe to exhaust the dryer" PVC piping increases the risk of a dryer vent fire due to it creates static electricity which causes the lint to build up, and that PVC is only rated at 140 degrees of heat. Dryers get hotter. Recommend PVC pipe be converted to flexible metal ridge or solid metal pipe for your safety. Replace as needed.

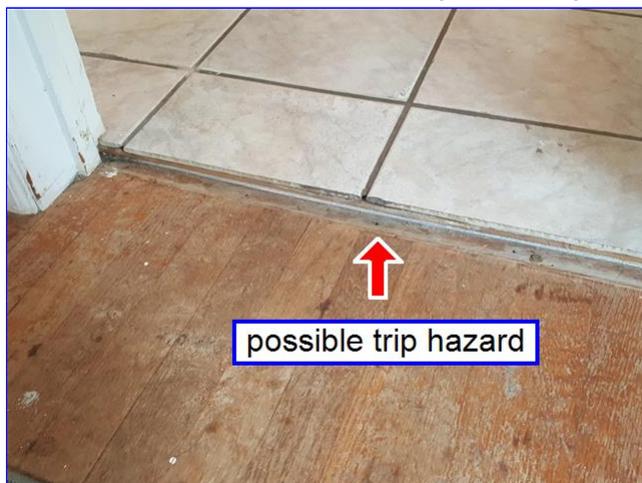
6.0 Item 1(Picture)

The floor in the family room is lower than the floor in the master bathroom. This is a safety issue and a possible tripping hazard. A serious injury could occur if not corrected. Recommend a qualified contractor correct as needed for your safety. A molding strip maybe needed.

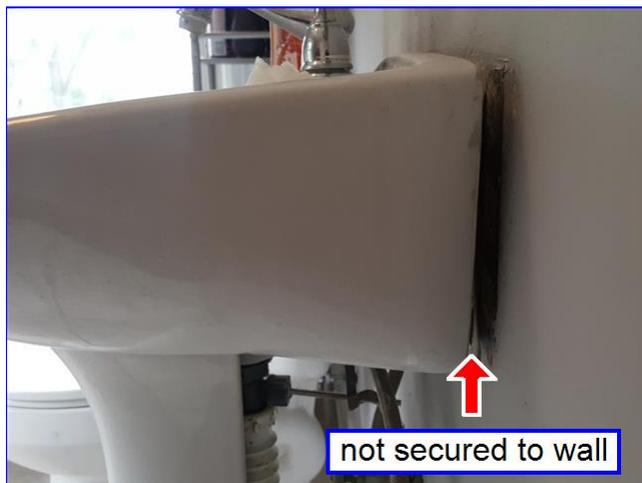
6.4 Item 1(Picture)

The pedestal sink in the master bathroom is loose and not secured to the wall correctly. This is a safety issue. The sink may fall which could result in an injury of a person and/or place strain on plumbing pipes which could result in a leak. Recommend this be better secured, then caulk the area to prevent water penetration. A general contractor is recommend for this repair.

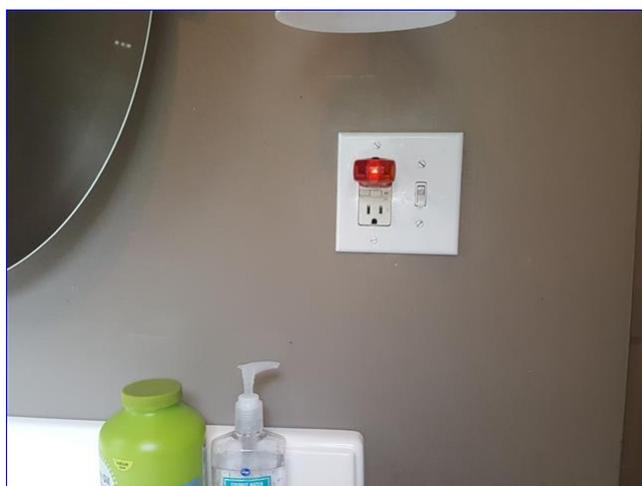
6.6 Item 1(Picture)

(1) The outlet(s) in the 2nd bathroom is a non-grounded outlet which is currently acceptable, however, they maybe GFCI protected and if so they should be labeled a non-grounded GFCI and it is not as safe as a grounded GFCI. This is for your information. I would recommend a qualified electrician further check to see if this outlet is GFCI protected.

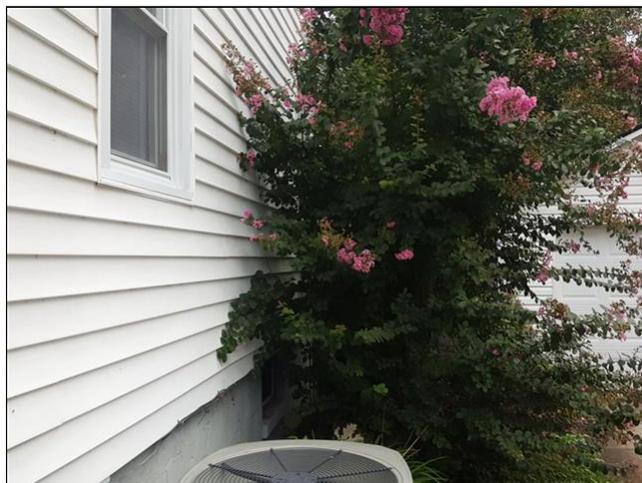
3.9 Item 1(Picture) right side of home

(1) The vegetation is overgrown where indicated in the photos. Recommend that all bushes, shrubs and trees where applicable be kept neatly trimmed and away from the foundation, wall siding, and window frames to prevent damage to the home and allow proper venting and inspection of house. A 6" clearance is recommended.

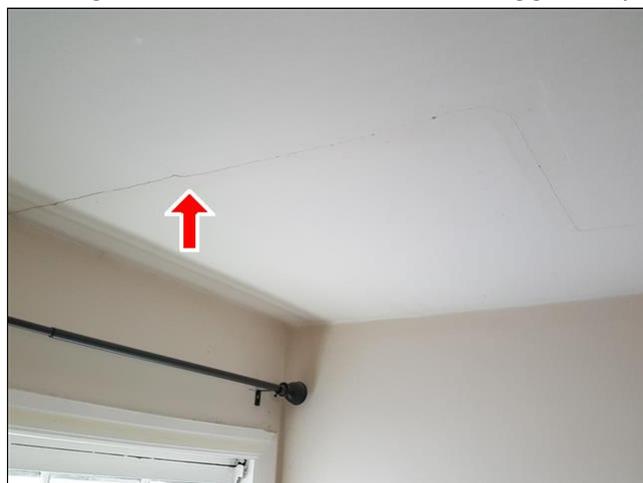
5.0 Item 1(Picture) family room

The cracks in the ceiling in the (upstairs) family room and 2nd bedroom (see photos for location) appear to be common settlement cracks. Cracks larger than 1/16" are of concern only. Minor settlement of the home has occurred due to the age of the home and from perhaps framing shrinkage. Cracks of this nature are also caused by moisture, changing temperature, or framing shrinkage due to a lack of ventilation. Recommend repairing cracks then paint and monitor. If cracks reappear and become larger than 1/16" then would recommend a structural engineer further investigate to determine cause and suggest repairs.

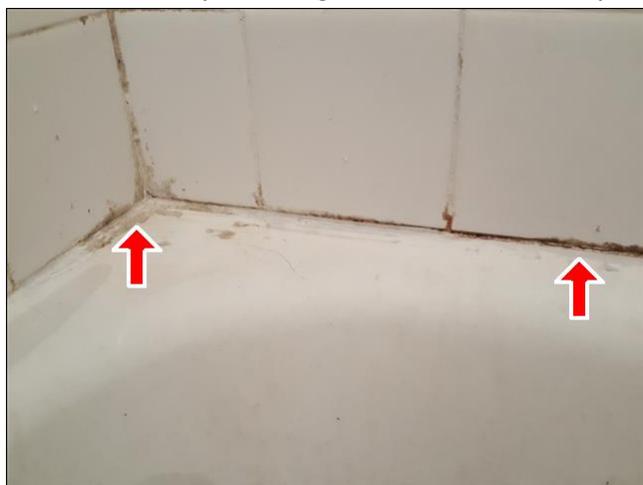
6.7 Item 1(Picture)

Old, shrinking, or dirty caulk with cracks was seen in the master bathroom shower enclosure. All of the caulk should be kept in perfect condition to prevent further cracking or more holes appearing to reduce the possibility of water leaking underneath the shower enclosure and tiled wall. If not corrected mold and/or deterioration of the floor/wall framing can occur beneath the shower enclosure. Recommend re-caulking where needed to seal openings and deteriorated caulk. Use a quality silicone caulk that is expandable and moisture resistant. [Choosing the right caulk](#) Would recommend a qualified general contractor repair as needed.

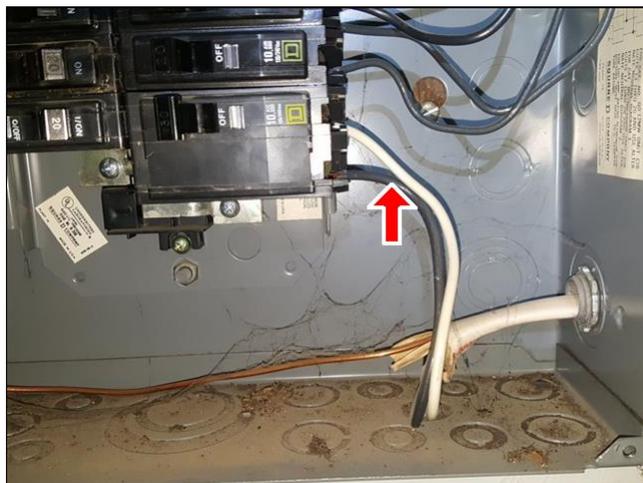
8.3 Item 10(Picture)

(7) The white wire(s) that are connected to the circuit breaker(s) should be marked black to indicate that they are live (hot wires) and are being used for the flow of electricity to travel. Recommend an electrician correct due to safety.
