SAGUACHE CREEK DIVERSION INFRASTRUCTURE INVENTORY

Structure Name: LAUGHLIN D

Date: August 8, 2019

Saguache Creek Stream Management Plan

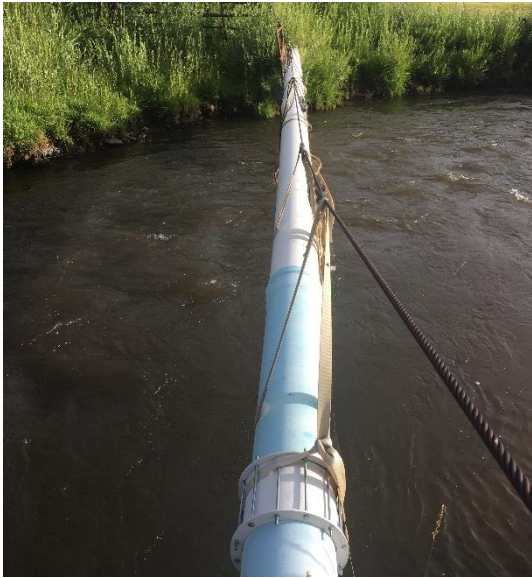
Ditch conduit looking north

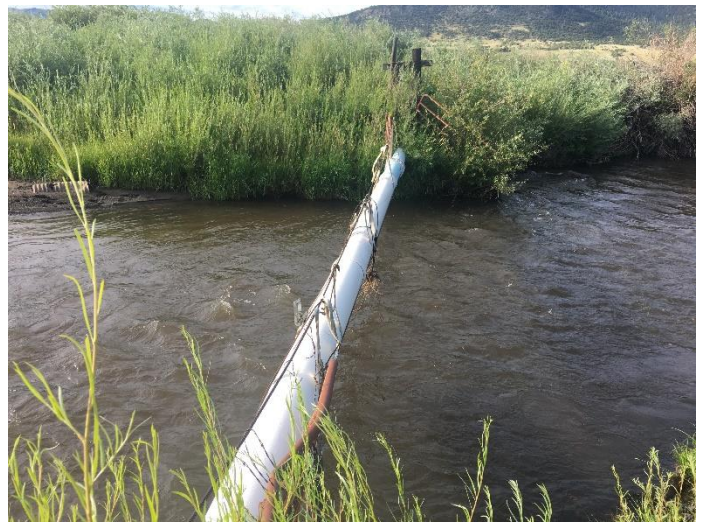
Ditch conduit looking south

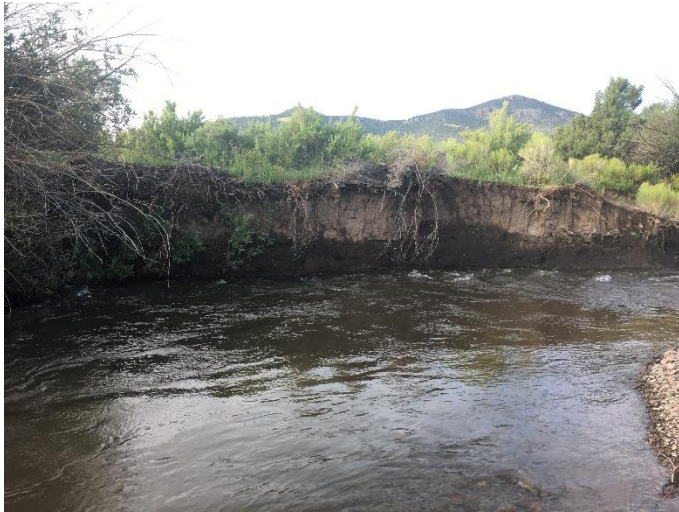
Structure Description: This structure does not have a headgate on mainstem Saguache Creek; rather, water is delivered to the ditch via other water rights. The ditch crosses Saguache Creek via a 10" PVC pipe and delivers irrigation water south of Saguache Creek. Just upstream of the structure, the south bank of the stream is experiencing accelerated erosion. It could be stabilized to prevent further erosion. No other improvements or repair needs were noted.

South bank erosion looking upstream

Repair(s) or Improvement(s) Currently Needed: The south stream bank just upstream of the structure could be stabilized to prevent further erosion and potential damage to the ditch. Existing fish passage should be maintained and riparian restoration should be considered as part of any future repairs or improvements.

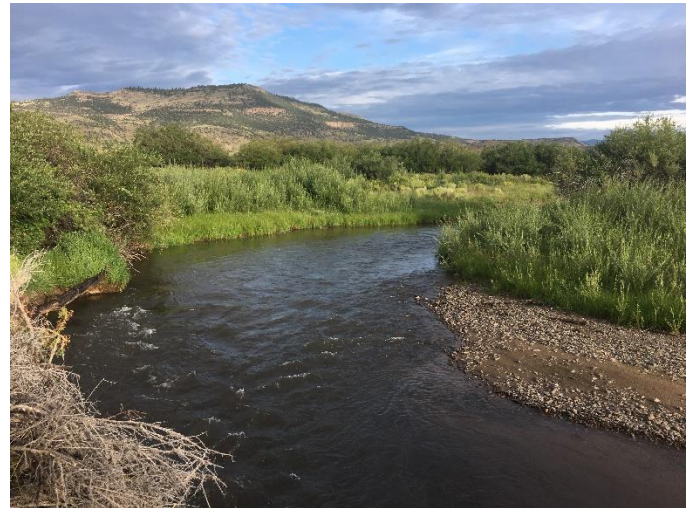
Stream channel looking upstream

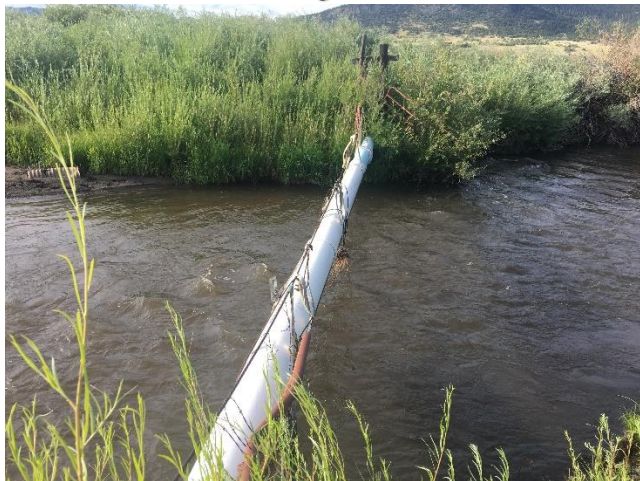
Flume looking downstream

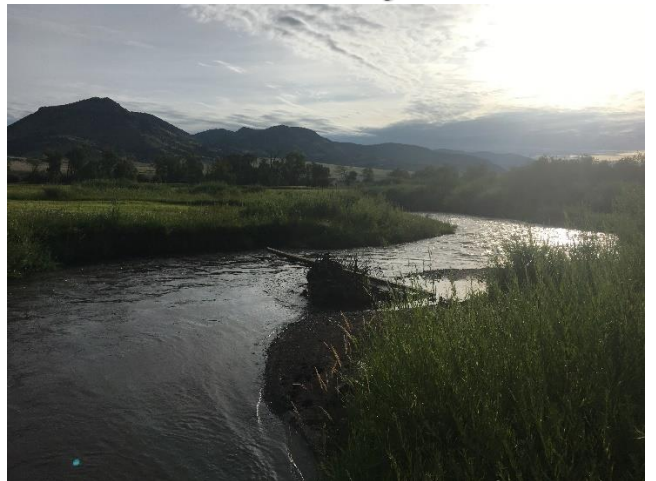
Stream channel looking downstream
