# Spring Creek Horse Palace Feasibility Study

Elko, Nevada  
October 14, 2016

# INTRODUCTION

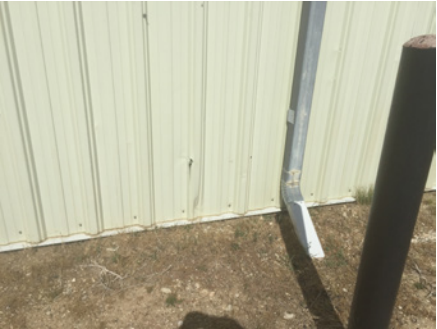
EXISTING GRADE PILED AGAINST SIDING

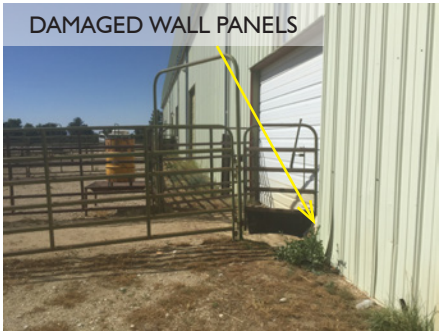
DAMAGED WALL PANELS

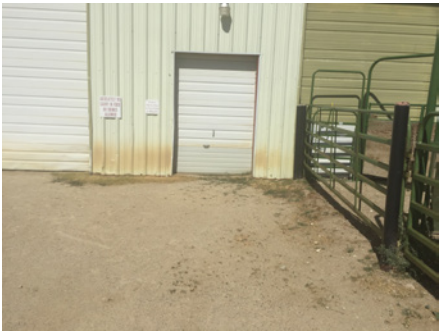
DAMAGED SIDING AT OVERHEAD DOOR

These doors and frames should be removed and replaced with new industrial grade insulated overhead doors and frames. Bollards should be installed to prevent future damage to door frames and tracks.

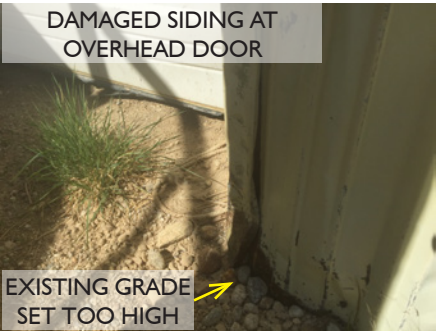
EXISTING GRADE SET TOO HIGH

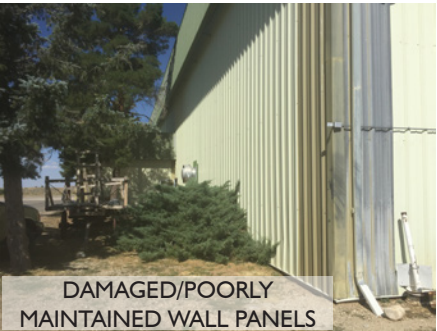
DAMAGED/POORLY MAINTAINED WALL PANELS

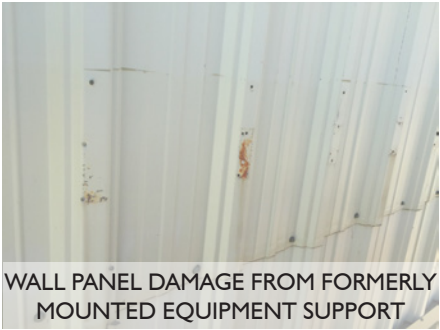
WALL PANEL DAMAGE FROM FORMERLY MOUNTED EQUIPMENT SUPPORT

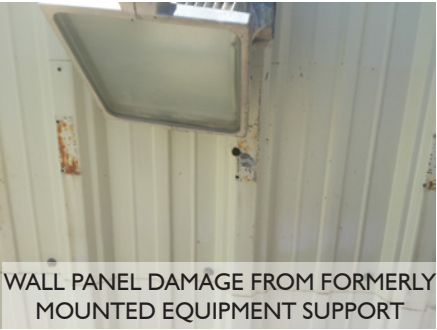
WALL PANEL DAMAGE FROM FORMERLY MOUNTED EQUIPMENT SUPPORT

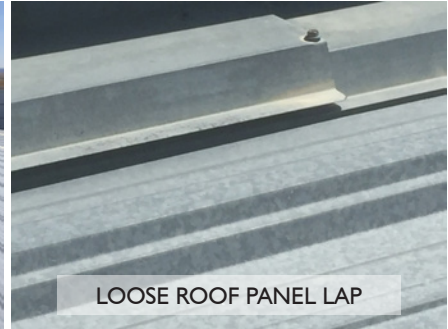
LOOSE ROOF PANEL LAP

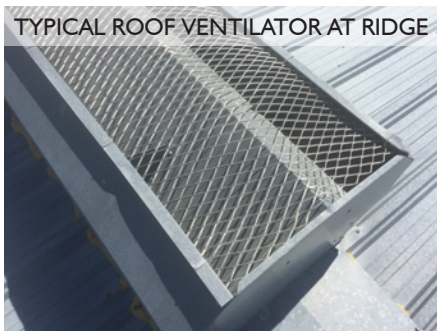
TYPICAL ROOF VENTILATOR AT RIDGE

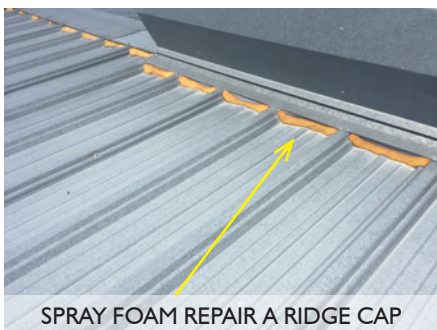
SPRAY FOAM REPAIR A RIDGE CAP

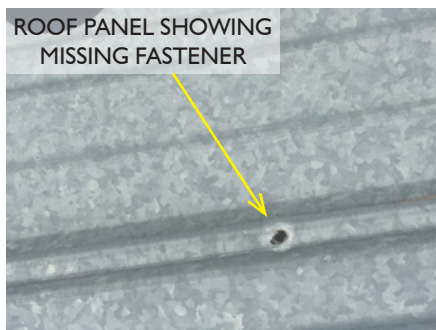
ROOF PANEL SHOWING  
MISSING FASTENER

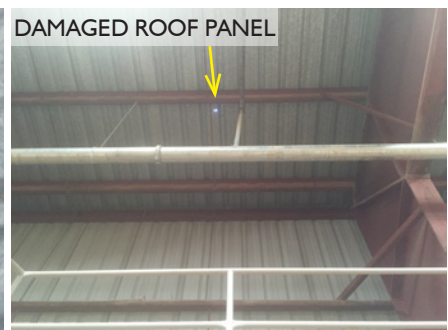
DAMAGED ROOF PANEL

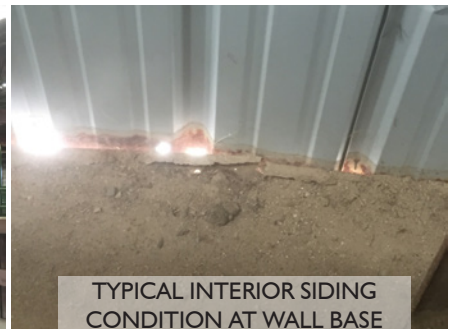
TYPICAL INTERIOR SIDING  
CONDITION AT WALL BASE

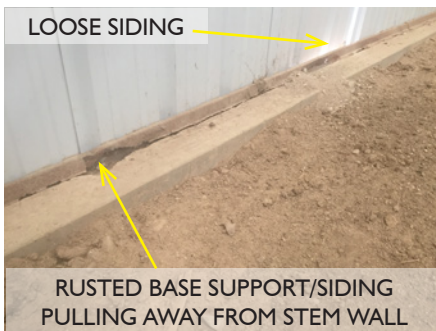
LOOSE SIDING

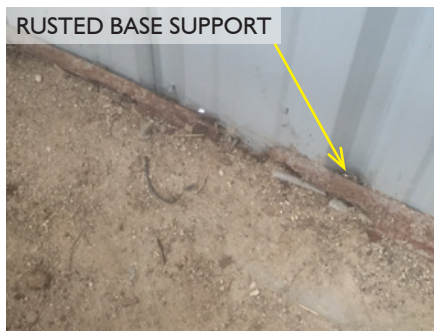
RUSTED BASE SUPPORT

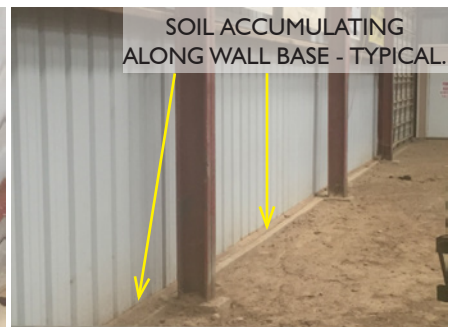
SOIL ACCUMULATING  
ALONG WALL BASE - TYPICAL.

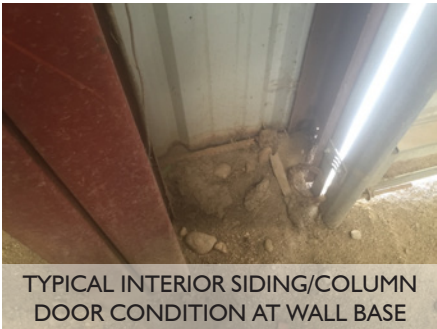
TYPICAL INTERIOR SIDING/COLUMN  
DOOR CONDITION AT WALL BASE

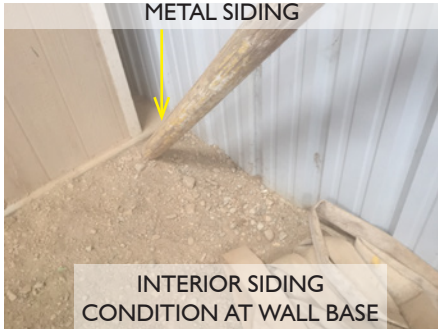
INTERIOR SIDING  
CONDITION AT WALL BASE

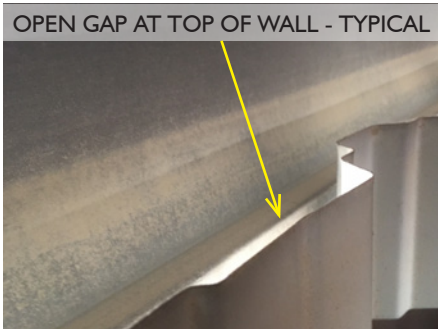
OPEN GAP AT TOP OF WALL - TYPICAL

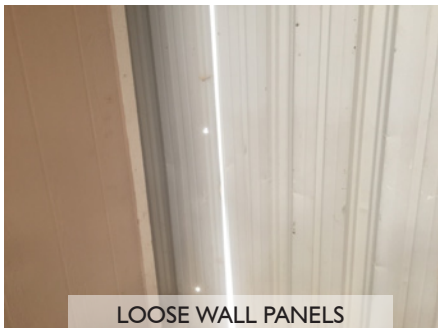
LOOSE WALL PANELS

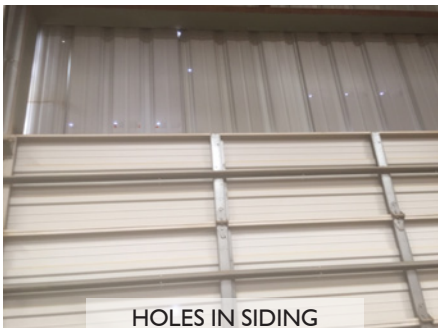
HOLES IN SIDING
