CONEJOS RIVER DIVERSION INFRASTRUCTURE INVENTORY

Structure Name: LE DUC D

LE DUC DITCH

**Conejos River Stream
Management Plan**

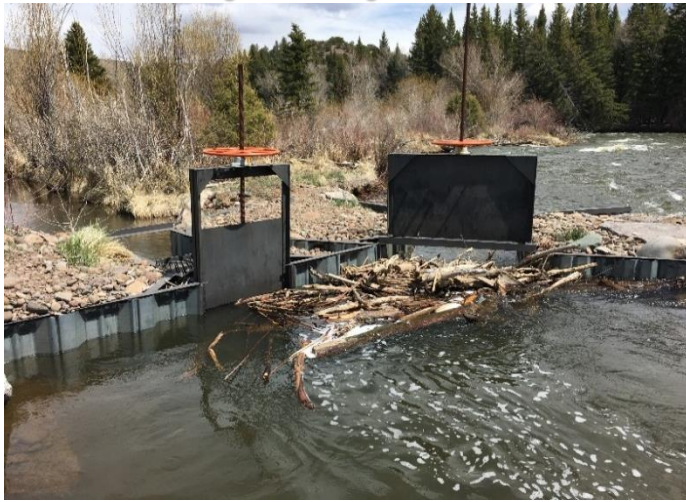
River headgate looking downstream

Repair(s) or Improvement(s) Currently Needed: The headgate could be replaced, but it functions well in its current condition. The flume should be reset to improve accuracy. Debris accumulates at the river headgate, but does not pose a significant maintenance issue for the structure. There is minor erosion occurring downstream of the headgate, but it does not appear to be adversely affecting the structure. Existing fish and boat passage should be maintained and riparian restoration should be considered as part of any future repairs or improvements.

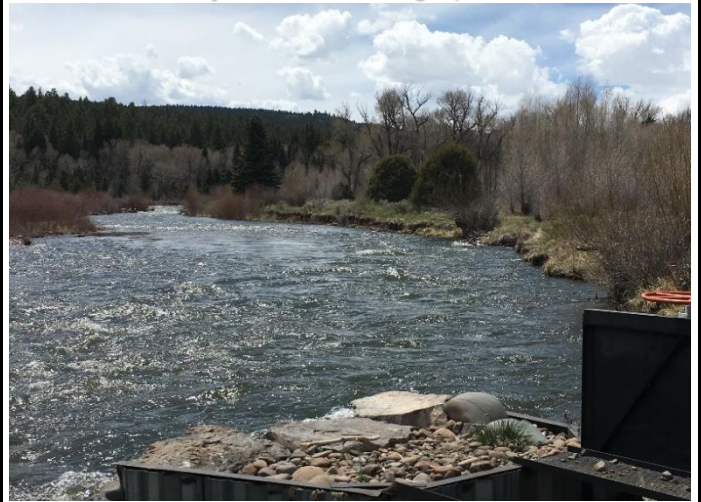
Conejos River looking upstream

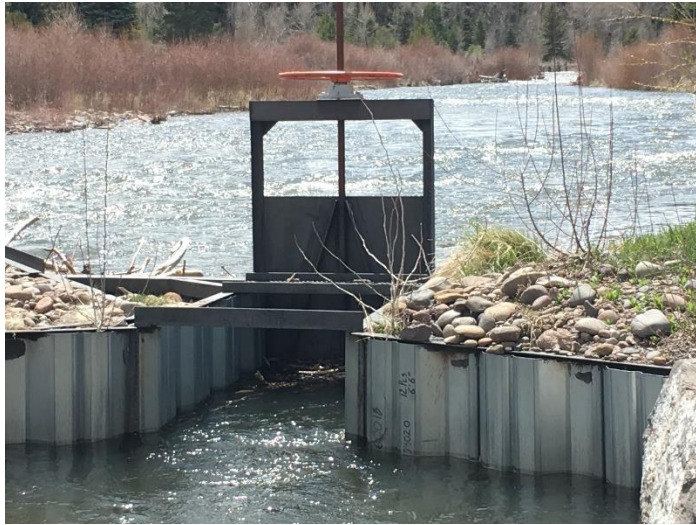
River headgate outlet

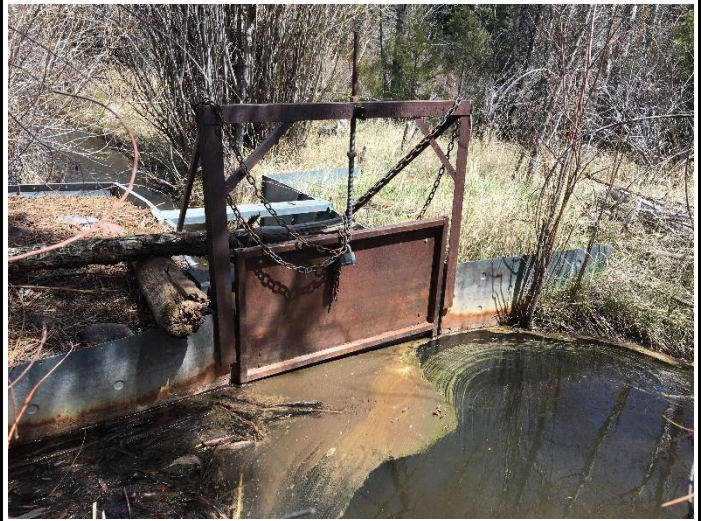
Main headgate looking downstream

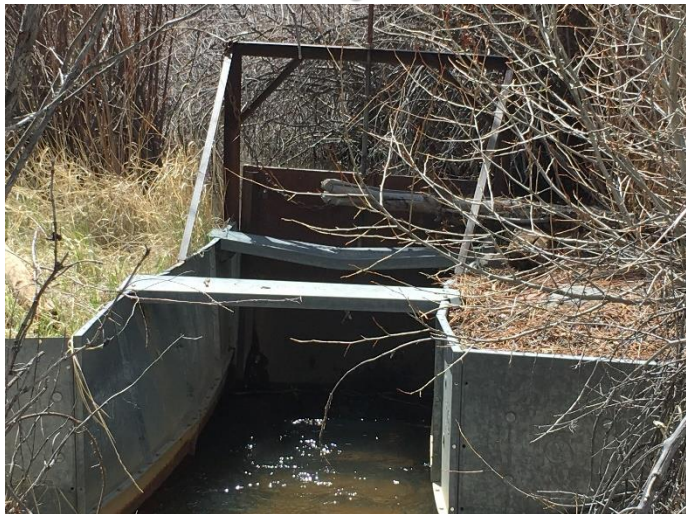
Main headgate outlet

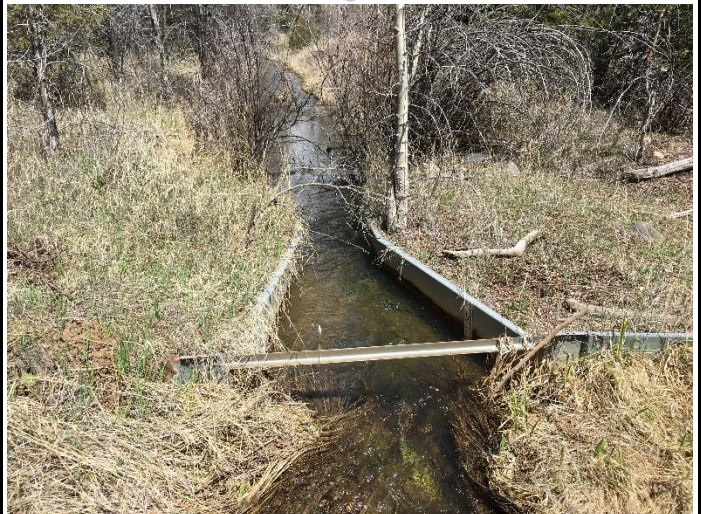
Flume looking downstream
