RIO GRANDE DIVERSION INFRASTRUCTURE INVENTORY

Structure Name: CHICAGO D

CHICAGO DITCH

PHOTO LOG

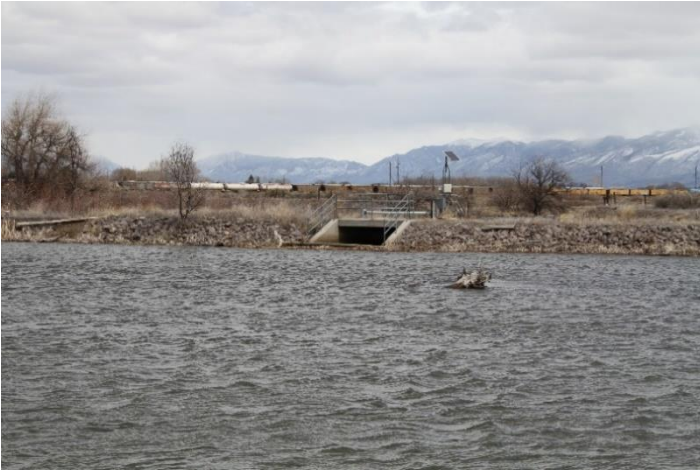
Headgate (from diversion dam)

Repair(s) or Improvement(s) Currently Needed: Some woody debris accumulates in front of the headgate but it does not appear to be a significant issue for water users. Bank stabilization and riparian vegetation restoration downstream of the diversion dam would improve river function. A portage route for recreational boaters around the diversion dam is also recommended. Any future repairs or improvements to the diversion dam should incorporate fish and boat passage.

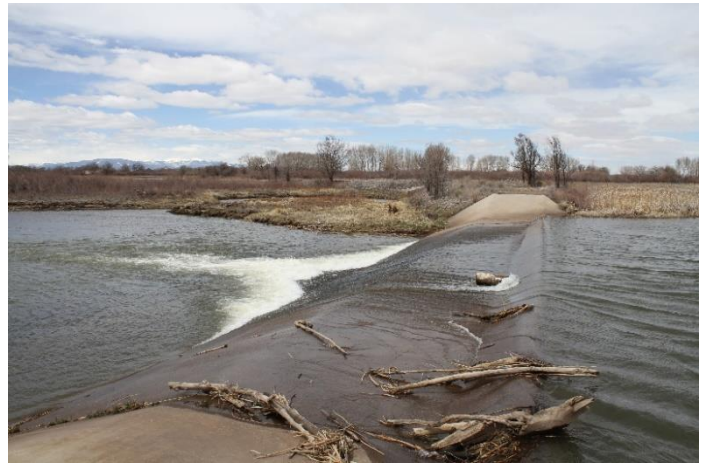
Diversion dam

Structure Description: This structure is located ~1.3 miles downstream of the Westside Ditch. Channel avulsion has occurred both upstream and downstream of the diversion dam. The trapezoidal concrete diversion dam creates head pressure for the headgate, which is located ~230 feet upstream. There is a radial adjustment/overflow gate on the east side of the diversion dam. The diversion functions well for water users, but it is a significant barrier to recreational boating, especially at low flows. The weir measures accurately.
