## **Inspection Report**

**Property Address:**  
780 Nutfield Way  
Richmond KY 40475

<b>Date:</b> 7/15/2018	<b>Time:</b> 09:00 AM till 03:00 PM	<b>Report ID:</b> 180715BETHAM
<b>Property:</b> 780 Nutfield Way Richmond KY 40475	<b>Customer:</b> Mrs. Gail Schneider	<b>Real Estate Professional:</b>

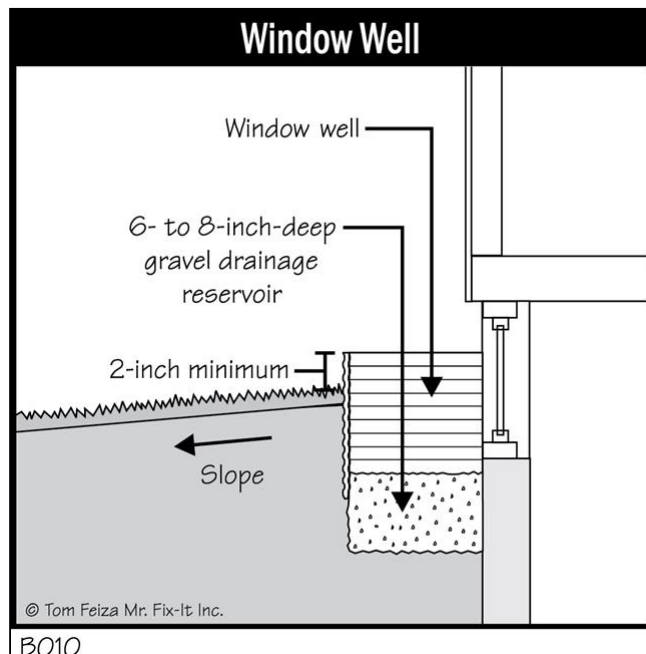
1.7 Item 1(Picture)

**1.7** The basement window at the rear right side of the home is at or near ground level. This can allow water entry into the basement. Water intrusion in a basement can lead to more costly repairs and cause mildew or mold to form. Recommend a half-round window well be installed where needed. The dirt inside the well should be replaced with approximately four inches of gravel. A couple of inches clearance between the gravel and window opening is recommended. Recommend a general contractor correct as needed.

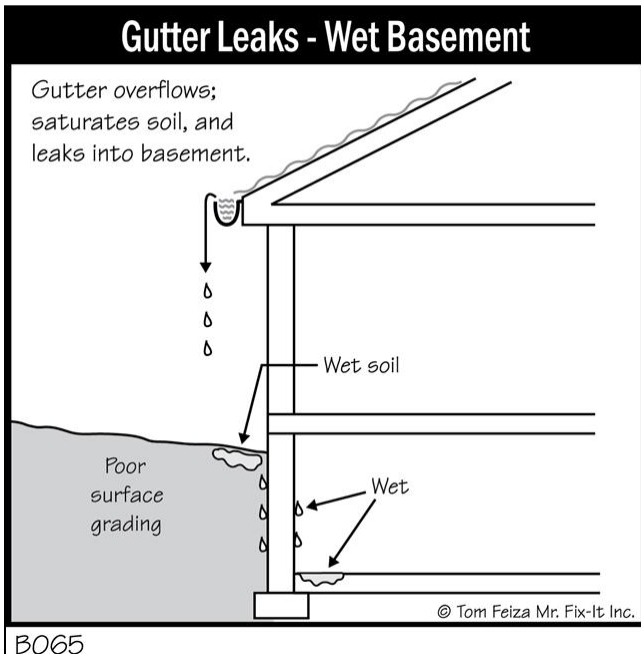
2.4 Item 9(Picture)

**2.4** (5) The gutter(s) where indicated in the photos, especially where they drain into the downspouts, are full of debris and need to be cleaned. The debris in gutters can also conceal rust, deterioration or leaks that are not visible until cleaned, and I am unable to determine if such conditions exist. Gutters require cleaning to avoid spilling roof runoff around the building - a potential source of water entry or water damage, and/or the fascia could become damaged. Recommend cleaning the gutters as needed. You may wish to consider installing gutter guards due to trees surrounding the home.

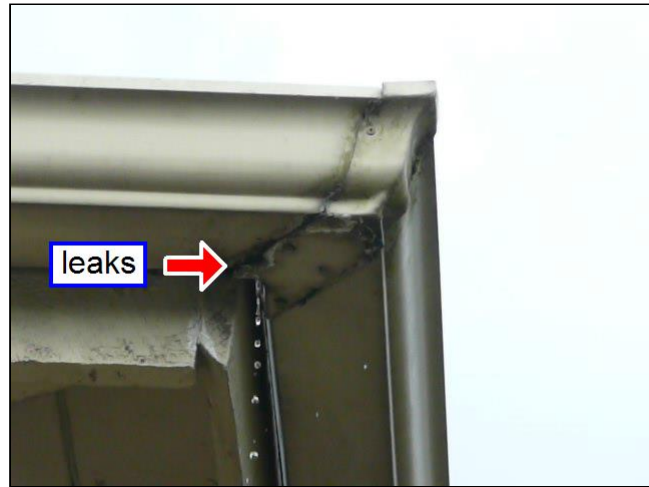
2.4 Item 13(Picture) rear right corner of home

2.4 (7) The gutter leaks at the seam where indicated in the photos. Evidence of minor leakage was observed in this area during the inspection. Repairs are needed to prevent possible deterioration of the fascia and/or soffit via water intrusion. Recommend a general contractor repair as needed.

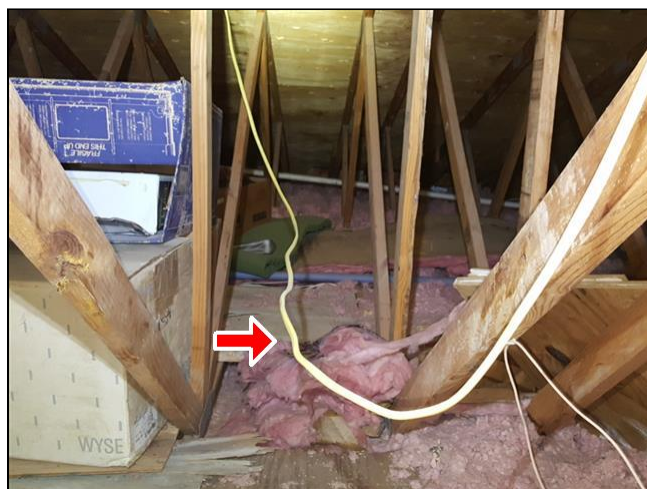
2.10 Item 1(Picture) garage

2.10 (1) Loose wiring in the garage attic should be secured to prevent tripping accidents. This is a safety issue. Recommend a licensed electrician secure where needed.

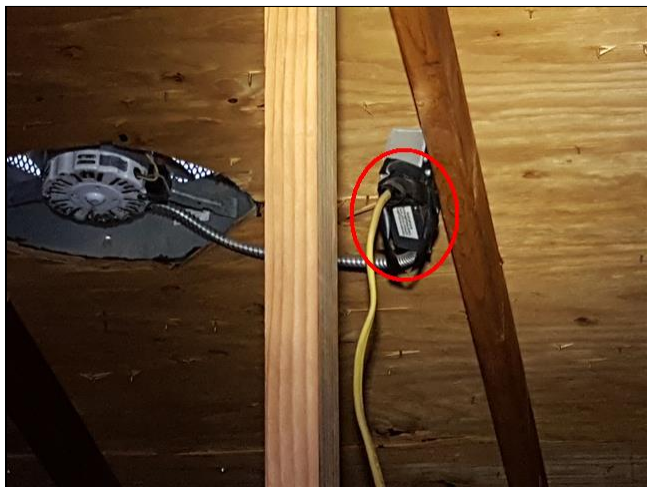
2.10 Item 2(Picture)

**2.10 (2)** The wiring installation of the power vent in the garage attic is non-standard. It is suspected that an amateur, rather than a licensed electrician performed the installation. Splices in electrical wiring should be enclosed in junction boxes and fitted with cover plates, not covered in insulation tape. This is a safety issue. Recommend a licensed electrician repair as needed to prevent accidental electric shocks.

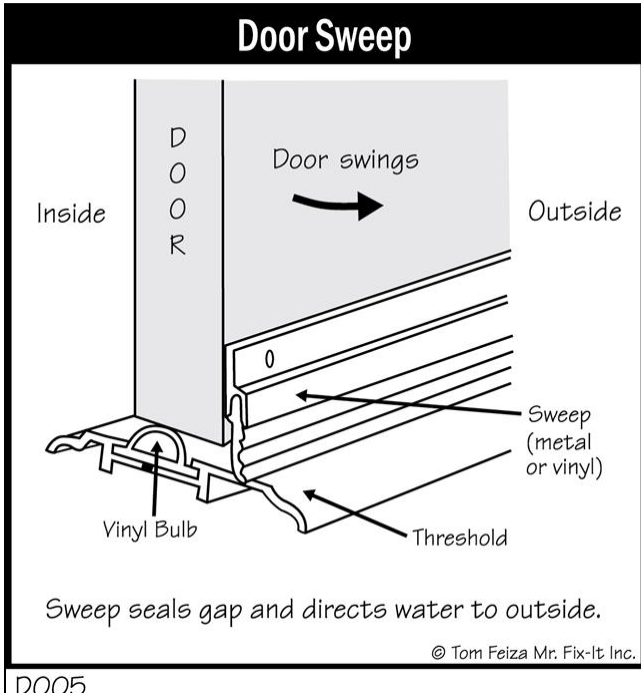
D005

3.3 I would recommend a door sweep be installed at the basement door at the left side of the home to ensure water intrusion does not occur. This is for your information

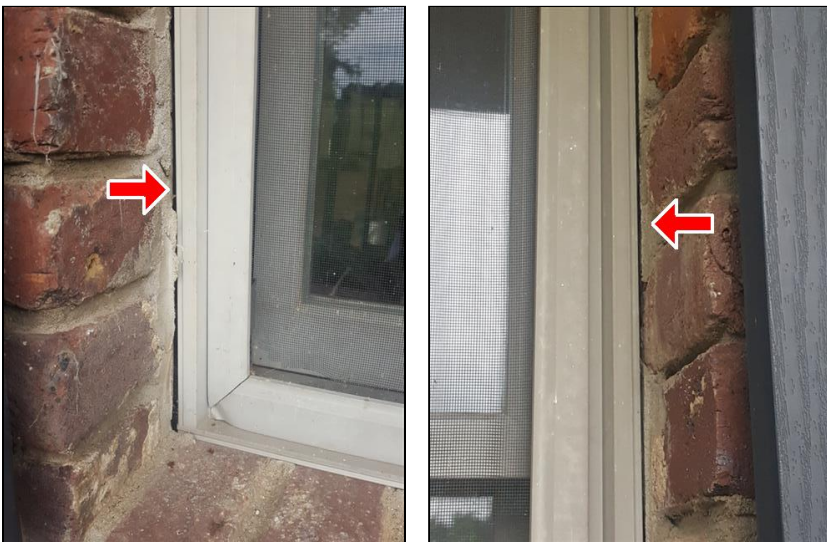
3.4 Item 1(Picture)

3.4 (1) The gaps between the window frames and the siding around the home need to be sealed correctly to prevent water intrusion. Water entering here can lead to deterioration of the wall siding and potential leaks inside the wall cavity. Recommend caulking these areas with a quality moisture resistant caulk that expands and contracts. [Choosing the right caulk](#)

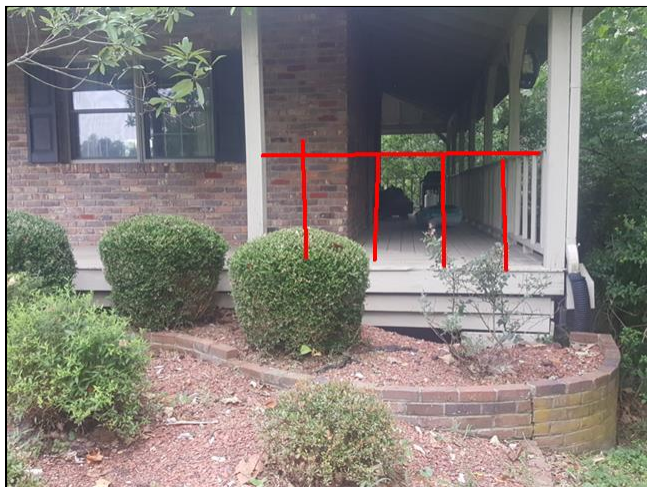
3.5 Item 4(Picture) front right side of home

**3.5 (2)** Recommend a guard rail be installed at the front porch on the right side to prevent a fall from occurring which may result in an injury of a person. This is a potential safety issue. The railing needs to be at least 36 inches high and balusters need spacing to be at least 4 inches. Recommend a qualified contractor install one for safety.

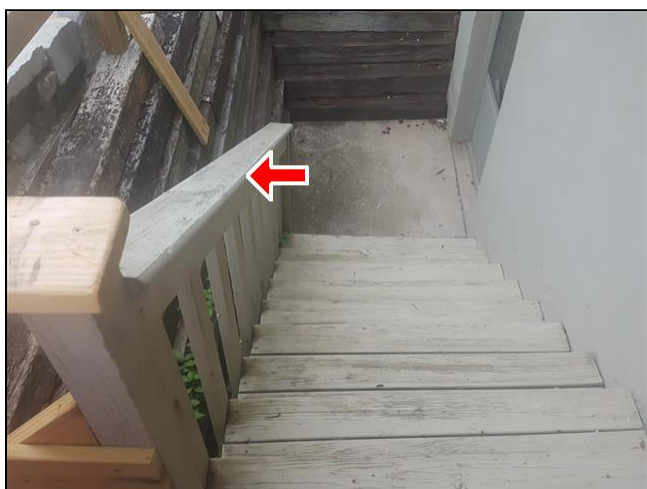
3.5 Item 5(Picture)

**3.5 (3)** 2x6s are installed for handrails for the basement staircase at the left side of the home and are not considered "gripable" by industry standards. This is a safety issue and an injury could occur if not corrected. Recommend that a standard approved handrail be installed for safety by a general contractor.

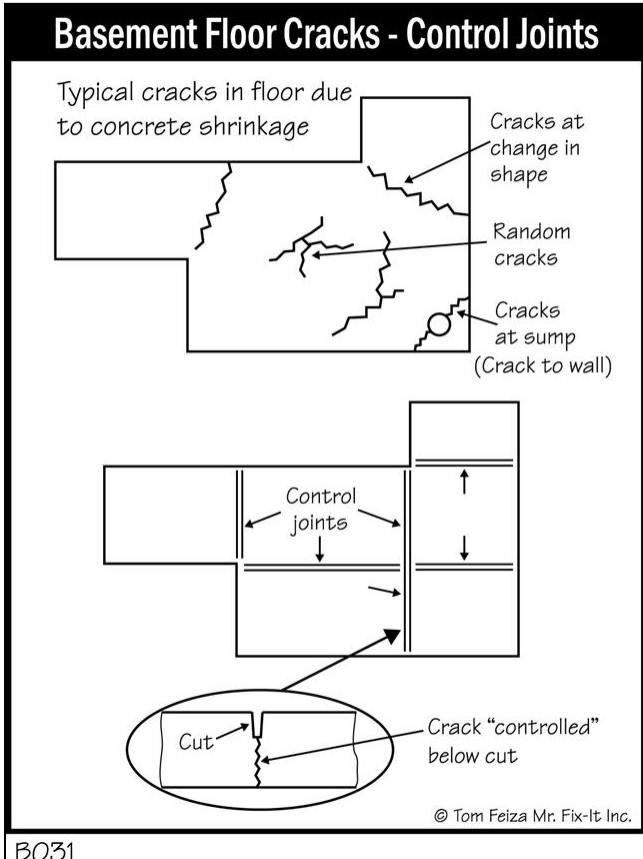
B031

4.2 There are no control joints in the garage floor. All concrete cracks. Control joints allow poured concrete to crack at the joint to prevent large running cracks. Recommend adding control joints by a qualified contractor.

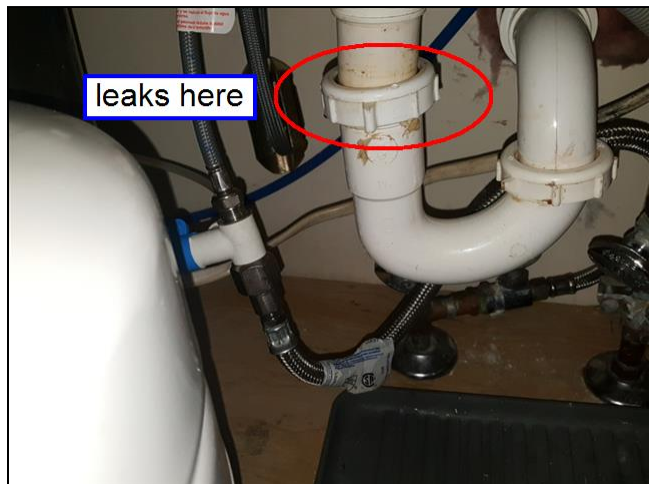
5.1.A Item 1(Picture)

**5.1.A** The p-trap on the waste line is leaking at the connection underneath the sink in the kitchen. Repairs are needed to stop leaking water from damaging the cabinet bottom or to eliminate moisture that may contribute to fungi growth. A qualified licensed plumber is recommended for repairs as needed.

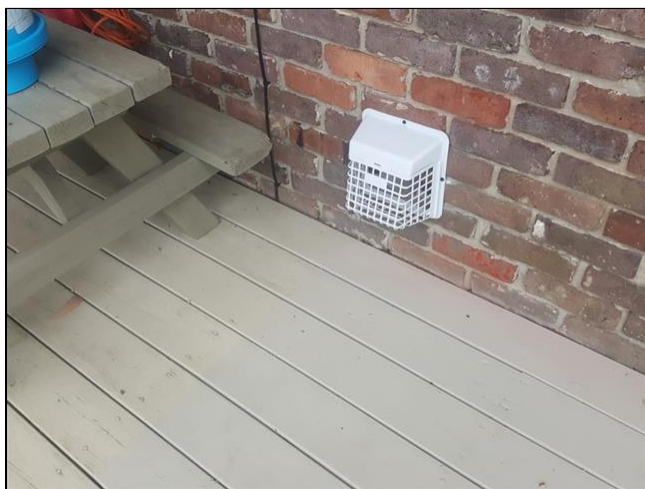
5.11.A Item 1(Picture)

**5.11.A (1)** The exterior port for the dryer vent pipe is located on the rear right side of the home. (see photo for location) This is for your information.

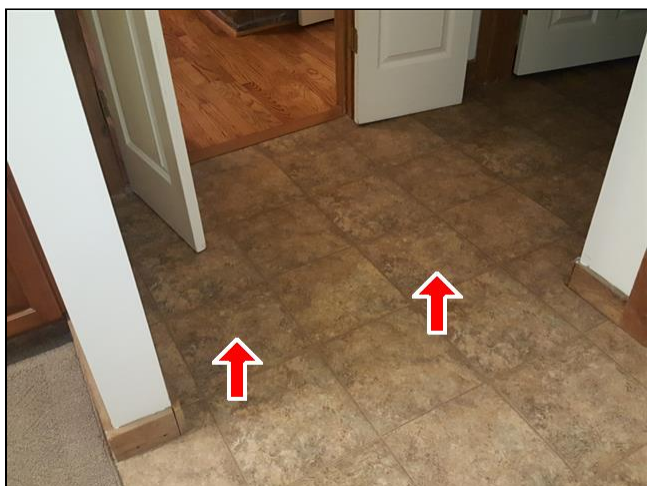
6.2 Item 1(Picture)

**6.2** (1) The floor in the washer dryer room slopes towards the center of the kitchen in the home as indicated in the photo. This is normal and to be expected in a house of this age due to the joists may be sagging and/or require additional support. There was no evidence of cracks or damaged materials in relation to the floor being in this state. All doors opened and closed without rubbing on the jambs. There was no visible access under this area. Inspections are limited and exhaustive or destructive inspections are excluded. Recommend monitoring the floor and walls in this area periodically to see if cracks appear and if so this area may need further evaluation to determine cause and remedy. A structural engineer will need to be consulted if further sloping and/or settlement cracks greater than 1/8 inch start to occur. This is for your information.

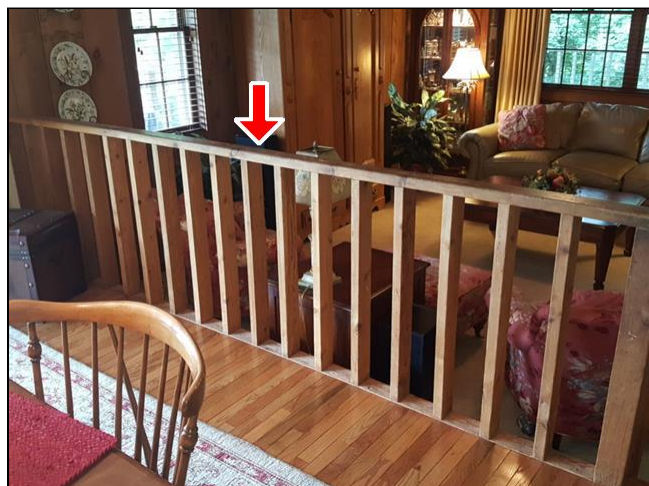
6.3 Item 1(Picture) dining room

6.3 (1) The balcony railing is loose/unstable between the dining and living room. This is extremely dangerous and is a safety concern. This could collapse if someone was pushed against or was leaning on the railing. Recommend repair by a qualified contractor before closing.

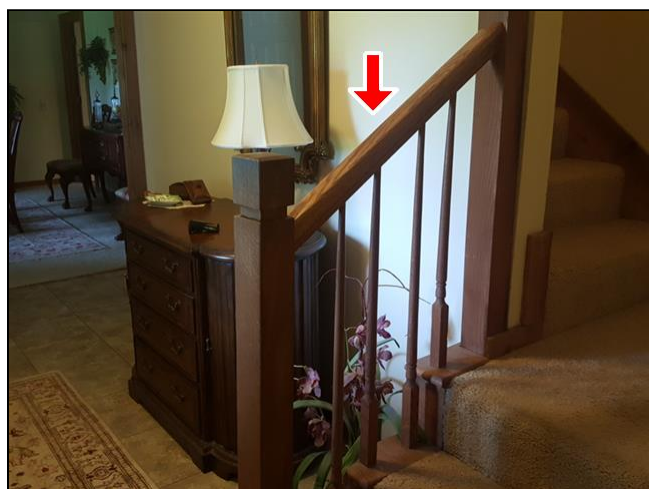
6.3 Item 2(Picture)

6.3 (2) The stair case rail on the on the left side leading to the upstairs is unstable and not secured properly. This is extremely dangerous and is a safety concern. It may fail under a medium or heavy force or if someone was pushed against or was leaning on the railing. For your safety it should be strengthened and secured. Recommend a qualified contractor repair as needed before closing.

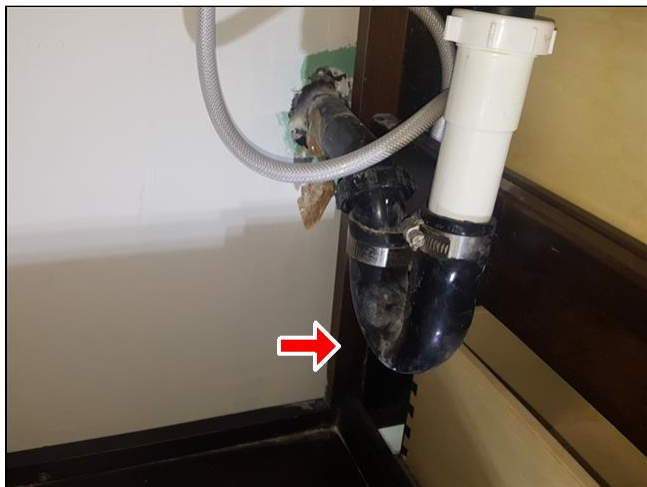
7.5 Item 2(Picture)

**7.5 (2)** Rubber hose pipe is being used for the connection to the drain line under the sink in the basement bathroom. The pipe connections may leak in the future. Recommend you seek a qualified licensed plumber to correct as needed as this type of work is not to standard workman like practices.

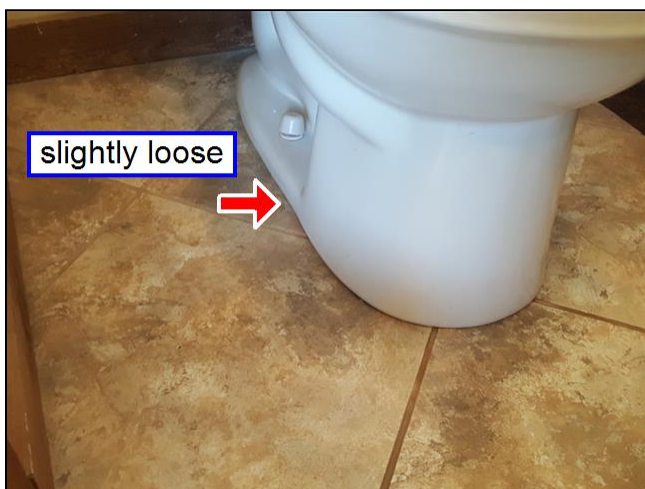
7.8 Item 1(Picture)

7.8 The toilet tank base is loose at the floor in the master bathroom. The screws may need tightening to secure the toilet base to the floor to prevent a water leak between the toilet and the drain line connection. If tightening the screws at the base of the toilet does not secure the toilet, repairs may involve re-setting the toilet on a new wax seal and/or repairs to the floor may be required. Recommend a qualified licensed plumber repair or correct as needed.

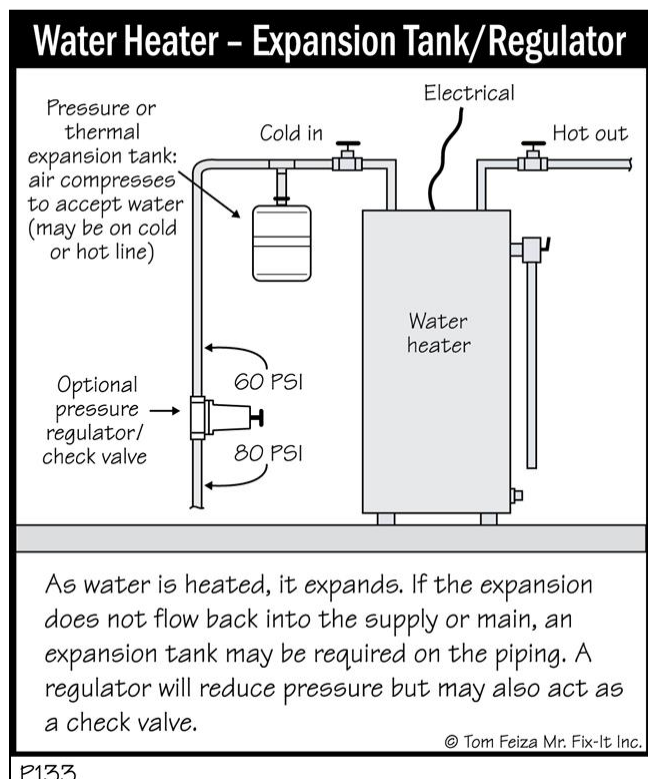
### 8.2 Item 1(Picture)

**8.2 (2)** Both of your water heaters do not have a "Thermal Expansion tank" installed to prevent a possible leak at the TPR or "pop-off" valve. If the water pressure gets high enough it can damage valves in the plumbing fixtures, joints in the supply pipes and even the water heater. Thermal expansion always occurs in water heaters. Like most substances, water expands as it is heated. There were no visible leaks or drips at the TPR valve during the inspection. If your water heater does begin to drip or leak, then a thermal expansion tank may be needed. This is for your information.

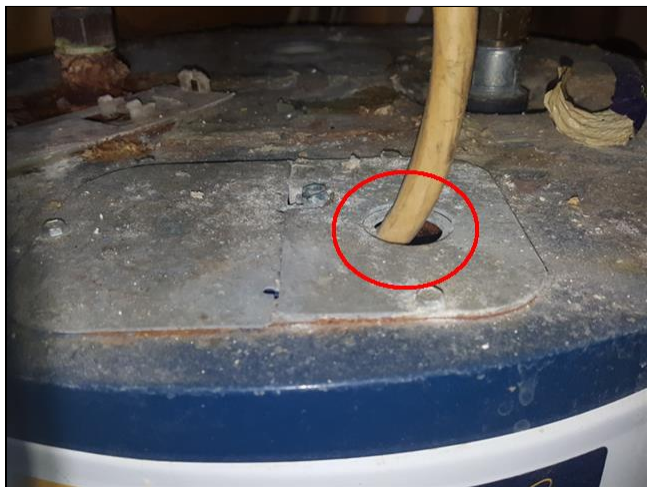
8.2 Item 6(Picture)

8.2 (8) There is no strain-relief clamp on the wire where it enters the top of the water heater in the basement. This is a safety issue. A child or person could easily pull the wire out of the heater, touch an energized conductor, and be electrocuted causing possible death. Recommend a qualified licensed electrician repair as needed for safety.

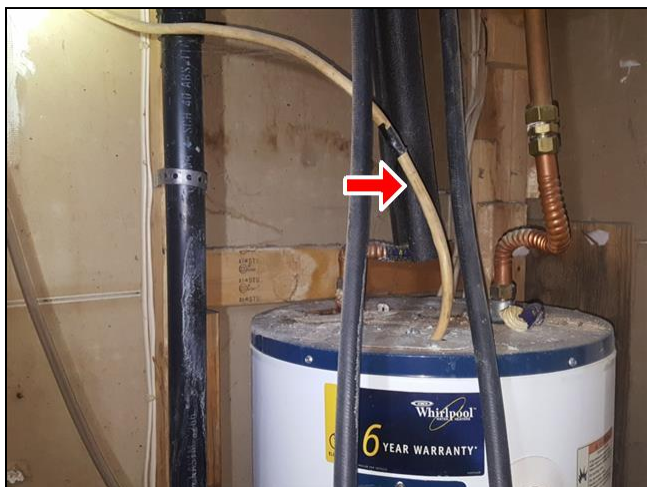
8.2 Item 8(Picture)

8.2 (9) Unprotected electrical wiring leading into the water heater in the basement is susceptible to being damaged and should be covered or protected by a rigid conduit. This is a potential safety issue. This will protect the wire jacket from possible melting if it comes in contact with the hot water line which could energize the unit and cause an electric shock if any water or metal surface is touched. Recommend a qualified electrician install a conduit to make the connection safer and protect the wire from being damaged.

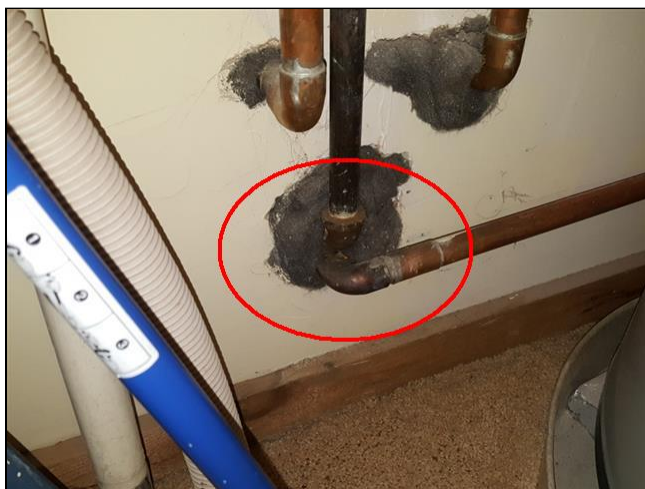
8.3 Item 2(Picture)

8.3 (2) Could not identify or visibly see where the drainage for the TPR line for the water heater in the upstairs closet is draining to the exterior. Recommend contacting owner for location.

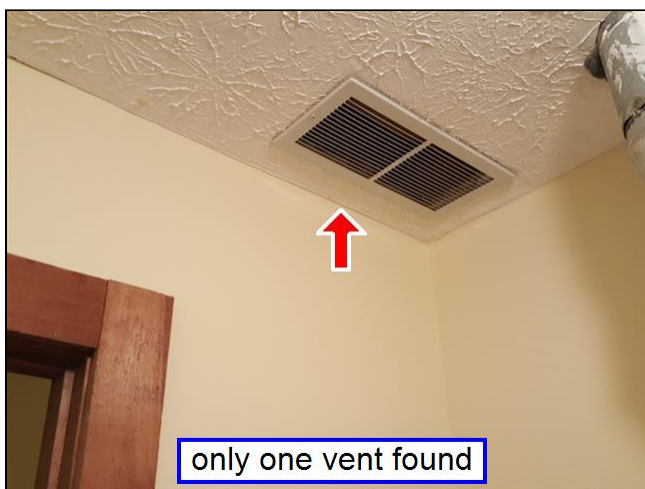
8.4 Item 1(Picture)

Note: Vent screens that are used for combustion air for a gas appliance **must not have any damper or closing device**. This is a serious safety issue. Recommend replacing vents that are not adjustable.

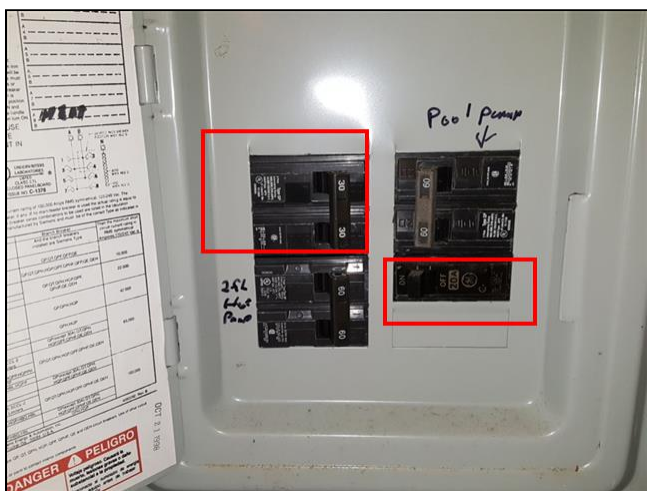
9.2 Item 8(Picture)

9.2 (6) Some of the circuit breakers are not labelled at the sub panel cover. This is a safety issue. Could not check if breakers may be overloaded with appliances in the home. The electrical panel should be indexed, identifying each circuit breaker. This will allow for quick de-energizing of a circuit under emergency situations. Recommend the panel be fully labelled to facilitate turning off breakers to circuits. A licensed electrician is recommended to correct as needed.

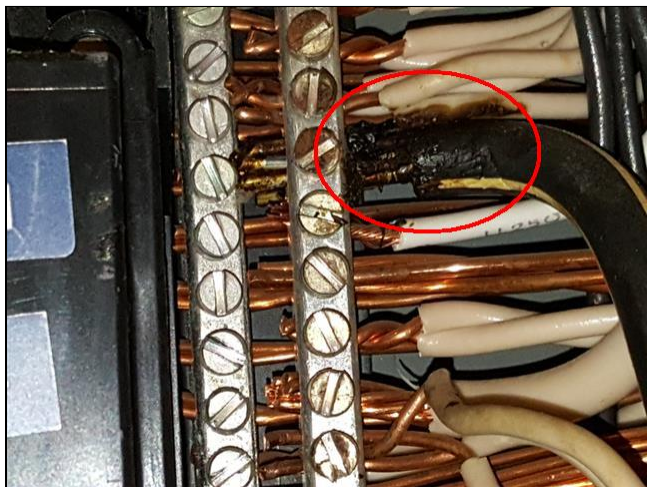
9.3 Item 1(Picture)

**9.3 (1)** Evidence of scorched wires was noted on the bus bar in the main panel. This indicates that a short is happening and a fire could develop if not repaired or corrected. Strongly recommend a qualified licensed electrician further investigate all wiring in the panel box and correct problems found as needed for your safety.

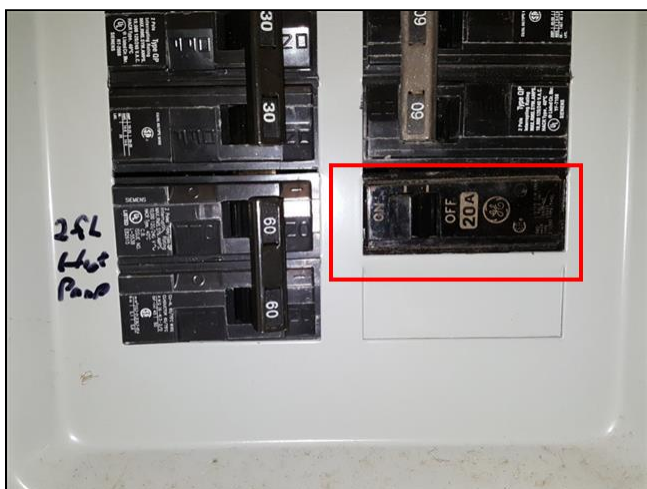
9.3 Item 7(Picture)

9.3 (5) Some of the breakers are not manufactured by the maker of the sub panel. Most mismatched breakers are normally not allowed because the connections may be loose or tight which can result in an electrical fire or short. This is a potential safety hazard. Recommend a qualified electrician verify that these breakers are compatible with this panel prior to closing.

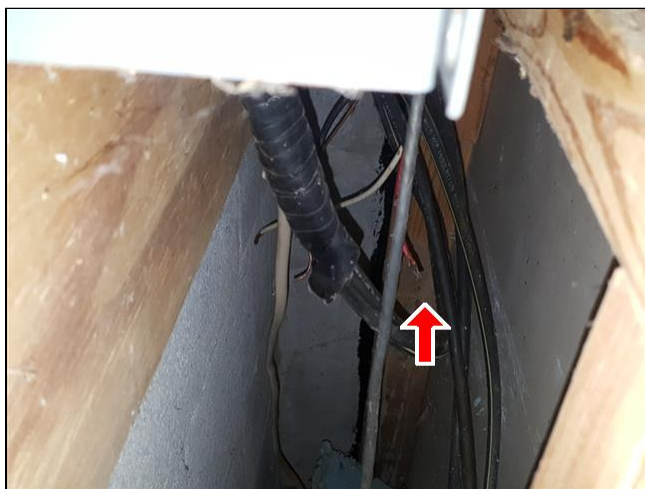
9.3 Item 8(Picture)

**9.3** (6) Wires that are not in use or connected to a breaker in the panel box should have a twist cap to protect the wire from possibly being energized if it comes in contact with current. If not corrected this could lead to a possible short creating a fire or it may energize the panel box creating an electrical shock when the box is touched. This is a serious safety issue. Recommend a qualified electrician repair as needed and further inspect panel to determine any other additional issues that could not be found within the panel box for your safety.

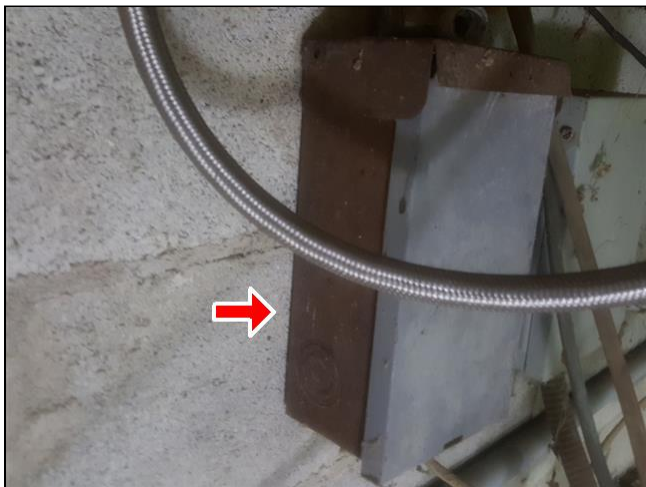
10.2.B Item 1(Picture)

**10.2.B (1)** The exterior electrical box for the Heat Pump is rusted on the outside and on the inside. Recommend it be painted or replaced to prevent further rusting. If replaced a qualified electrician should perform replacement.

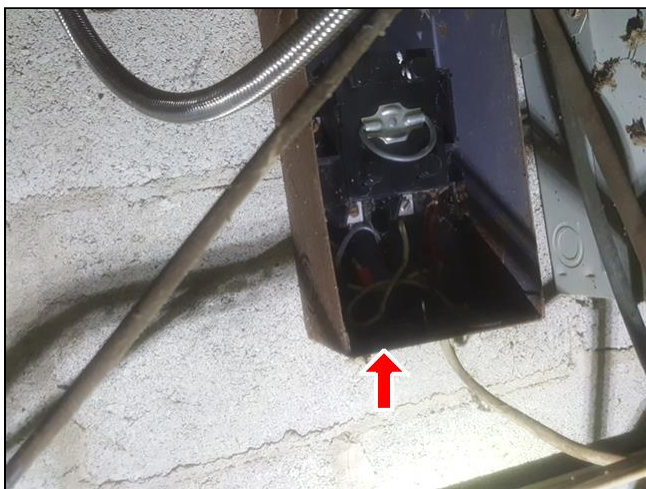
10.2.B Item 2(Picture)

**10.2.B (2)** The disconnect for the Heat Pump at the right side of the home is missing a cover inside the box to protect the wiring. This is a safety issue especially due to no lock on the box cover. The wires are exposed. A child or person can be shocked if wires are tampered with which may result in a death or injury. Recommend a qualified electrician correct and repair for safety.

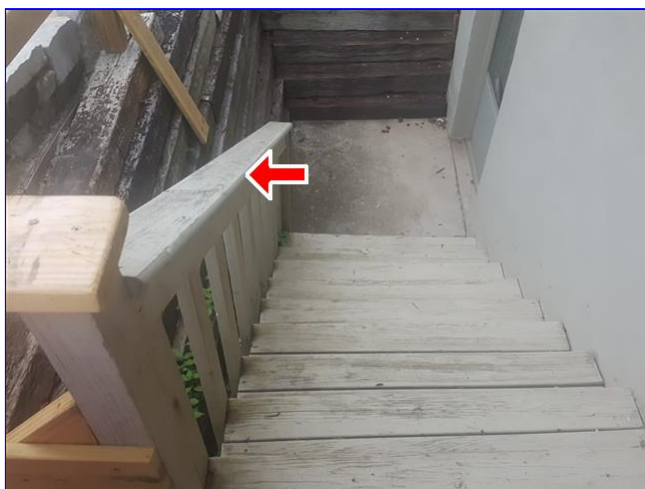
3.5 Item 5(Picture)

(3) 2x6s are installed for handrails for the basement staircase at the left side of the home and are not considered "gripable" by industry standards. This is a safety issue and an injury could occur if not corrected. Recommend that a standard approved handrail be installed for safety by a general contractor.

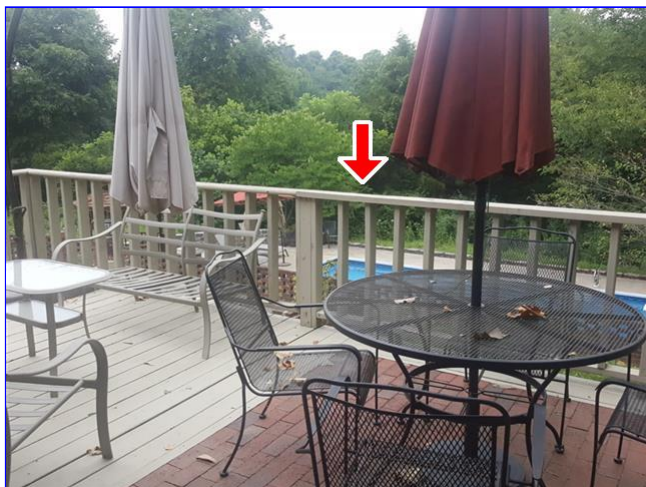
3.6 Item 5(Picture)

(3) The guard rail for rear deck is loose, unstable and not secured properly. This is extremely dangerous and is a major safety concern. It may fail under a medium or heavy force or if someone was pushed against or was leaning on the railing. For your safety it should be strengthened and secured. Recommend a qualified contractor repair as needed before closing.

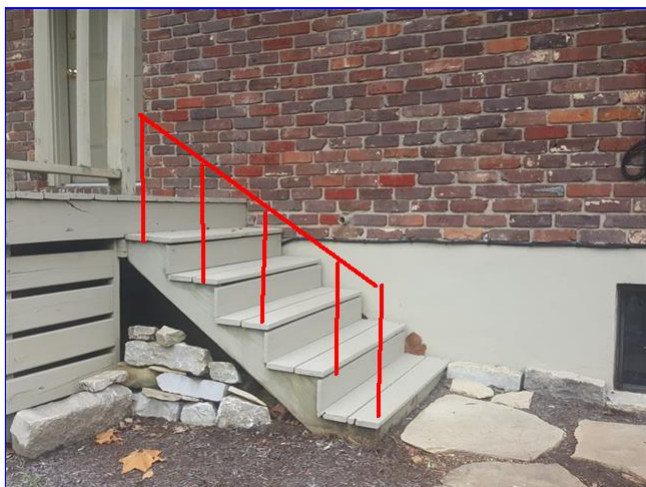
3.6 Item 7(Picture)

(4) Recommend a guard rail be installed for the staircase at the rear right side of the home to prevent a fall from occurring which may result in an injury of a person. This is a potential safety issue. The railing needs to be at least 36 inches high and balusters need spacing to be at least 4 inches. Recommend a qualified contractor install one for safety.

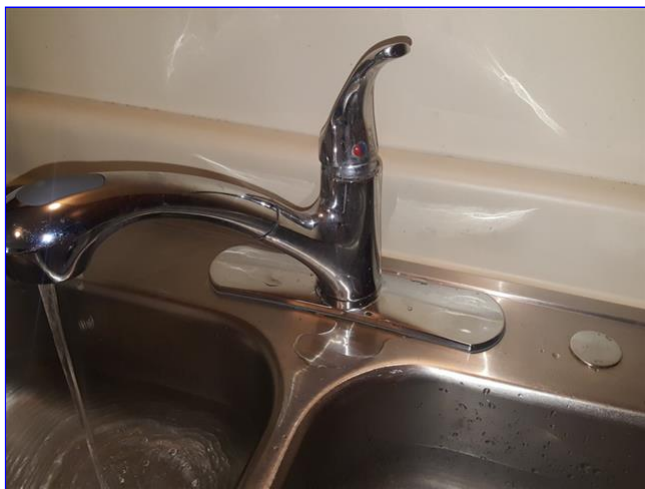
5.0.B Item 1(Picture)

(1) The hot and cold water lines are connected to the faucets at the sink in reverse from there normal positions in the basement kitchen. This could result in scalding burns. Recommend they be changed to the accepted normal locations with the cold water valve on the right side of the fixture. Recommend a licensed plumber correct as needed.

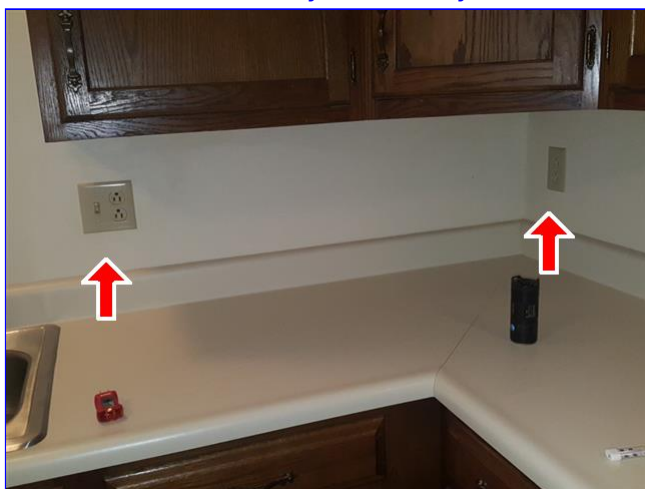
5.6.B Item 1(Picture)

(2) The outlets in the basement kitchen are not GFCI protected. GFCI (Ground fault circuit interrupters) outlets should be considered for installation as a safety upgrade in all locations where water is present if the outlets are not presently connected to a GFCI. They are now required in all bathrooms, kitchen, unfinished basements, garages, exterior outlets, or other locations within 6' of a water source or sink. GFCI outlets may not have been required when this house was built but should be considered for safety. Personally recommend a licensed electrician replace as needed.
