CONEJOS RIVER DIVERSION INFRASTRUCTURE INVENTORY

Structure Name: JM ESPINOSA D

Date: April 15, 2019

Conejos River Stream
Management Plan

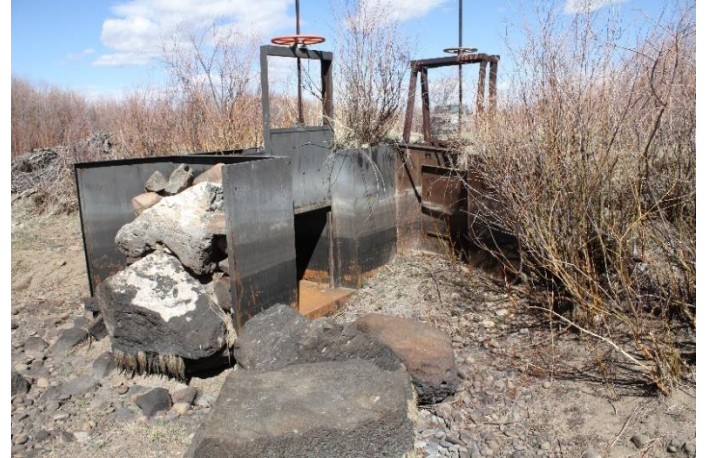
Headgate and sluice gate

Structure Description: Located on the North Branch of the Conejos River. A rock diversion dam directs water to the headgate, which is located on the east bank of the channel. The headgate is located near the downstream end of a bend in the river. The sluice gate was recently replaced.
