Sand Dollar Home Inspections

Your Property Inspection Report

1234 Main St, Anywhere, FL 33767 Inspection prepared for: Steve Miller Date of Inspection: 4/28/2016 Time: 9am Age of Home: 25 Weather: 70 degrees, Dry

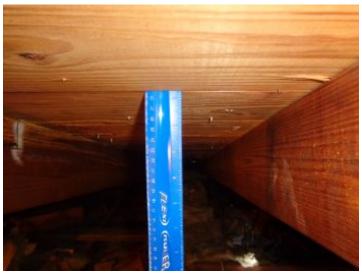
Garage, Basement & Attic Attic

- Cellulose Insulation
- Insulation averages 3 to 4 inches. Recommend installing more.
- 75% of homes have animal or insect activity and recommend an evaluation by a licensed exterminator.

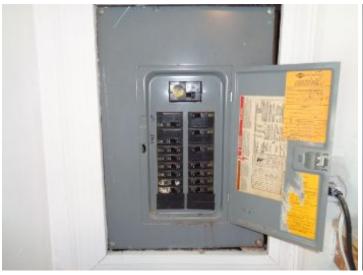
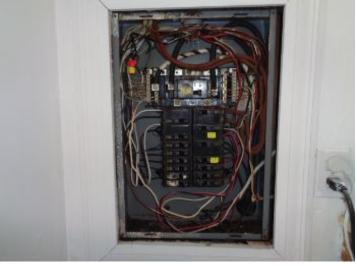
Electric, Heat, Water Heater Electrical Panel

- Double tapped breaker(s) inside panel box (more than one electrical conductor attached). This is not standard practice, and may cause overheating or even an electrical fire. Recommend evaluation by an electrician. Double tapping and lugging can create hot spots on breakers and neutral bars because they are not tightened to the correct torque--especially if two different size conductors are used. Because the hot [black] and neutral [white]wires are both current carrying conductors, the chance is then greater for potential hot spots. If the **double tap** or lug becomes loose, it begins to arc. As it arcs it builds up carbon. Carbon is then resistance and with more carbon buildup the more difficult it is for the conductor to make contact, thus increasing the current. The end result can be the breaker tripping because of the loose connection [current exceeding the rating of the breaker], or signs of overheating such as discolored wires, melted wires, etc, or even fire.

- Dirt or rust buildup inside panel box.
- Recommend having breaker connections evaluated by a licensed electrician.

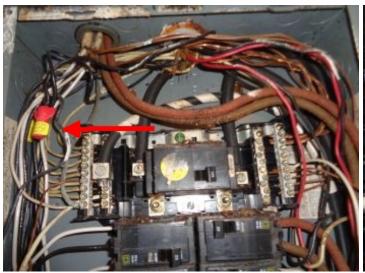
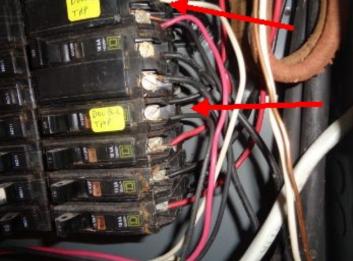
Electric, Heat, W	/ater Heater	
Page 6 Item: 1	Electrical Panel	• Double tapped breaker(s) inside panel box (more than one electrical conductor attached). This is not standard practice, and may cause overheating or even an electrical fire. Recommend evaluation by an electrician. Double tapping and lugging can create hot spots on breakers and neutral bars because they are not tightened to the correct torqueespecially if two different size conductors are used. Because the hot [black] and neutral [white]wires are both current carrying conductors, the chance is then greater for potential hot spots. If the louble ap or lug becomes loose, it begins to arc. As it arcs it builds up carbon. Carbon is then resistance and with more carbon buildup the more difficult it is for the conductor to make contact, thus increasing the current. The end result can be the breaker tripping because of the loose connection [current exceeding the rating of the breaker], or signs of overheating such as discolored wires, melted wires, etc, or even fire. • Dirt or rust buildup inside panel box. • Recommend having breaker connections evaluated by a licensed electrician.

Pigtail double tap

Double Taps

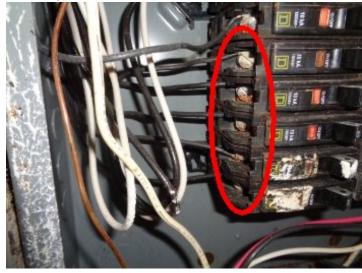
Corrosion

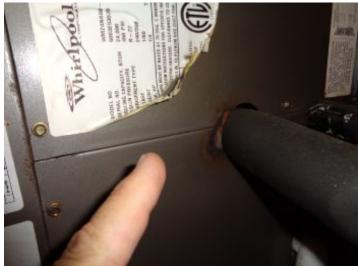
Page 7 Item: 2	HVAC Unit	• Burn marks on the outside of unit, have a licensed HVAC Technician further evaluate.
Page 9 Item: 3	Water Heater	• Temperature – Pressure drain line is missing. One should be installed to terminate within six inches of the floor to minimize personal injury which may be caused by scalding water, in the event of a pressure blow-off.

- No Smoke Detector in vicinity.
 Burn marks on the outside of unit, have a licensed HVAC Technician further evaluate.

HVAC exterior burning

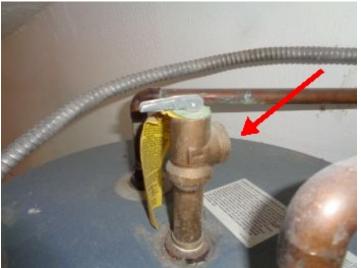
• Temperature – Pressure drain line is missing. One should be installed to terminate within six inches of the floor to minimize personal injury which may be caused by scalding water, in the event of a pressure blow-off.

Missing Drain Pipe
