CONEJOS RIVER

DIVERSION INFRASTRUCTURE INVENTORY

Structure Name: RICHFIELD CANAL

Date: April 16, 2019

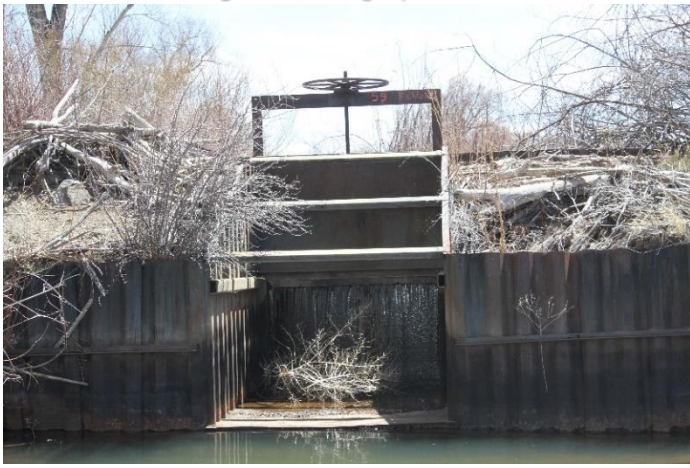
Headgate looking upstream

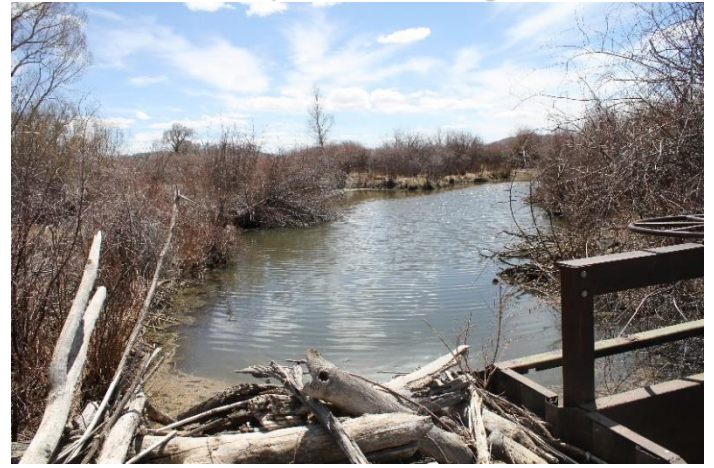
Ditch upstream of headgate

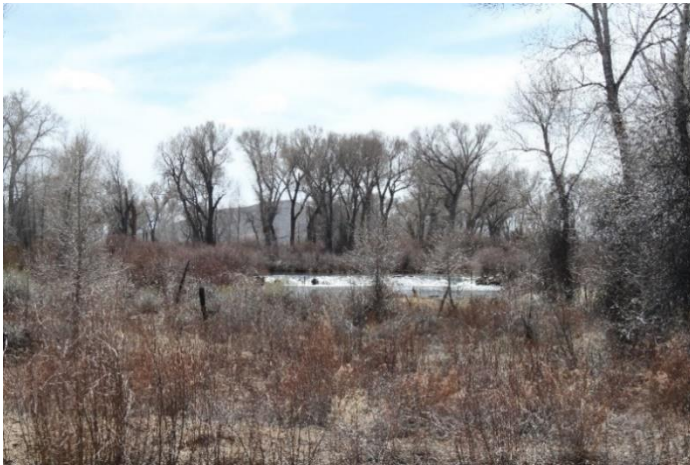
Diversion dam at confluence of Rio San Antonio and South Branch Coneos River

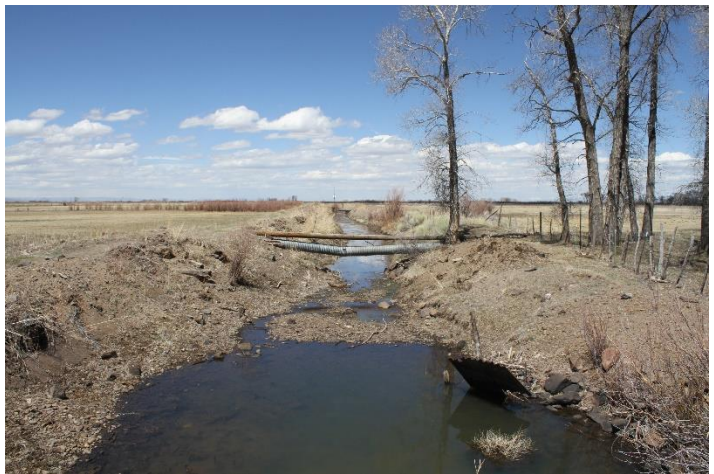
Ditch downstream of headgate

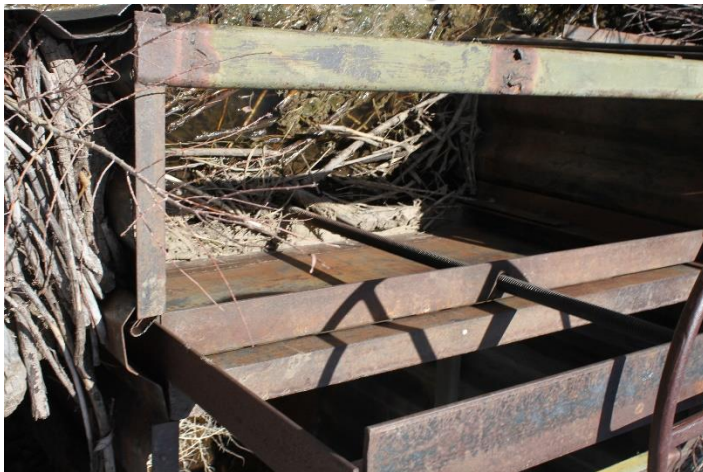
Debris at headgate

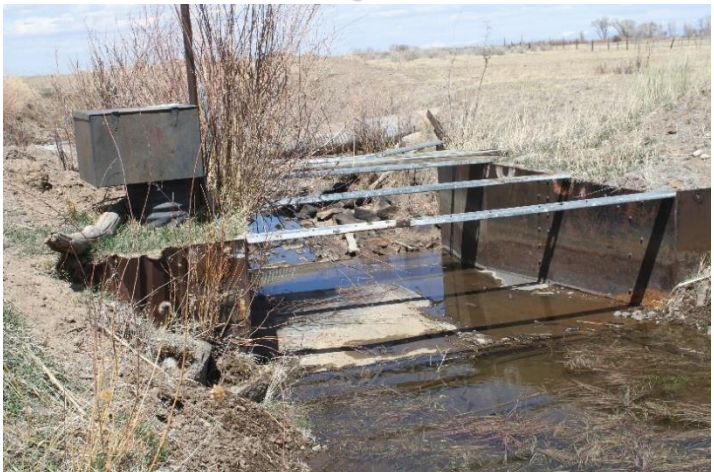
Flume looking downstream
