MINIMUM INSPECTION PROCEDURAL GUIDELINES FOR BUILDING ELECTRICAL RECERTIFICATION

Table with 1 column and 13 rows containing structure details: a. Name on Title: Village at Dadeland Condominiums (K), b. Street Address: 7400 SW 82nd St. Miami, Florida 33143, c. Legal Description: Village at Dadeland Condominiums, d. Owner's Name: Village at Dadeland Condominiums, e. Owner's Mailing Address: 7400 SW 82nd St. Miami, Florida 33143, f. Folio Number of Property on which Building is Located: 30-4035-047-XXXX, g. Building Code Occupancy Classification: R2 - Residential, h. Present Use: Condominium, Residential, i. General Description, Type of Construction, Size, Number of Stories, and Special Features. Additional Comments: The condominium building was built in 1970. The 4-story twenty-four unit building at the Village at Dadeland Condominium has an approximate footprint of 175ftx50ft. Building 7400 is 1 of 2 buildings that comprise the VILLA "K" area of the community. Buildings 7410 and 7400 are linked at their east and west ends respectively and have an approximate combined footprint of 350ftx50ft. Two stair/elevator towers are located on their south front elevation and provide access to

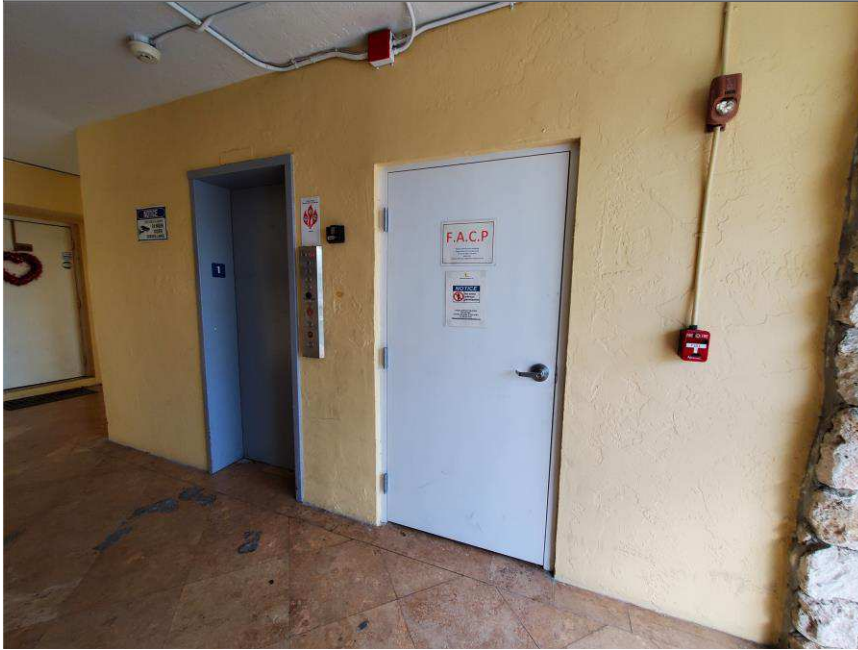
Photo 1 – Village at Dadeland Condominium Association

Existing Electrical Room - 1st FL
No Storage Permitted

Building Number sign is missing.

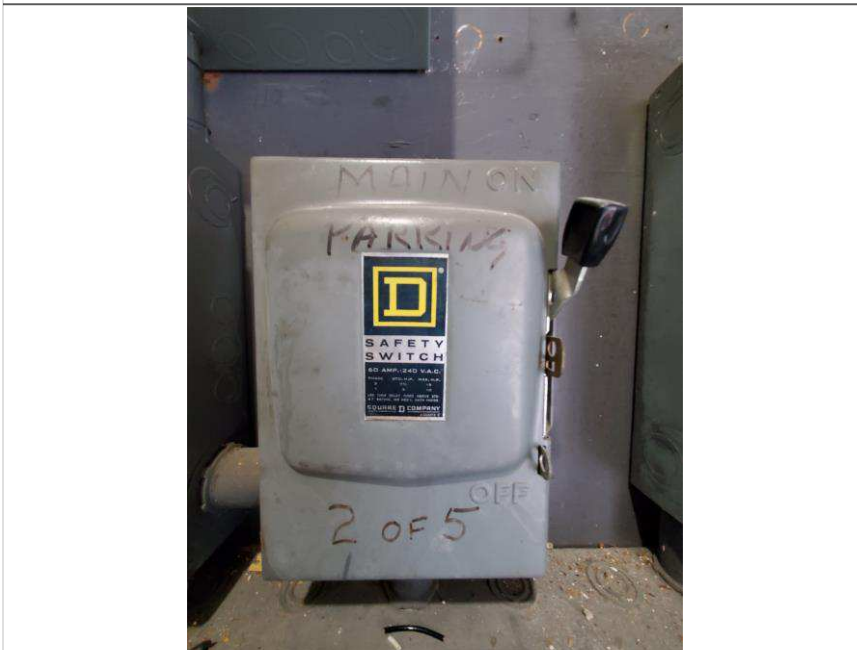
Photo 4 – Village at Dadeland Condominium Association

Existing Electrical Room - 1st FL
House Main Disconnect 2 of 5
is a 50 year old electrical
component.

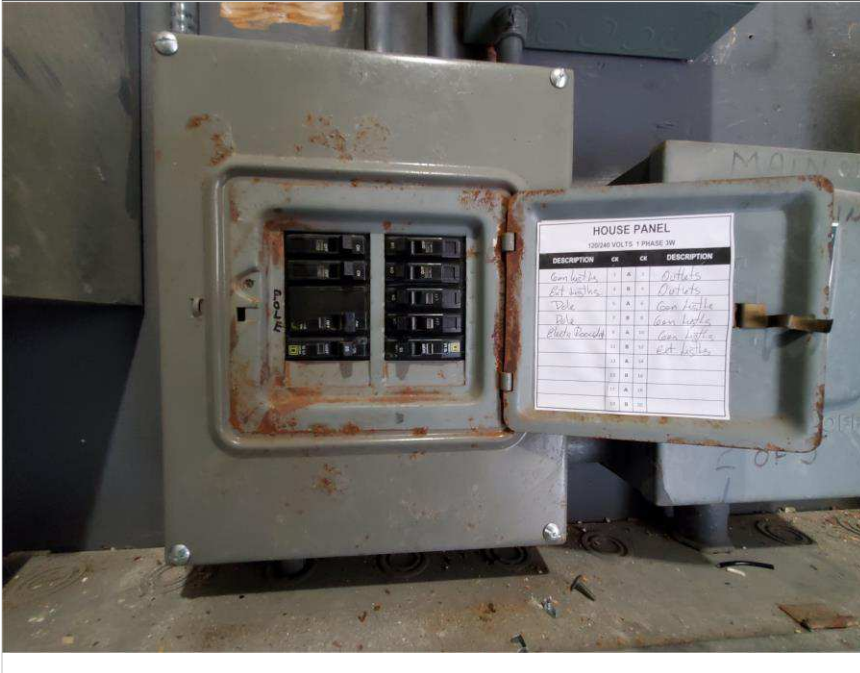
Photo 5 – Village at Dadeland Condominium Association

Existing Electrical Room - 1st FL
House Panel Board #1.

Old and oxidized house panel.

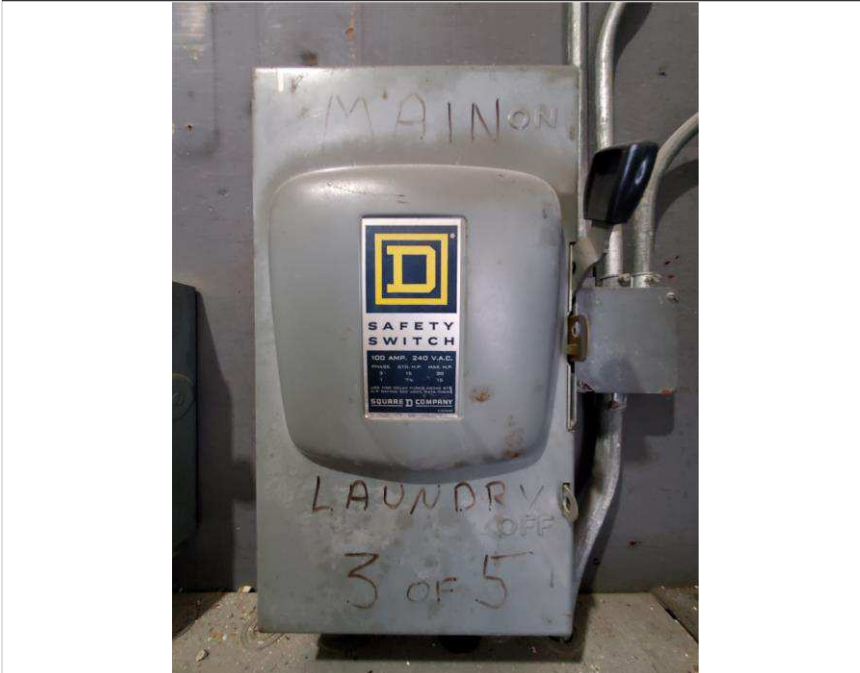
Photo 6 – Village at Dadeland Condominium Association

Existing Electrical Room - 1st FL
House Main Disconnect 3 of 5
is a 50 year old electrical
component.

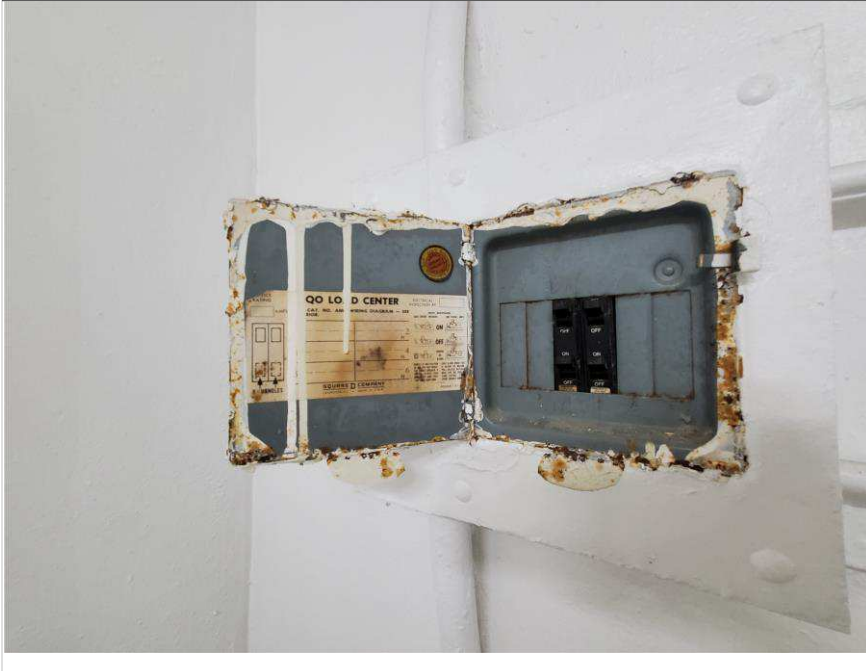
Photo 7 – Village at Dadeland Condominium Association

1st FL - Laundry/Water Heater Room: Typical House Laundry Panel Board 1 of 4 Laundry Panel Boards

Old and oxidized panel.

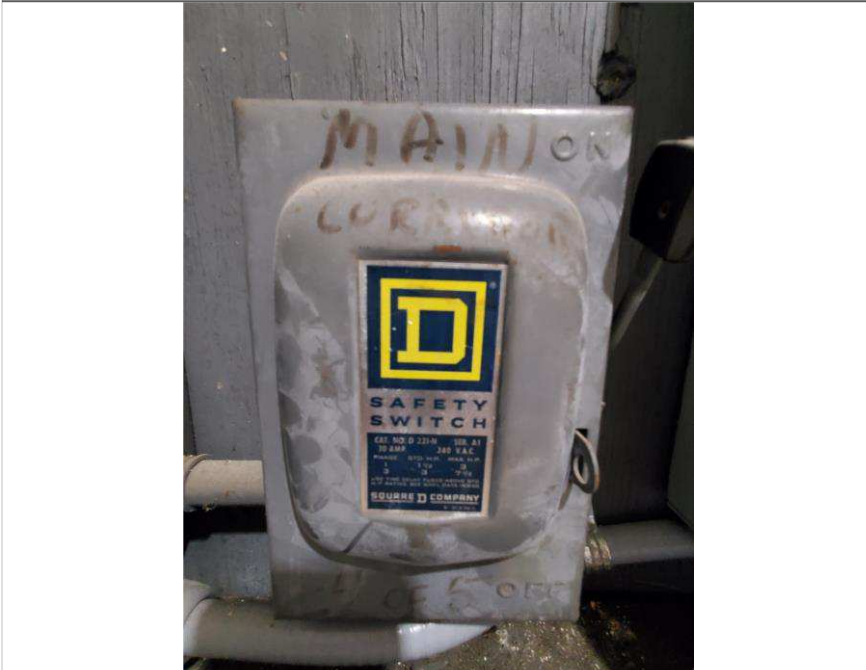
Photo 8 – Village at Dadeland Condominium Association

Existing Electrical Room - 1st FL House Main Disconnect 4 of 5 is a 50 year old electrical component.

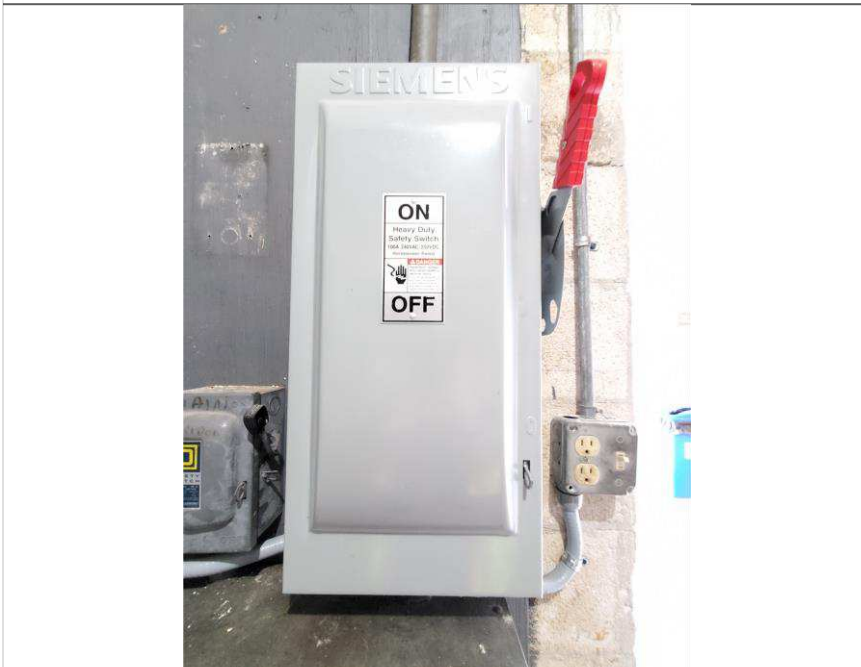
Photo 10 – Village at Dadeland Condominium Association

Existing Electrical Room - 1st FL
Elevator Disconnect Switch

Not properly identified.

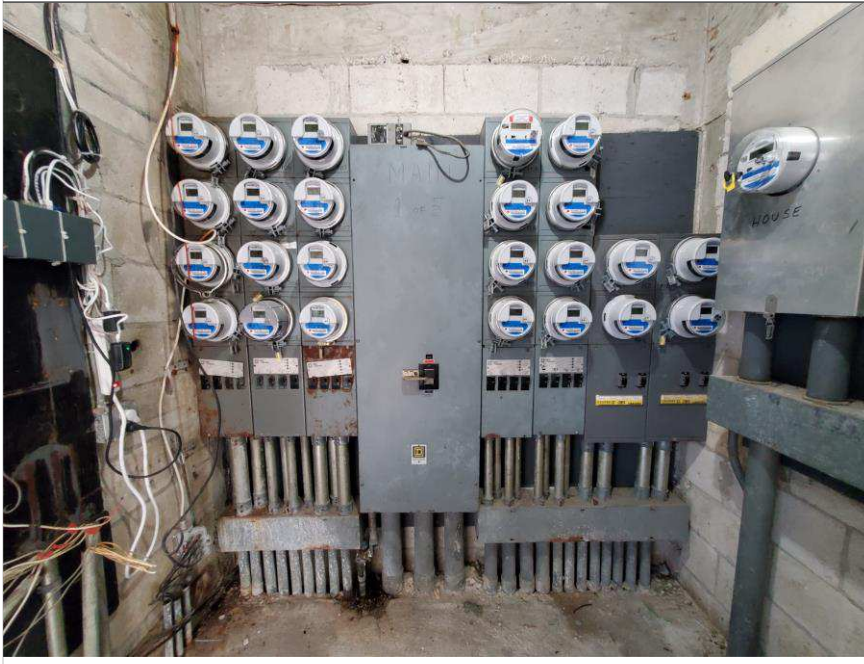
Photo 11 – Village at Dadeland Condominium Association

Existing Electrical Room - 1st FL
Main Switches and Meters

Old and oxidized meter stacks,
breakers, and gutters.

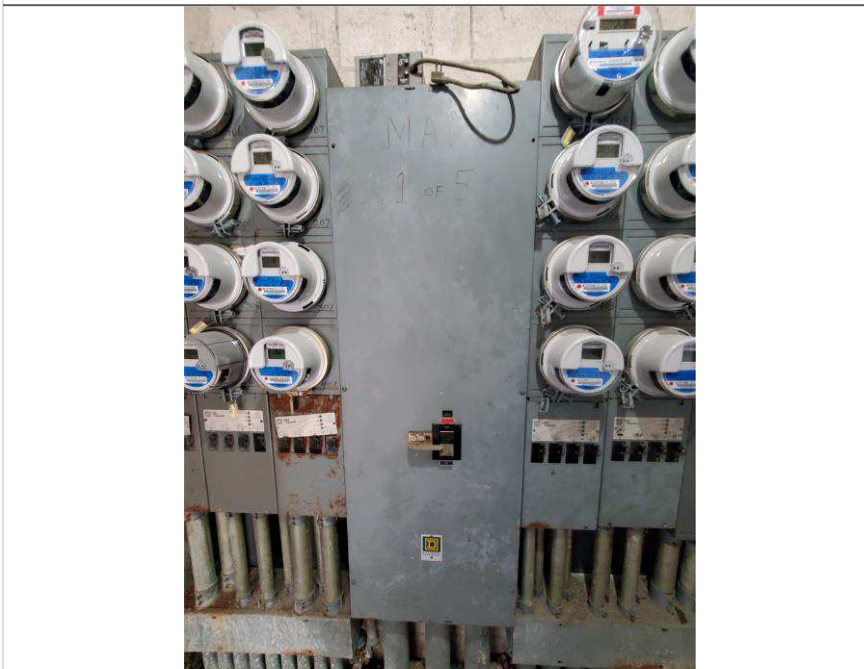
Photo 12 – Village at Dadeland Condominium Association

Existing Electrical Room - 1st FL
Main Disconnect Switch
1 of 5

Breakers not properly set in
meter stacks.

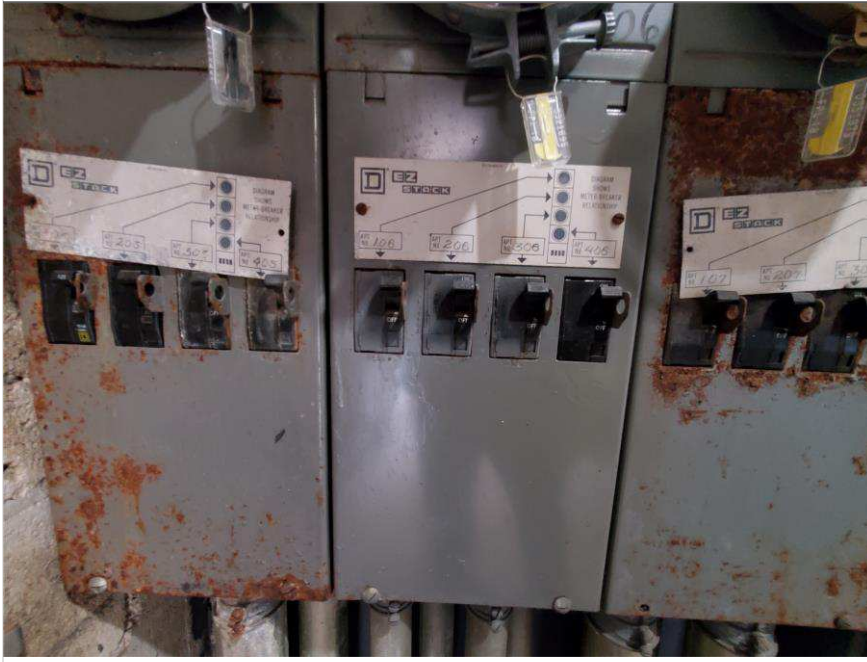
Photo 13 – Village at Dadeland Condominium Association

Existing Electrical Room - 1st FL
Apartment Meters and Main
Switches

Old and oxidized meter stacks

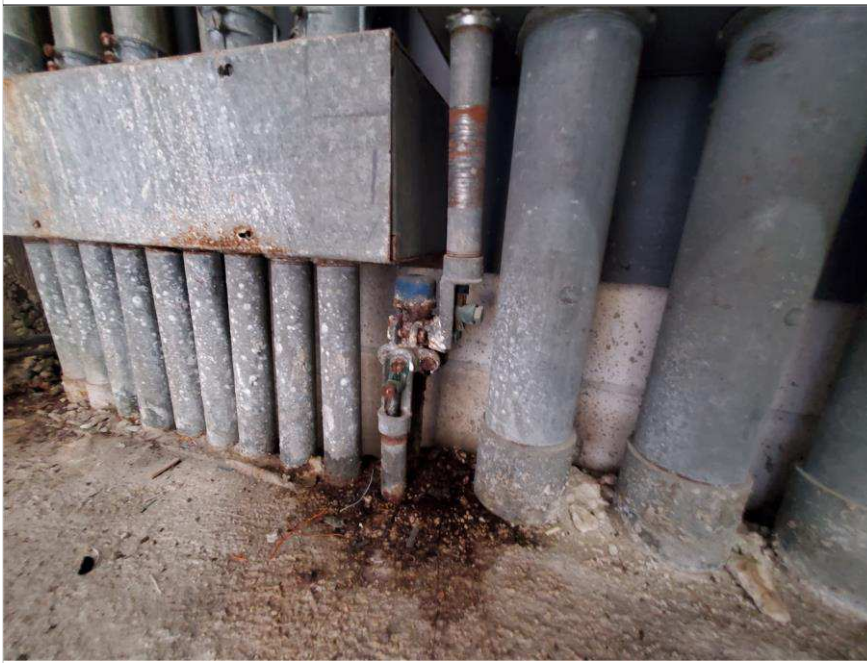
Photo 14 – Village at Dadeland Condominium Association

Existing Electrical Room - 1st FL
Main Service – Grounding

Grounding resistance to be
tested to determine if repairs
and/or maintenance are
required.

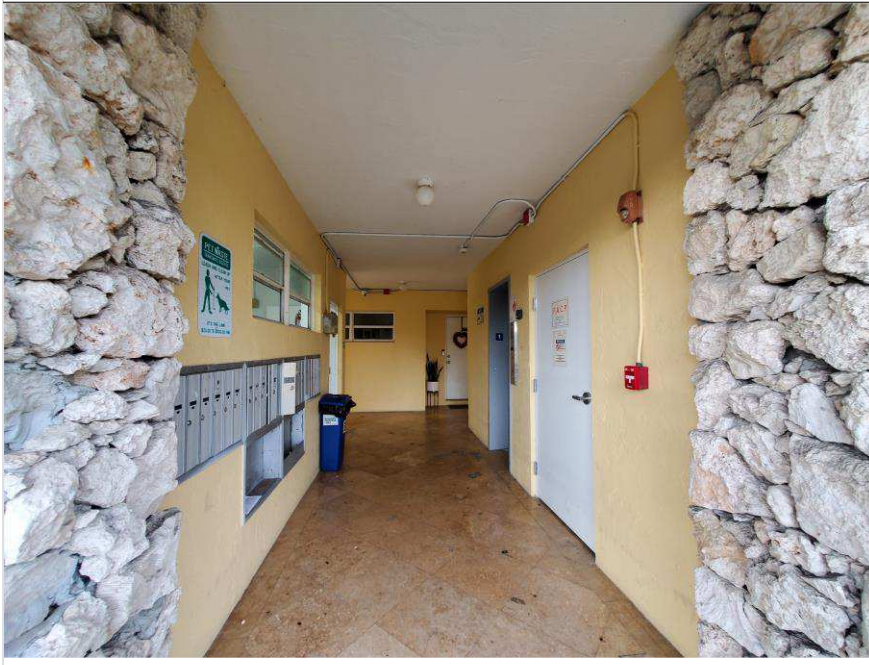
Photo 16 – Village at Dadeland Condominium Association

Level 1
Fire Alarm - Old and Weathered
Fire Alarm Devices

Old Strobe Horn/Strobe Device
and Pull Stations

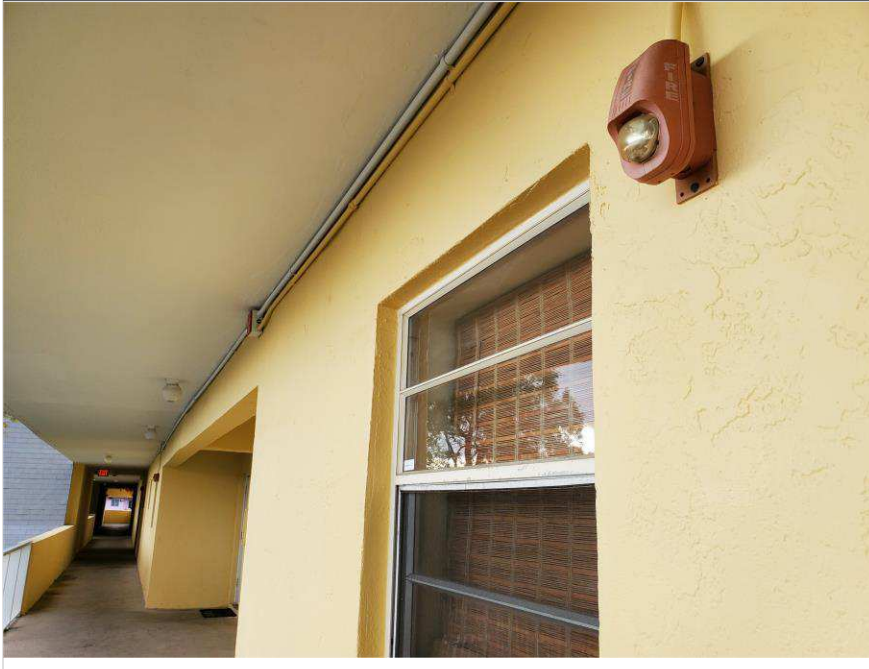
Photo 17 – Village at Dadeland Condominium Association

Level 2
Fire Alarm - Old and Weathered
Fire Alarm Devices

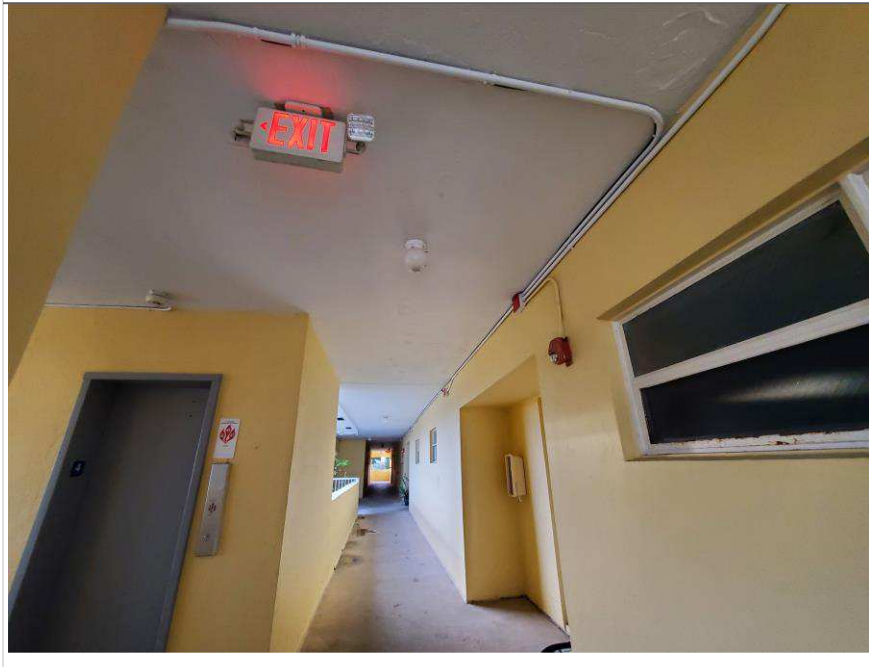
Photo 18 – Village at Dadeland Condominium Association

EM Lights Exit Lights/Signs

Old combination EM lights and
Exit Lights/Signs, typical.

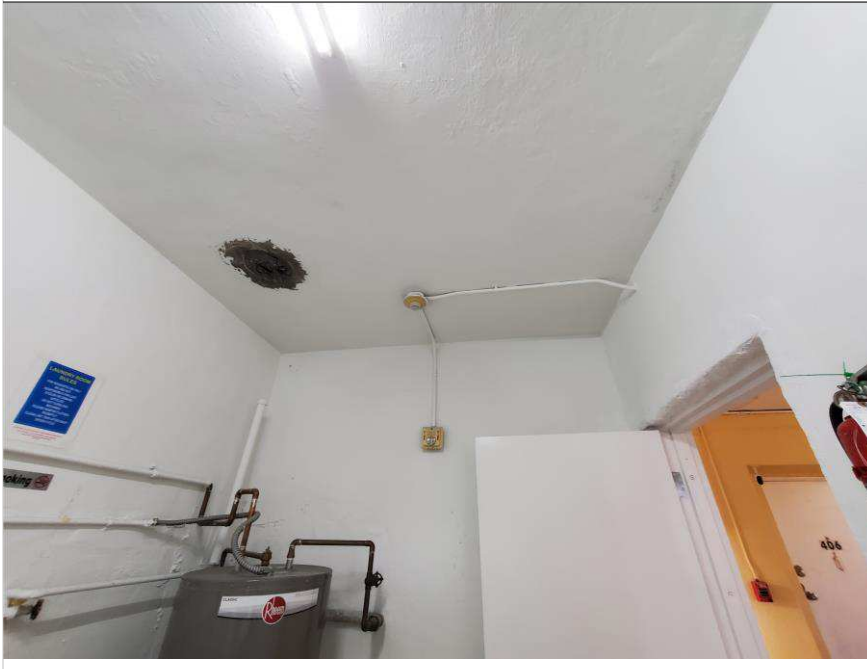
Photo 19 – Village at Dadeland Condominium Association

Laundry Room – 4th FL
Fire Alarm Devices

Old Strobe Horn/Strobe Device
In laundry rooms, typical.

Old smoke detector.

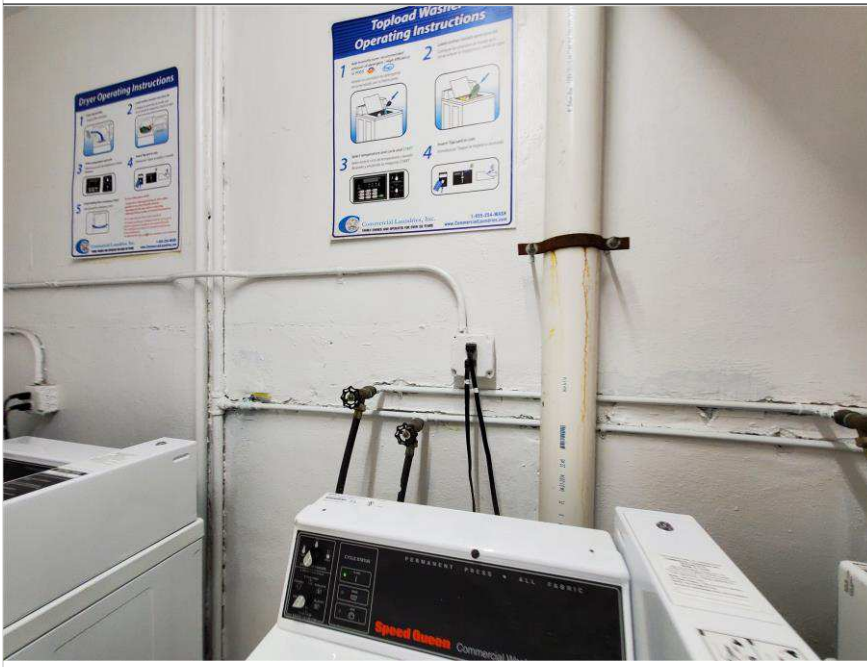
Photo 20 – Village at Dadeland Condominium Association

Laundry Room -
Outlets are not GFCI type.

18. Outlets in laundry room and water heater room are not GFCI - Repairs Required.

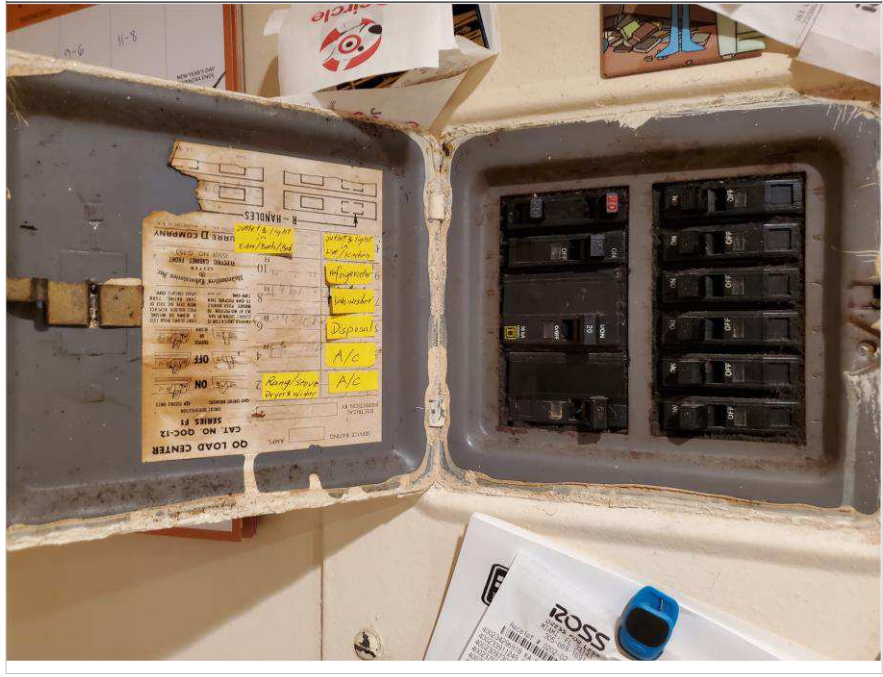
Photo 21 – Village at Dadeland Condominium Association

Apartments - Old Electrical Panels

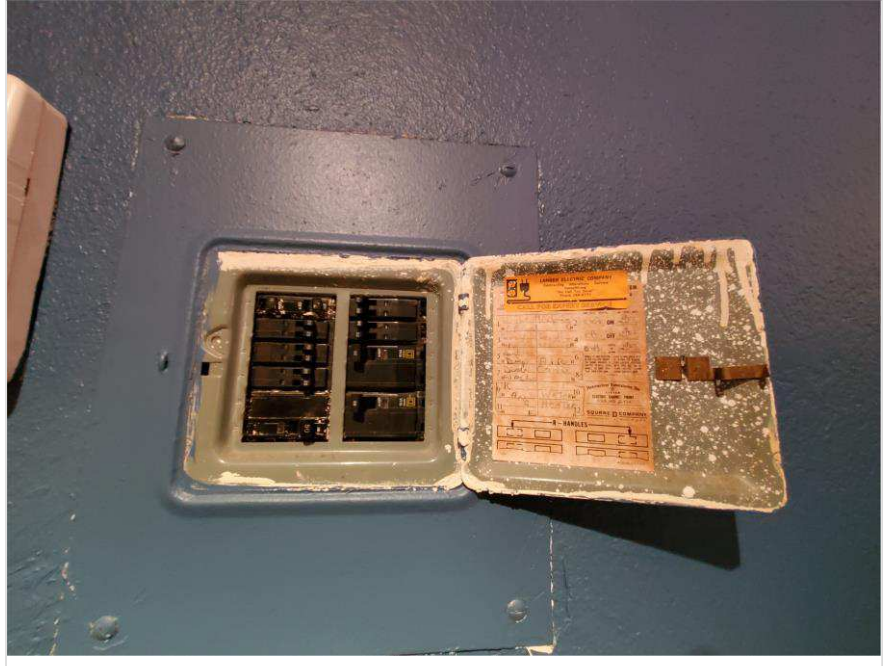
Photo 22 – Village at Dadeland Condominium Association

Apartments - Old Electrical Panels

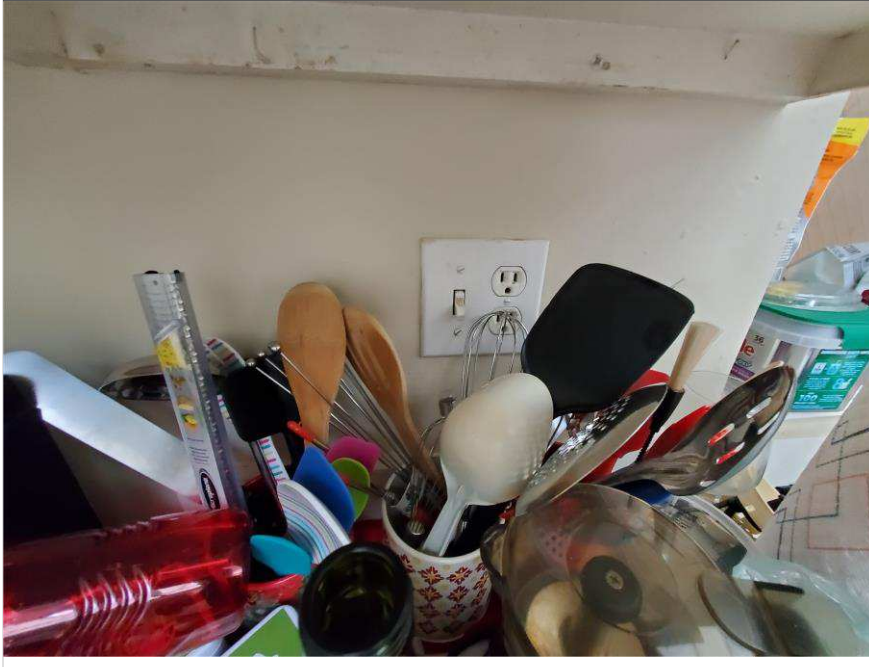
Photo 23 – Village at Dadeland Condominium Association

Apartments - Kitchen outlets
not GFCI type.

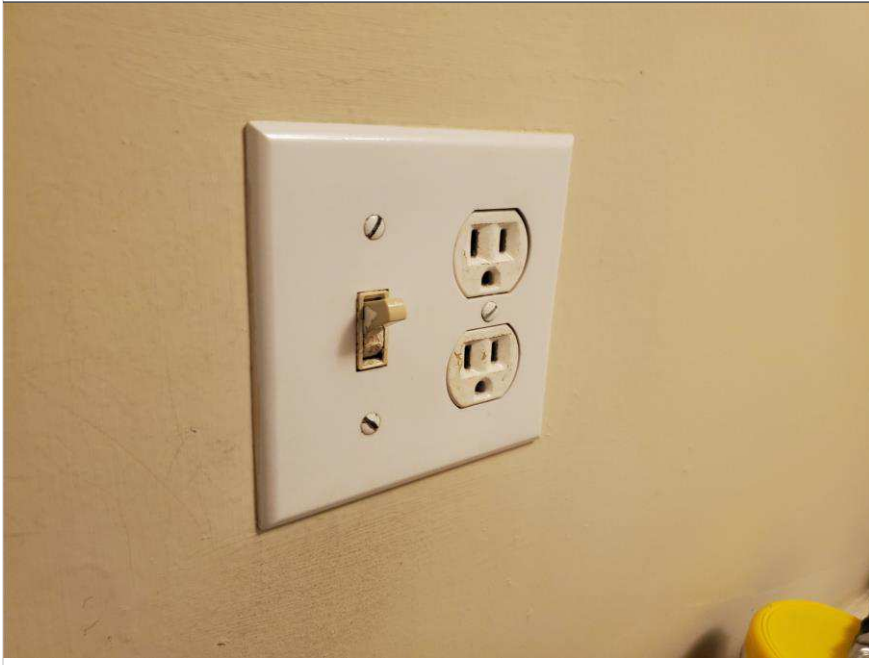
Photo 24 – Village at Dadeland Condominium Association

Apartments - Bathroom outlets
not GFCI type

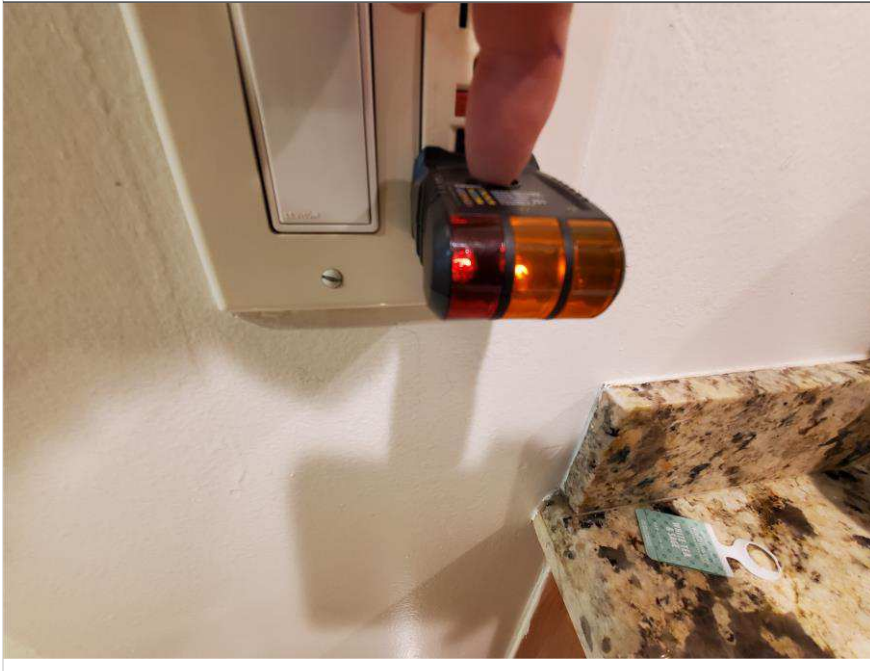
Photo 25 – Village at Dadeland Condominium Association

Apartments - Bathroom GFCI
Type outlets not properly wired.

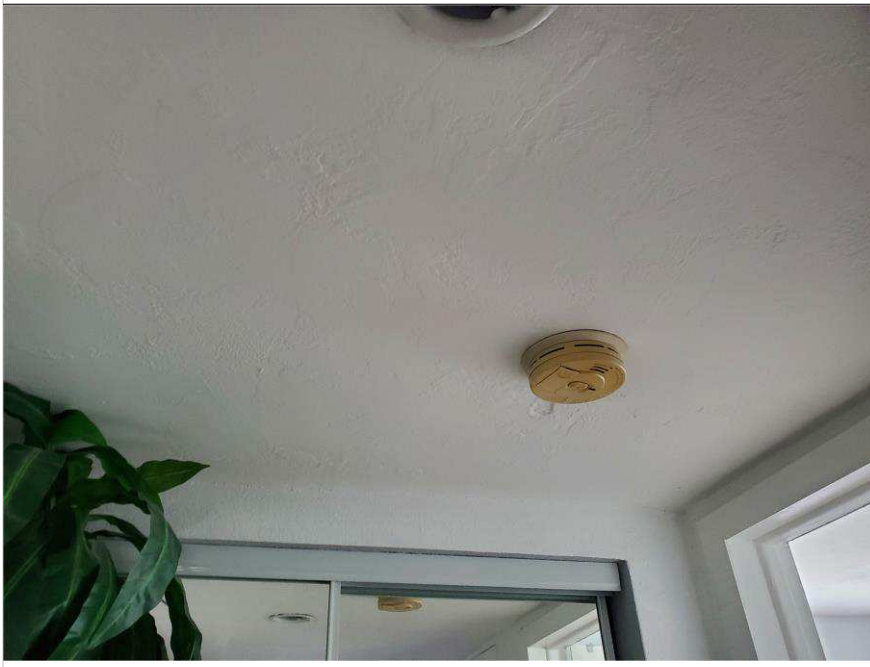
Photo 26 – Village at Dadeland Condominium Association

Apartments –
Old Smoke Detectors

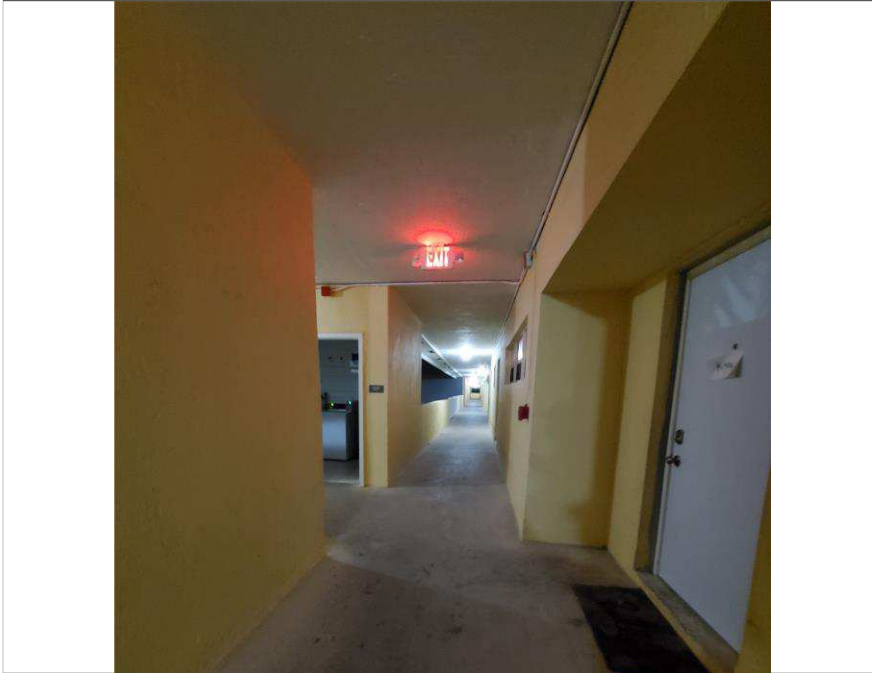
Photo 27 – Village at Dadeland Condominium Association

Points of Egress - Poorly Illuminated Building Points of Egress and Catwalks – Light Fixtures are too far apart, and some are not functioning properly.

Exterior lights not functional

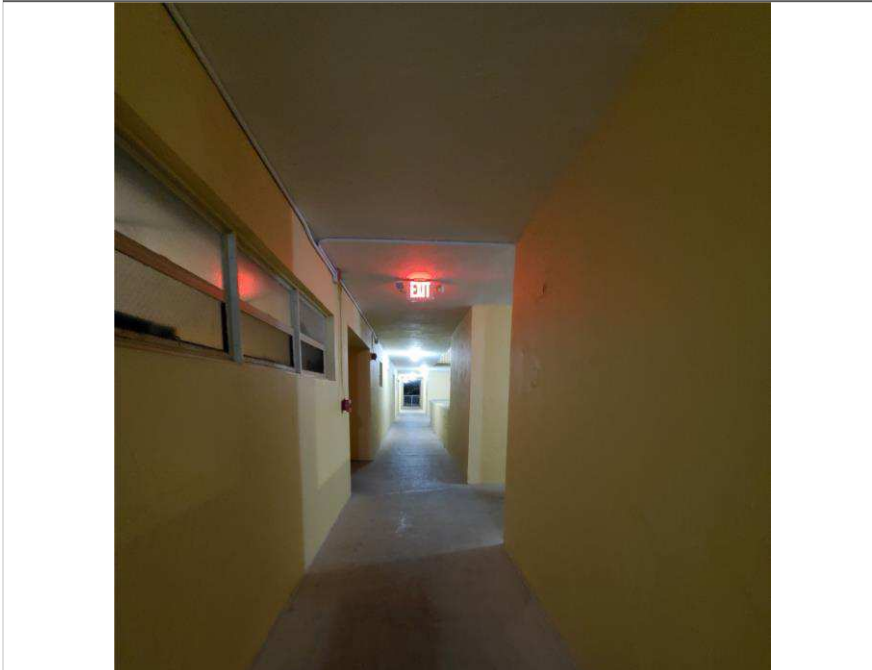
Photo 28 – Village at Dadeland Condominium Association

Points of Egress - Poorly Illuminated Building Points of Egress and Catwalks – Light Fixtures are too far apart, and some are not functioning properly.

Exterior lights not functional

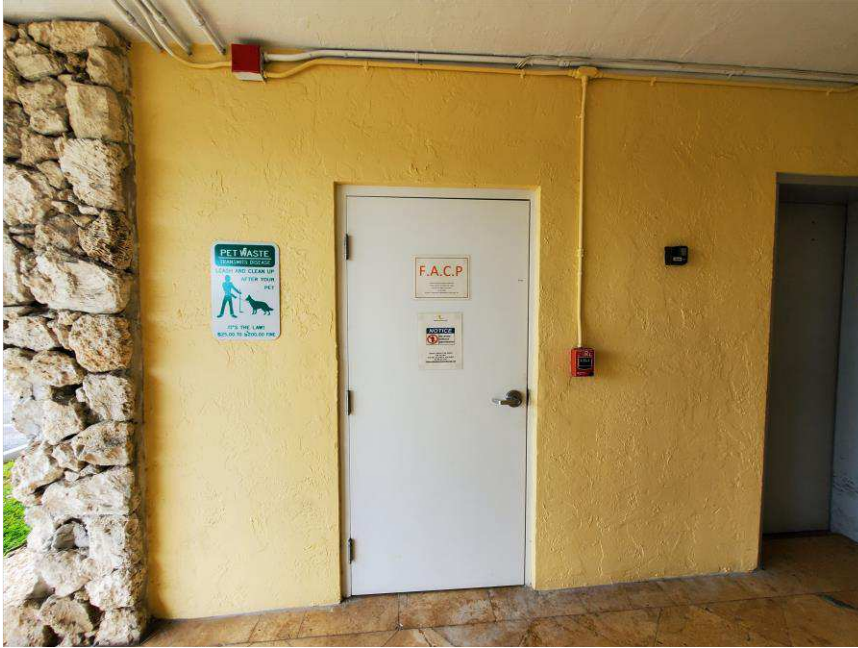
Photo 1 – Village at Dadeland Condominium Association

Existing Electrical Room - 1st FL
No Storage Permitted

Building Number sign is missing.

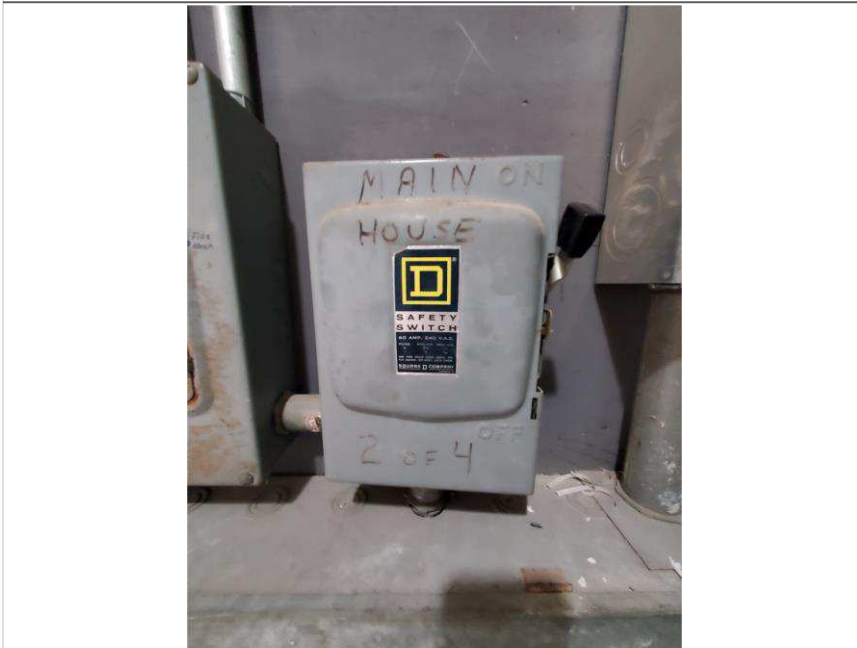
Photo 4 – Village at Dadeland Condominium Association

Existing Electrical Room - 1st FL
House Main Disconnect 2 of 4
is a 50 year old electrical
component.

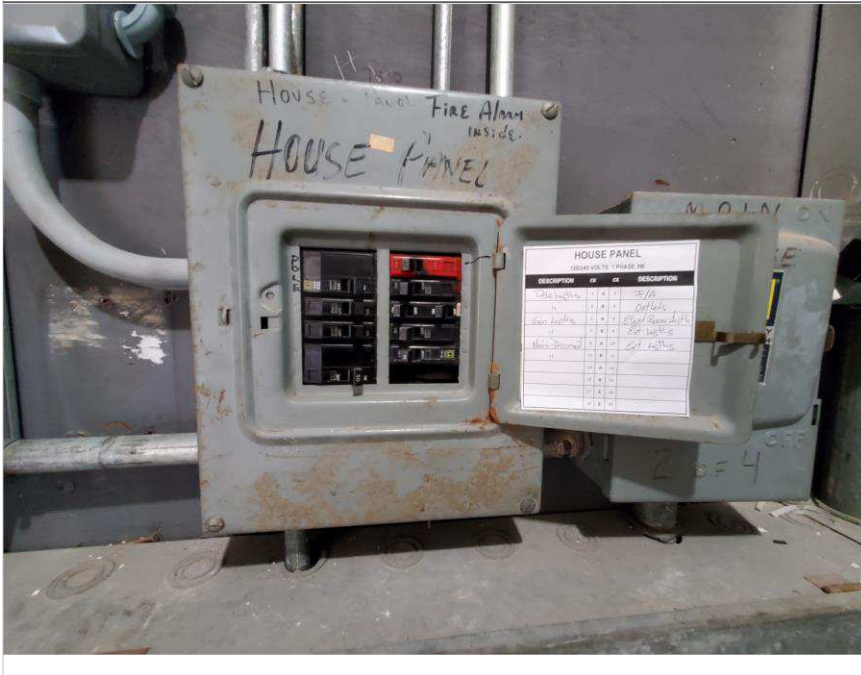
Photo 5 – Village at Dadeland Condominium Association

Existing Electrical Room - 1st FL
House Panel Board #1.

Open breaker slot.

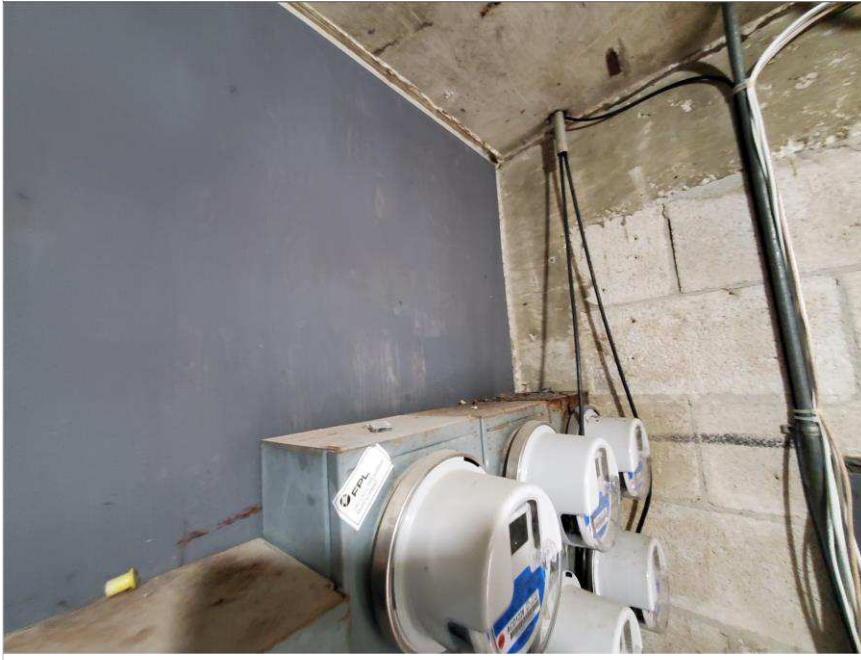
Photo 10 – Village at Dadeland Condominium Association

Existing Electrical Room - 1st FL
Main Switches and Meters

Old and oxidized meter stacks
and breakers.

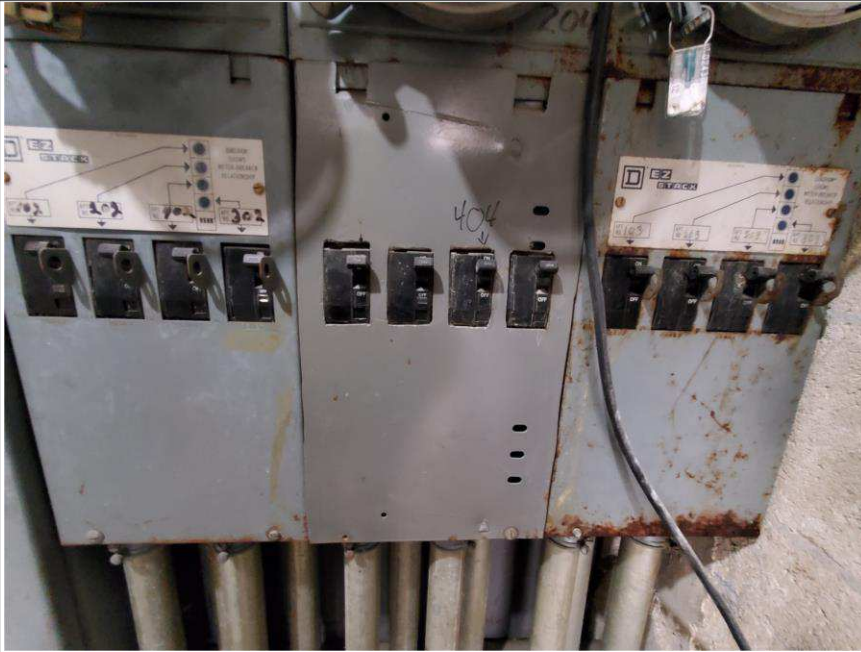
Photo 11 – Village at Dadeland Condominium Association

Existing Electrical Room - 1st FL
Apartment Meters and Main
Switches

Old and oxidized meter stacks

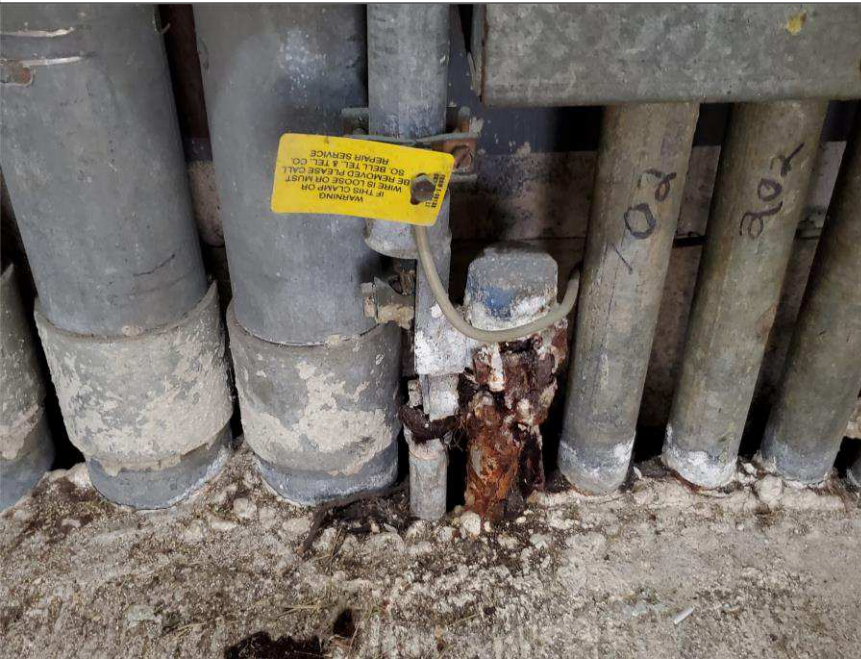
Photo 12 – Village at Dadeland Condominium Association

Existing Electrical Room - 1st FL
Main Service – Grounding

Grounding resistance to be
tested to determine if repairs
and/or maintenance are
required.

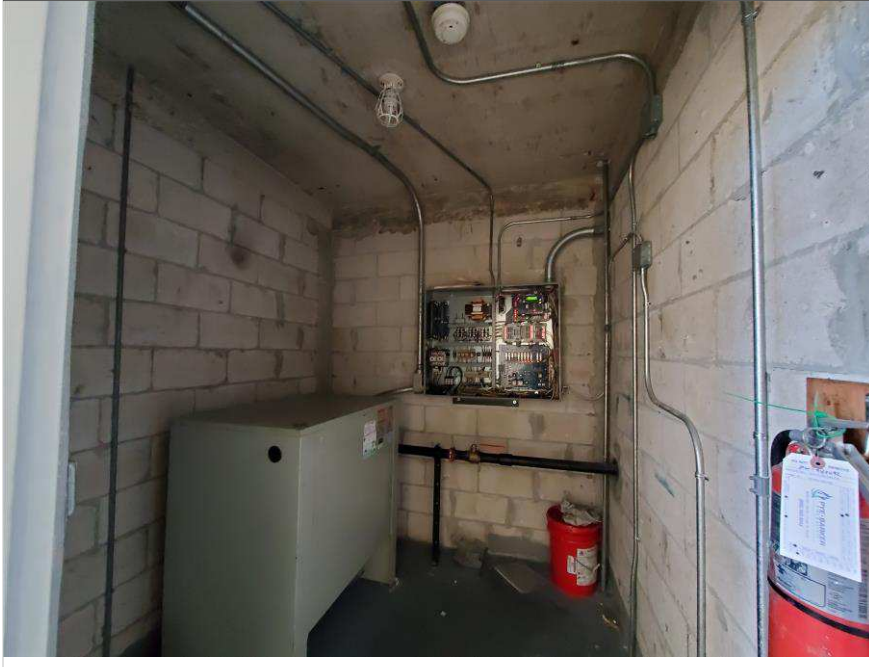
Photo 13 – Village at Dadeland Condominium Association

Elevator Machine Room -
Open Elevator Control Box

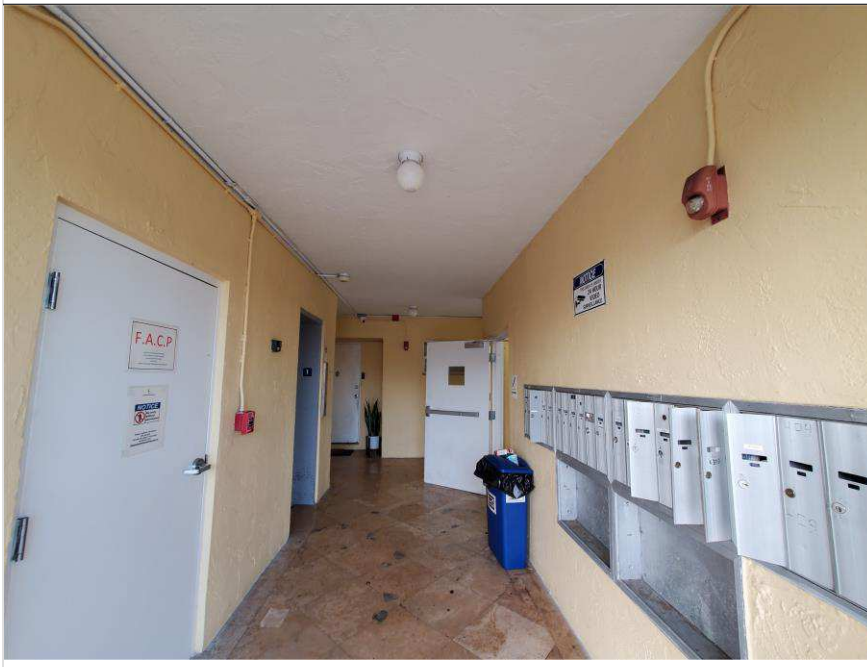
Photo 16 – Village at Dadeland Condominium Association

Level 1
Fire Alarm - Old and Weathered
Fire Alarm Devices

Old Strobe Horn/Strobe Device
and Pull Stations

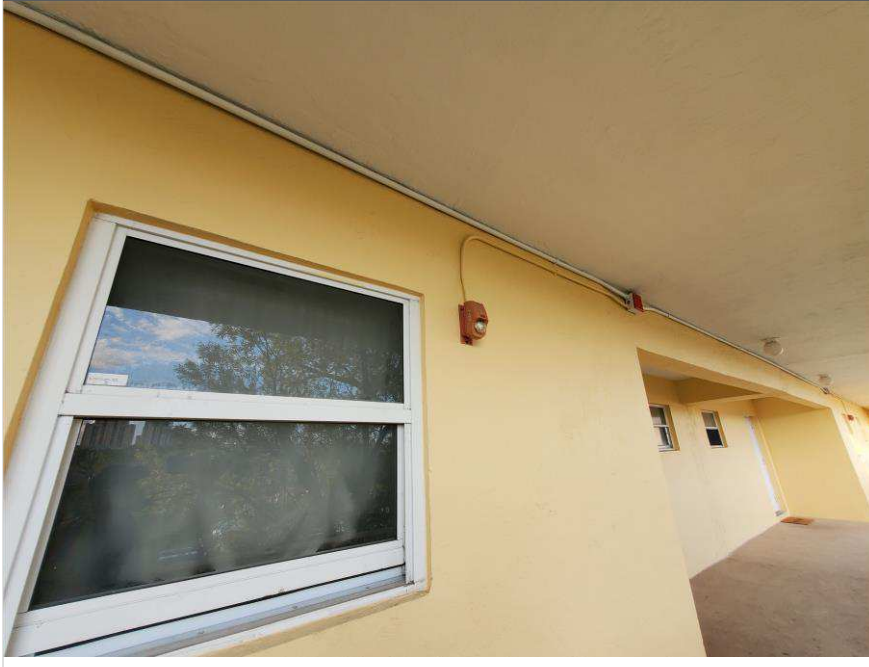
Photo 17 – Village at Dadeland Condominium Association

Level 2
Fire Alarm - Old and Weathered
Fire Alarm Devices

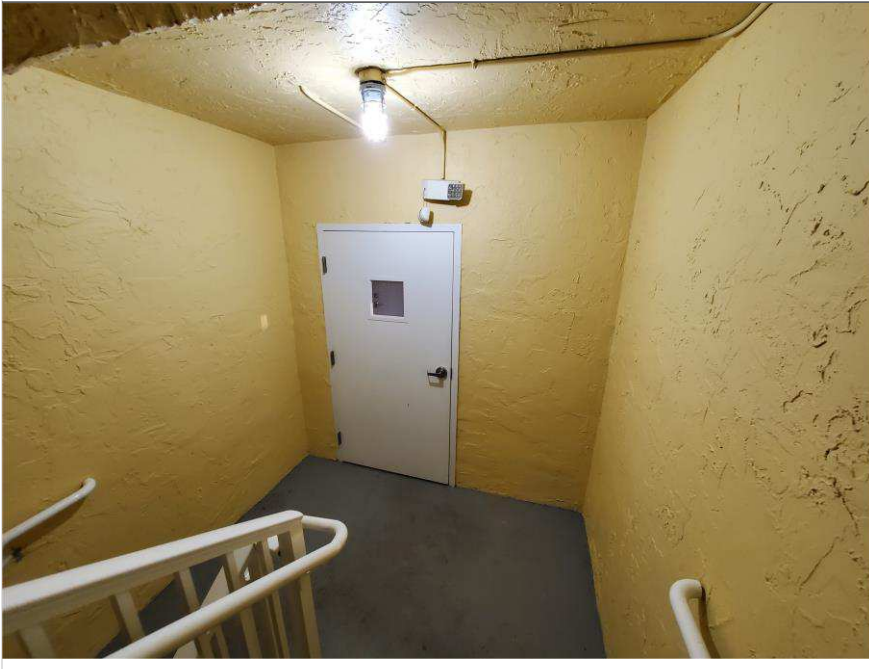
Photo 19 – Village at Dadeland Condominium Association

EM Lights/Exit Lights -

Broken EM Light in stairwell.

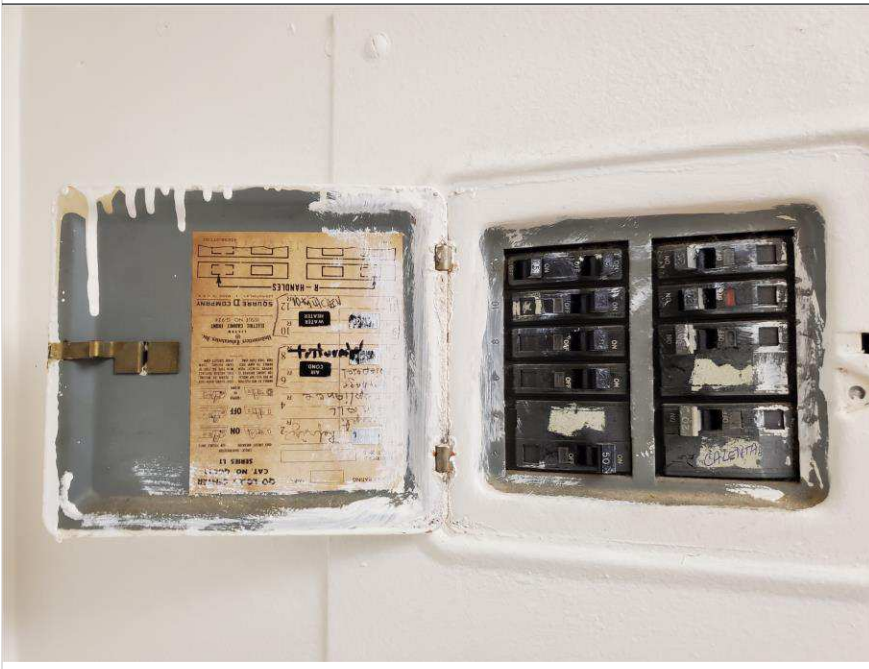
Photo 20 – Village at Dadeland Condominium Association

Apartments - Old Electrical Panels

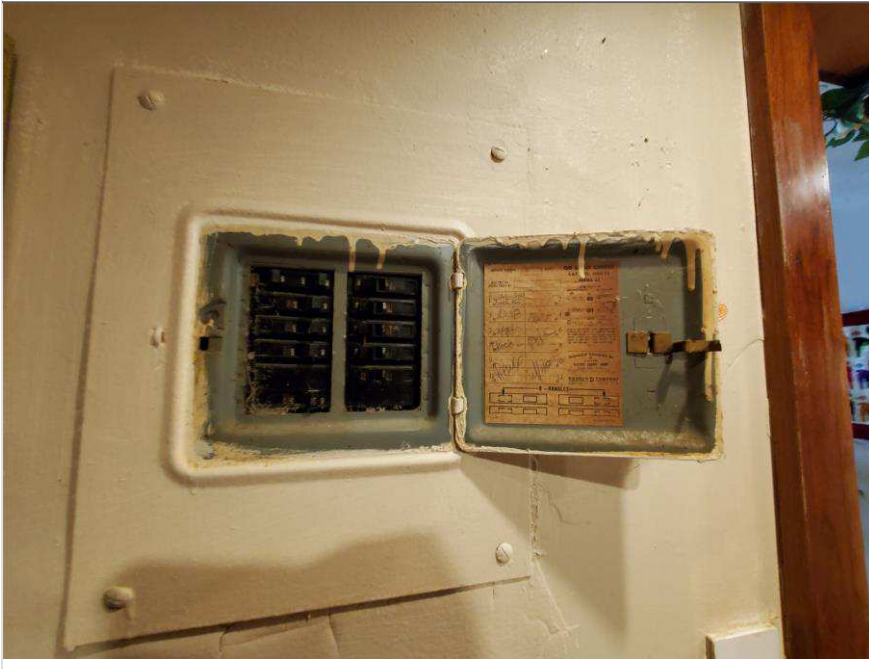
Photo 21 – Village at Dadeland Condominium Association

Apartments - Old Electrical Panels

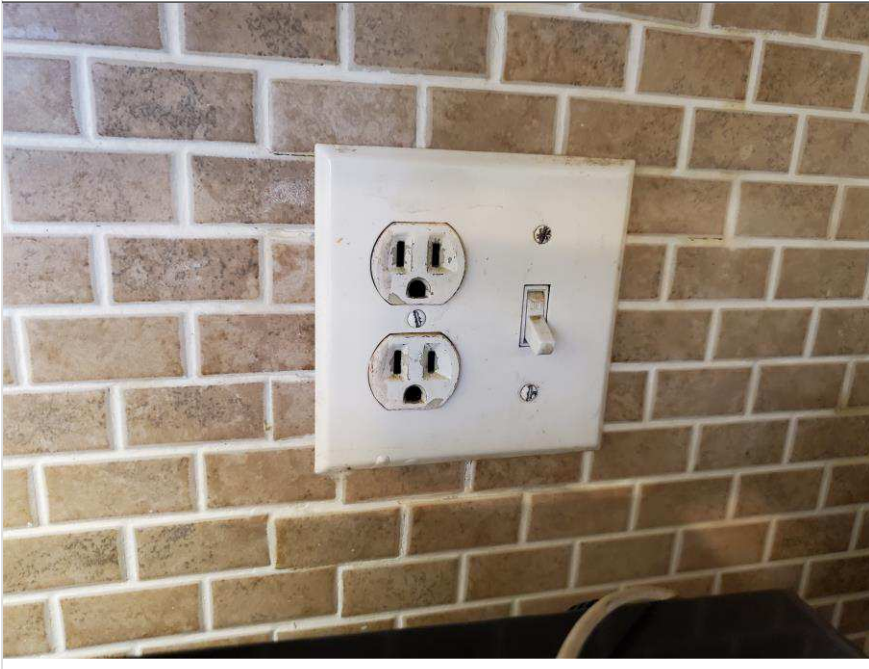
Photo 22 – Village at Dadeland Condominium Association

Apartments - Kitchen outlets not GFCI type.
