MINIMUM INSPECTION PROCEDURAL GUIDELINES FOR BUILDING ELECTRICAL RECERTIFICATION

Table with 1 column and 13 rows containing structure details: a. Name on Title: Village at Dadeland Condominiums (K), b. Street Address: 7400 SW 82nd St. Miami, Florida 33143, c. Legal Description: Village at Dadeland Condominiums, d. Owner's Name: Village at Dadeland Condominiums, e. Owner's Mailing Address: 7400 SW 82nd St. Miami, Florida 33143, f. Folio Number of Property on which Building is Located: 30-4035-047-XXXX, g. Building Code Occupancy Classification: R2 - Residential, h. Present Use: Condominium, Residential, i. General Description, Type of Construction, Size, Number of Stories, and Special Features. Additional Comments: The condominium building was built in 1970. The 4-story twenty-four unit building at the Village at Dadeland Condominium has an approximate footprint of 175ftx50ft. Building 7400 is 1 of 2 buildings that comprise the VILLA "K" area of the community. Buildings 7410 and 7400 are linked at their east and west ends respectively and have an approximate combined footprint of 350ftx50ft. Two stair/elevator towers are located on their south front elevation and provide access to

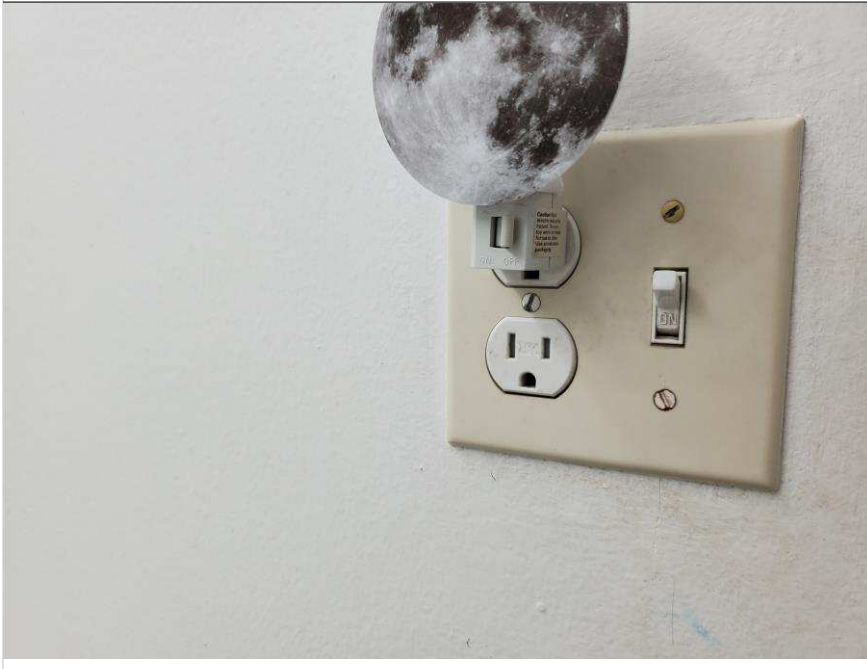
Photo 23 – Village at Dadeland Condominium Association

Apartments - Bathroom outlets
not GFCI type

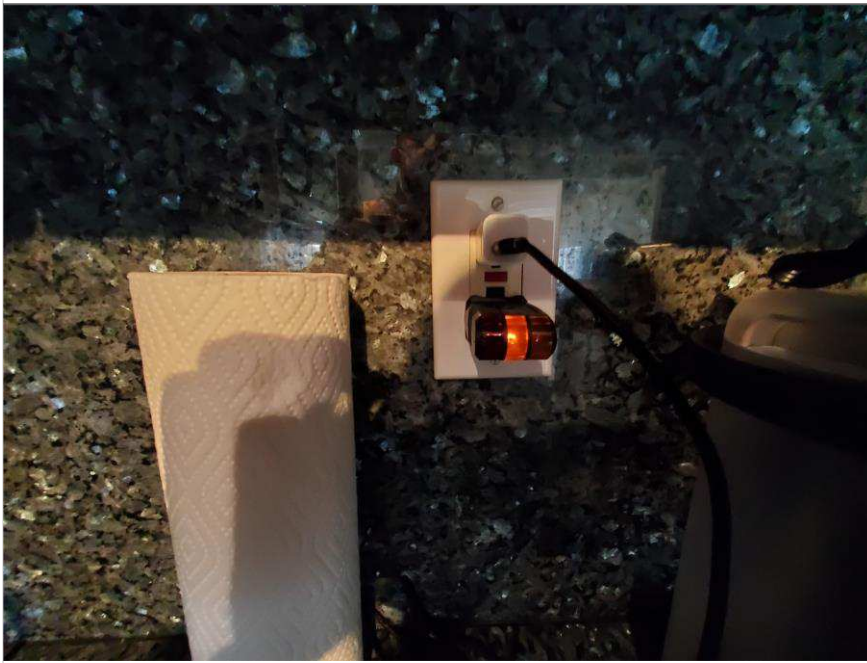
Photo 24 – Village at Dadeland Condominium Association

Apartments - Kitchen outlets
GFCI type.

GFCI type outlet is incorrectly
wired.

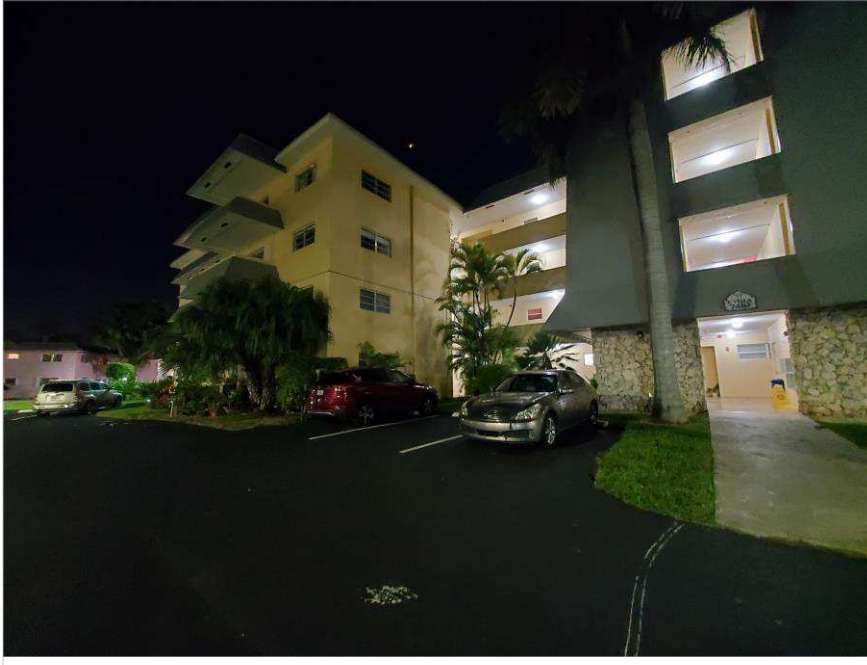
Photo 25 – Village at Dadeland Condominium Association

Parking -
Poorly illuminated sidewalks &
Parking Areas.

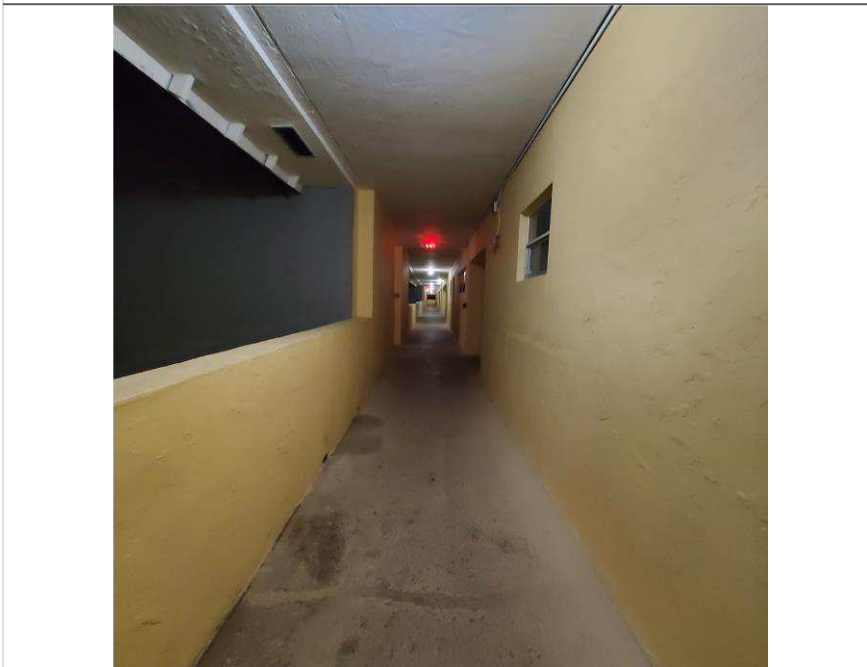
Photo 26 – Village at Dadeland Condominium Association

Points of Egress - Poorly
Illuminated Building Points of
Egress and Catwalks – Light
Fixtures are too far apart, and
some are not functioning
properly.

Exterior lights not functional

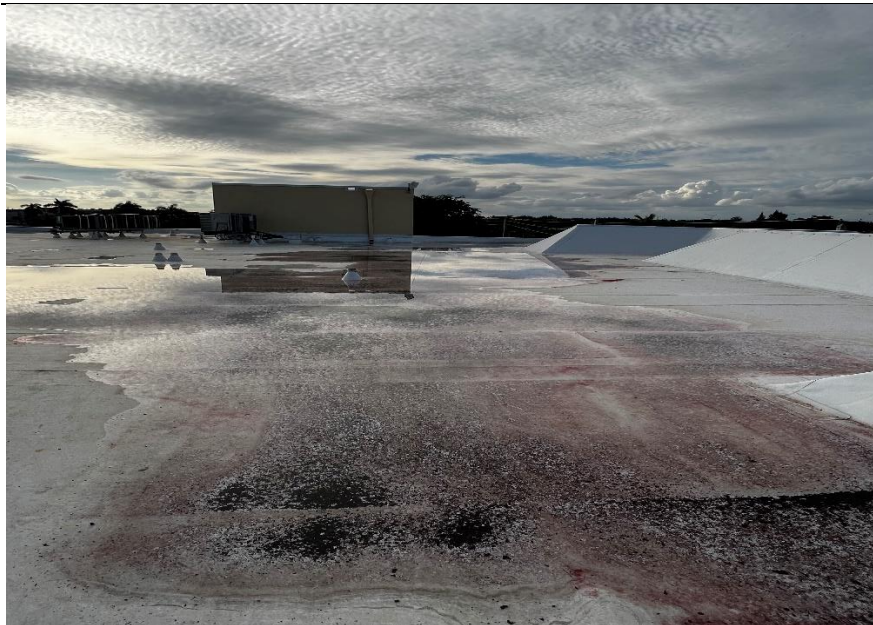
Photo #2:

Water ponding observed on
the roof.

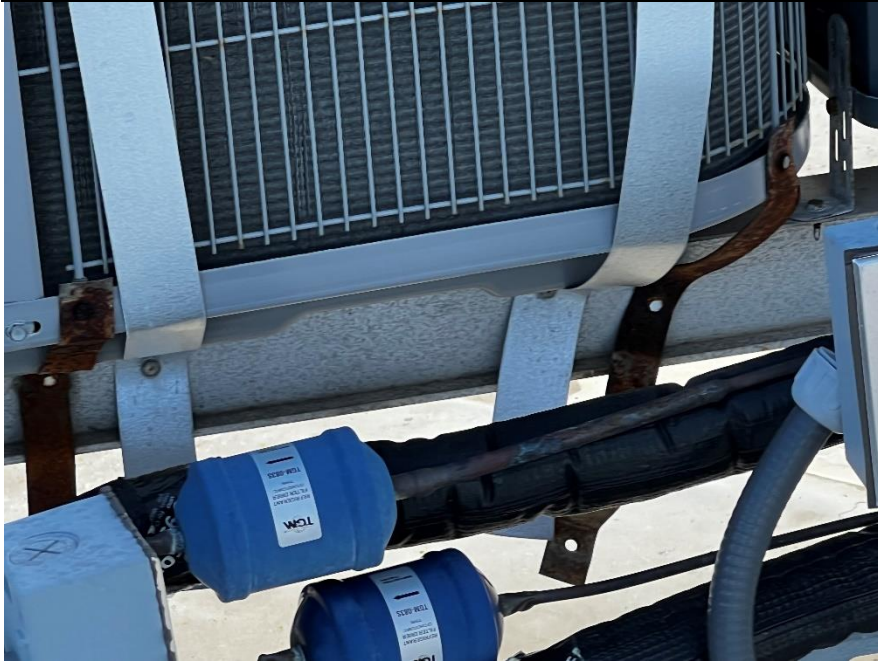
Photo #3:

Corroded steels straps.

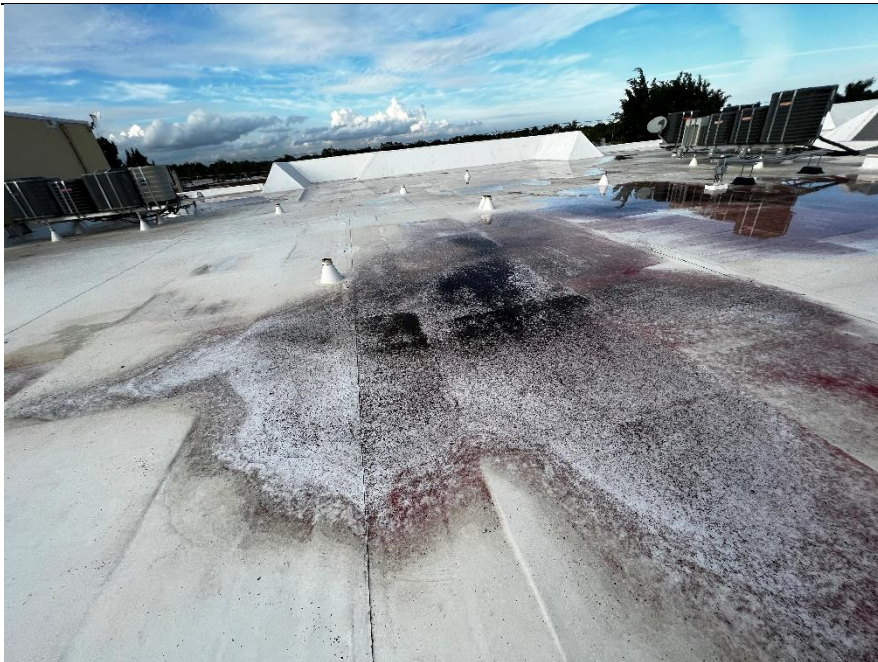
Photo #4:

TPO roof membrane deemed to be in fair condition with roof ponding conditions

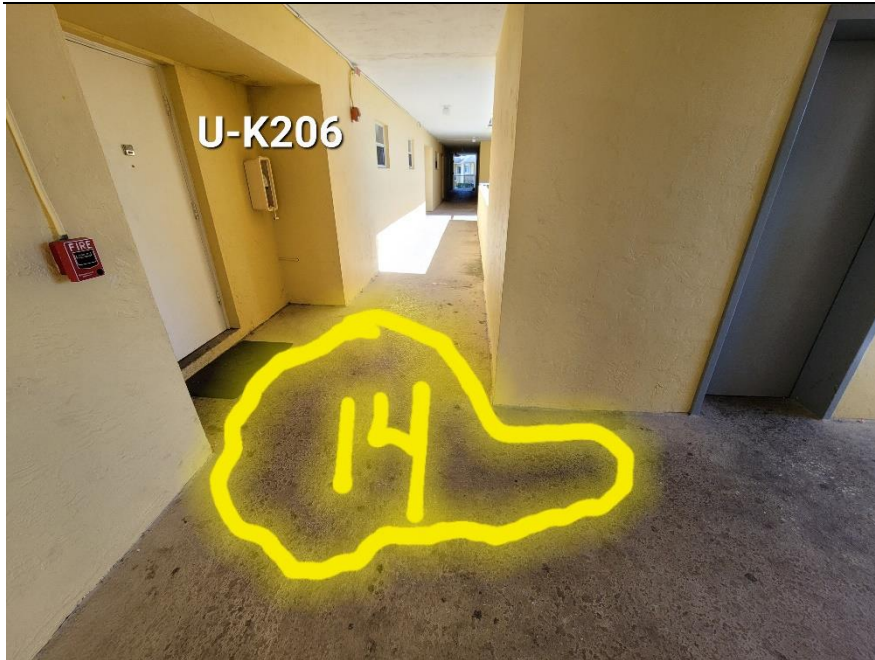
Photo #5:

Several small to moderate size unsound catwalk top surfaces.

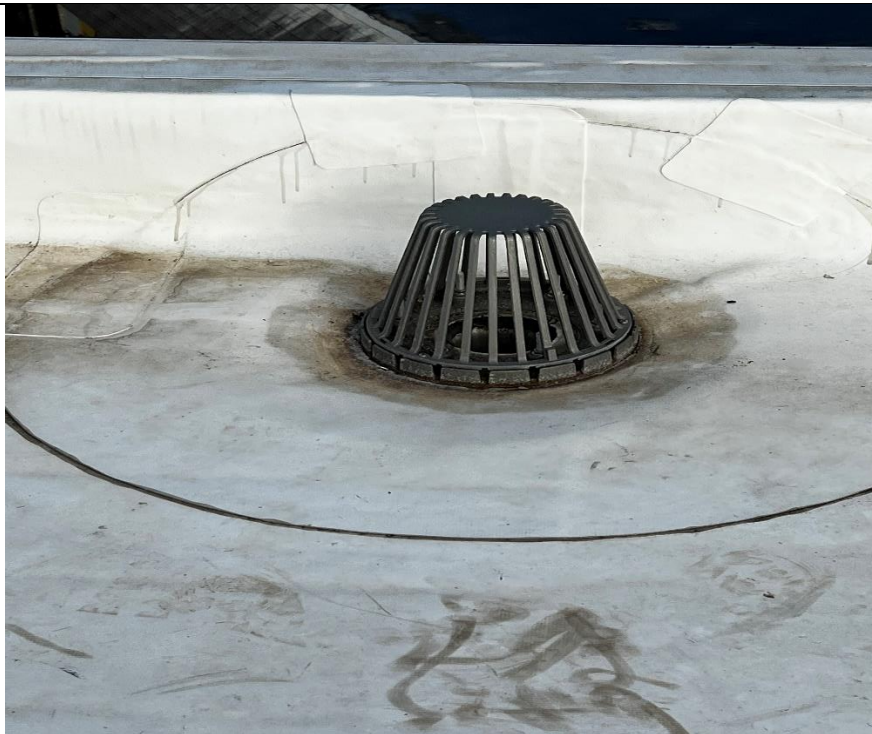
Photo #6:

The roof drainage system consists of interior main drain lines with metal strainers. The Interior main drain lines deemed to be in fair condition. No overflow system observed on the roof.

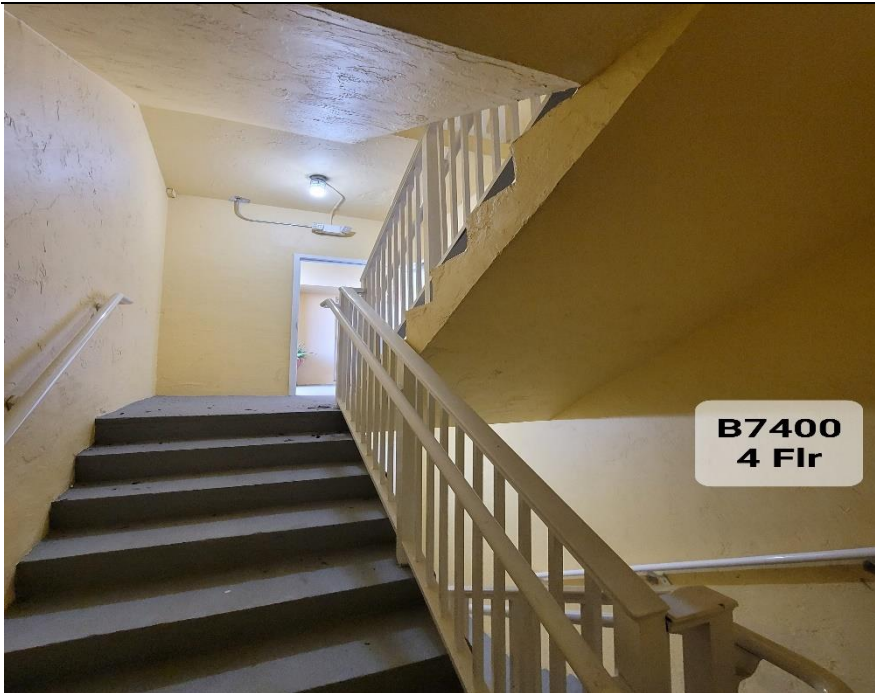
Photo #7:

The stair tower masonry and concrete elements deemed to be in fair condition

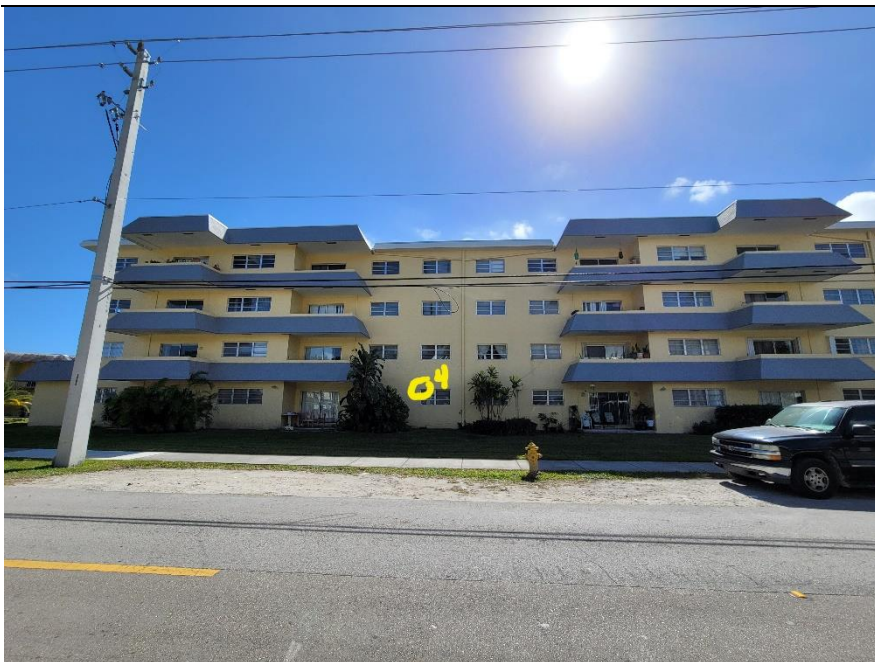
Photo #8:

In general the exterior envelope was deemed to be in good condition with small localized areas of unsound stucco surfaces.

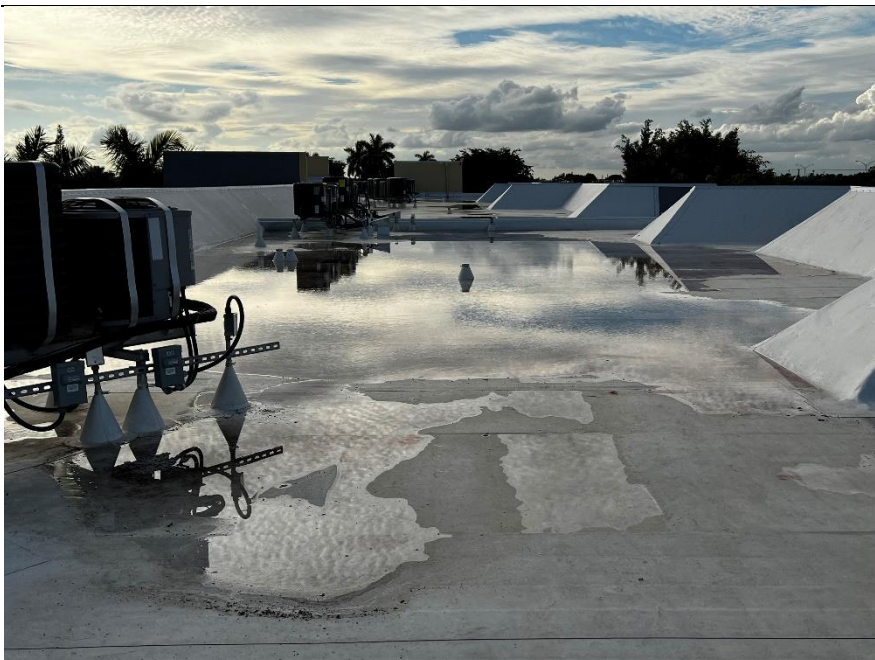
Photo #2:

Water ponding observed on the roof.

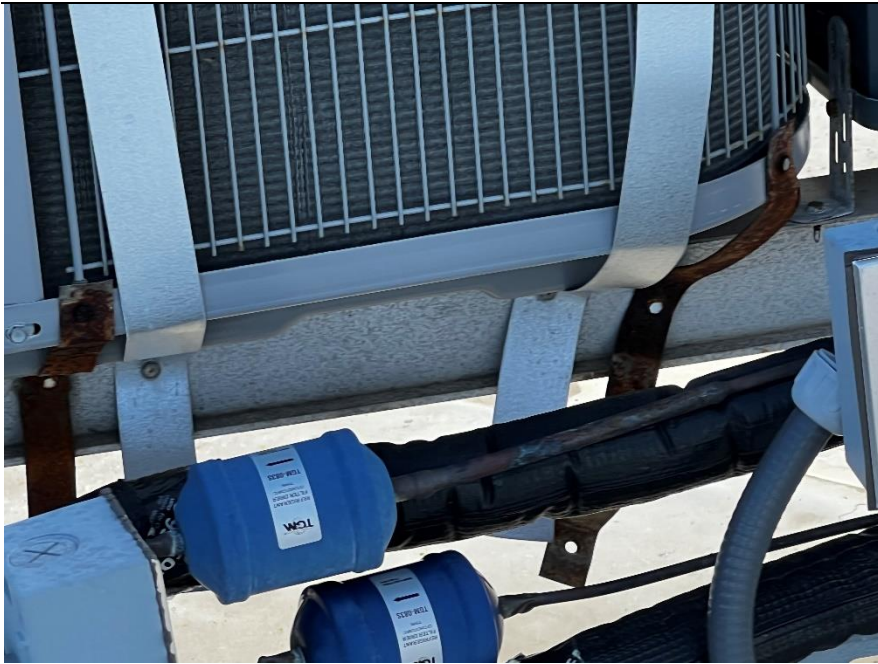
Photo #3:

Corroded steels straps.

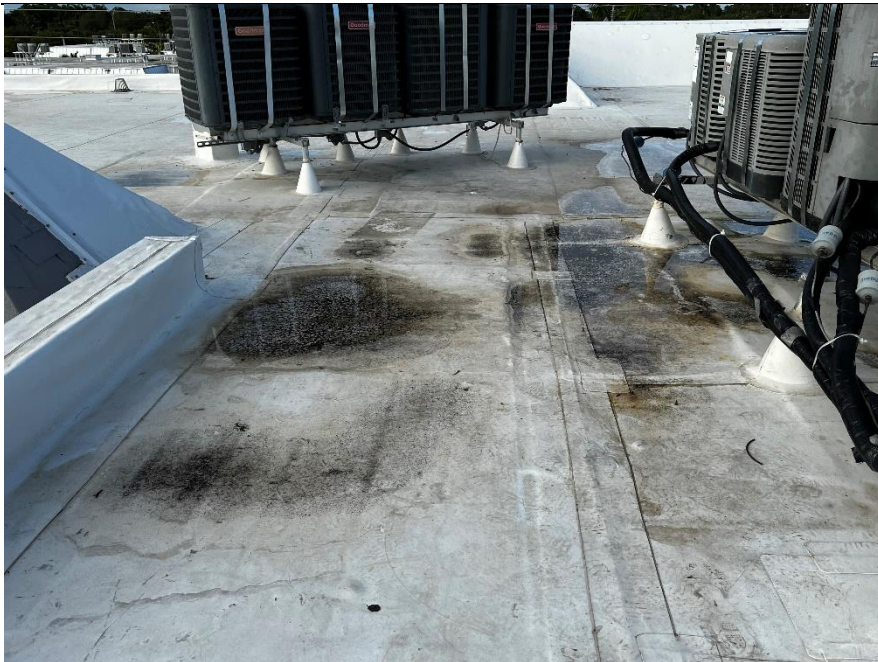
Photo #4:

TPO roof membrane deemed to be in fair condition with roof ponding conditions

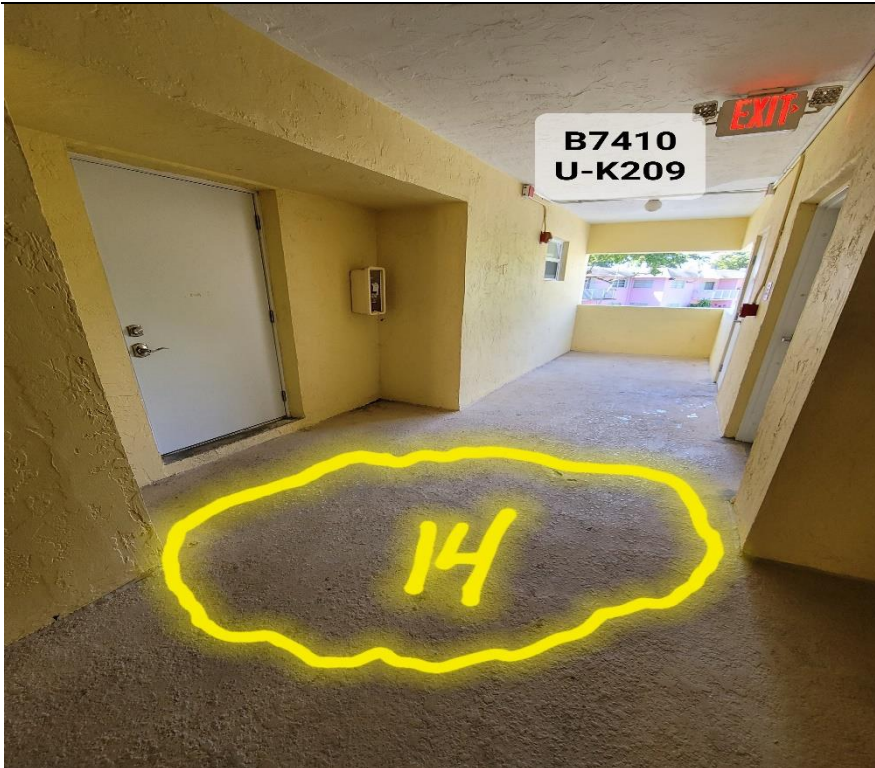
Photo #5:

Several small to moderate size unsound catwalk top surfaces.

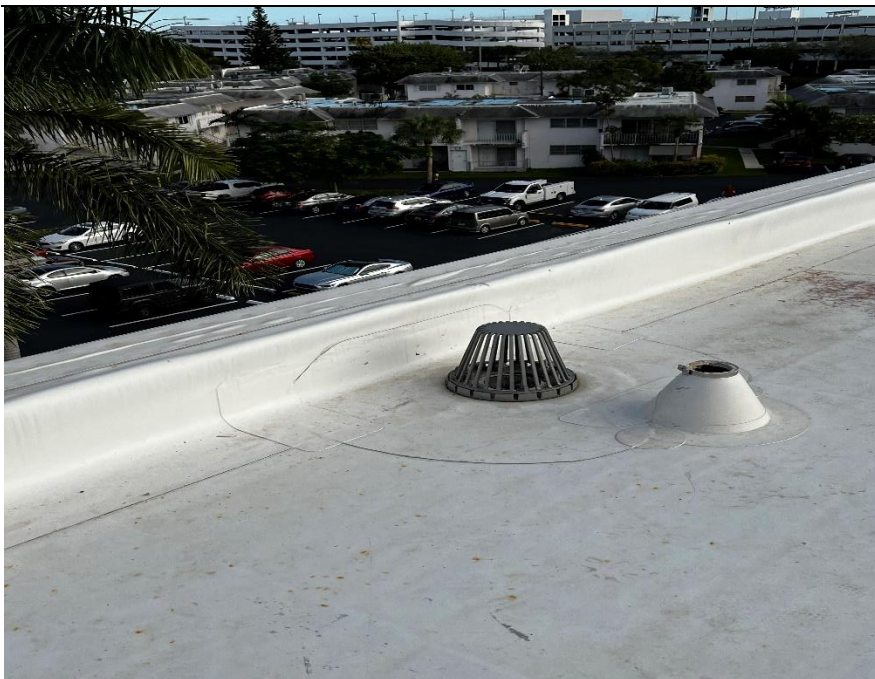
Photo #6:

The roof drainage system consists of interior main drain lines with metal strainers. The Interior main drain lines deemed to be in fair condition. No overflow system observed on the roof.

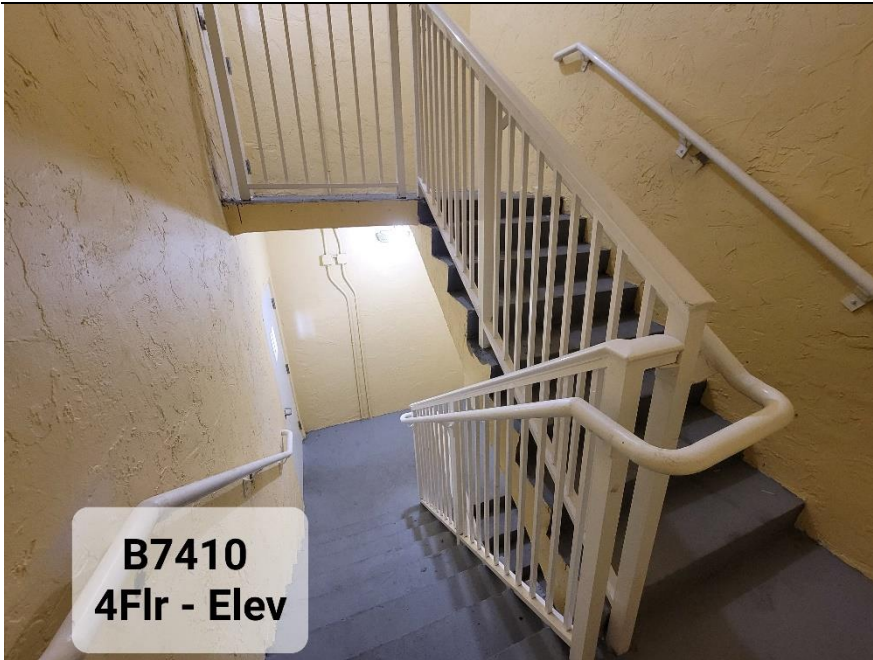
Photo #7:

The stair tower masonry and concrete elements deemed to be in fair condition

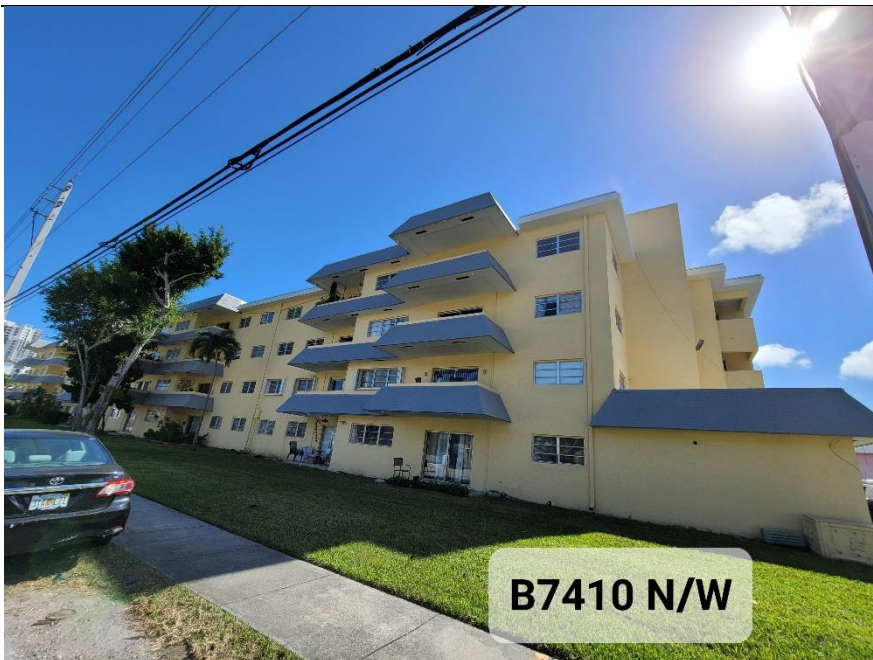
Photo #8:

In general the exterior envelope was deemed to be in good condition with small localized areas of unsound stucco surfaces.
