CONEJOS RIVER DIVERSION INFRASTRUCTURE INVENTORY

Structure Name: CARPE & REEKERS CANON D

Date: April 15, 2019

Conejos River Stream Management Plan

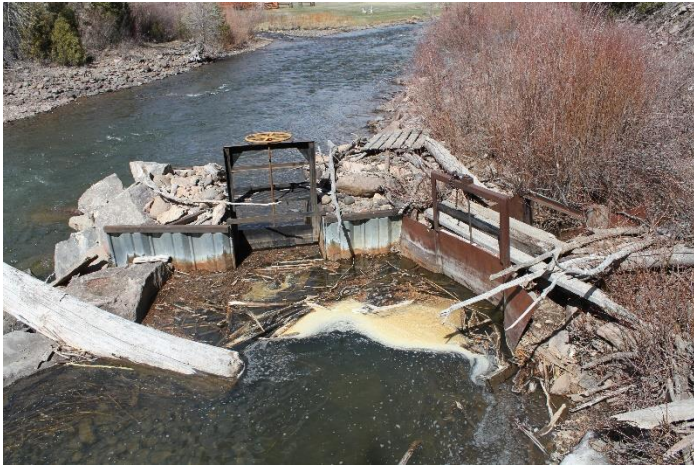
Repair(s) or Improvement(s) Currently Needed: Woody debris accumulates at the headgate and overflow gate. A trash rack would improve the function of this structure. This structure could also use improvements to the diversion dam to get water at low flows. The ditch downstream of the headgate is very inefficient in carrying water due to its geologic characteristics and could be lined, however, the gate can be adjusted to compensate and lost water through seepage recharges the adjacent river. Existing fish and boat passage should be maintained and riparian restoration should be considered as part of any future repairs or improvements.

Headgate and overflow structure

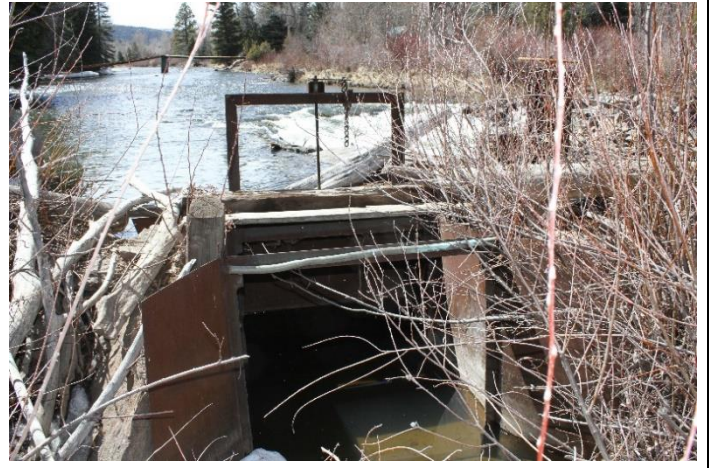
Headgate outlet

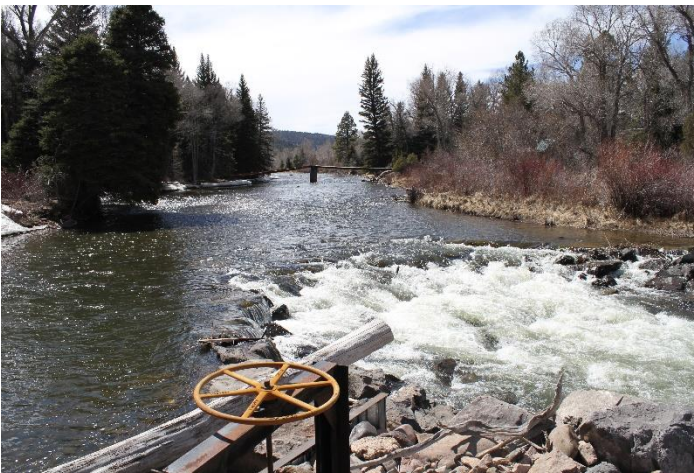
Diversion dam

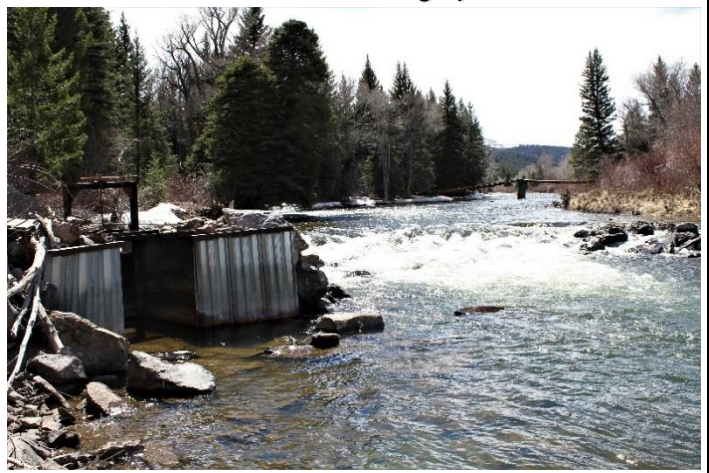
Diversion dam looking upstream

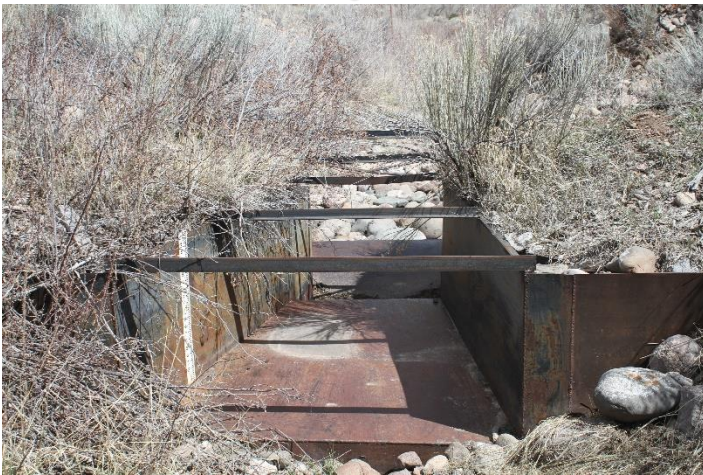
Flume looking downstream

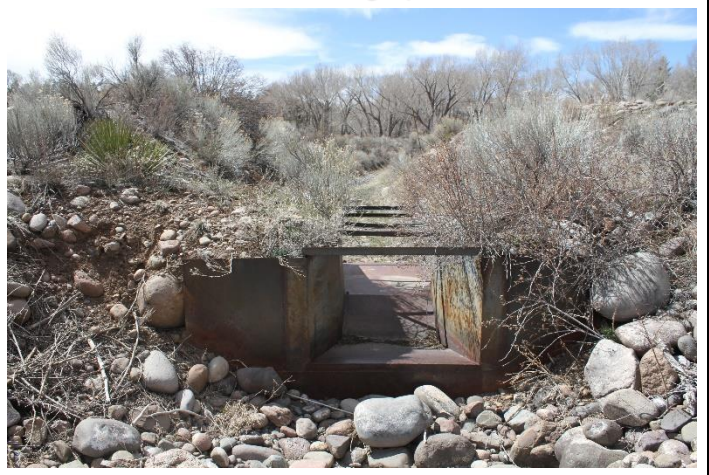
Flume looking upstream
