Superior LawnCare

Tree Report

Woodwind Lakes

Photo Sampler

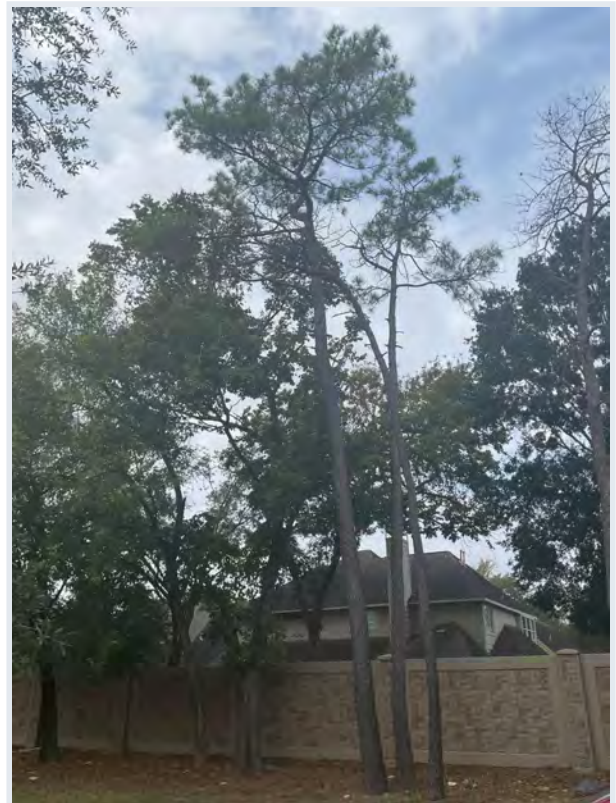
Loblolly pine Tree ID #44

Scientific Name:	Pinus taeda
Common Name:	Loblolly pine
Genus:	Pinus
Condition:	Poor
Status:	Alive
Number of Stems (Multi Calc):	1
Trimming Class:	B (Moderate)
DBH Range:	12-18in
Height Range:	50ft-75ft
Risk Rating:	
Priority:	High
Crown Spread:	
Canopy Shape:	
Observations- Characteristics:	Deadwood
Observations-Biotic Pest:	Little to No Pest Pressure
Observations-Abiotic:	None
Observation Comments:	
Tree Work-PHC:	Chemical Systemic
Tree Work-Other:	Not Needed
Last Modified:	12/30/2025
Notes:

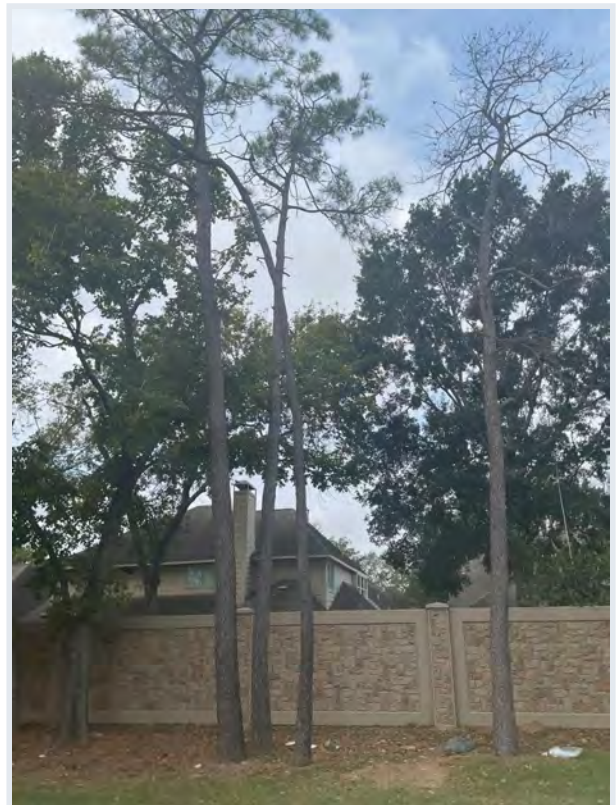
Loblolly pine Tree ID #45

Scientific Name:	Pinus taeda
Common Name:	Loblolly pine
Genus:	Pinus
Condition:	Poor
Status:	Alive
Number of Stems (Multi Calc):	1
Trimming Class:	C (Light)
DBH Range:	6-12in
Height Range:	50ft-75ft
Risk Rating:	
Priority:	High
Crown Spread:	
Canopy Shape:	
Observations-Characteristics:	Deadwood
Observations-Biotic Pest:	Little to No Pest Pressure
Observations-Abiotic:	None
Observation Comments:	
Tree Work-PHC:	Chemical Systemic
Tree Work-Other:	Not Needed
Last Modified:	12/30/2025
Notes:

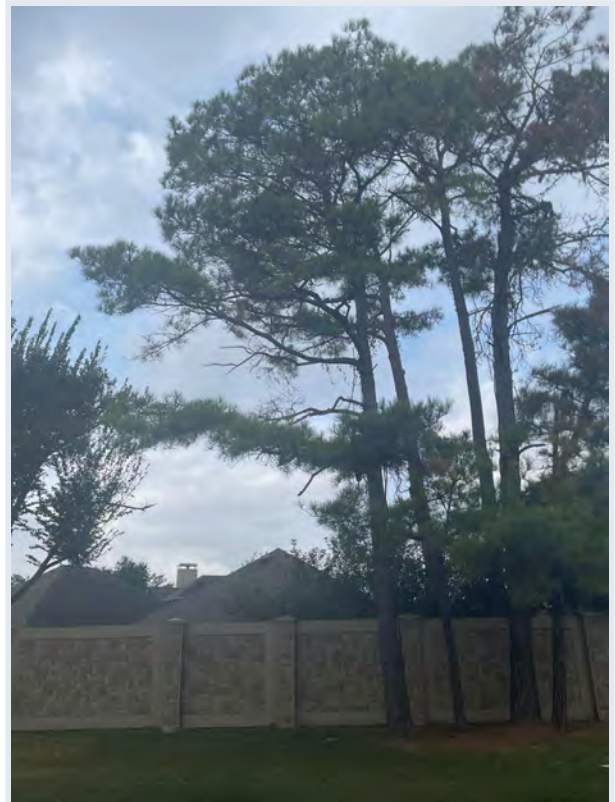
Loblolly pine Tree ID #48

Scientific Name:	Pinus taeda
Common Name:	Loblolly pine
Genus:	Pinus
Condition:	Poor
Status:	Alive
Number of Stems (Multi Calc):	1
Trimming Class:	B (Moderate)
DBH Range:	12-18in
Height Range:	30ft-50ft
Risk Rating:	
Priority:	High
Crown Spread:	
Canopy Shape:	
Observations-Characteristics:	Deadwood
Observations-Biotic Pest:	Little to No Pest Pressure
Observations-Abiotic:	None
Observation Comments:	
Tree Work-PHC:	Chemical Systemic
Tree Work-Other:	Not Needed
Last Modified:	12/30/2025
Notes:

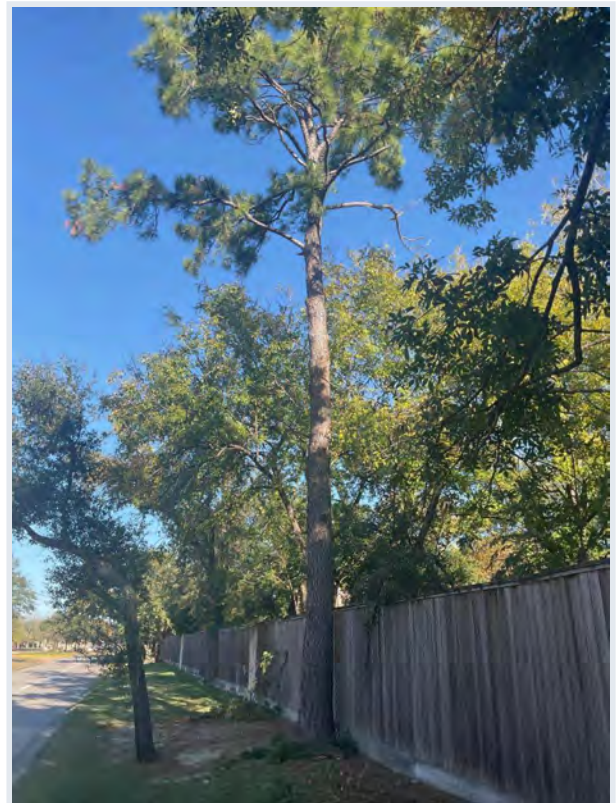
Loblolly pine Tree ID #70

Scientific Name:	Pinus taeda
Common Name:	Loblolly pine
Genus:	Pinus
Condition:	Good
Status:	Alive
Number of Stems (Multi Calc):	1
Trimming Class:	B (Moderate)
DBH Range:	12-18in
Height Range:	50ft-75ft
Risk Rating:	
Priority:	Medium
Crown Spread:	
Canopy Shape:	
Observations-Characteristics:	Deadwood, Broken Limb
Observations-Biotic Pest:	Little to No Pest Pressure
Observations-Abiotic:	None
Observation Comments:	
Tree Work-PHC:	Not Needed
Tree Work-Other:	Not Needed
Last Modified:	12/30/2025
Notes:	Multiple broken branches at base

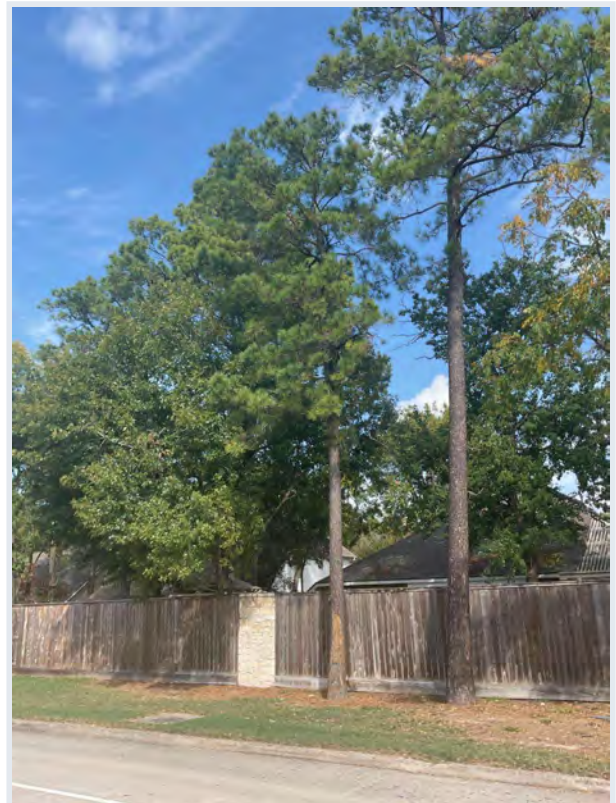
Loblolly pine Tree ID #73

Scientific Name:	Pinus taeda
Common Name:	Loblolly pine
Genus:	Pinus
Condition:	Poor
Status:	Alive
Number of Stems (Multi Calc):	1
Trimming Class:	C (Light)
DBH Range:	6-12in
Height Range:	30ft-50ft
Risk Rating:	
Priority:	High
Crown Spread:	
Canopy Shape:	
Observations-Characteristics:	Deadwood, Cavity
Observations-Biotic Pest:	Little to No Pest Pressure
Observations-Abiotic:	Mechanical Damage, None
Observation Comments:	
Tree Work-PHC:	Chemical Systemic
Tree Work-Other:	Not Needed
Last Modified:	12/30/2025
Notes:

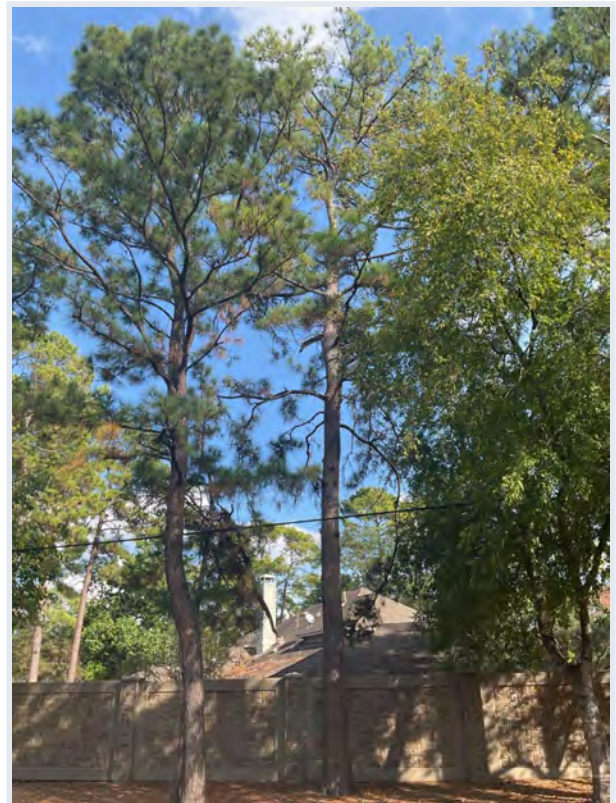
Loblolly pine Tree ID #110

Scientific Name:	Pinus taeda
Common Name:	Loblolly pine
Genus:	Pinus
Condition:	Poor
Status:	Alive
Number of Stems (Multi Calc):	1
Trimming Class:	B (Moderate)
DBH Range:	18-24in
Height Range:	50ft-75ft
Risk Rating:	
Priority:	High
Crown Spread:	
Canopy Shape:	
Observations-Characteristics:	Deadwood, Crack, Broken Limb
Observations-Biotic Pest:	Boring Insect
Observations-Abiotic:	None
Observation Comments:	
Tree Work-PHC:	Chemical Systemic
Tree Work-Other:	Not Needed
Last Modified:	12/30/2025
Notes:

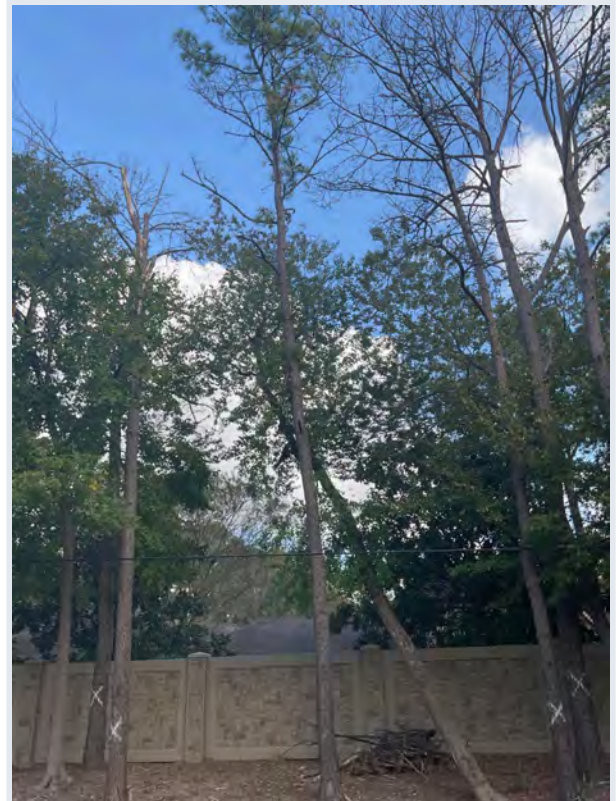
Loblolly pine Tree ID #123

Scientific Name:	Pinus taeda
Common Name:	Loblolly pine
Genus:	Pinus
Condition:	Poor
Status:	Alive
Number of Stems (Multi Calc):	1
Trimming Class:	C (Light)
DBH Range:	12-18in
Height Range:	50ft-75ft
Risk Rating:	
Priority:	High
Crown Spread:	
Canopy Shape:	
Observations-Characteristics:	Deadwood, Cavity
Observations-Biotic Pest:	Boring Insect
Observations-Abiotic:	Mechanical Damage
Observation Comments:	
Tree Work-PHC:	Chemical Systemic
Tree Work-Other:	Not Needed
Last Modified:	12/30/2025
Notes:

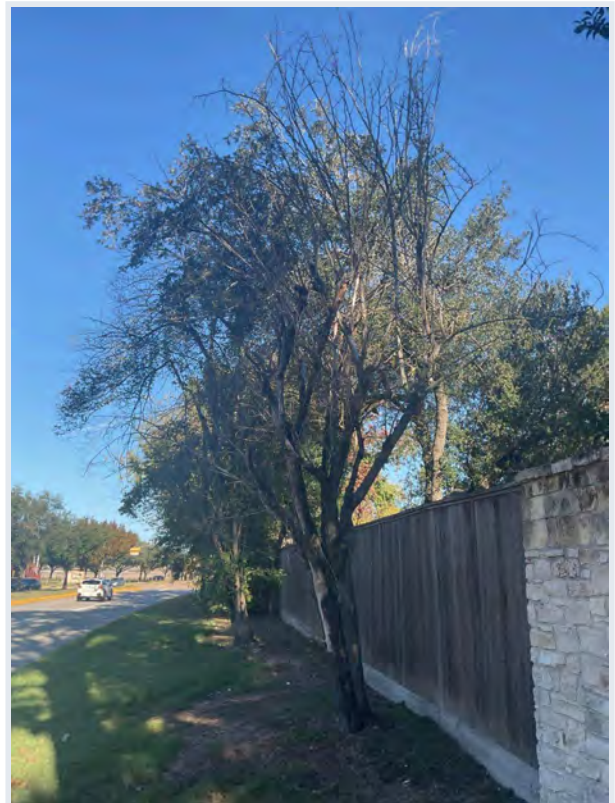
Scientific Name:	Ulmus americana
Common Name:	American elm
Genus:	Ulmus
Condition:	Poor
Status:	Alive
Number of Stems (Multi Calc):	Multiple Stems
Trimming Class:	Not Needed
DBH Range:	6-12in
Height Range:	15ft-30ft
Risk Rating:	
Priority:	Medium
Crown Spread:	
Canopy Shape:	
Observations-Characteristics:	Deadwood, Cavity
Observations-Biotic Pest:	Fungus
Observations-Abiotic:	None
Observation Comments:	
Tree Work-PHC:	Not Needed
Tree Work-Other:	Remove
Last Modified:	12/30/2025
Notes:	Hypoxylon Canker

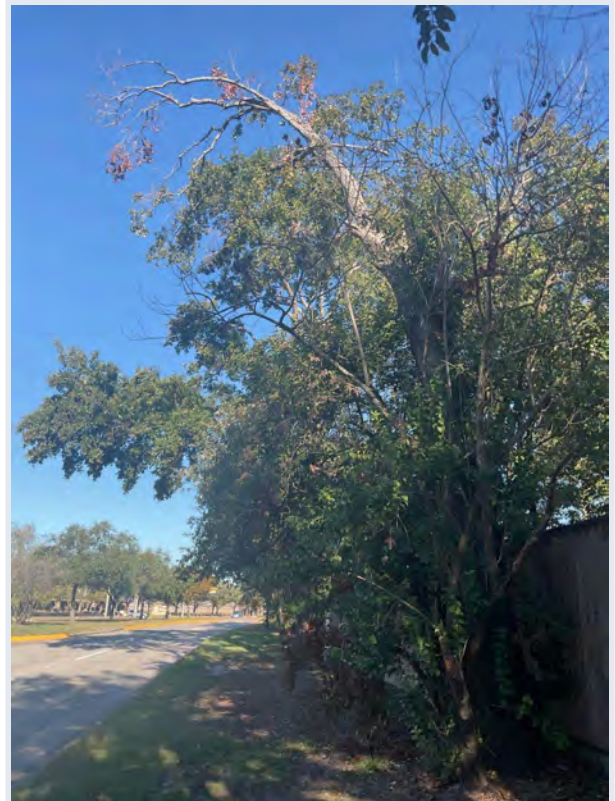
Water oak Tree ID #315

Scientific Name:	Quercus nigra
Common Name:	Water oak
Genus:	Quercus
Condition:	Poor
Status:	Alive
Number of Stems (Multi Calc):	1
Trimming Class:	Not Needed
DBH Range:	12-18in
Height Range:	30ft-50ft
Risk Rating:	
Priority:	Medium
Crown Spread:	
Canopy Shape:	
Observations-Characteristics:	Broken Limb, Deadwood, Crack, Cavity
Observations-Biotic Pest:	Fungus
Observations-Abiotic:	None
Observation Comments:	
Tree Work-PHC:	Not Needed
Tree Work-Other:	Remove
Last Modified:	12/30/2025
Notes:	Hypoxylon Canker

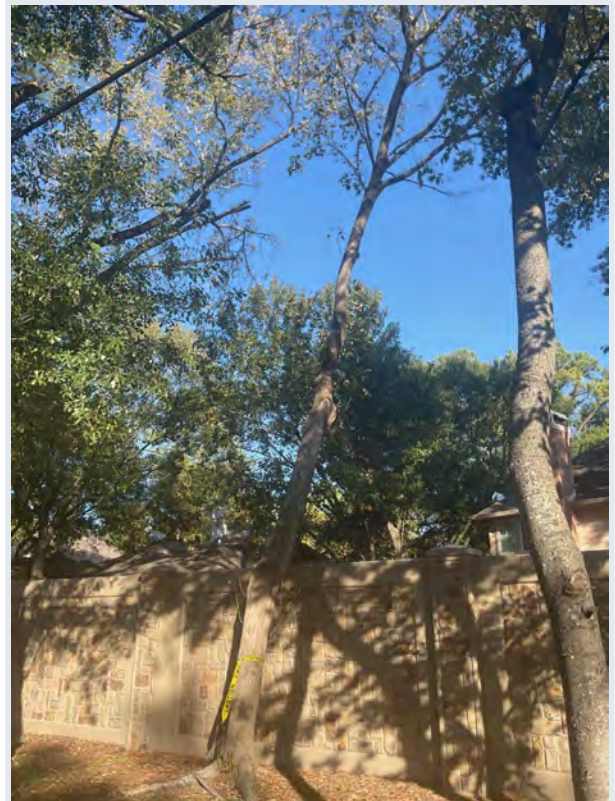
Chinaberry Tree ID #502

Scientific Name:	Melia azedarach
Common Name:	Chinaberry
Genus:	Melia
Condition:	Fair
Status:	Alive
Number of Stems (Multi Calc):	1
Trimming Class:	Not Needed
DBH Range:	12-18in
Height Range:	30ft-50ft
Risk Rating:	
Priority:	Medium
Crown Spread:	
Canopy Shape:	
Observations-Characteristics:	
Observations-Biotic Pest:	Little to No Pest Pressure
Observations-Abiotic:	None
Observation Comments:	
Tree Work-PHC:	Not Needed
Tree Work-Other:	Remove
Last Modified:	12/30/2025
Notes:	Caution tape wrap

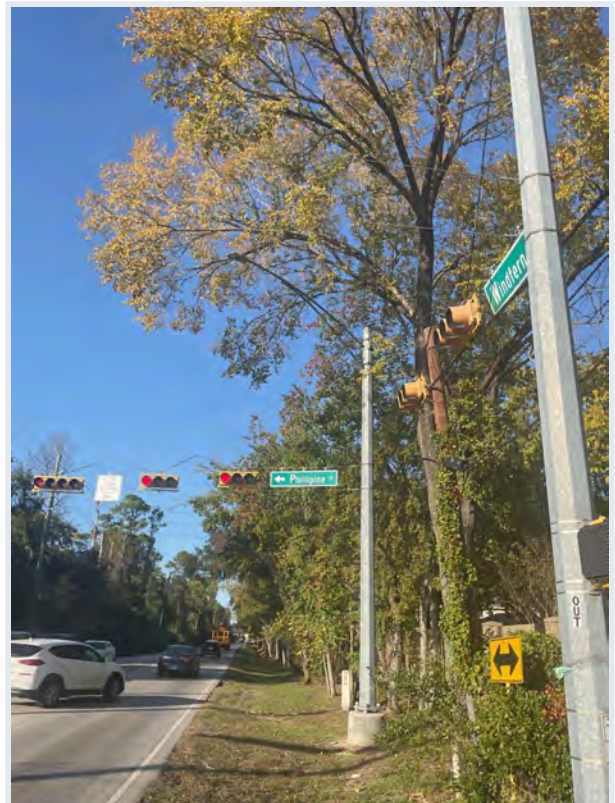
American elm Tree ID #520

Scientific Name:	Ulmus americana
Common Name:	American elm
Genus:	Ulmus
Condition:	Fair
Status:	Alive
Number of Stems (Multi Calc):	1
Trimming Class:	A (Aggressive)
DBH Range:	24-30in
Height Range:	50ft-75ft
Risk Rating:	
Priority:	High
Crown Spread:	
Canopy Shape:	
Observations-Characteristics:	Deadwood
Observations-Biotic Pest:	Little to No Pest Pressure
Observations-Abiotic:	None
Observation Comments:	
Tree Work-PHC:	Not Needed
Tree Work-Other:	Not Needed
Last Modified:	12/30/2025
Notes:	Streetlight clearance

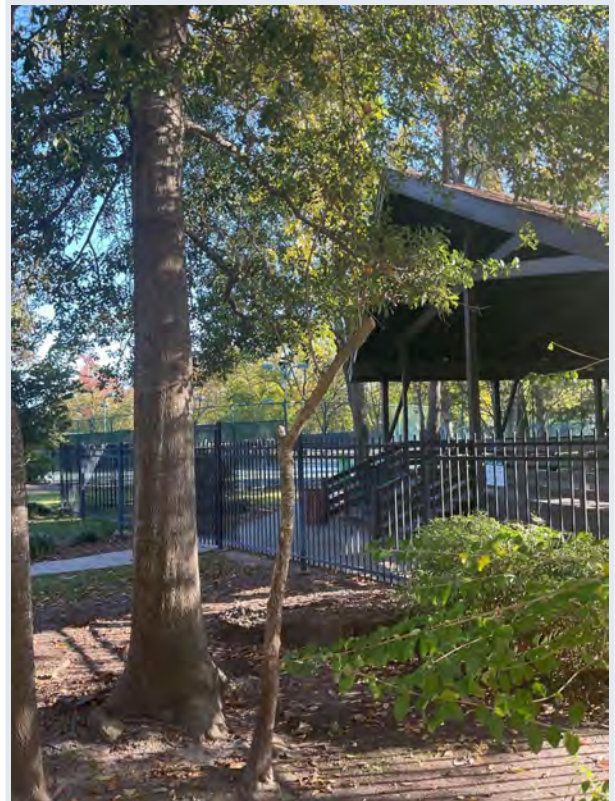
Water oak Tree ID #694

Scientific Name:	Quercus nigra
Common Name:	Water oak
Genus:	Quercus
Condition:	Dead
Status:	Dead
Number of Stems (Multi Calc):	1
Trimming Class:	Not Needed
DBH Range:	3-6in
Height Range:	<15ft
Risk Rating:	
Priority:	Medium
Crown Spread:	
Canopy Shape:	
Observations-Characteristics:	
Observations-Biotic Pest:	Little to No Pest Pressure
Observations-Abiotic:	None
Observation Comments:	
Tree Work-PHC:	Not Needed
Tree Work-Other:	Remove
Last Modified:	12/30/2025
Notes:
