SAGUACHE CREEK DIVERSION INFRASTRUCTURE INVENTORY

Structure Name: COMMODORE D

Date: April 4, 2019

Saguache Creek Stream Management Plan

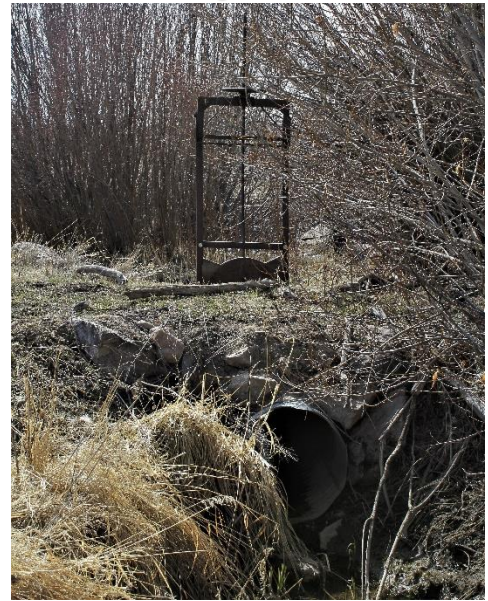
Headgate outlet

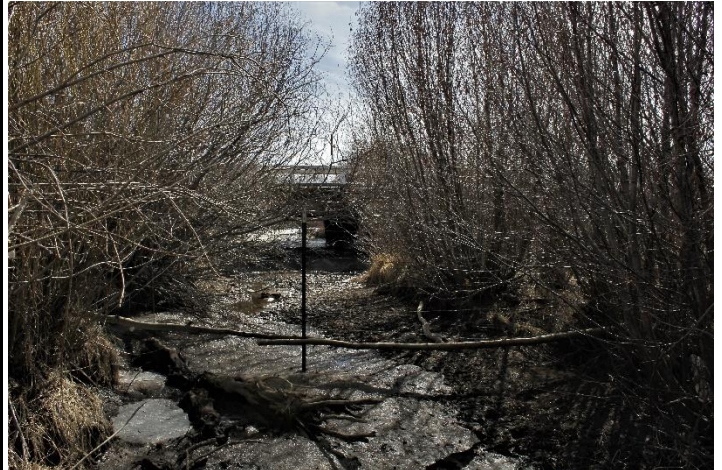
Feeder ditch looking upstream

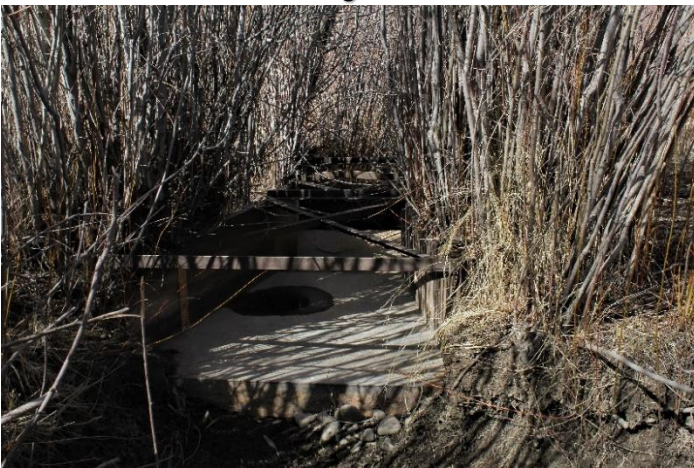
Flume looking downstream

Repair(s) or Improvement(s) Currently Needed: Bank stabilization to prevent meander downstream of the diversion from being cut off. This would also protect the diversion dam and headgate as well as Hwy 114. The flume is eroding on its downstream side and could be filled. Existing fish passage should be maintained and riparian restoration should be considered as part of any future repairs or improvements.

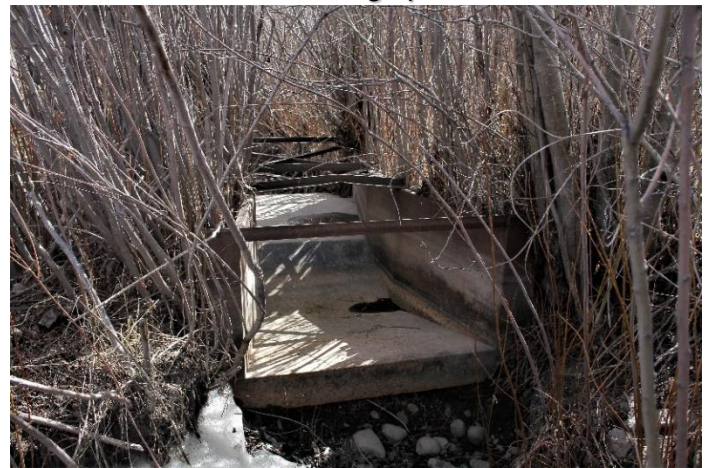
Flume looking upstream
