SAGUACHE CREEK DIVERSION INFRASTRUCTURE INVENTORY

Structure Name: MCCREE D

Date: April 4, 2019

Saguache Creek Stream Management Plan

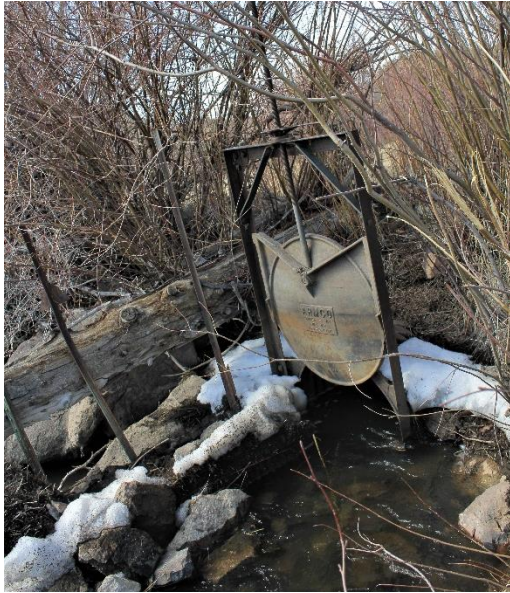
Headgate looking downstream

Repair(s) or Improvement(s) Currently Needed: Bank stabilization is needed to protect the headgate. The diversion dam could be improved to reduce maintenance. For example, an improved stacked rock diversion may reduce maintenance while still effectively diverting water at various flows. Fish passage and riparian restoration should be considered as part of any future repairs or improvements.

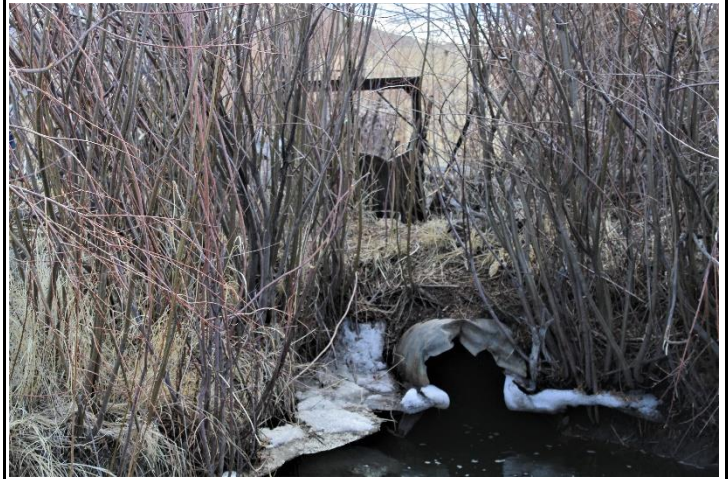
Headgate outlet

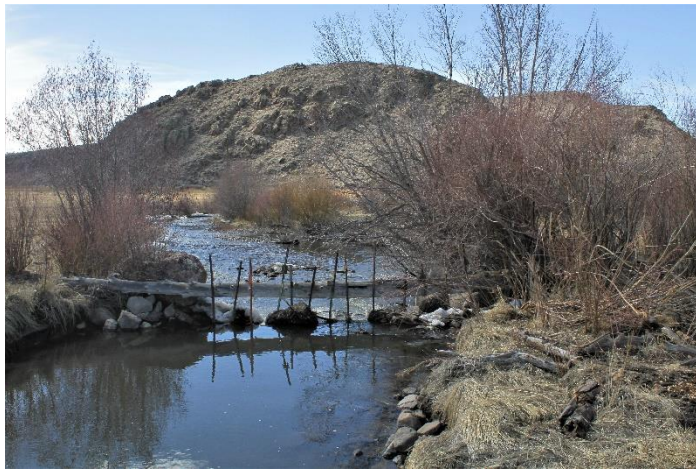
Headgate and diversion dam

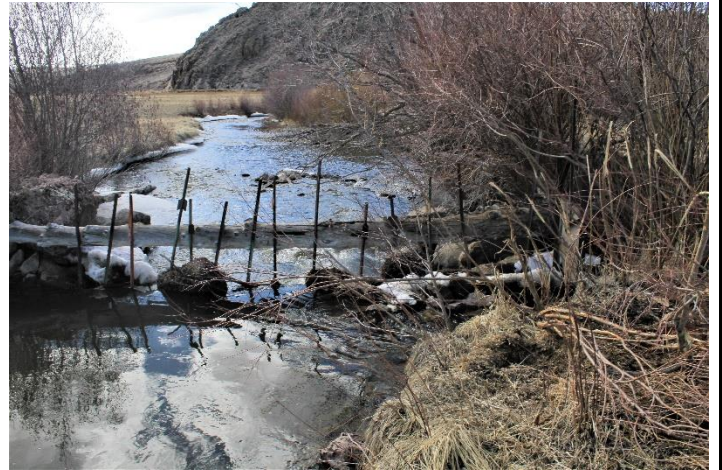
Structure Description: This structure is located just upstream of County Rd 33 CC. The diversion dam is made up of boulders, t-posts, and a large tree trunk. The t-posts are braced against the tree and allow checkboard or other materials to be installed for adjustments in head pressure. The diversion dam is located on the downstream end of a meander and directs water to the headgate, which is located on the east bank of the river. Bank erosion is an issue at this location, particularly upstream of the diversion. Bank stabilization structures have been installed downstream of this structure.

Diversion dam

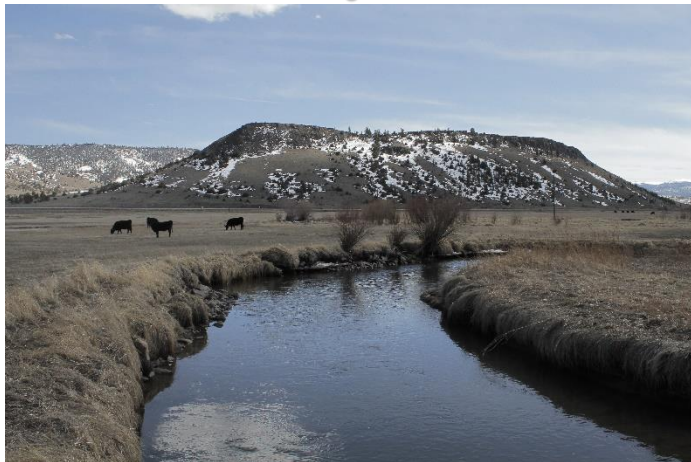
Flume looking downstream

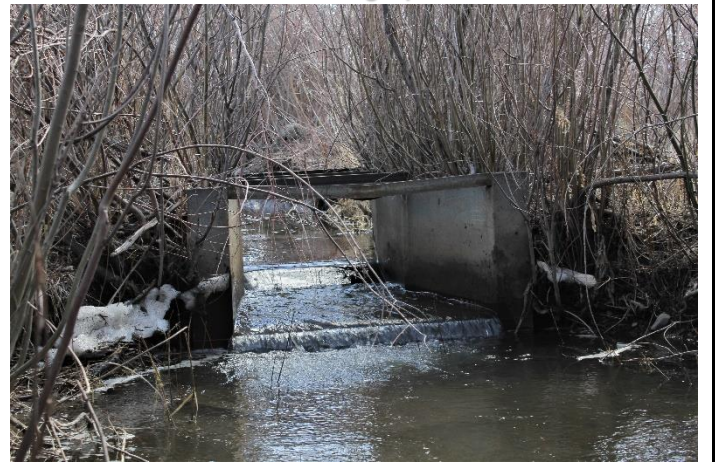
Flume looking upstream
