RIO GRANDE DIVERSION INFRASTRUCTURE INVENTORY

Structure Name: CHICAGO D

CHICAGO DITCH

PHOTO LOG

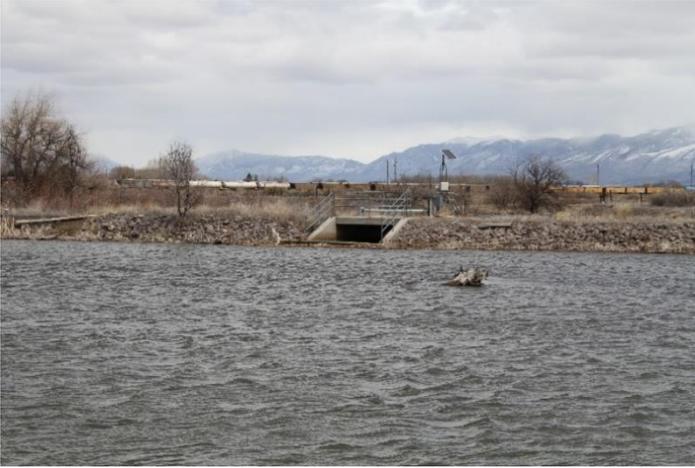
Headgate (from diversion dam)

Repair(s) or Improvement(s) Currently Needed: Some woody debris accumulates in front of the headgate and could be cleared, but it does not appear to be a significant issue for water users. Bank stabilization, floodplain reconnection, and riparian vegetation restoration downstream of the diversion dam would improve river function. Potential ditch failure due to channel migration should be avoided through bank stabilization or relocating the path of the ditch. A portage route for recreational boaters around the diversion dam is also recommended. Any future repairs or improvements to the diversion dam should incorporate fish and boat passage, as this structure currently acts as a fish barrier at low flows.

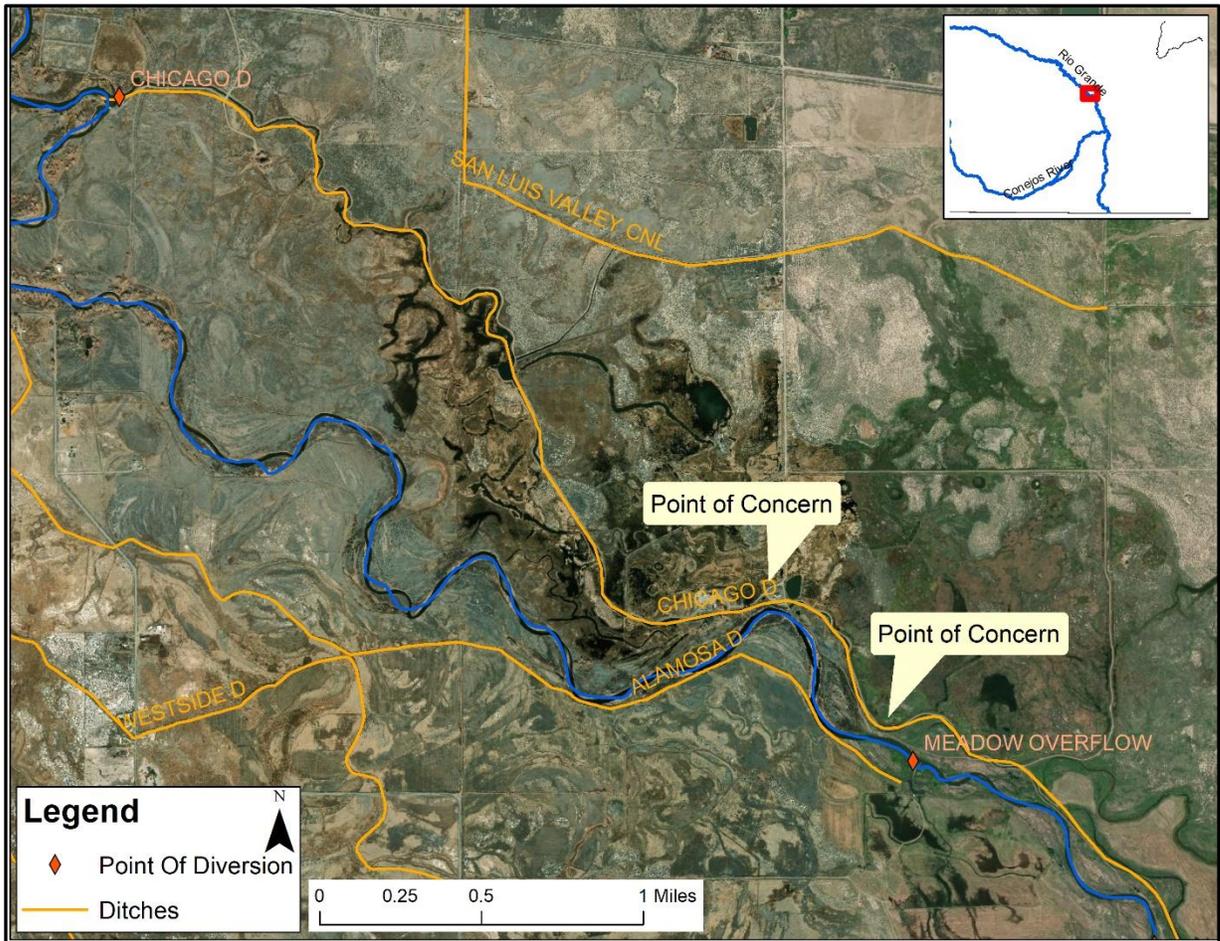
Structure Description: This structure is located ~1.3 miles downstream of the Westside Ditch. Channel avulsion has occurred both upstream and downstream of the diversion dam. The trapezoidal concrete diversion dam creates head pressure for the headgate, which is located ~230 feet upstream. There is a radial adjustment/overflow gate on the east side of the diversion dam. The diversion functions well for water rights holders, but it is a significant barrier to recreational boating and fish passage, especially at low flows. At two locations downstream of the headgate (~3.4 miles and ~4 mi, respectively), the ditch is very close to the Rio Grande, in part due to channel migration. If migration continues, the ditch could be washed out in either of these locations (see map below).

Points of concern on Chicago Ditch where ditch is very close to river channel.

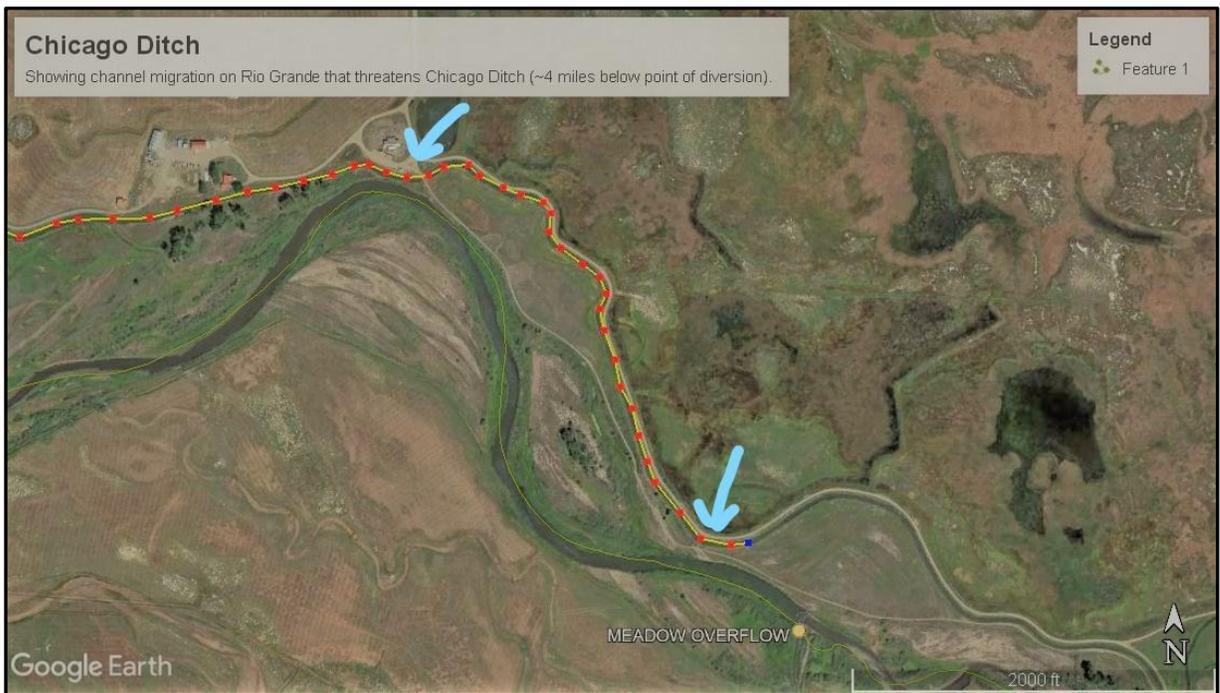
Close up of points of concern.
