Home Inspection Report

781 Castillo Street Santa Barbara, CA 93101

1234

Report Overview

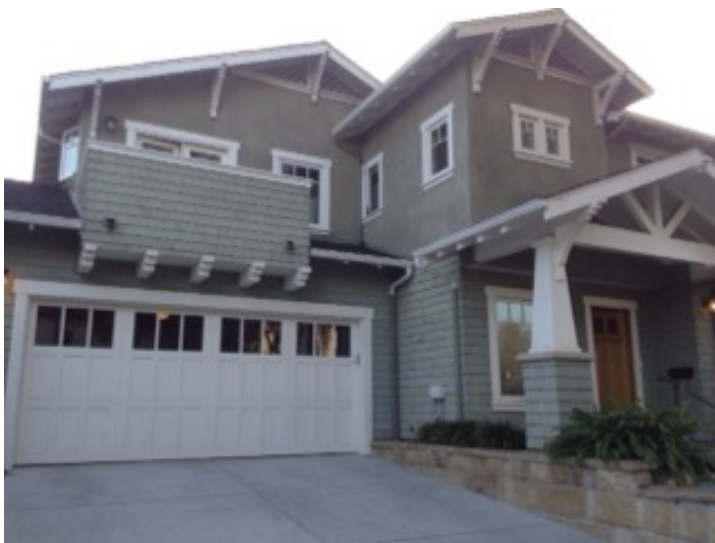
Not a fix, just best for down pipe to have elbow to divert water away from house. However there is a good slab and grade profile here.

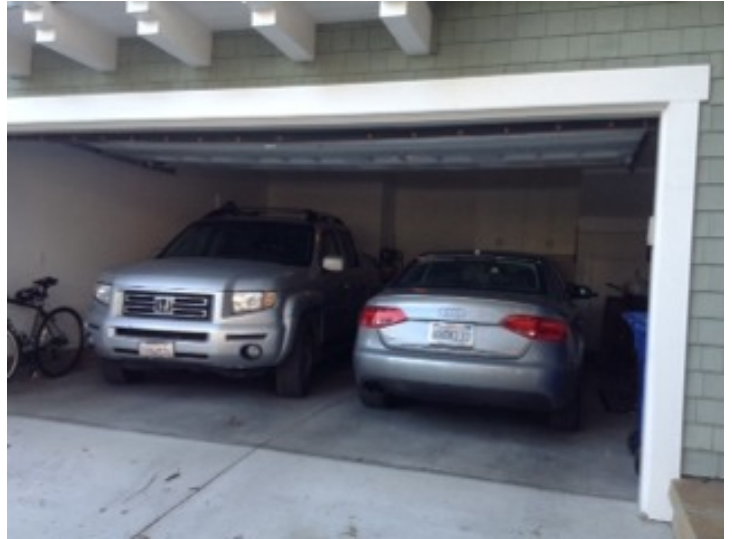
Very minor slab cracking

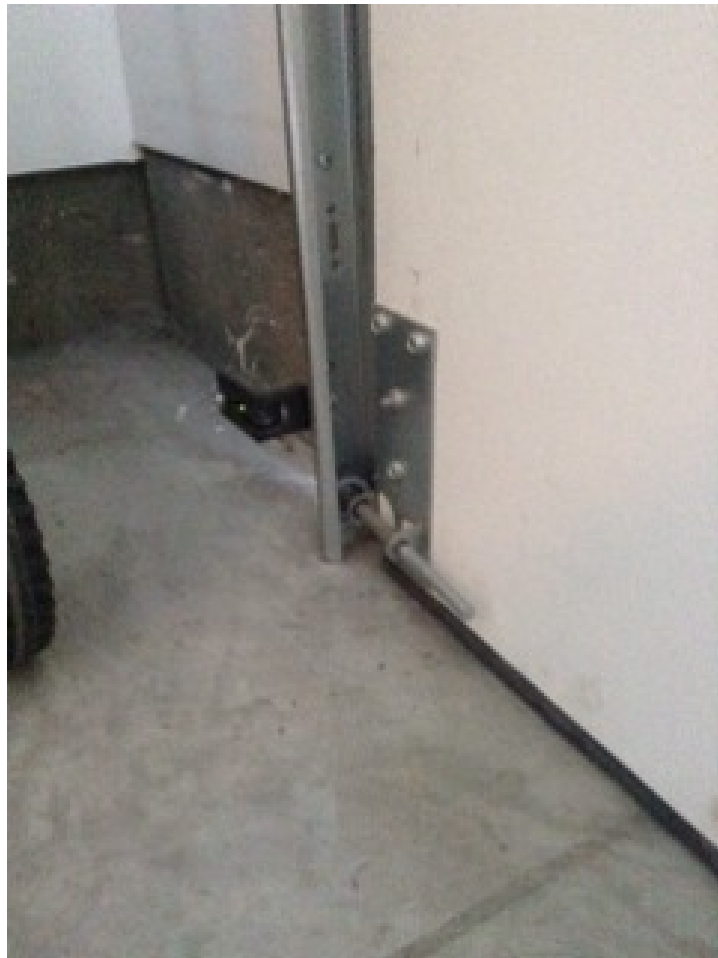
Correct sensor positioning

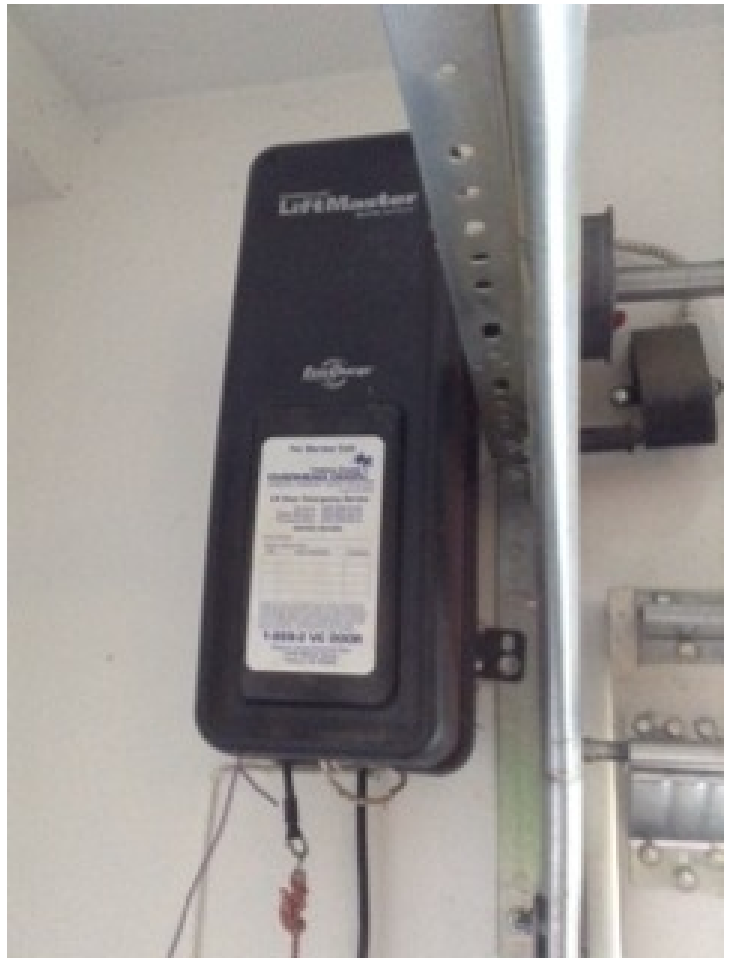
Door motor does have working safety chain

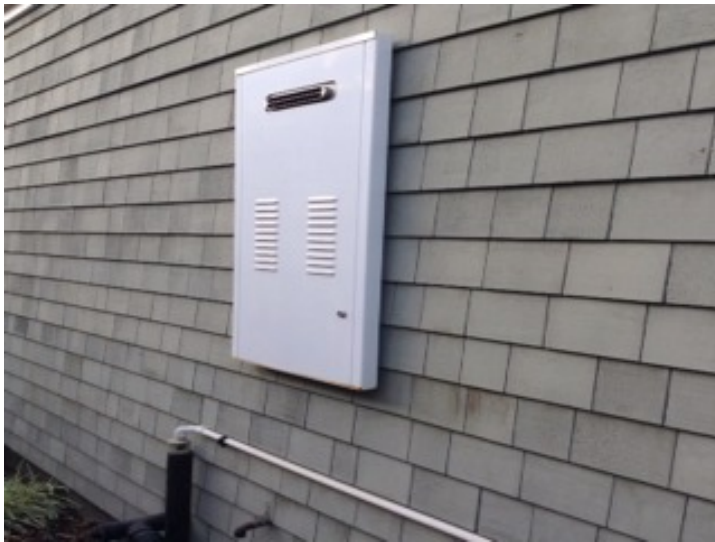
Instant hot water system <5 years old
