SAGUACHE CREEK DIVERSION INFRASTRUCTURE INVENTORY

Structure Name: NORTH MEADOWN NO 779 D

NORTH MEADOWS NO 779 DITCH

PHOTO LOG

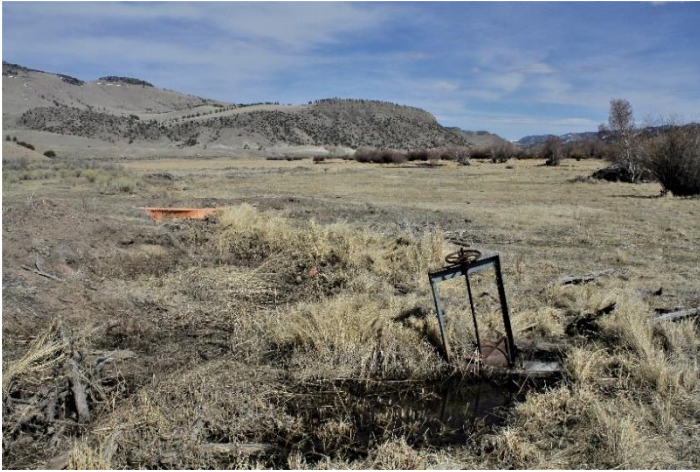
Headgate looking downstream

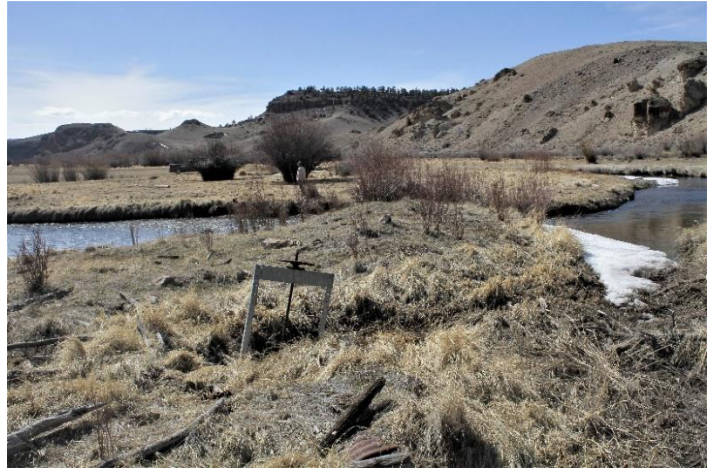
Headgate outlet

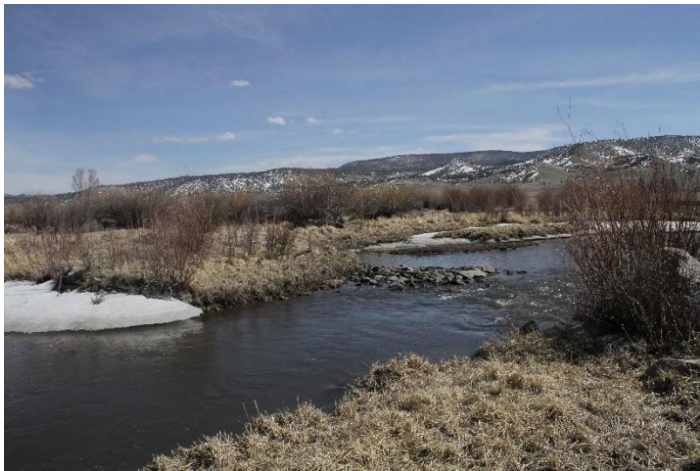
Headgate and diversion dam

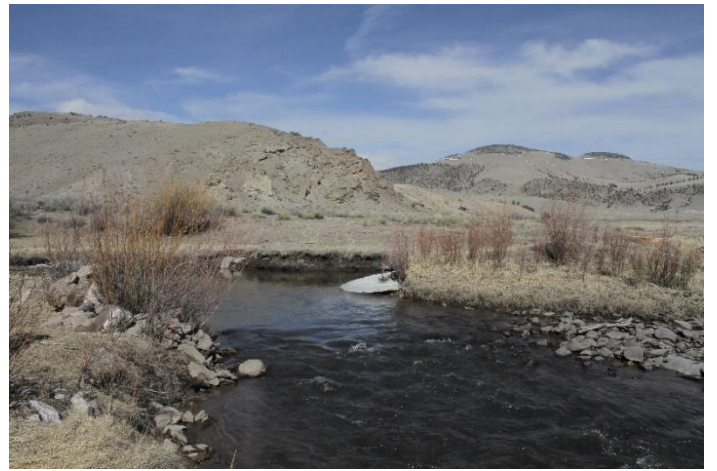
Diversion dam

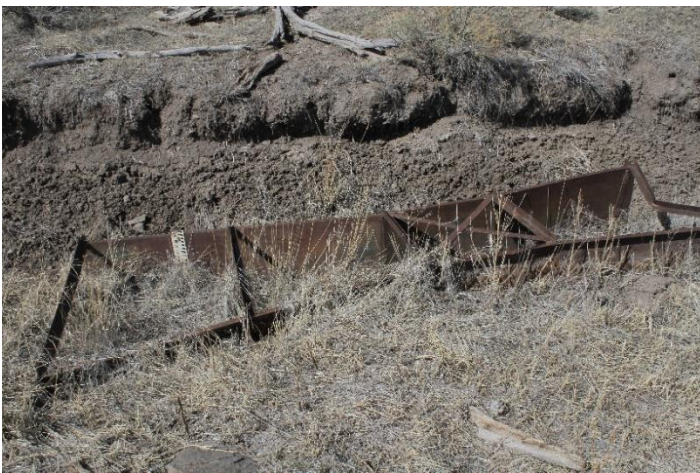
Flume

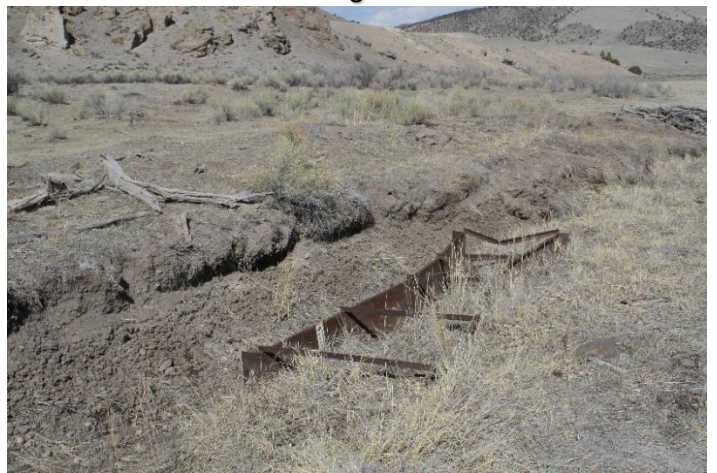
Flume looking downstream
