# RIO GRANDE DIVERSION INFRASTRUCTURE INVENTORY

**Structure Name:** HALL-VOSS D

HALL-VOSS DITCH

Rio Grande Stream  
Management Plan

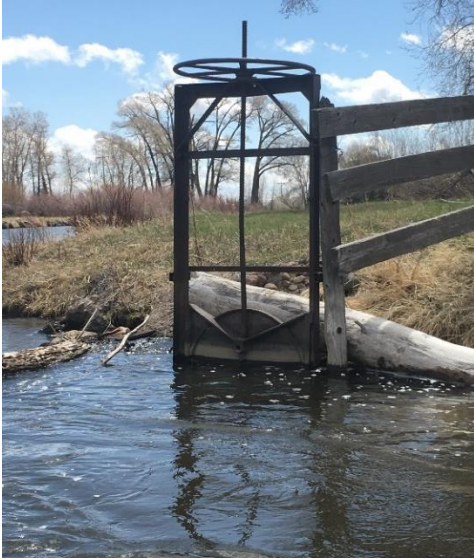
**Repair(s) or Improvement(s) Currently Needed:** Headgate leaks and does not function well. It needs to be repaired, especially to fix the leak. The diversion dam functions well for its priority, but the ditch has difficulty conveying flows in high flow situations. Fish passage and riparian restoration should be considered as part of any repairs or improvements.

Headgate looking downstream

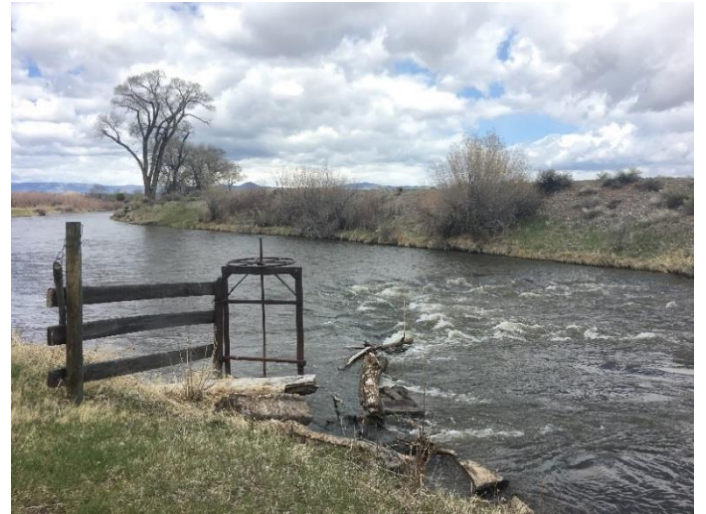
Headgate and diversion dam

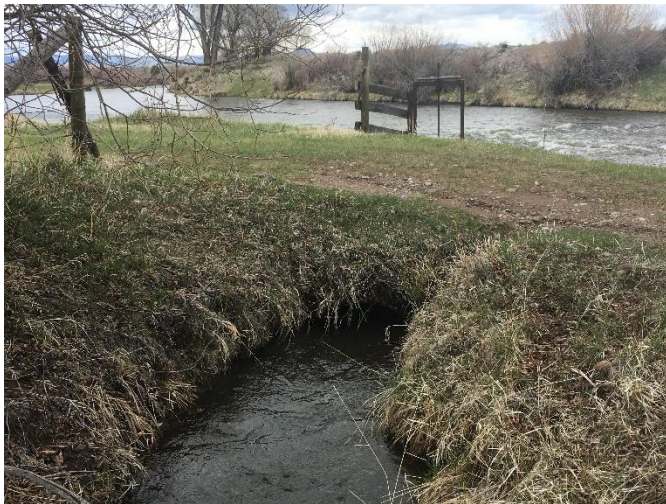
Headgate outlet

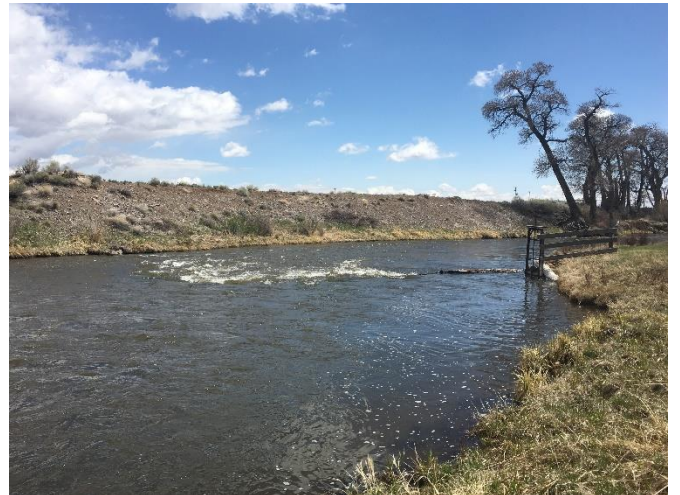
Diversion dam

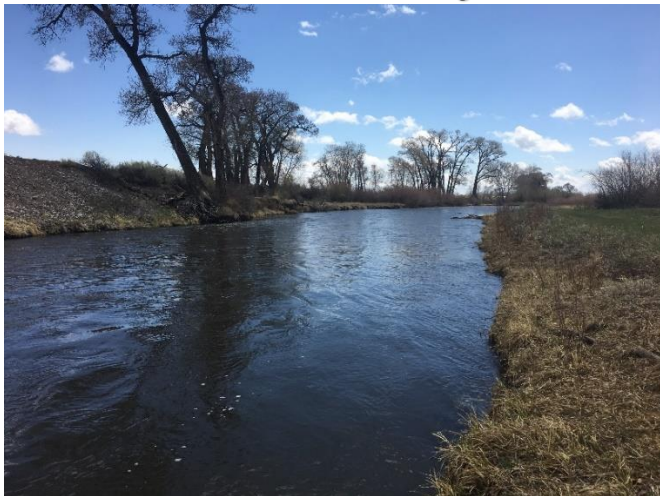
North channel Rio Grande looking downstream

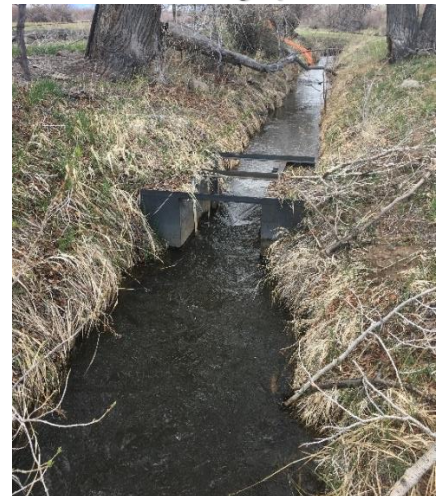
**Repair(s) or Improvement(s) Completed Since 2006:** Wooden weir was replaced with steel Parshall flume.

Flume looking upstream
