# SAGUACHE CREEK

## DIVERSION INFRASTRUCTURE INVENTORY

**Structure Name:** MUNRO D 2

**Date:** April 11, 2019

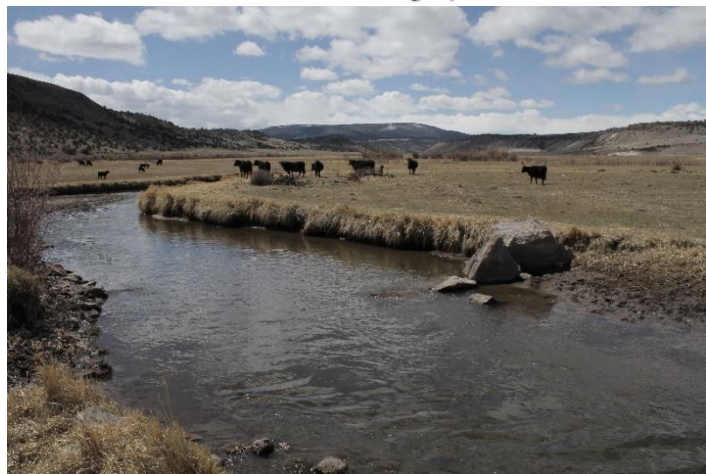
**Structure Description:** This ditch is located at the downstream end of a meander in the stream. A couple of boulders form the diversion dam but it does not function well. The streambank upstream of the diversion is eroding. The flume has sunk into the soil and willows have caused its side walls to collapse slightly.

Diversion dam looking upstream

**Repair(s) or Improvement(s) Currently Needed:** Bank stabilization is recommended upstream of the headgate. The diversion dam should be improved. The flume needs to be repaired or replaced. Existing fish passage should be maintained and riparian restoration should be considered as part of any future repairs or improvements.

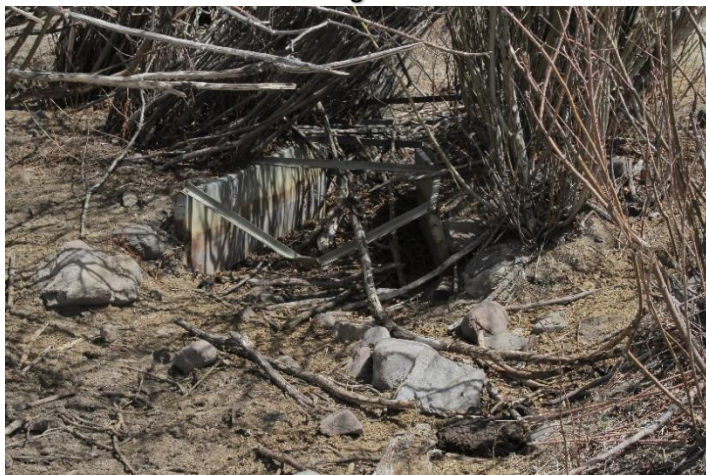
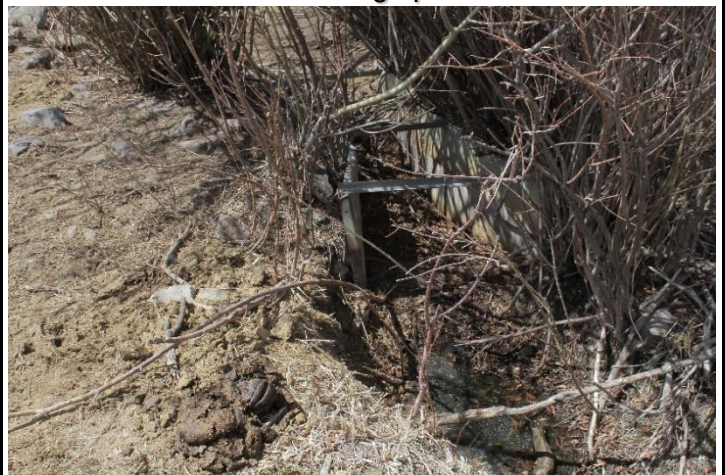
Flume looking downstream

Flume looking upstream
