Thermal Imaging - A Better Solution for Inspecting G10 Laminates

By Charles J. Hazouri,

Qualitative and Quantitative Infrared Thermography is a more informative and non-invasive inspection technique-making it the perfect tool for marine inspections of G10 as well as all Fiberglass Laminates.

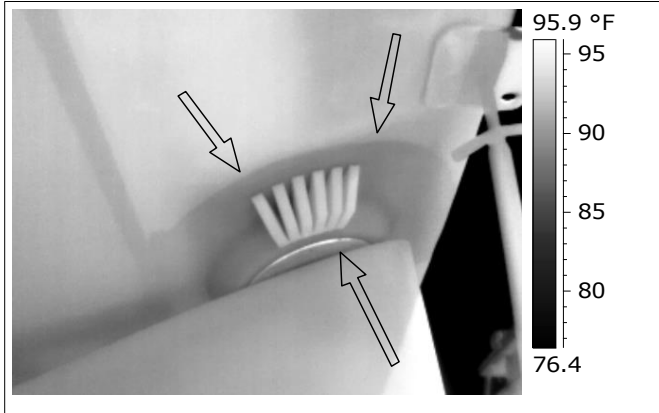
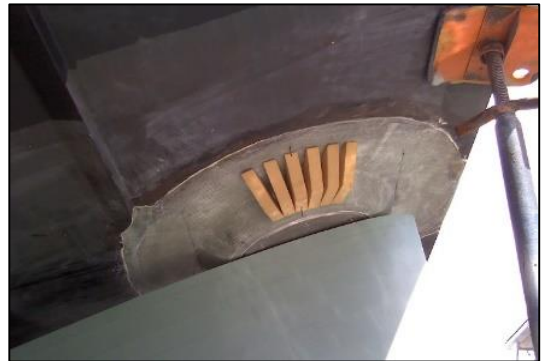
The following Thermographic images of the stabilizer mounting and backing areas show that G10 has very well-defined, delineated edges, and appears much darker and is distinctive from regular laminates, which is indicated by the arrows in the following four thermal images:

Lead portion of the stabilizer systems mounting and backing installation looking aft.

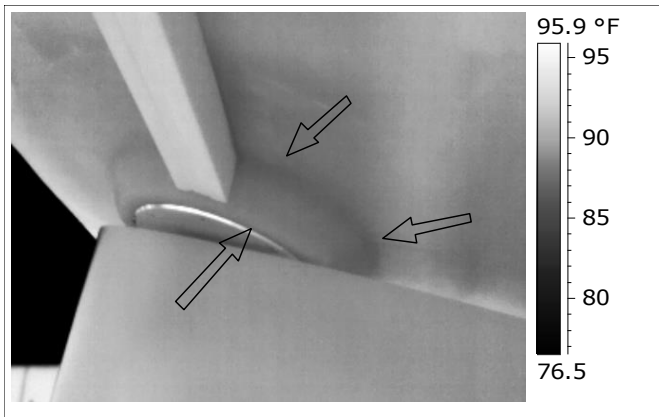
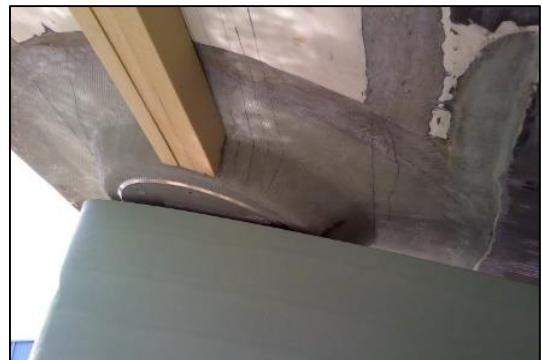
Trailing part of the stabilizer systems mounting and backing installation looking forward.

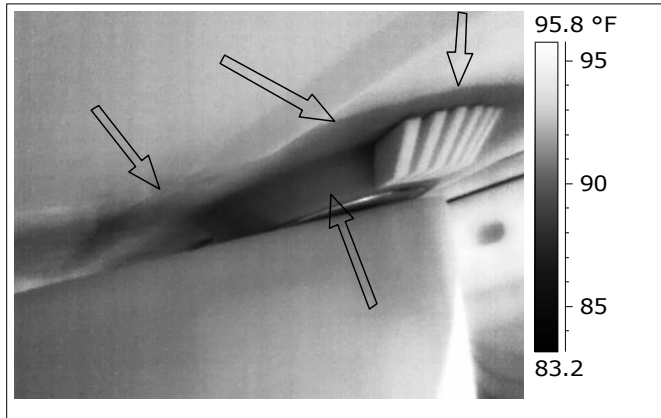
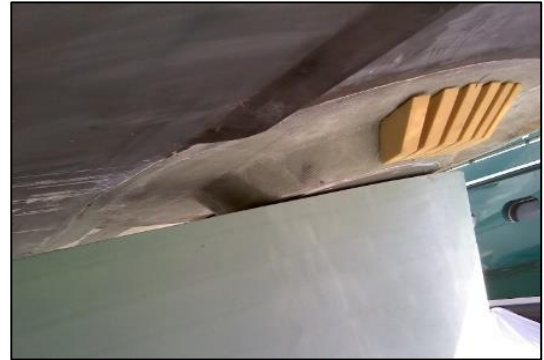
Lead portion of the stabilizer systems mounting and backing looking aft and outboard.

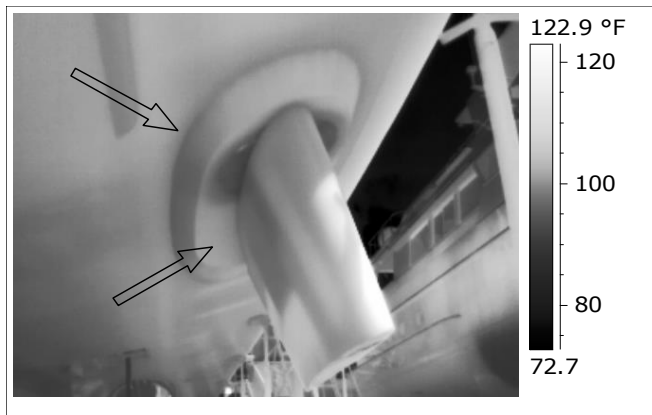
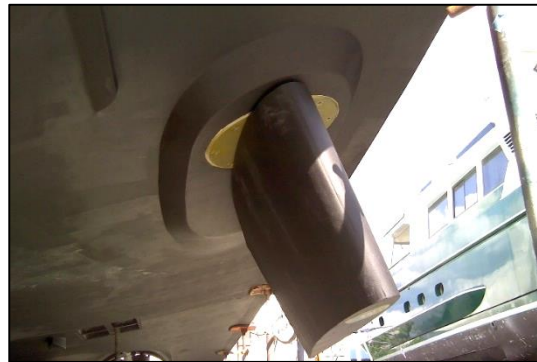
Lead portion of the stabilizer systems mounting and backing installation looking aft after the reconstruction and repairs.

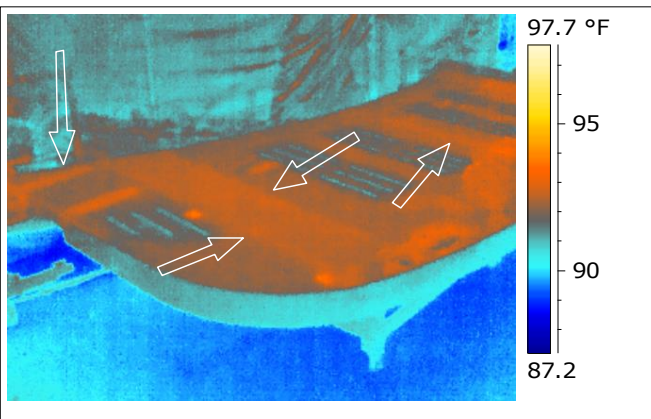
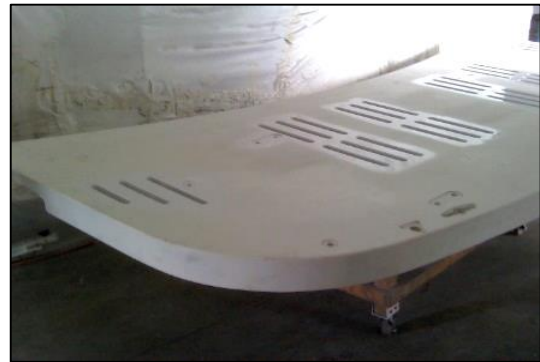
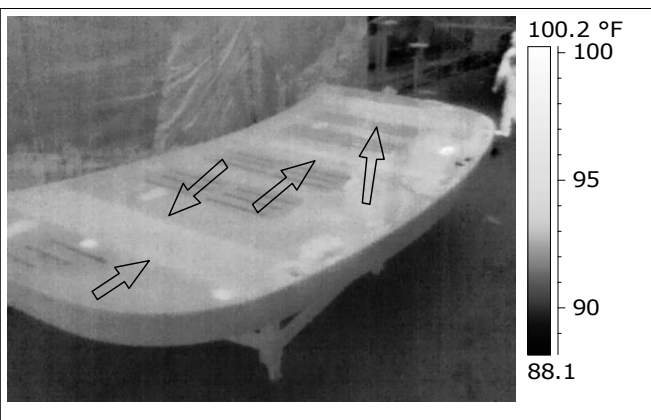
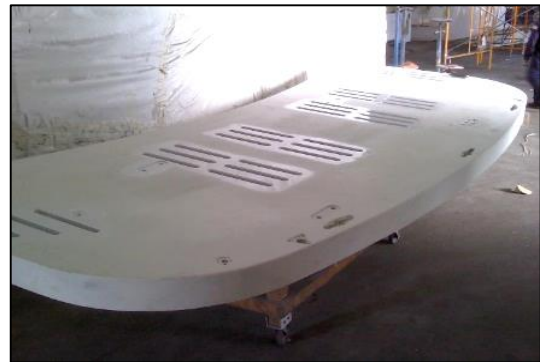
The top section of the swim platform prior to installation.

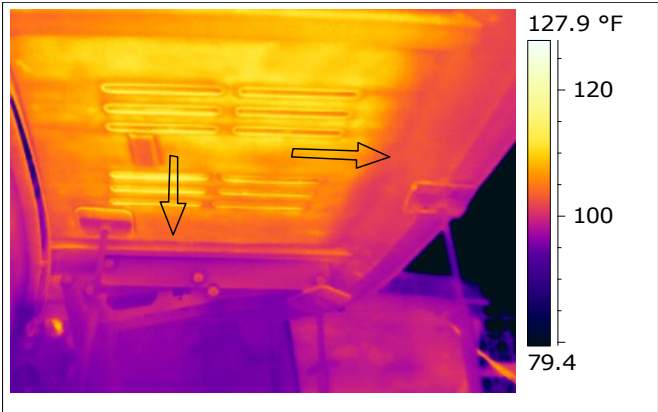
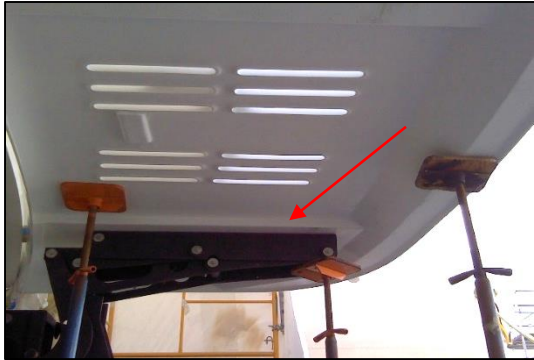
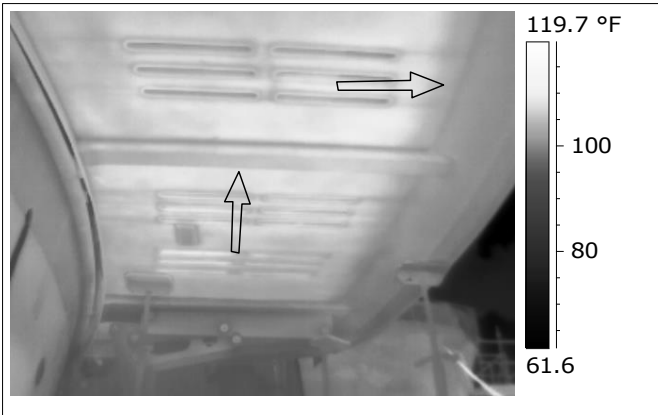
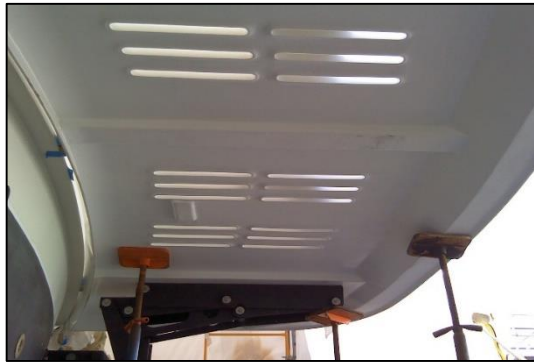
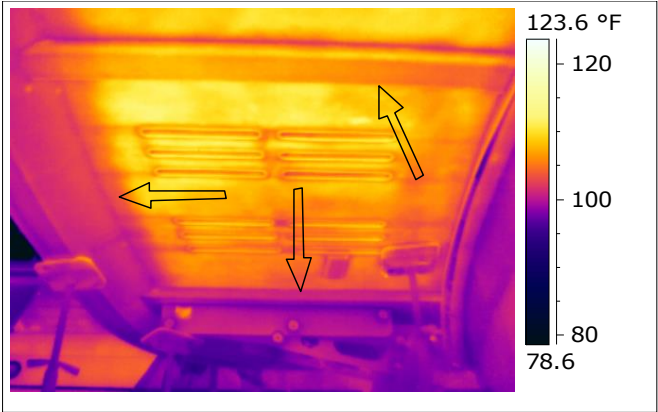
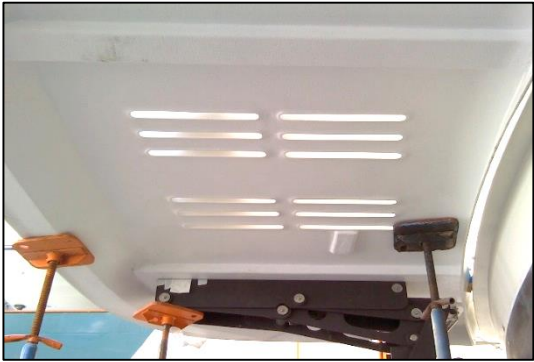
The underside of the swim platform after installation. Take note that using a product with strength and versatility such as G10 allows the contractor to use a non-metallic structural member that can withstand the weight and force of the swim platform's hydraulic rams (indicated by the red arrow in the first digital picture) as seen in this application and in the images above of the underside of the starboard portion of the swim platform.

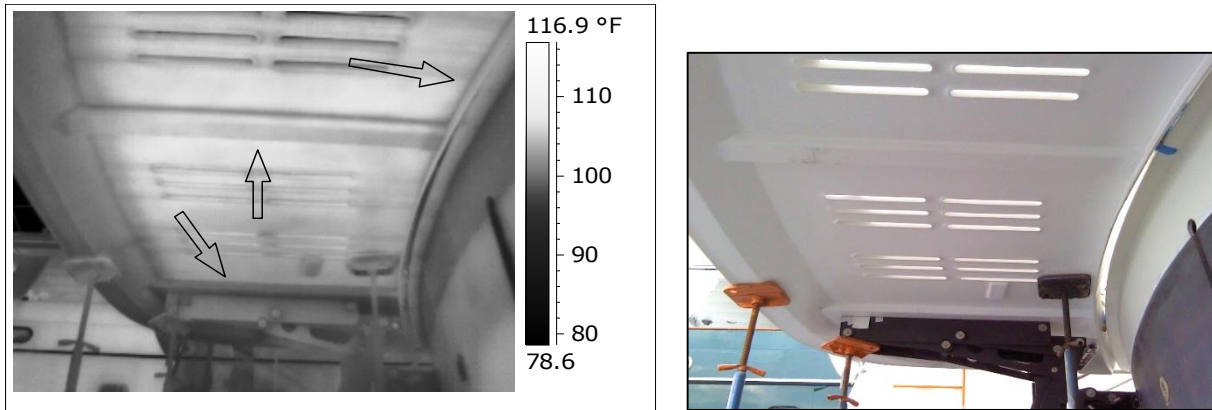
The underside of the port portion of the swim platform.

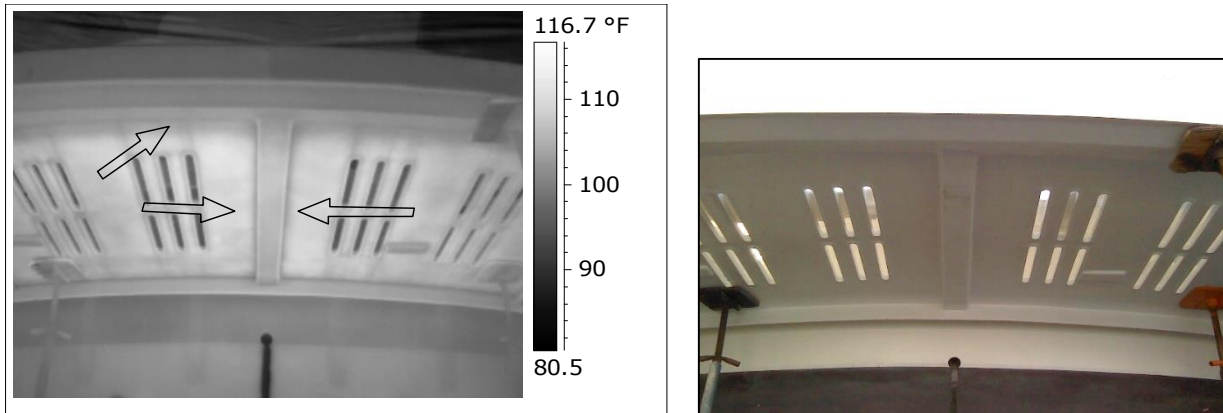
The underside of the center portion of the swim platform.

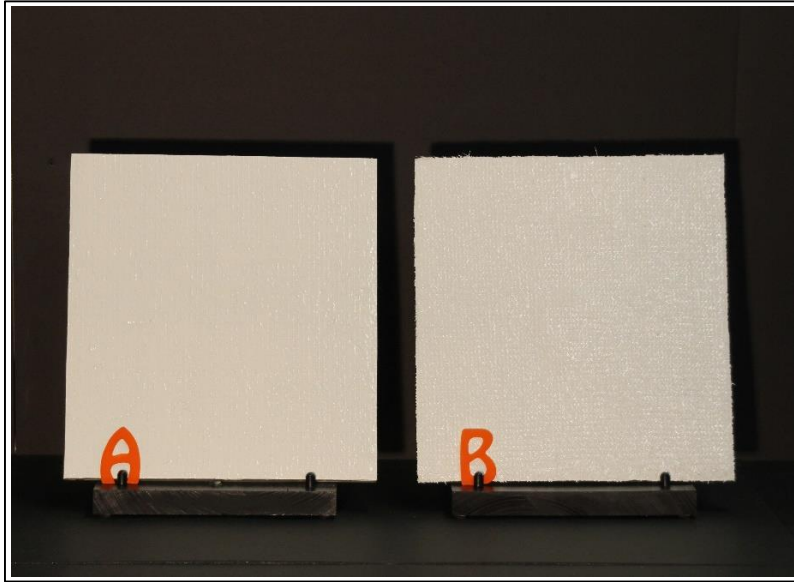
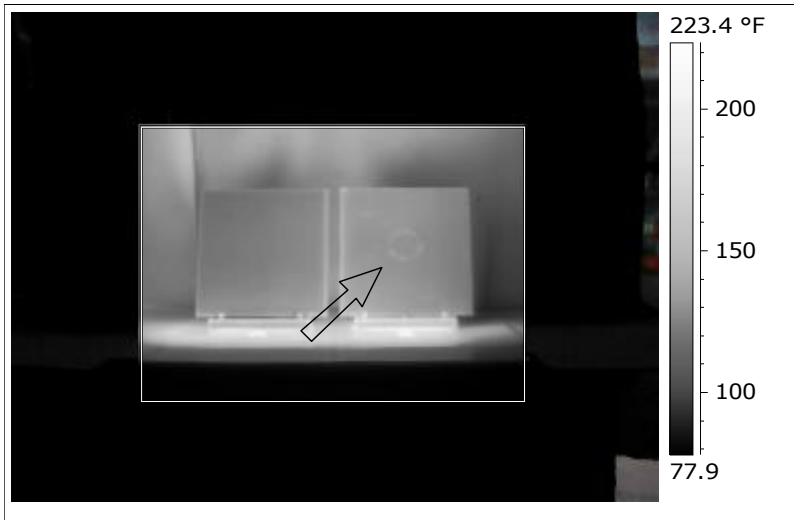
Sample A and B, together shows that there is a defined pattern when imaging G10 laminates and that any non-conformity can be easily identified using thermographic inspection techniques.

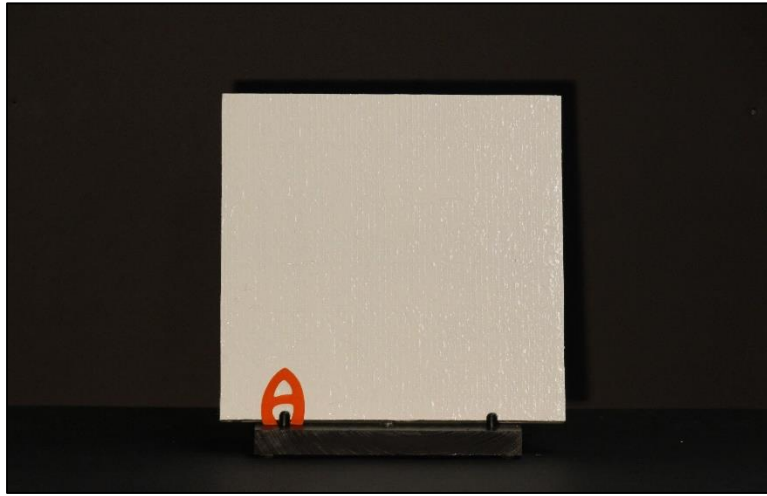
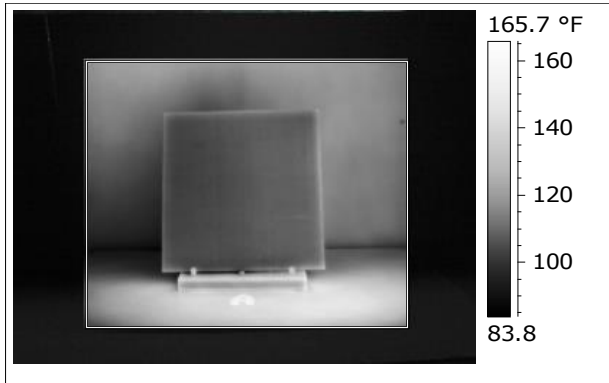
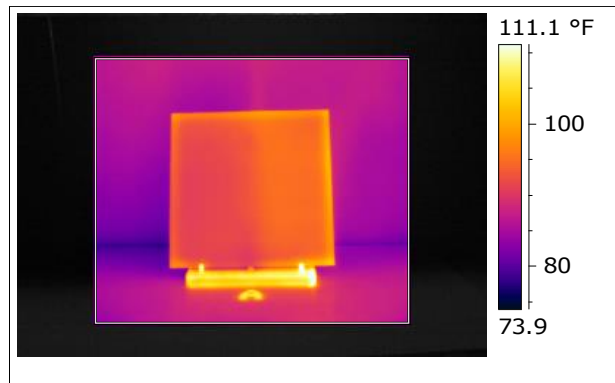
Sample A, which was imaged in Gray and Iron Scales, shows a distinct pattern to the G10 laminate. There were no non-conformities in this image.

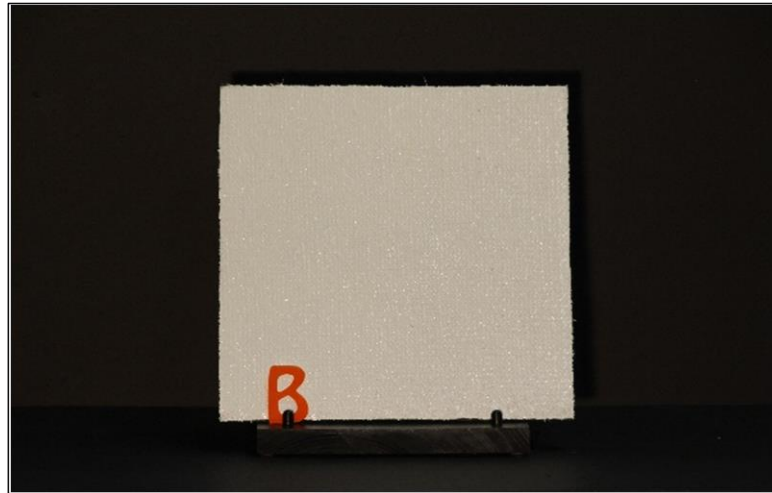
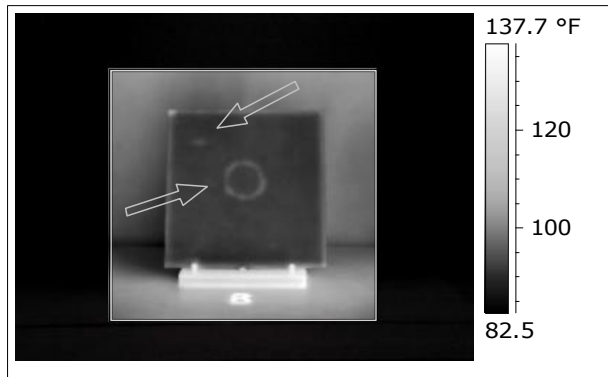
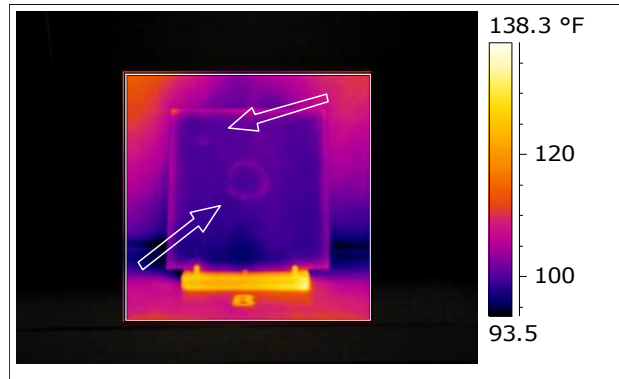
Delamination is an area of separation within or between two plies in a laminate or within a bonded joint caused by contamination, improper adhesion during processing, or damaging interlaminar stresses.ⁱⁱ

A small **Void** refers to a situation where air or gas has been trapped and cured in a laminate during the manufacturing process.ⁱⁱⁱ

Sample B, which was imaged in Gray and Iron Scales, shows that a distinct and pronounced non-conformity exists within this sample of G10 laminate. The non-conformity is consistent to an area of delamination and/or a small void.

For best results, it's recommended that all areas constructed using G10 as well as all Fiberglass Laminates be Thermal Imaged and documented prior to and after repairs and/or construction.
