CONEJOS RIVER

DIVERSION INFRASTRUCTURE INVENTORY

Structure Name: MANASSA D

Date: April 15, 2019

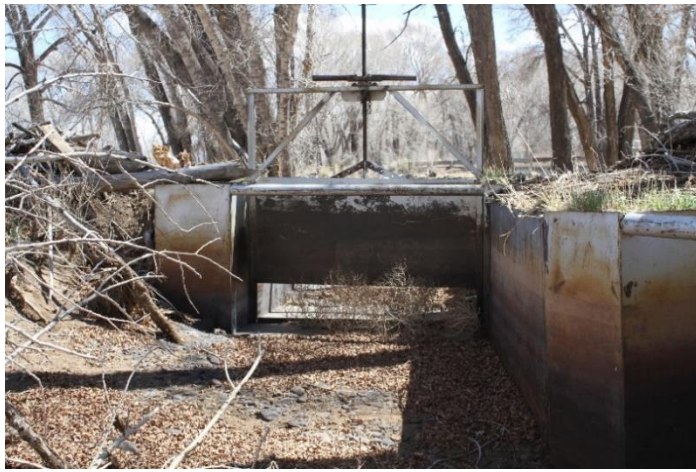
Repair(s) or Improvement(s) Currently Needed: The headgate is slightly crooked. There are plans to straighten the headgate to improve its function and administration. Fish passage and riparian area restoration should be considered as part of any future repairs or improvements.

Headgate looking downstream

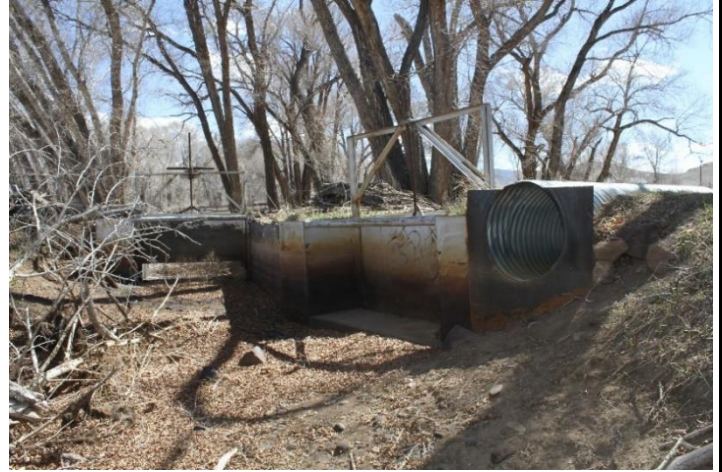
Headgate and diversion dam

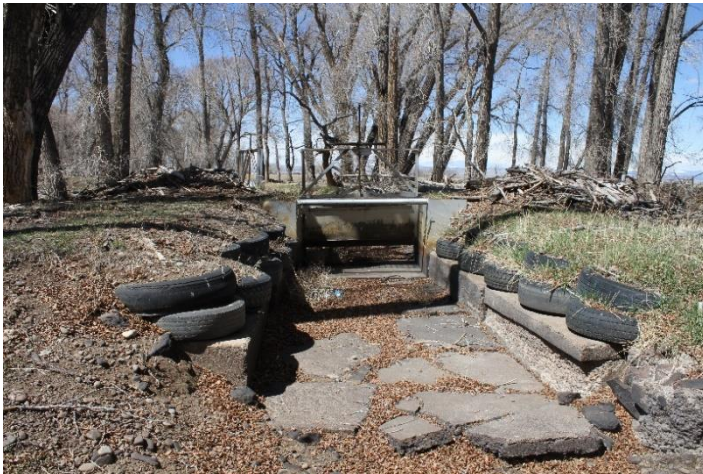
Headgate outlet

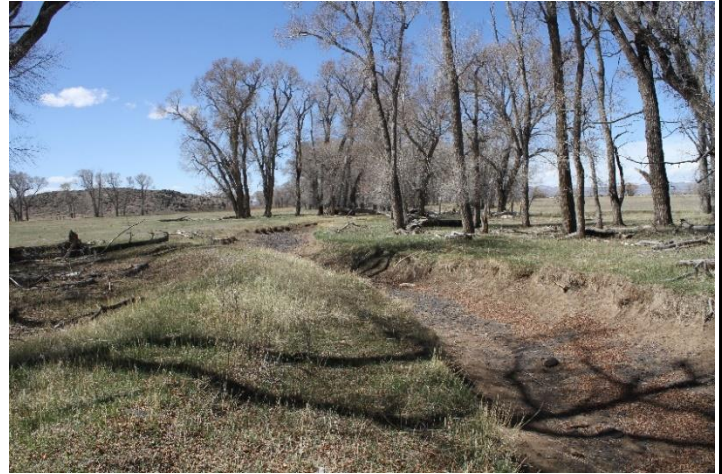
North branch Conejos looking upstream of structure

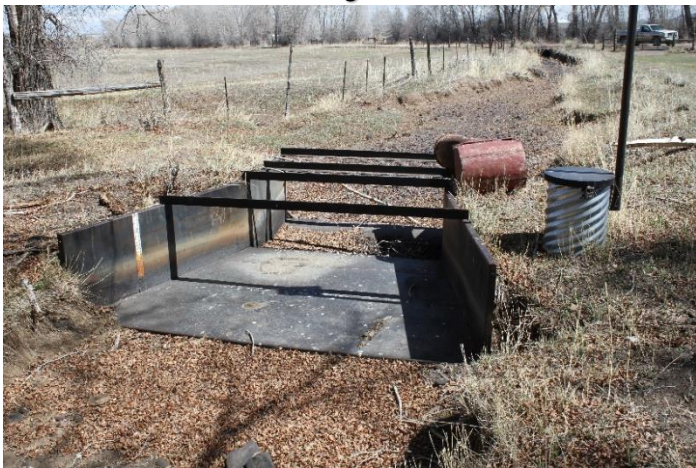
Flume looking downstream

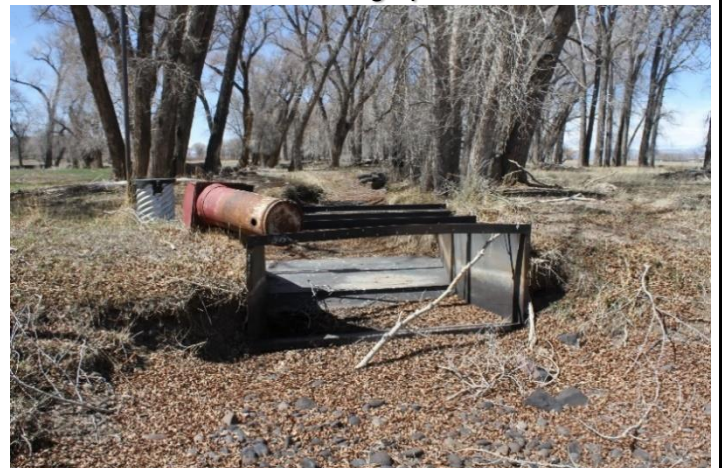
Flume looking upstream
