CONEJOS RIVER DIVERSION INFRASTRUCTURE INVENTORY

Structure Name: CHRISTENSEN D

Date: April 16, 2019

Conejos River Stream
Management Plan

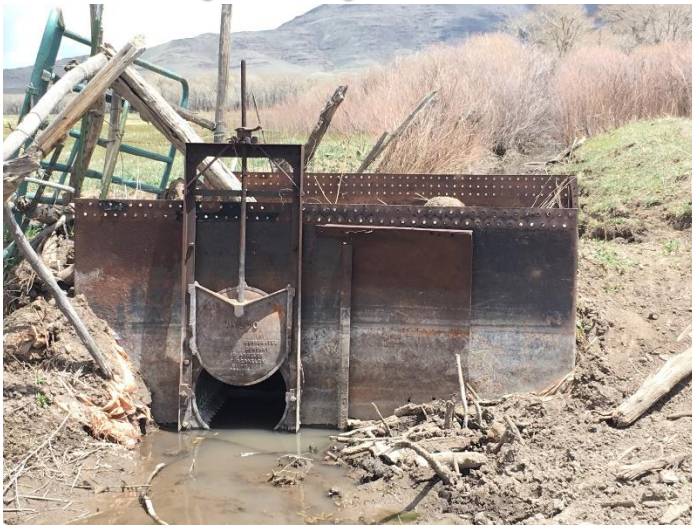
Repair(s) or Improvement(s) Currently Needed: The headgate is aging and should be replaced. The ditch requires general maintenance, including clearing accumulated sediment.

Headgate looking downstream

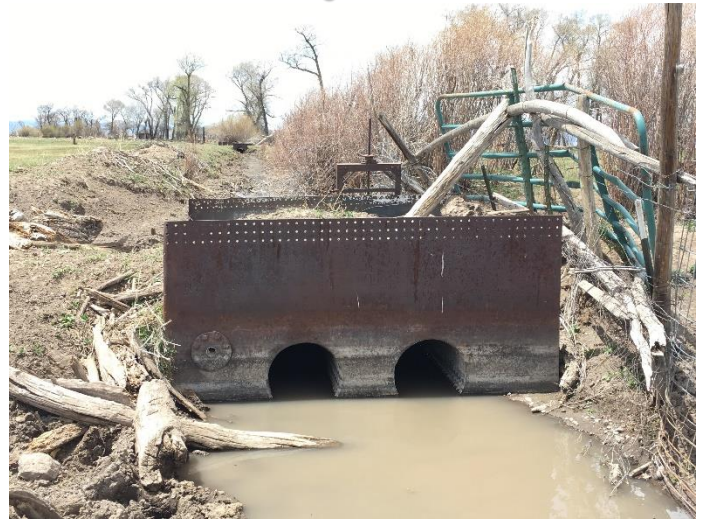
Headgate outlet

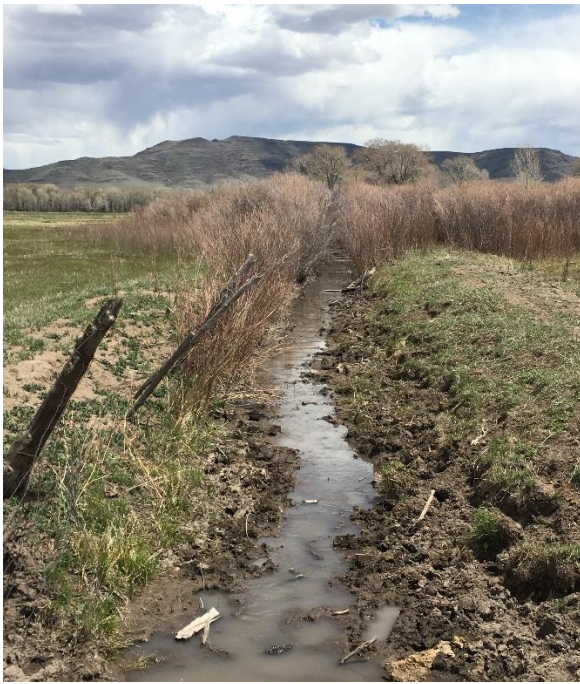
Ditch looking downstream of headgate
