# SAGUACHE CREEK DIVERSION INFRASTRUCTURE INVENTORY

**Structure Name:** FORD D 1 AND 2

**Date:** April 11, 2019

Saguache Creek Stream Management Plan

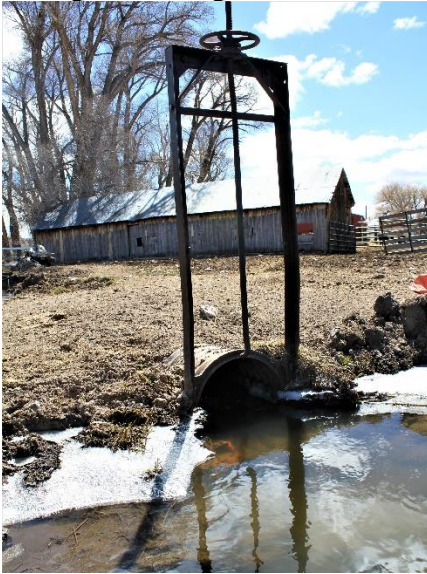
**Repair(s) or Improvement(s) Currently Needed:** The headgate has no cover and needs to be repaired. The flume does not measure accurately due to aquatic plants growing in front of the flume. It needs to be regularly cleaned and maintained.

Headgate looking downstream

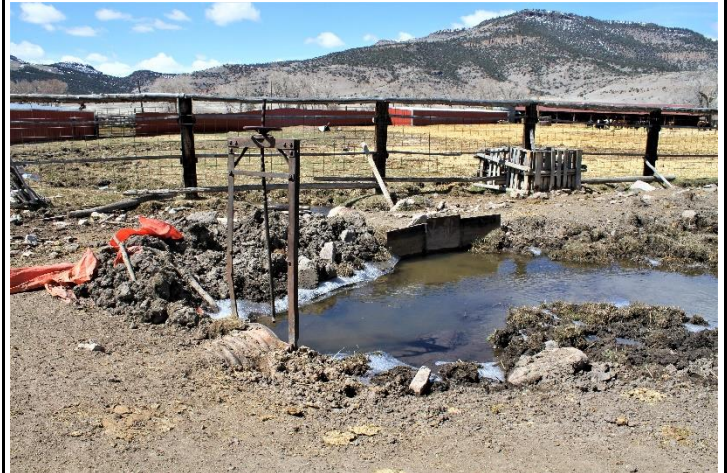
Headgate and overflow gate

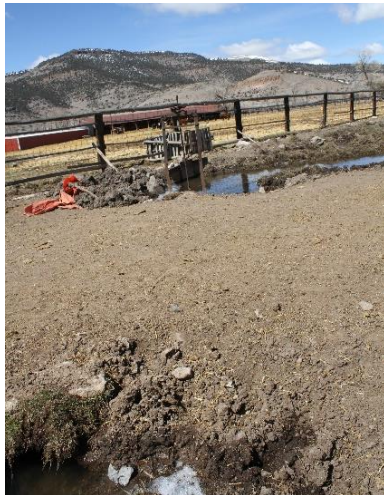
Headgate outlet

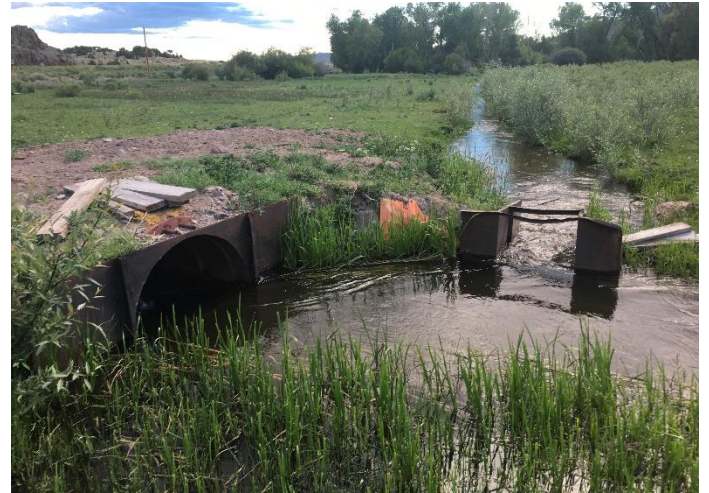
Branch in Ford Ditch (culvert on left services Ford Ditch 1 and 2)

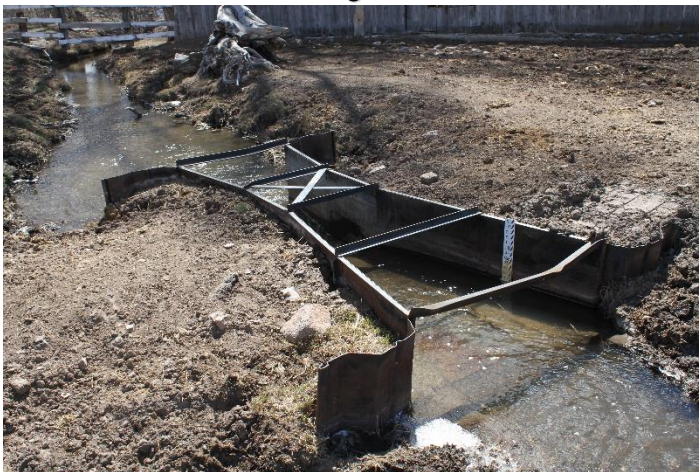
Flume looking downstream

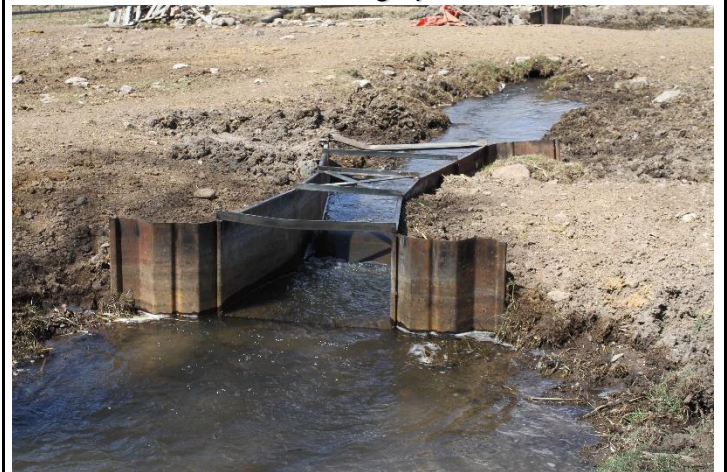
Flume looking upstream
