Apr 18th, 2024

2585 Redding Drive, Whitestown, IN, 46705

Home Inspection Report

Kyle Pfeifer / Pfeifer Home Inspection

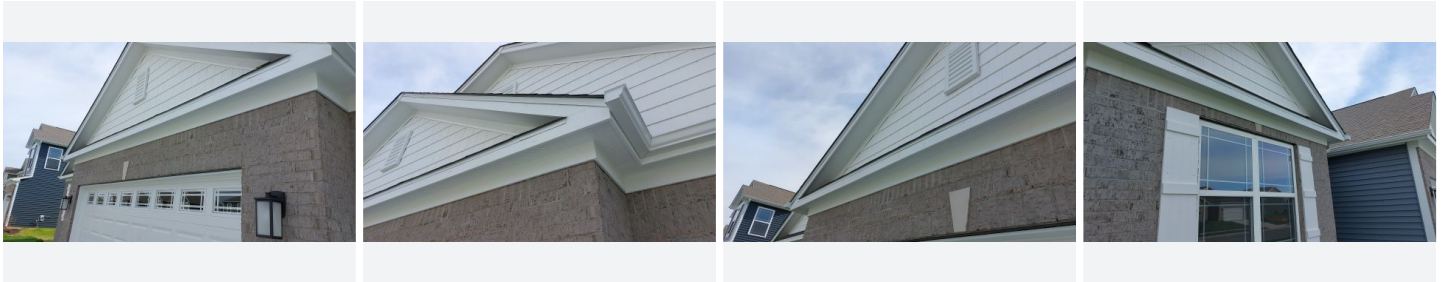
1.1 EXTERIOR TRIM

The exterior trim needs to be re-painted as several marks and blemishes were noted. A qualified contractor will need to review.

Maintenance

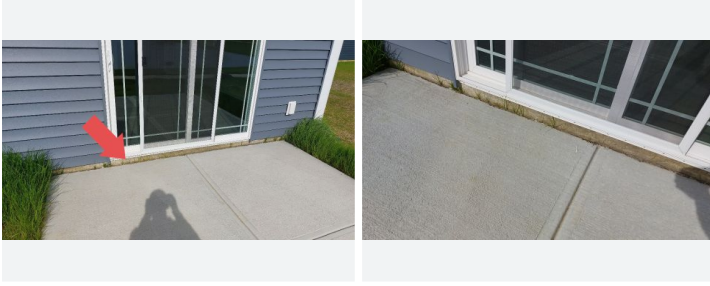
1.2 PATIO DOOR

Marginal

Typically, a piece of exterior wooden trim is installed under a sliding door to finish off this area. A qualified contractor will need to review.

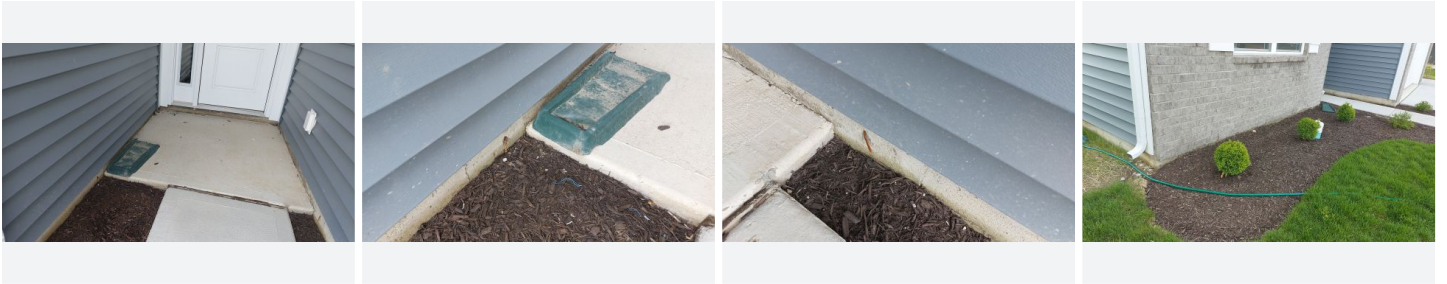
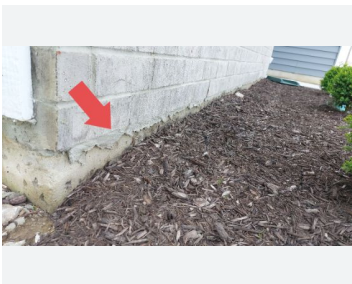
1.3 FOUNDATION/BRICK

Marginal

In pictures 1-3 we found two nails sticking out of the foundation needing to be removed. Along the front of the home, we noticed the mortar below the last row of brick was finished poorly and is cosmetically not pleasing. Further evaluation is required.

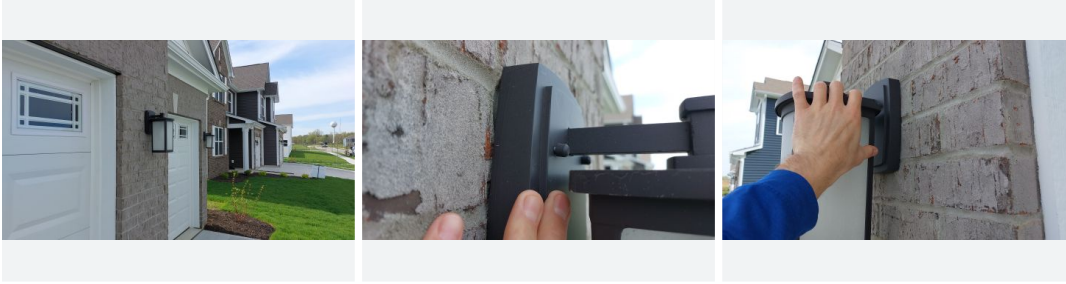
1.4 EXTERIOR LIGHTING

Marginal

All of the exterior electrical fixtures are loose. Furthermore, we recommend applying a layer of clear caulking around the lights to prevent insects from living inside the junction box.

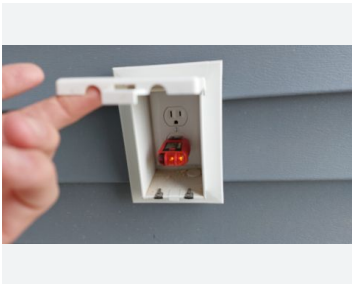
1.5 EXTERIOR ELECTRIC OUTLETS

Acceptable

The exterior outlets were all tested and in working condition. The exterior covers are properly protecting the outlets.

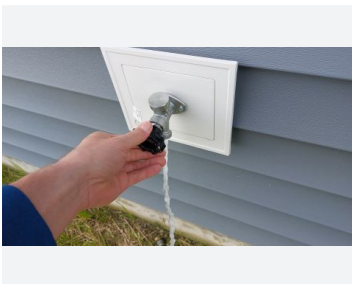
1.6 HOSE BIBS

Acceptable

The exterior hose bibbs were in working condition during our inspection. No leaks or obvious imperfections were observed.

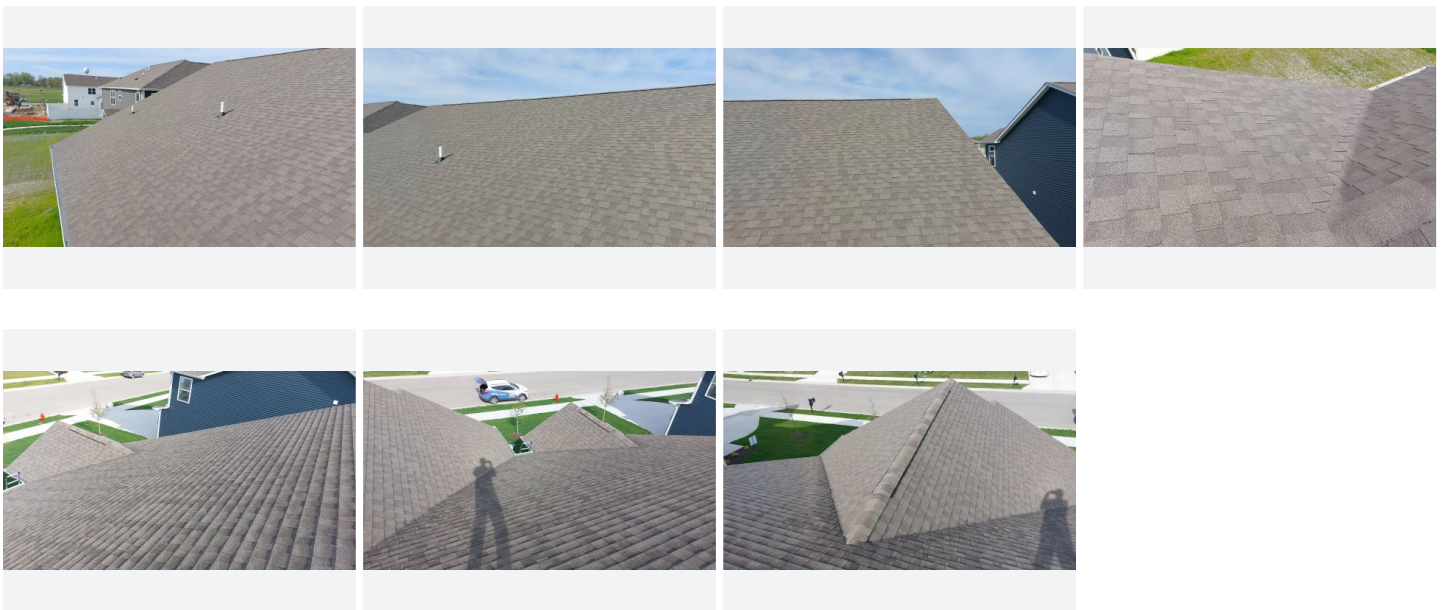
2.1 ROOFING MATERIAL

Marginal

We did not notice any major issues or imperfections with the architectural shingles. The shingles are relatively new with no significant deterioration noted. Water is properly being shed down to the gutters and away from the foundation as expected. No active or previous signs of water entry were discovered. All of the roofing/plumbing vents were installed correctly and leak free. The only issue we noticed was the large amount of roofing nails left on the roof.

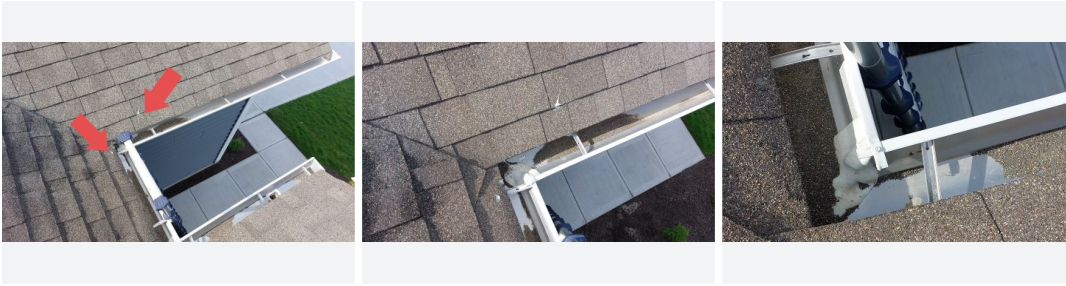
2.2 GUTTERS

Marginal

On the roof we found two spots where the white caulking from the gutter installation has contacted a few shingles. Further evaluation is needed.

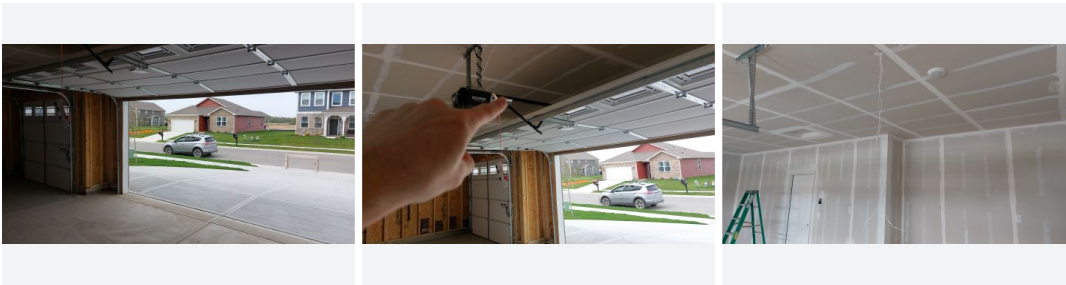
3.1 GARAGE DOORS

Marginal

We tested the operation of the two-door garage door and found the chain needs to be heard as the trolley is contacting the chain. We also noticed a motor was not installed on the one door garage door. A qualified contractor will need to review.

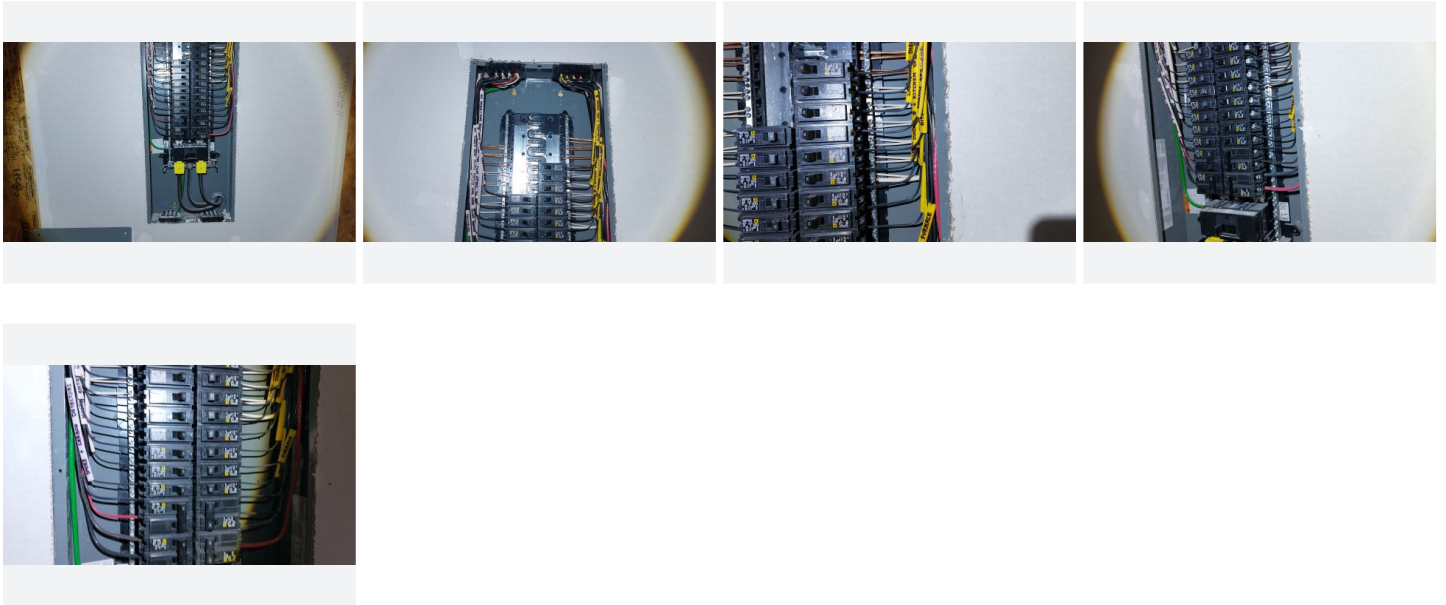
4.1 ELECTRICAL PANEL

Acceptable

After carefully reviewing the electrical panel, we did not observe any major imperfections. All the wiring was the correct size for the attached breaker. No loose or 'arced' wiring was noticed inside of the panel. All white/neutral wiring was properly isolated on the bus bars. No open knockouts were found as well.

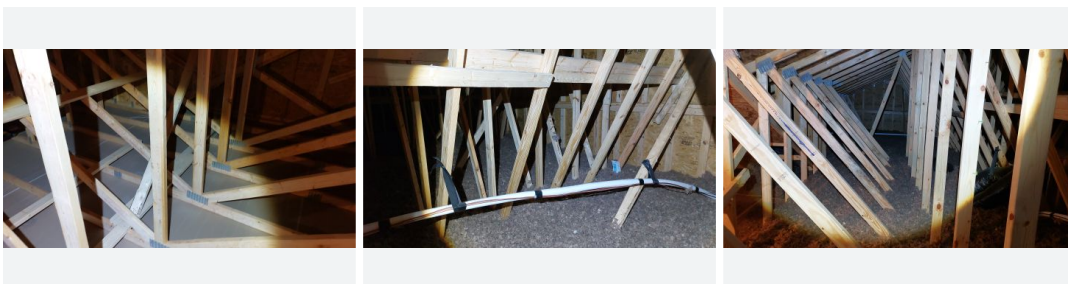
5.1 ROOF FRAMING

Acceptable

Structurally speaking we do not see any issues with any of the 2x4 trusses we could see. All of the trusses are properly connected with no signs of any stress cracks/splitting. No active or previous signs of water entry were found. The attic appears to be ventilating properly as it is roughly the same temperature as the outside. A satisfactory amount blown in insulation was found throughout the attic.

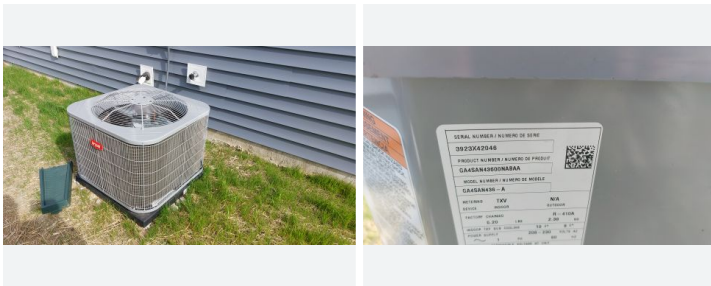
6.1 A/C SYSTEM OPERATION

Acceptable

The exterior condensing unit was tested and in working condition. The exterior aluminum fins were in good condition and the suction line properly insulated. We also recommend servicing the AC unit yearly.

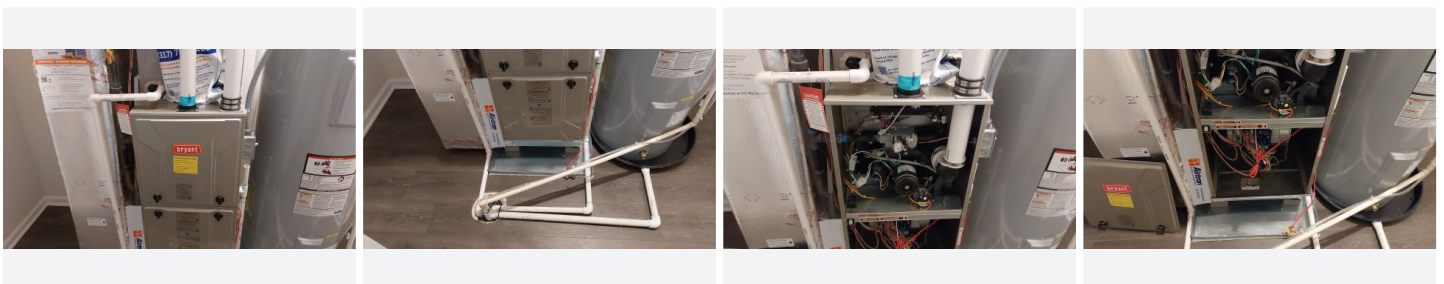
7.1 HEATING SYSTEM OPERATION

Acceptable

We tested the furnace and found everything functioning normal. We removed the exterior covers and found no imperfections inside the unit. The wiring is hooked up correctly and with no active leaks inside the unit. We recommend servicing the unit yearly.

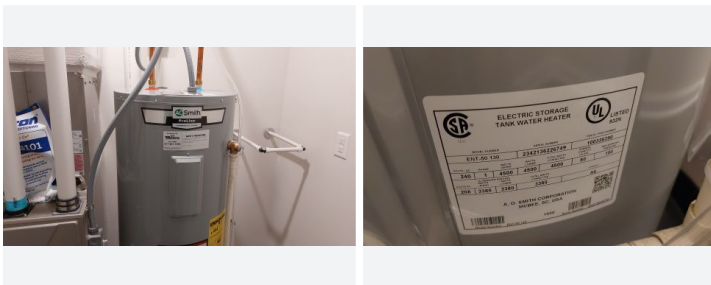
8.1 WATER HEATER OPERATION

Acceptable

This particular hot water heater was functioning properly during our inspection. Hot water was getting delivered to the appropriate places as expected. We recommend draining ten gallons from the tank to clean it out and wash any built up sediment out.

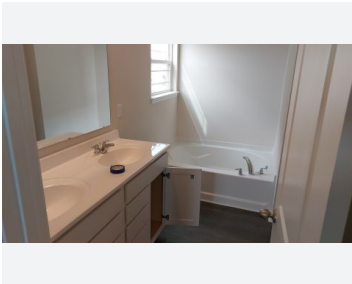
10.1 WALLS

Maintenance

A few holes/imperfections were noticed on the drywall in this room. We noted all paint or drywall mistakes with blue tape.

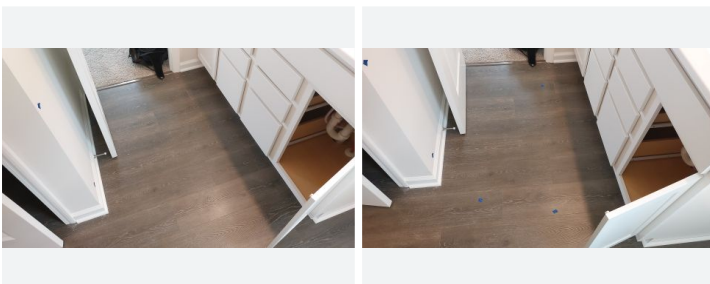
10.2 FLOOR

Marginal

As we were reviewing the floor we found a few scratches around the sink. A qualified contractor will need to review.

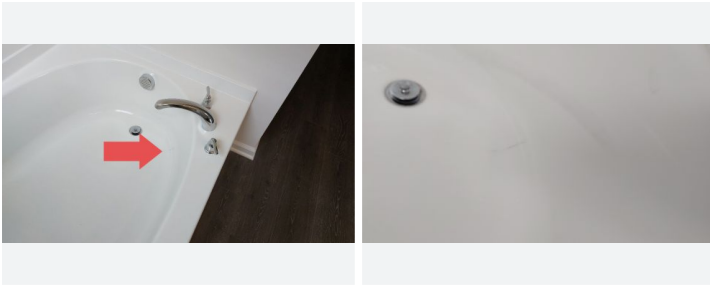
10.3 TUB/SURROUND

Marginal

In the tub we noticed a few scratches. They may come up with a good cleaning. Further evaluation is needed.

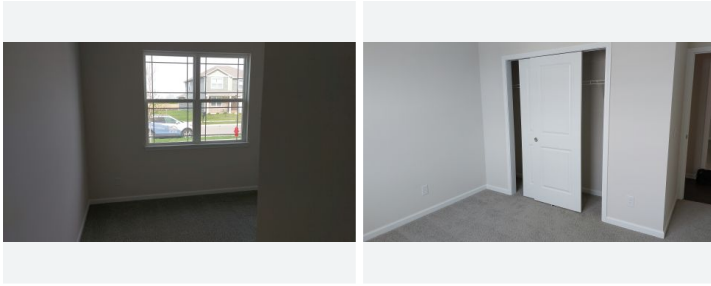
13.1 WALLS

Maintenance

A few holes/imperfections were noticed on the drywall in this room. We noted all paint or drywall mistakes with blue tape.

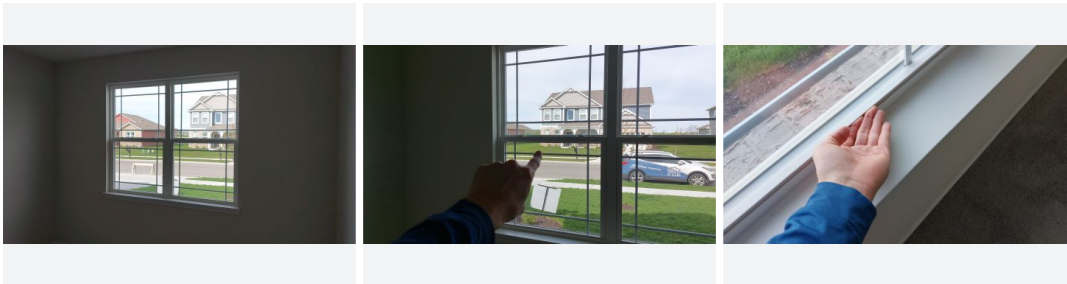
13.2 WINDOWS

Marginal

We were unable to open the window on the left side in this room. A qualified contractor will need to review.

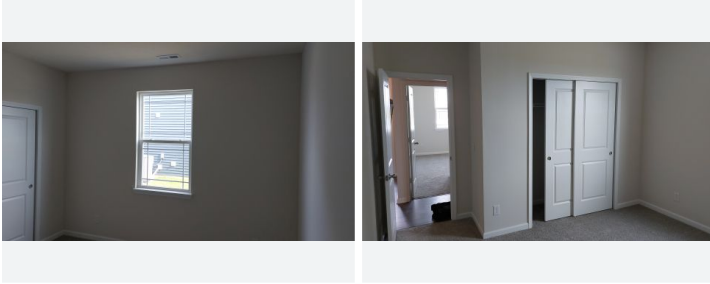
14.1 WALLS

Maintenance

A few holes/imperfections were noticed on the drywall in this room. We noted all paint or drywall mistakes with blue tape.

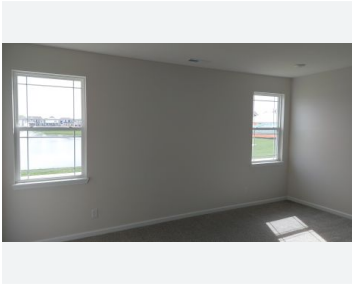
15.1 WALLS

Maintenance

A few holes/imperfections were noticed on the drywall in this room. We noted all paint or drywall mistakes with blue tape.

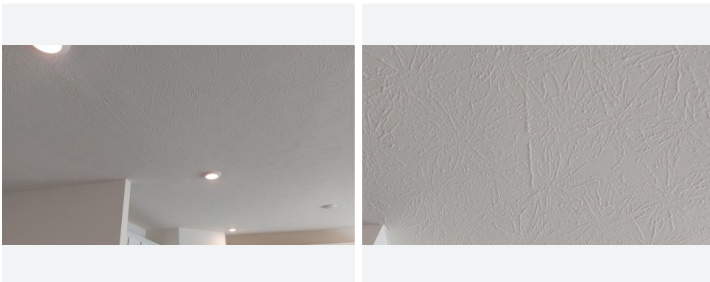
16.1 CEILING

Maintenance

One minor crack was found on the ceiling in the family room. Repairs will need to be made by a qualified contractor.

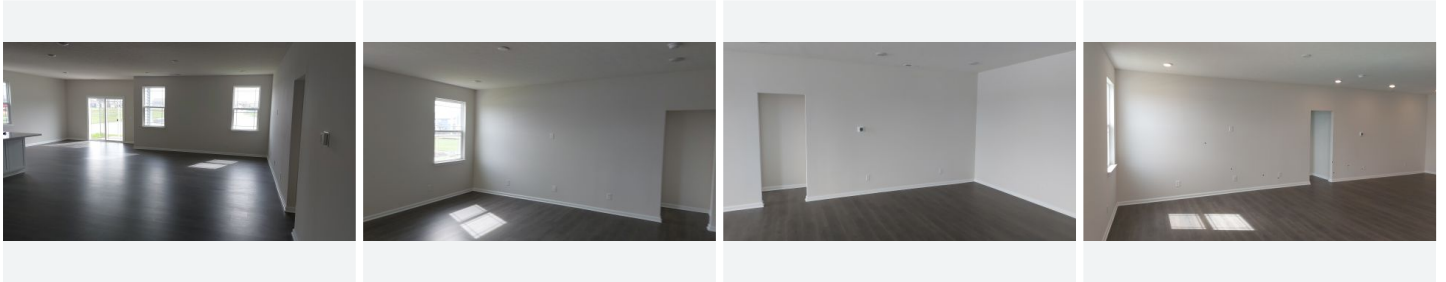
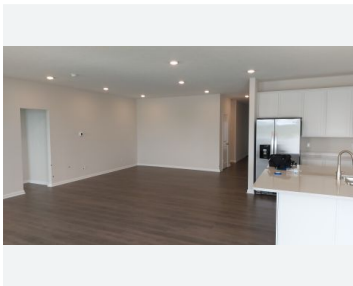
16.2 WALLS

Maintenance

A few holes/imperfections were noticed on the drywall in this room. We noted all paint or drywall mistakes with blue tape.

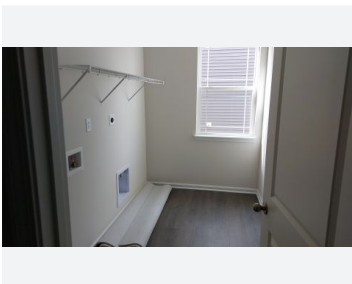
17.1 WALLS

Acceptable

Currently, no washer or dryer is hooked up inside of the laundry room. We did review the plumbing box and found both shut off valves were in good condition.
