CONEJOS RIVER

DIVERSION INFRASTRUCTURE INVENTORY

Structure Name: JACKS IRRIGATING D

Date: April 15, 2019

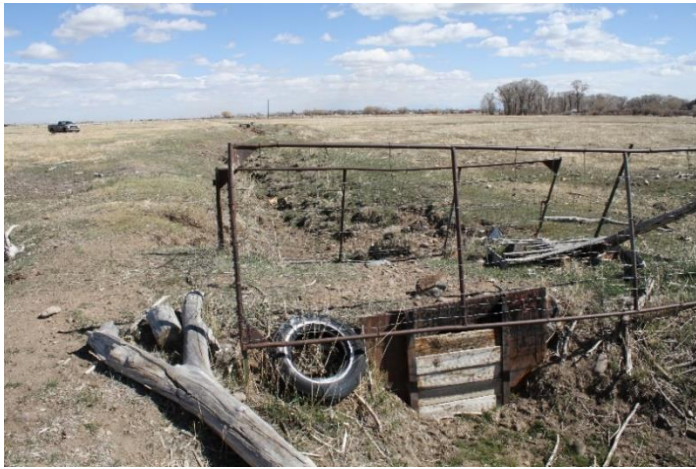
Headgate looking downstream

Repair(s) or Improvement(s) Currently Needed: The headgate needs to either be improved with a steel slide gate or replaced. The flume needs to be repaired or replaced. Significant erosion downstream of the flume and around the wing walls may cause it to fail and/or not measure accurately. Debris accumulation and sedimentation is an issue at this structure, particularly on the diversion dam. Fish passage restoration should be considered as part of any future repairs or improvements. Riparian area restoration would improve bank stability and provide beneficial stream shading.

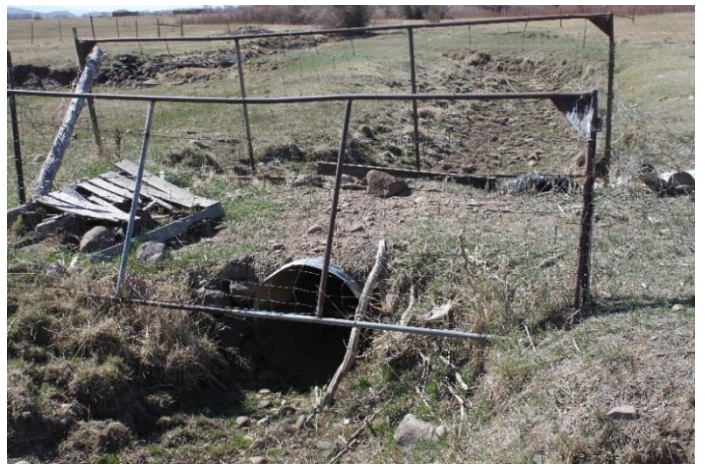
Headgate outlet

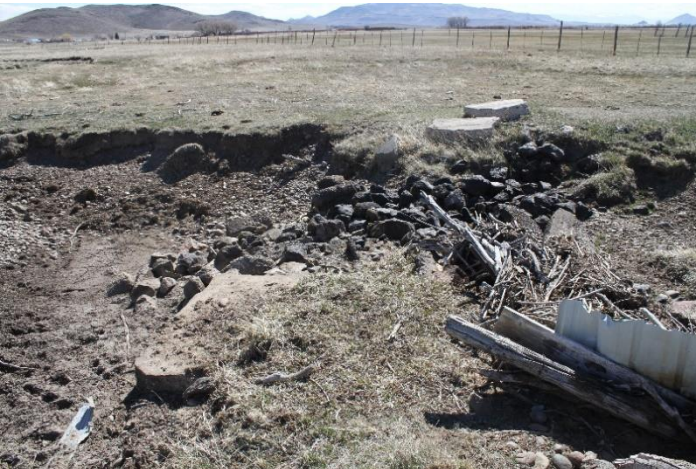
Diversion dam

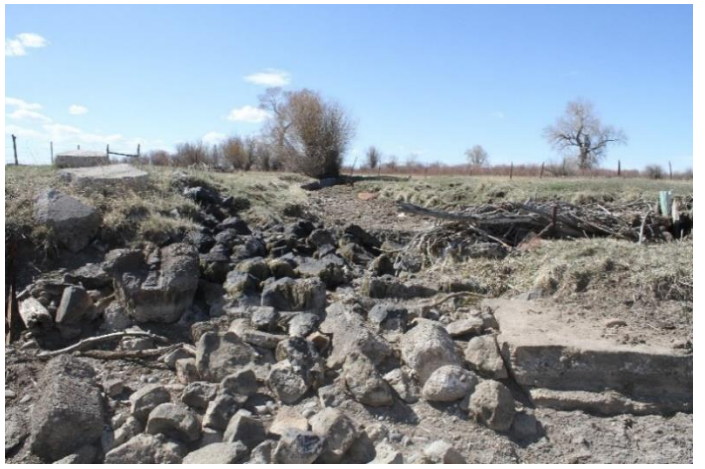
Diversion dam looking upstream

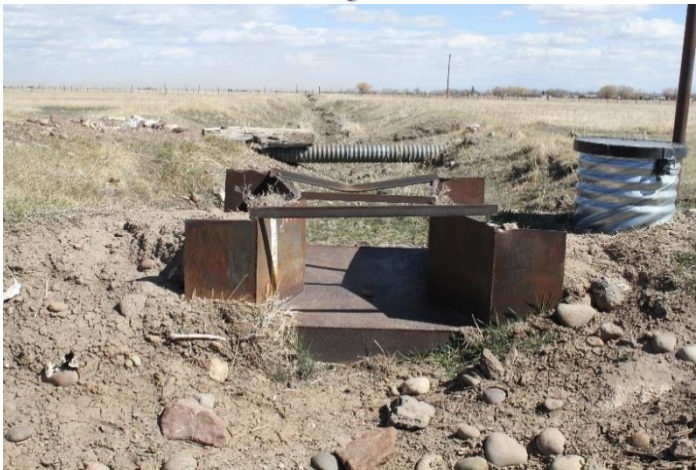
Flume looking downstream

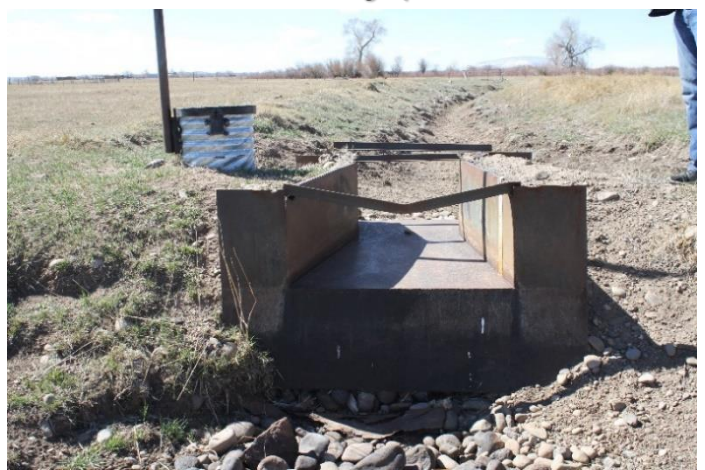
Flume looking upstream
