Northeast Home Inspections LLC

Report: Doe 2

Confidential Inspection Report 1 Center Green Road Northtown, NJ 07000

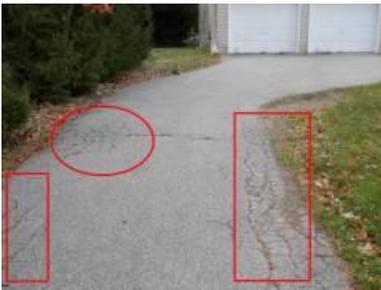
5.1 Driveway:

Asphalt construction, Common cracks (¼-inch or less) were visible in the driveway at the time of the inspection. Cracks exceeding ¼ inch should be filled with an appropriate sealant to avoid continued damage to the driveway surface from freezing moisture.

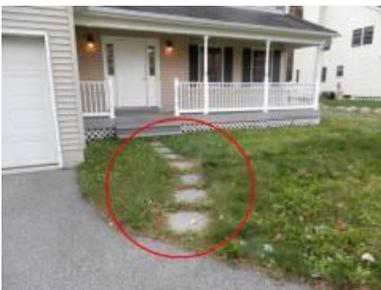
5.2 Walks:

The front walkway was comprised of separate stones set in the ground surrounded by grass. During the freeze and thaw cycles of the seasons, a trip hazard might develop. Recommend continued monitoring and upgrading the walkway in the future.

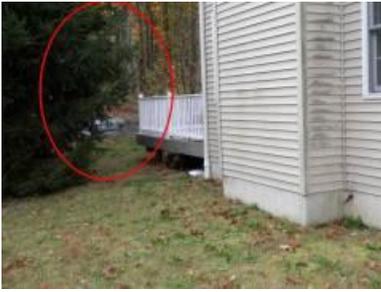
5.5 Condition:

Recommend trimming any bushes or trees in contact with the exterior siding, as this condition may also invite pests and Wood Destroying Insects to the location.

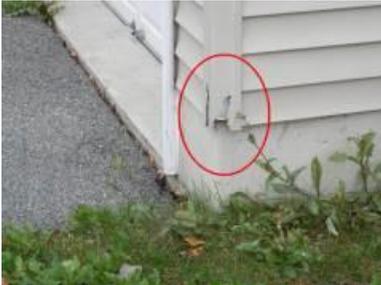
6.4 Exterior Trim

An exterior corner had some damage and should be replaced. This condition can lead to excessive moisture intrusion into the building envelope and over time compromise the structure.

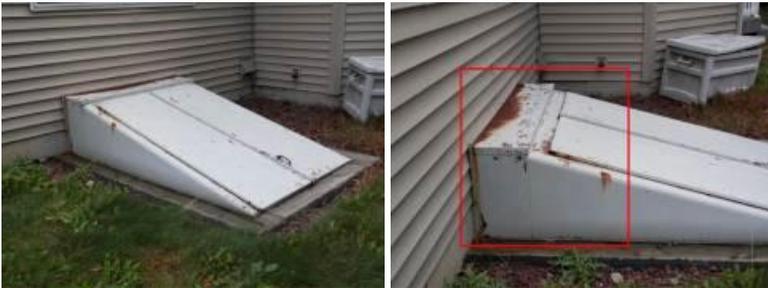
6.12 Exterior Basement Door:

At the time of the inspection the metal basement door appeared to be operational but needs maintenance to prevent further rusting and deterioration.

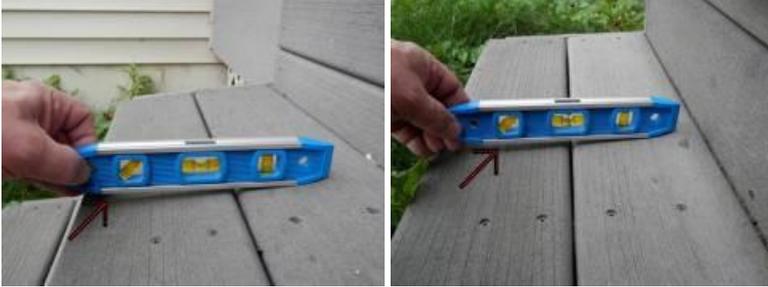
6.15 Condition:

Treads at the exterior porch stairway sloped more than the ¼-inch per foot maximum dictated by good building practice. This condition is a potential trip hazard. All corrections should be made by a qualified contractor.

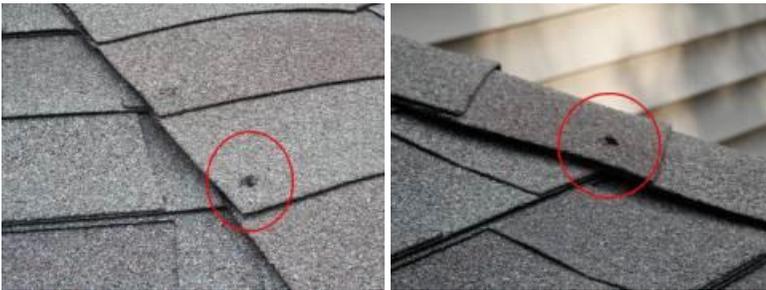
7.4 Roof Covering Condition:

The roof covering appeared serviceable at the time of the inspection but several locations were observed with popped nails which could lead to water infiltration. Recommend contacting a roofing contractor for further analysis and repair.

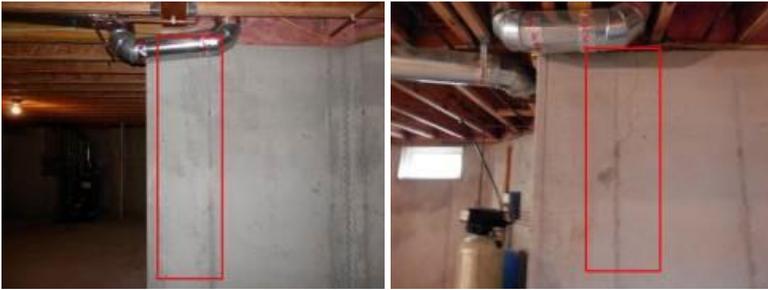
8.8 Cracked Foundation Wall

No Standards exist for evaluating cracks in concrete. Cracks appear for a wide variety of reasons, some of which may not be apparent at the time of the inspection. Cracks less than ¼-inch which do not exhibit displacement are typically not considered to be structural issues unless they appear in conjunction with another condition. The foundation below the kitchen out-cove appears to have settled separately from the main foundation creating observable cracks. No water infiltration was evident after a substantial amount of rainfall during the previous days suggests these cracks are not new. However, in the opinion of the inspector, conditions exist that warrant further investigation by a Professional Structural Engineer or foundation repair company. Seek bids to remedy the condition from at least three (3) Licensed Professional Foundation Contractors.

No Standards exist for evaluating cracks in concrete. Cracks appear for a wide variety of reason, some of which may not be apparent at the time of the inspection. Cracks less than 1/4-inch which do not exhibit displacement are typically not considered to be structural issues unless they appear in conjunction with another condition. The foundation below the kitchen out-cove appears to have settled separately from the main foundation creating observable cracks. No water infiltration was evident after a substantial amount of rainfall during the previous days suggests these cracks are not new. However, in the opinion of the inspector, conditions exist that warrant further investigation by a Professional Structural Engineer or foundation repair company. Seek bids to remedy the condition from at least three (3) Licensed Professional Foundation Contractors.

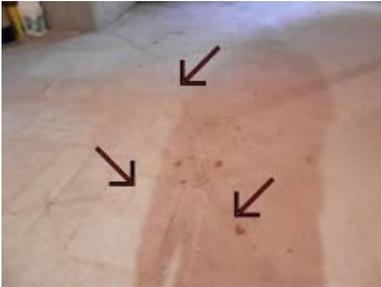
8.15 Condition

Common cracks were visible in the basement floor. This type of cracking can have several causes: (1) Concrete shrinkage, which is a normal part of the concrete curing process and not a structural concern. (2) Post-construction settling due to incomplete compaction of the soil beneath the slab during construction and is not an unusual condition and typically will not continue. (3) Heaving of the soil due to the presence of expansive soils. Determining the cause of cracking lies beyond the scope of the General Home Inspection but continued monitoring is recommended.

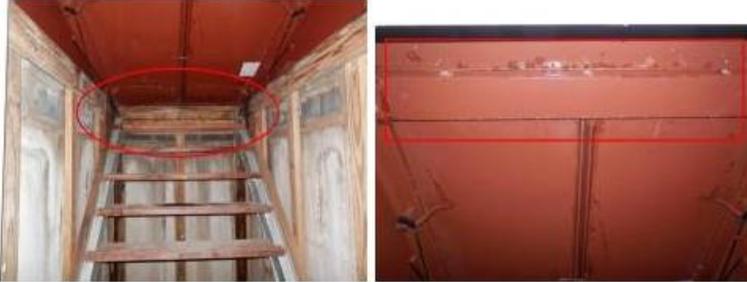
8.20 Exposed Walls

The exposed walls in the walk-out-well showed signs of moisture and the metal cover should be repaired and properly weather sealed.

EI The exposed walls in the walk-out-well showed signs of moisture and the metal cover should be repaired and properly weather sealed.

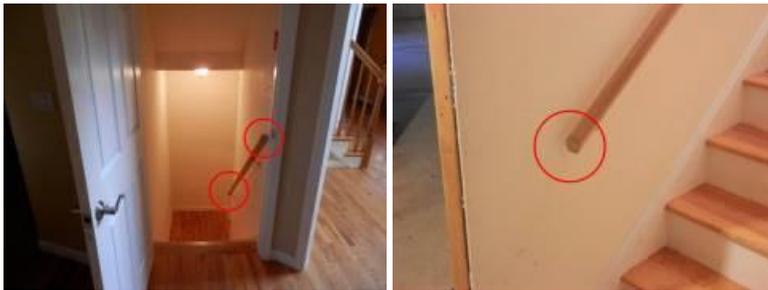
9.4 Handrail Termination:

The stairway descending into the basement had a handrail that was not secured properly at the top and bottom. Current safety standards require handrails terminate into a wall or a newel post to prevent snagging of clothing or objects as you walk up and down the steps. This condition can cause serious personal harm if this condition results in a fall. Recommend contacting a licensed contractor for repair.

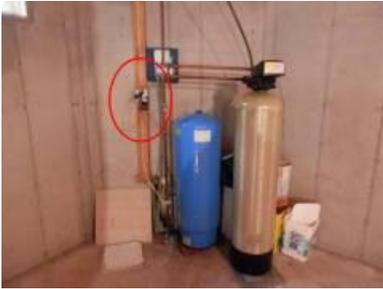
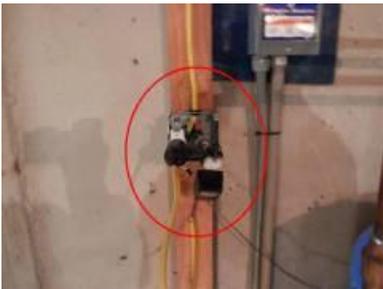
Energized electrical wires visible in the basement terminated outside of junction boxes. This condition is a potential shock/electrocution hazard. Wires should be terminated in an approved junction box with a cover installed by a qualified electrical contractor.

9.11 Energized electrical wires visible in the basement terminated outside of junction boxes. This condition is a potential shock/electrocution hazard. Wires should be terminated in an approved junction box with a cover installed by a qualified electrical contractor.

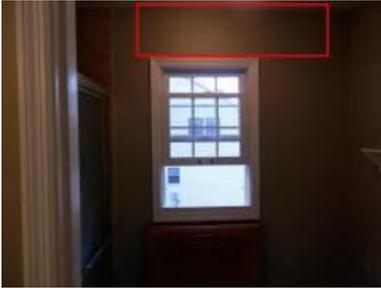
12.21 Master Bath:

Some black spots were noted at the time of the inspection by the shower window. These spots could be mold growth under the paper, but only lab testing would properly identify this condition. Excessive mold growth has been known to cause health issues with continued exposure. Recommend contacting a licensed contractor for testing if desired.

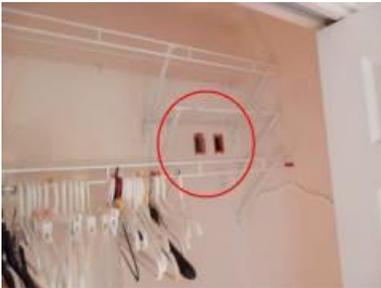
12.83 Living Room:

conditions were present. Recommend repairing the holes or adding cover plates to the openings.

The closet by the front of the room had openings in the drywall which could lead to the spread of fire if the conditions were present. Recommend repairing the holes or adding cover plates to the openings.

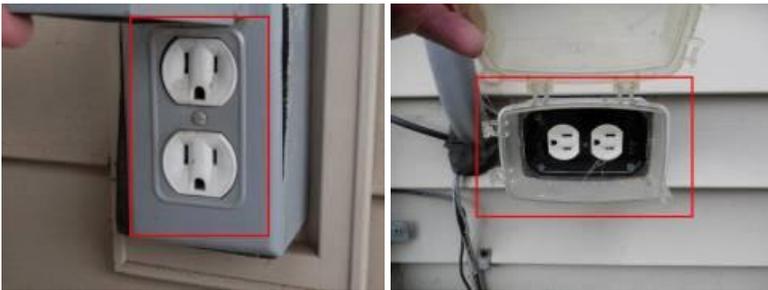
13.29 Exterior Walls:

Some exterior outlets did not have Ground Fault Circuit Interrupter (GFCI) protection at the time of the inspection. For safety reasons, the Inspector recommends all exterior outlets be provided with GFCI protection in good working order to avoid potential shock or electrocution hazards. All work should be performed by a qualified electrical contractor.

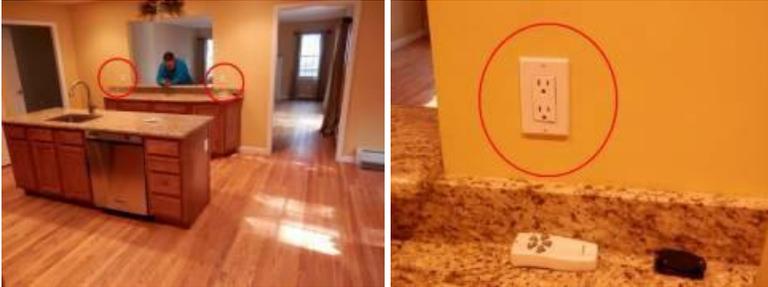
13.30 Kitchen Interior:

Electrical outlets in the kitchen were operable at the time of the inspection but some didn't have Ground Fault Circuit Interrupter (GFCI) protection. Consider having GFCI protection installed for outlets relating to all horizontal kitchen counter top surfaces. While this may have been the practice when the outlets were installed, more recent requirements suggest all outlets that service a countertop should be GFCI rated. The Inspector recommends installation of ground fault circuit GFCI protection as a safety precaution to help prevent electrical shock. This can be achieved by: 1. Replacing the current standard outlets with GFCI outlets. 2. Replacing the breaker currently protecting the electrical circuit that contains these kitchen outlets with a GFCI breaker. All electrical work should be performed by a qualified electrical contractor.

Electrical outlets in the kitchen were operable at the time of the inspection but some didn't have Ground Fault Circuit Interrupter (GFCI) protection. Consider having GFCI protection installed for outlets relating to

all horizontal kitchen counter top surfaces. While this may have been the practice when the outlets were installed, more recent requirements suggest all outlets that service a countertop should be GFCI rated. The Inspector recommends installation of ground fault circuit GFCI protection as a safety precaution to help prevent electrical shock. This can be achieved by: 1. Replacing the current standard outlets with GFCI outlets. 2. Replacing the breaker currently protecting the electrical circuit that contains these kitchen outlets with a GFCI breaker. All electrical work should be performed by a qualified electrical contractor.

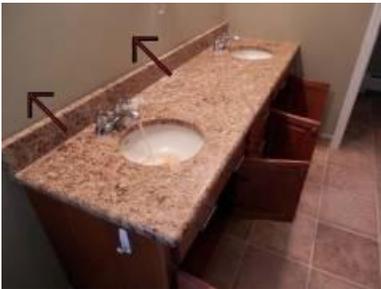
13.31 Master Bath:

This bathroom had an insufficient number of electrical outlets installed. The Inspector recommends installing a Ground Fault Circuit Interrupter (GFCI -protected) outlet for safety reasons. Contact a licensed electrician for further analysis and installation.

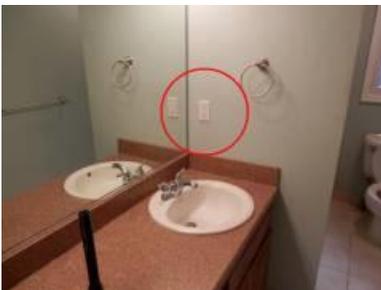
13.32 2nd Floor Hall Bath:

Electrical outlet(s) in this bathroom appeared to be in serviceable condition at the time of the inspection but did not have Ground Fault Circuit Interrupter (GFCI) protection. Although this condition may have been commonly considered safe or acceptable at the time the home was originally constructed, as general knowledge of safe building practices has improved with the passage of time, building standards have changed to reflect current understanding. Consider having GFCI protection installed as a safety precaution for outlets within 6 feet of a plumbing fixture. This can be achieved by: 1. Replacing the current standard outlets with GFCI outlets. 2. Replacing the outlet in this bathroom circuit which is nearest the main electrical service panel with a GFCI outlet. 3. Replacing the breaker currently protecting the electrical circuit which contains these bathroom outlets with a GFCI breaker.

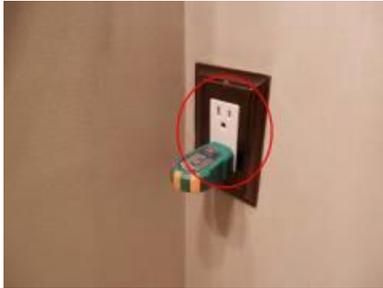
13.33 First Floor 1/2 Bath:

Electrical outlet(s) in this bathroom appeared to be in serviceable condition at the time of the inspection but did not have Ground Fault Circuit Interrupter (GFCI) protection. Although this condition may have been commonly considered safe or acceptable at the time the home was originally constructed, as general knowledge of safe building practices has improved with the passage of time, building standards have changed to reflect current understanding. Consider having GFCI protection installed as a safety precaution for outlets within 6 feet of a plumbing fixture. This can be achieved by: 1. Replacing the current standard outlets with GFCI outlets. 2. Replacing the outlet in this bathroom circuit which is nearest the main electrical service panel with a GFCI outlet. 3. Replacing the breaker currently protecting the electrical circuit which contains these bathroom outlets with a GFCI breaker.

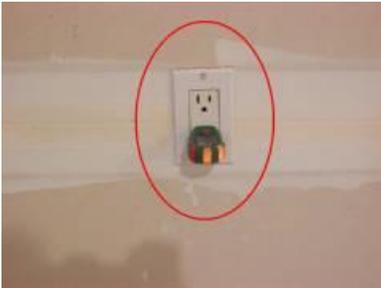
13.43 Garage Walls & Ceilings:

Only one wall outlet was observed in the garage. Absence of outlets in the garage may lead to unnecessary use of extension cords which could create a safety hazard. Recommend contacting a licensed electrician for further evaluation and upgrade. Ground Fault Circuit Interrupter (GFCI) outlets are recommended for installation at exterior, garage, bath rooms & kitchen outlets.

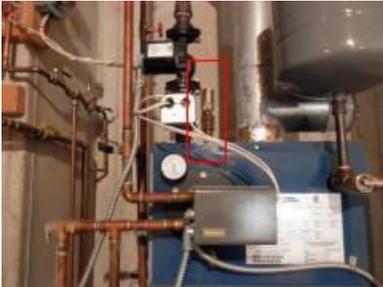
15.9 Pressure Relief Valve And Discharge Pipe

The pressure relief valve was leaking at the time of the inspection and should be replaced by a qualified HVAC technician or plumbing contractor. This condition was probably caused by the lack of use while the house was vacant.

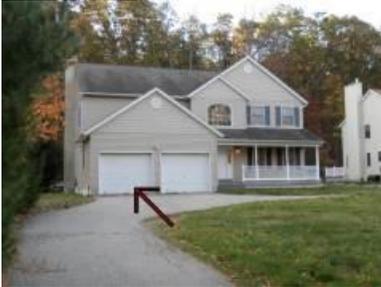
18.8 Automatic Opener:

The door opener to the left (see picture / arrow) was inoperative. The right automatic door opener operated properly. Recommend contacting a licensed garage door contractor for repair or replacement of the faulty opener.

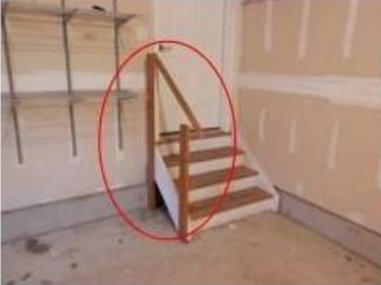
Although it may have complied with codes and standards in effect at the time of its original construction, the handrail assembly of the door between the garage and living space did not comply with modern building safety standards. The handrail assembly failed to comply with the standard which states that a stairway handrail must...1. provide a continuous, graspable handrail, 2. measure 1 1/4 inches to 2 inches across, 3. be 34 inches to 38 inches above the nosing of stair treads, 4. have baluster spacing which will not allow the passage of a 4 3/8-inch sphere. The handrail failed to comply with number ***. Although this condition may have been commonly considered safe or acceptable at the time the home was originally constructed, as general knowledge of safe building practices has improved with the passage of time, building standards have changed to reflect current understanding. Consider updating the existing condition to meet generally-accepted current standards.

Although it may have complied with codes and standards in effect at the time of its original construction, the handrail assembly of the door between the garage and living space did not comply with modern building safety standards. The handrail assembly failed to comply with the standard which states that a stairway handrail must...1. provide a continuous, graspable handrail, 2. measure 1 1/4 inches to 2 inches across, 3.

be 34 inches to 38 inches above the nosing of stair treads, 4. have baluster spacing which will not allow the passage of a 4 3/8-inch sphere. The handrail failed to comply with number •••. Although this condition may have been commonly considered safe or acceptable at the time the home was originally constructed, as general knowledge of safe building practices has improved with the passage of time, building standards have changed to reflect current understanding. Consider updating the existing condition to meet generally-accepted current standards.
