RIO GRANDE DIVERSION INFRASTRUCTURE INVENTORY

Structure Name: BILLINGS D

BILLINGS DITCH

PHOTO LOG

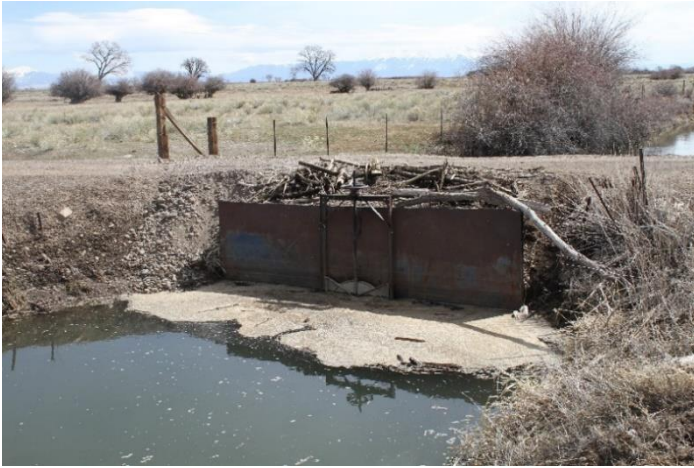
Headgate looking downstream

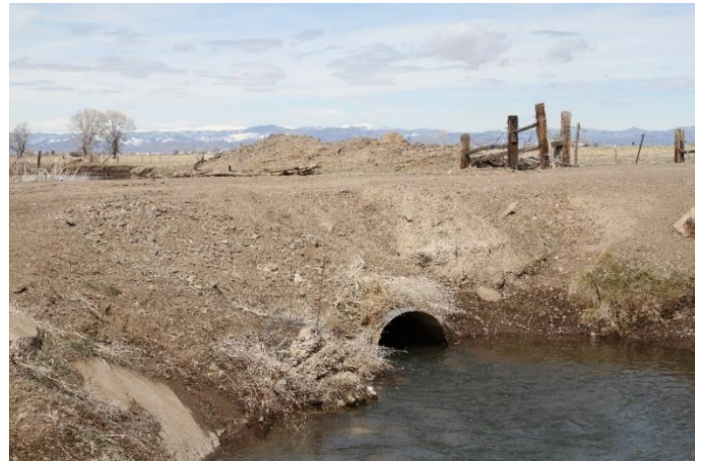
Headgate outlet

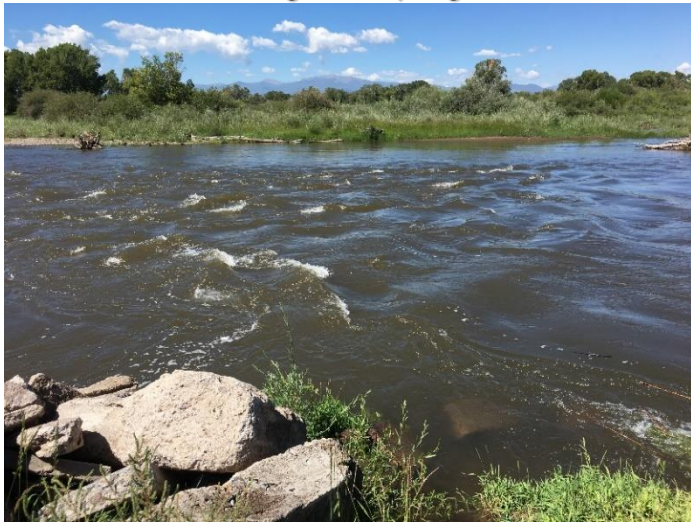
Diversion dam during 2019 spring runoff

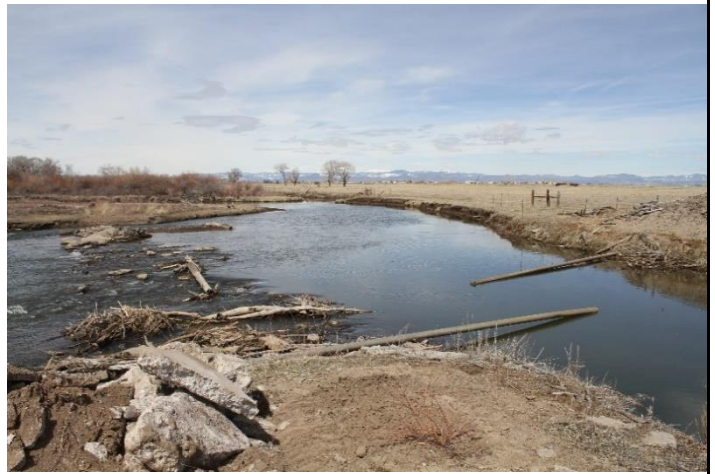
Diversion dam looking upstream

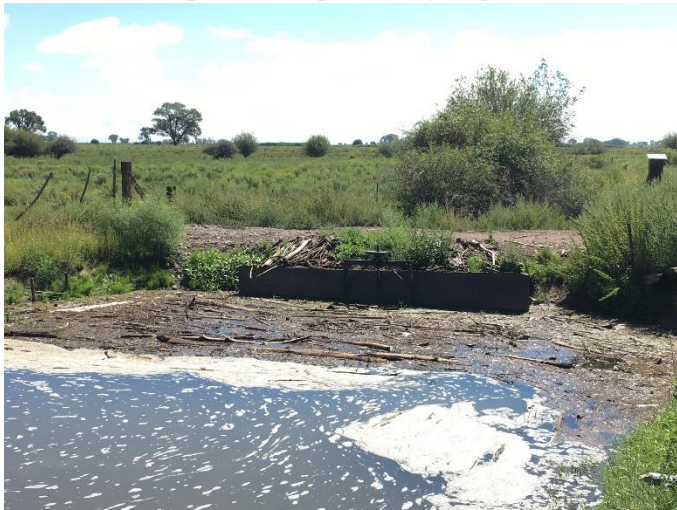
Headgate during 2019 spring runoff

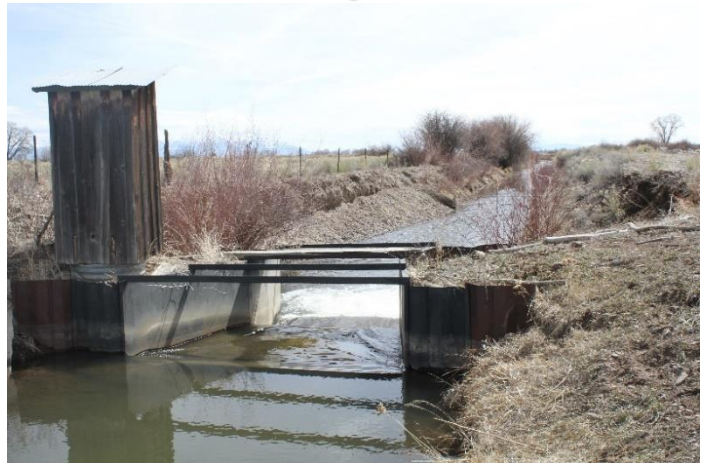
Flume looking downstream

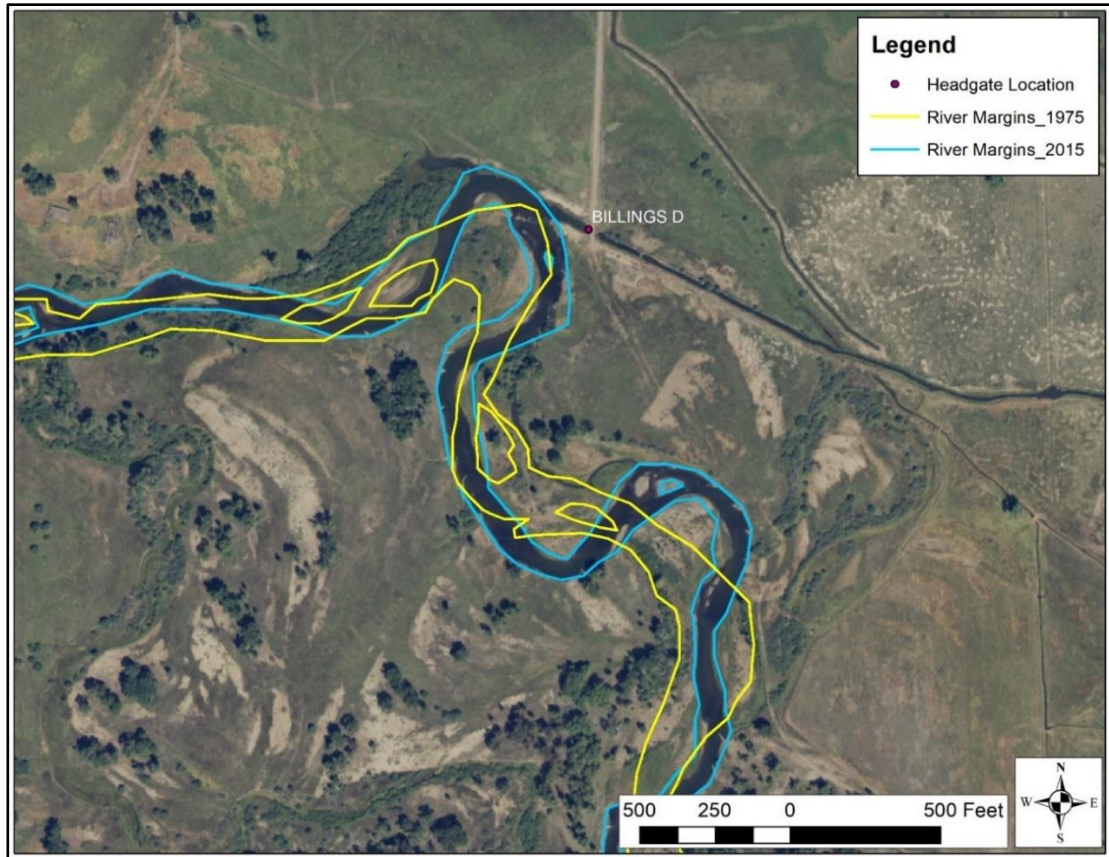
Structure Description: This structure is located near the apex of a meander. Channel migration analysis shows the meander is tightening and may be cut off in the future (see map below). If this occurs, the ditch will no longer be functional. There is a diversion dam made of rocks and debris along the river that directs flow to a short feeder ditch. There is a log trash boom at the entrance of the feeder ditch. At the end of the feeder ditch is a welded steel plate headwall with the headgate attached. The headgate does not seal properly and needs to be repaired. Debris accumulates on the diversion dam and is especially an issue at headgate. Sediment accumulation is also a serious issue at this structure. The flume is too large for the volume of the ditch and does not measure accurately at low flows.

Map showing Rio Grande margins in 1975 and 2015. Channel migration analysis shows the channel has migrated north and east since 1975, which has led to increased bank erosion, sediment and debris accumulation, and other challenges for Billings Ditch.

Repair(s) or Improvement(s) Currently Needed: The issue of sediment and debris accumulation needs to be addressed. A new diversion dam with sediment and debris-passing capabilities is recommended. Headgate repair or replacement is also recommended. In addition, bank restoration work upstream and downstream of this structure is critical to maintaining the function of the ditch and river. An alternative solution for all these issues is to move the point of diversion upstream. Fish and boat passage, as well as riparian restoration should be considered as part of any repairs or improvements.

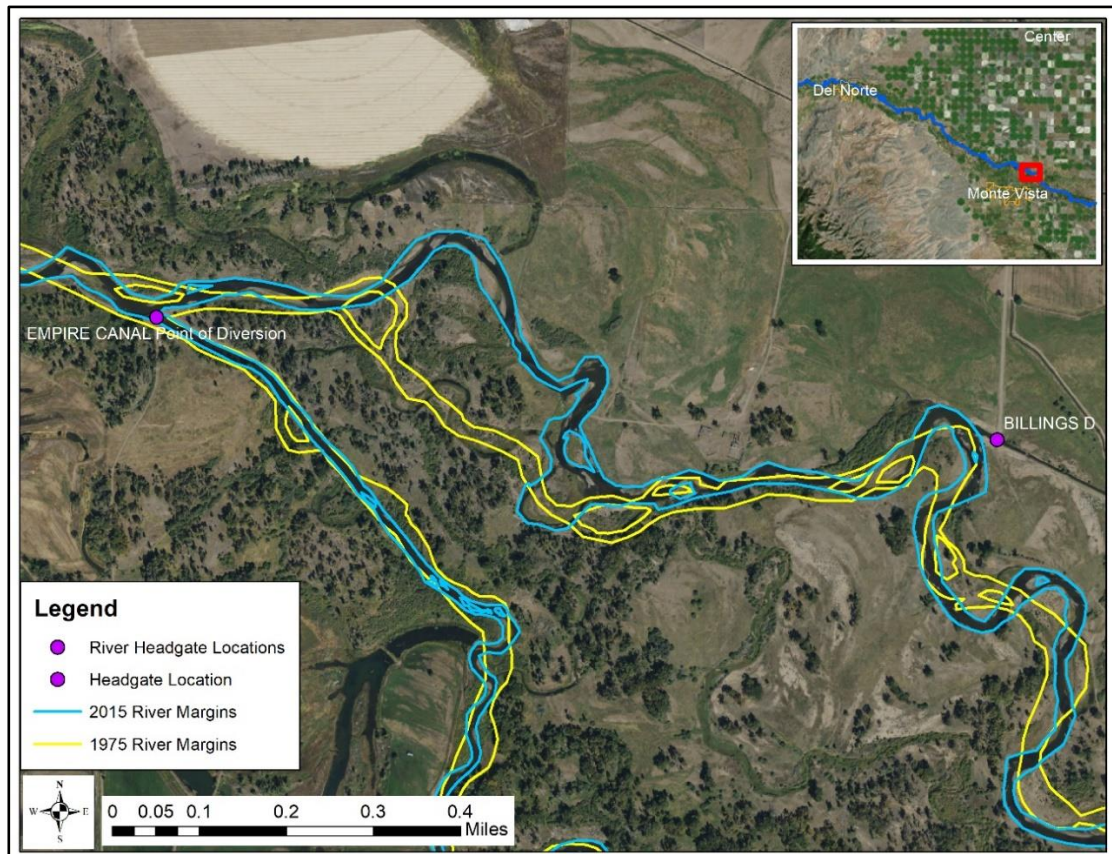
Map of 1975 and 2015 channel margins upstream of Billings Ditch.
