**Mitre House  
124 Kings Road  
London  
SW3 4TP**

**REFURBISHMENT  
OF THE COMMON PARTS**

**ASBESTOS SURVEY REPORT**

# Asbestos Management Survey

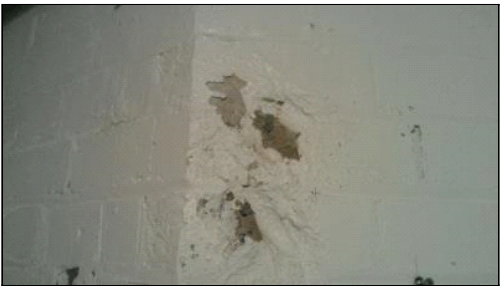
<b>Survey Date:</b>	<b>Lead Surveyor</b>	<b>Survey Type</b>	<b>Floor</b>	<b>Analysis</b>
	25 Jul 2017	Peter Lee (CoCA)	Management Survey	Basement1	
	<b>Building</b>	<b>Room</b>	<b>Item Description</b>	<b>Quantity</b>	
	Mitre House	Electric intake / store room B1.01	Insulation residue to wall.	Small amounts	
	<b>Sample No (S,SP,P,As)</b>	<b>Product Type</b>	<b>Surface Treatment</b>	<b>Condition</b>	<b>Accessibility</b>
	PL000619 (S) - Item 1	N/A	N/A	N/A	N/A
	<b>Material Risk Score</b>	<b>Surveyor comments</b>			
	N/A				
<b>Recommended action</b>	<b>No further action required</b>

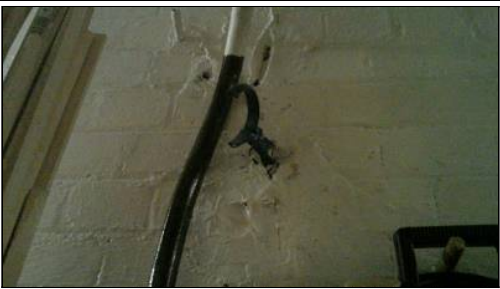
<b>Survey Date:</b>	<b>Lead Surveyor</b>	<b>Survey Type</b>	<b>Floor</b>	<b>Analysis</b>
	25 Jul 2017	Peter Lee (CoCA)	Management Survey	Basement1	
	<b>Building</b>	<b>Room</b>	<b>Item Description</b>	<b>Quantity</b>	
	Mitre House	Electric intake / store room B1.01	Insulation residue around old pipe bracket on wall.	Small amounts	
	<b>Sample No (S,SP,P,As)</b>	<b>Product Type</b>	<b>Surface Treatment</b>	<b>Condition</b>	<b>Accessibility</b>
	PL000620 (S) - Item 2	N/A	N/A	N/A	N/A
	<b>Material Risk Score</b>	<b>Surveyor comments</b>			
	N/A				
<b>Recommended action</b>	<b>No further action required</b>

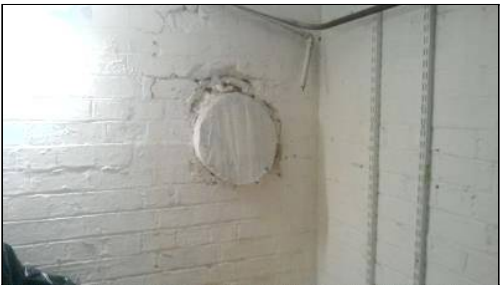
<b>Survey Date:</b>	<b>Lead Surveyor</b>	<b>Survey Type</b>	<b>Floor</b>	<b>Analysis</b>
	25 Jul 2017	Peter Lee (CoCA)	Management Survey	Basement1	Crocidolite (or unknown) (3)
	<b>Building</b>	<b>Room</b>	<b>Item Description</b>	<b>Quantity</b>	
	Mitre House	Electric intake / store room B1.01	Asbestos material may be consealed behind tape and expanding foam around redundant metal flue pipe to wall.	Small amounts	
	<b>Sample No (S,SP,P,As)</b>	<b>Product Type</b>	<b>Surface Treatment</b>	<b>Condition</b>	<b>Accessibility</b>
	Visual (P) - Item 5	Lagging (3)	Surface Sealed (1)	Good Condition (0)	Usually inaccessible or unlikely to be disturbed
	<b>Material Risk Score</b>	<b>Surveyor comments</b>			
7 (Medium Risk)					
<b>Recommended action</b>	Label and continue to manage

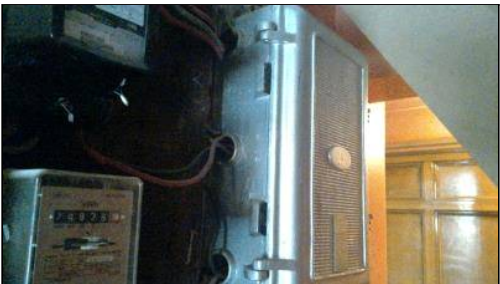
<b>Survey Date:</b>	<b>Lead Surveyor</b>	<b>Survey Type</b>	<b>Floor</b>	<b>Analysis</b>
	25 Jul 2017	Peter Lee (CoCA)	Management Survey	1st Floor	Chrysotile (1)
	<b>Building</b>	<b>Room</b>	<b>Item Description</b>	<b>Quantity</b>	
	Mitre House	Lobby to flats 1-3 01.01	Presumed ACMs within old electrical equipment on wall.	1no.	
	<b>Sample No (S,SP,P,As)</b>	<b>Product Type</b>	<b>Surface Treatment</b>	<b>Condition</b>	<b>Accessibility</b>
	Visual (P) - Item 6	Asbestos Textiles/Paper (2)	Surface Sealed (1)	Good Condition (0)	Usually inaccessible or unlikely to be disturbed
	<b>Material Risk Score</b>	<b>Surveyor comments</b>			
4 (Low Risk)					
<b>Recommended action</b>	Label and continue to manage

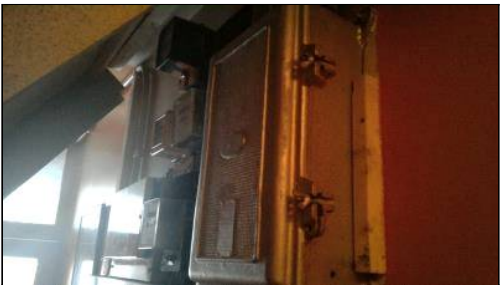
<b>Survey Date:</b>	<b>Lead Surveyor</b>	<b>Survey Type</b>	<b>Floor</b>	<b>Analysis</b>
	25 Jul 2017	Peter Lee (CoCA)	Management Survey	2nd Floor	Chrysotile (1)
	<b>Building</b>	<b>Room</b>	<b>Item Description</b>	<b>Quantity</b>	
	Mitre House	Lobby to flats 4-6 02.01	Presumed ACMs within old electrical equipment on wall.	1no.	
	<b>Sample No (S,SP,P,As)</b>	<b>Product Type</b>	<b>Surface Treatment</b>	<b>Condition</b>	<b>Accessibility</b>
	Visual (P) - Item 7	Asbestos Textiles/Paper (2)	Surface Sealed (1)	Good Condition (0)	Usually inaccessible or unlikely to be disturbed
	<b>Material Risk Score</b>	<b>Surveyor comments</b>			
4 (Low Risk)					
<b>Recommended action</b>	Label and continue to manage

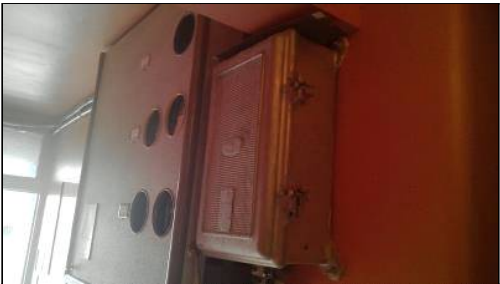
<b>Survey Date:</b>	<b>Lead Surveyor</b>	<b>Survey Type</b>	<b>Floor</b>	<b>Analysis</b>
	25 Jul 2017	Peter Lee (CoCA)	Management Survey	3rd Floor	Chrysotile (1)
	<b>Building</b>	<b>Room</b>	<b>Item Description</b>	<b>Quantity</b>	
	Mitre House	Lobby to flats 7-9 03.01	Presumed ACMs within old electrical equipment on wall.	1no.	
	<b>Sample No (S,SP,P,As)</b>	<b>Product Type</b>	<b>Surface Treatment</b>	<b>Condition</b>	<b>Accessibility</b>
	Visual (P) - Item 8	Asbestos Textiles/Paper (2)	Surface Sealed (1)	Good Condition (0)	Usually inaccessible or unlikely to be disturbed
	<b>Material Risk Score</b>	<b>Surveyor comments</b>			
4 (Low Risk)					
<b>Recommended action</b>	Label and continue to manage

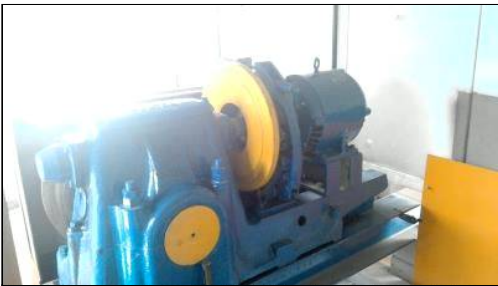
<b>Survey Date:</b>	<b>Lead Surveyor</b>	<b>Survey Type</b>	<b>Floor</b>	<b>Analysis</b>
	25 Jul 2017	Peter Lee (CoCA)	Management Survey	4th Floor	Chrysotile (1)
	<b>Building</b>	<b>Room</b>	<b>Item Description</b>	<b>Quantity</b>	
	Mitre House	Lift motor/water tank room 04.01	Lift brake shoes may contain asbestos.	1no.	
	<b>Sample No (S,SP,P,As)</b>	<b>Product Type</b>	<b>Surface Treatment</b>	<b>Condition</b>	<b>Accessibility</b>
	Visual (P) - Item 9	Friction Product (1)	Completely Sealed (0)	Good Condition (0)	Usually inaccessible or unlikely to be disturbed
	<b>Material Risk Score</b>	<b>Surveyor comments</b>			
2 (Low Risk)					
<b>Recommended action</b>	<b>Label and continue to manage</b>
