SERVICE BULLETIN - AUCKLAND	0002
Date of Issue	08.09.2017
Issue Number	A-01
Customer	ORIX New Zealand Ltd
Component Affected	Skid Plate

### **T605Z Trailer Incident**

## Report into kingpin supporting structure failure:

2012 Maxicube Reefer 3 Axle Semi Trailer

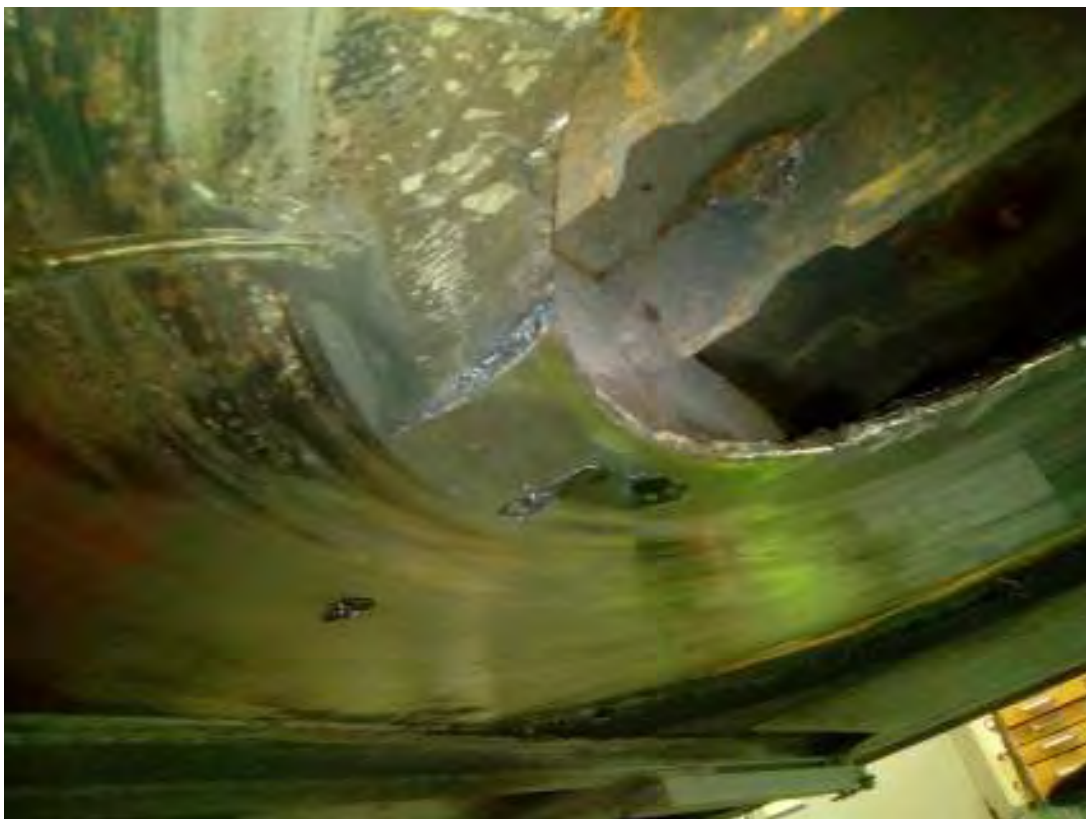
The kingpin, and housing had separated from the skidplate adjacent to the weld.

Photo1  
Skidplate at initial viewing, following cleaning. View is to the rear of the trailer

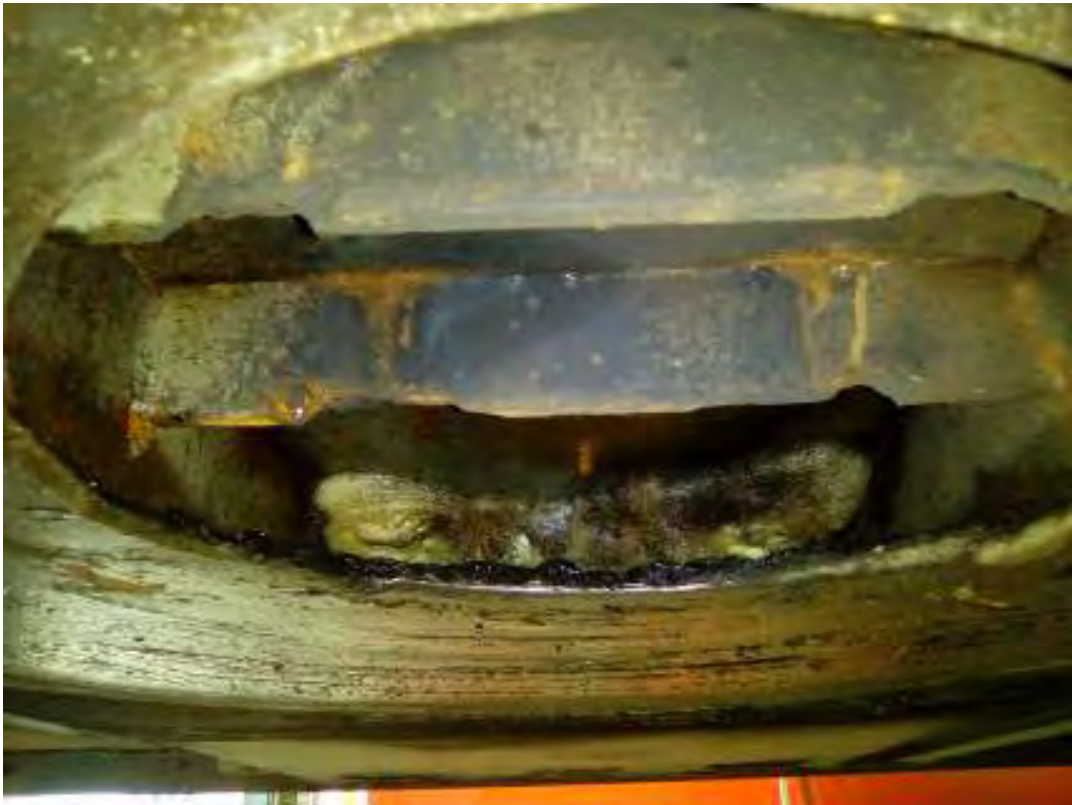
Photo 2  
Skidplate at initial viewing (view to right hand cavity)

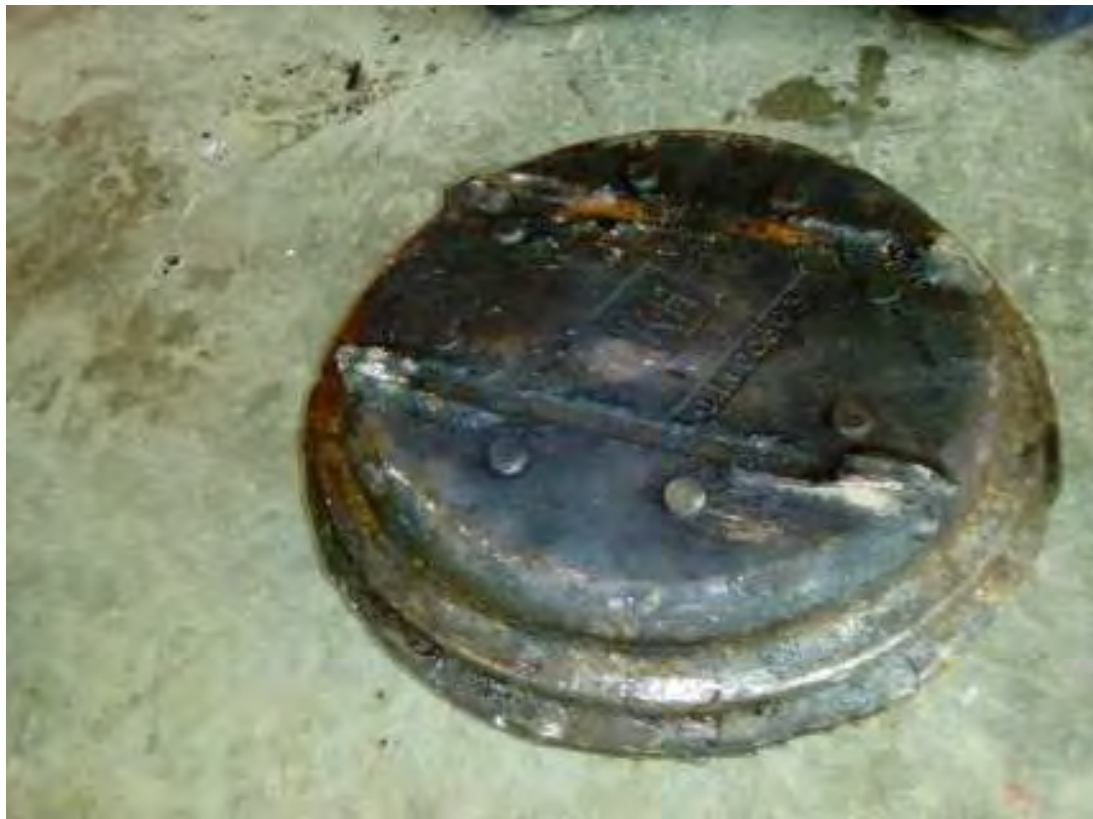
Photo 3  
King pin and housing at initial inspection

The kingpin and housing have since been separated, the items were difficult to identify, however I believe Fuwa K Hitch manufactured both the housing and kingpin. I was unable to identify if the housing was suitable for the skid plate thickness. The fractured edge was severely damaged, and so any failure analysis was impossible.

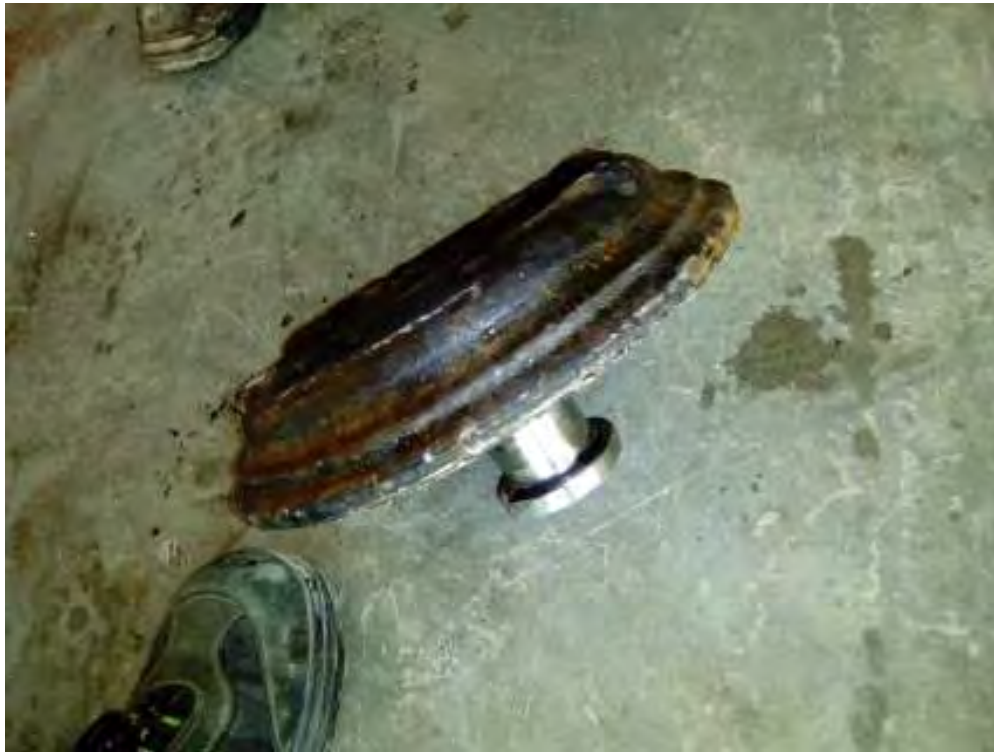
Photo 4  
King pin and housing at initial inspection

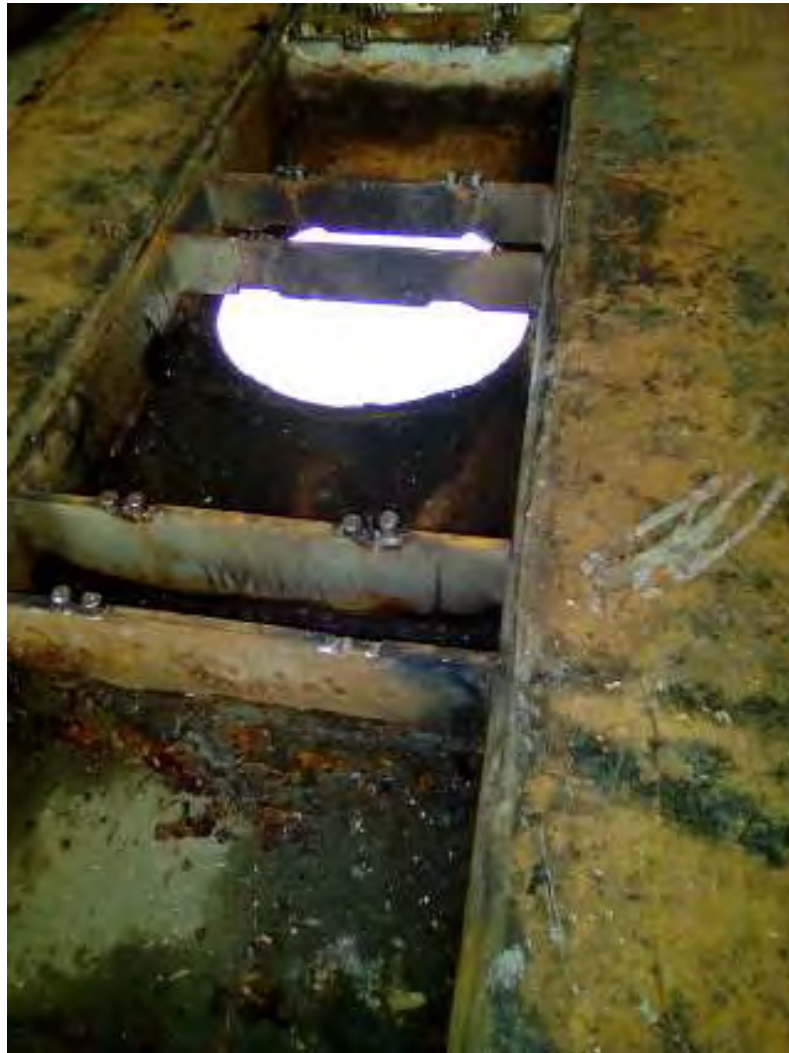
The structure consisted of two 8mm thick channels separated by approx 300mm, with a 8mm plate welded between, at the top, above the kingpin. All welding appears to be stitch welded (welded for approx 100mm, and then a space of approx 100mm).

The bridging plate was removed, revealing some stiffeners. Evidence of substantial cracking of the crossmembers, and the skid plate was found. Many of the skid plate cracks initiated at the ends of the stitch welds.

No water drain holes have been incorporated in the design, and corrosion has started. Expanded foam insulation, and cut polystyrene insulation removed was wet.

Photo 5  
Skid plate structure with bridging plate removed

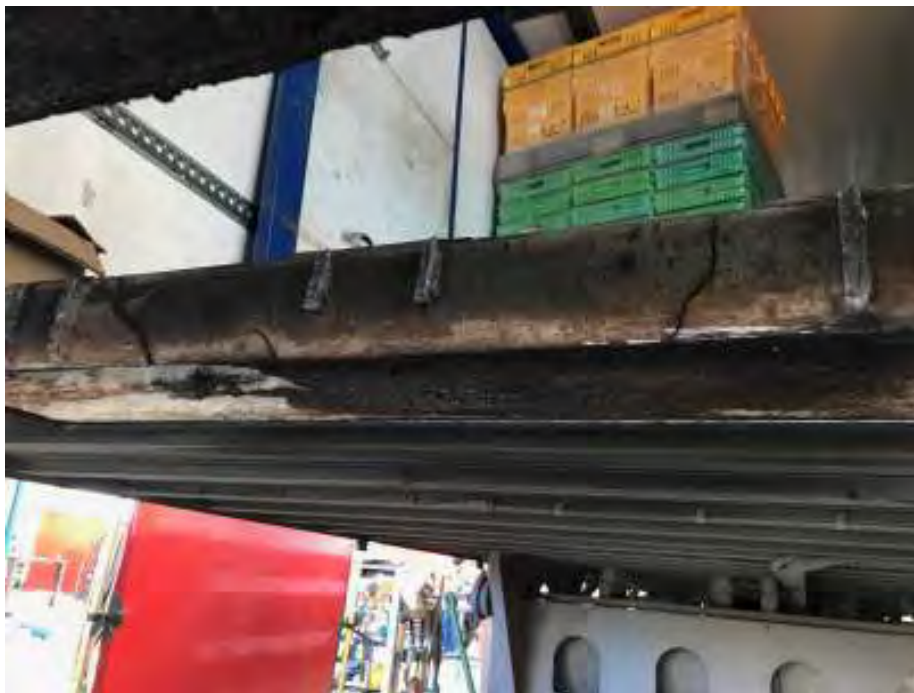
Photo 6  
Crack in crossmember with skid plate removed

Welding details appear to have contributed to initial cracks at the stress raisers on the weld ends. Stitch welded locations should be carefully selected.

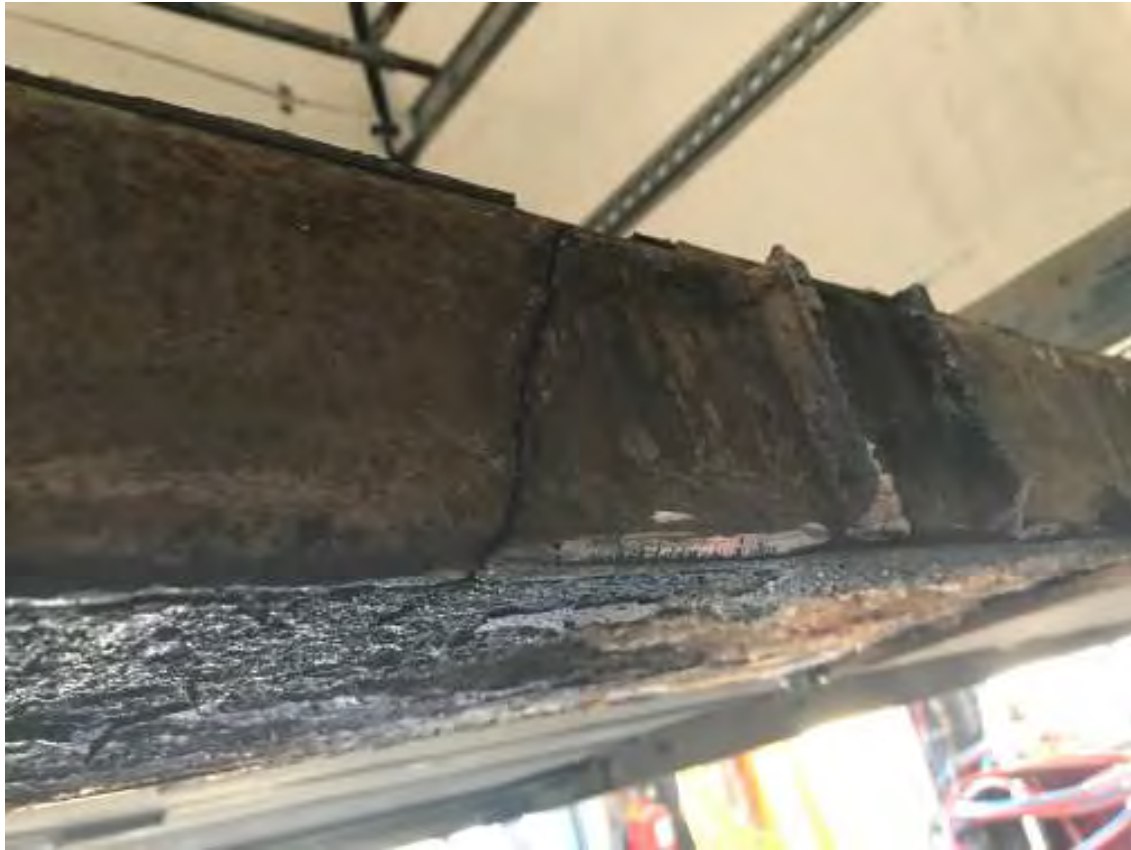
Photo 7  
Cracks in crossmember with skid plate removed
