TALON
Home Inspections

Inspection Report

Property Address:
2001 Crimea Street
Lawrenceburg KY 40324

Date: 12/17/2017	Time: 10:00 AM till 03:00 PM	Report ID: 171217PETERS
Property: 2001 Crimea Street Lawrenceburg KY 40324	Customer: Mr. Trevor Peters	Real Estate Professional:

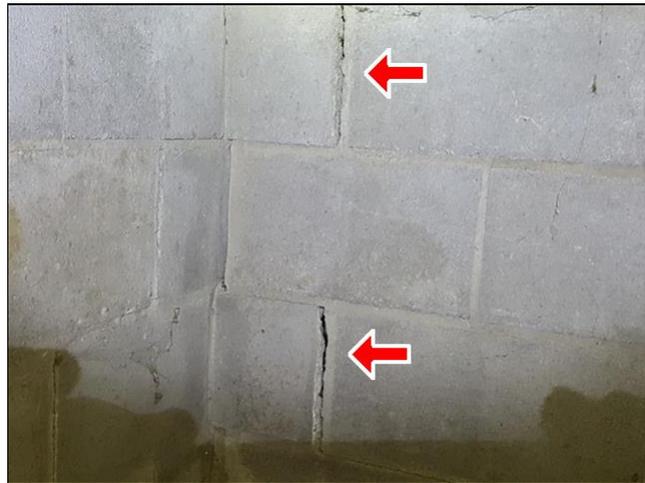
1.1 Item 2(Picture) front right corner of home

1.1 The stair step crack at the foundation wall on the front right corner of the home in the crawlspace was noted and is large enough for concern. Some degree of settlement has occurred. The size of the crack shown is 1/8 in width and is has bulged. This is cause for concern. The wall(s) may need reinforcement. Cannot tell if this movement is ongoing. While the rate of movement cannot be predicted during a one-time inspection it is likely that repairs maybe needed. Recommend a Foundation contractor be consulted to further evaluate this condition and the remedies available for correction prior to closing. These cracks need to be sealed to prevent further cracking due to freeze/thaw (water entering) and possible further deterioration via water intrusion in the crawlspace.

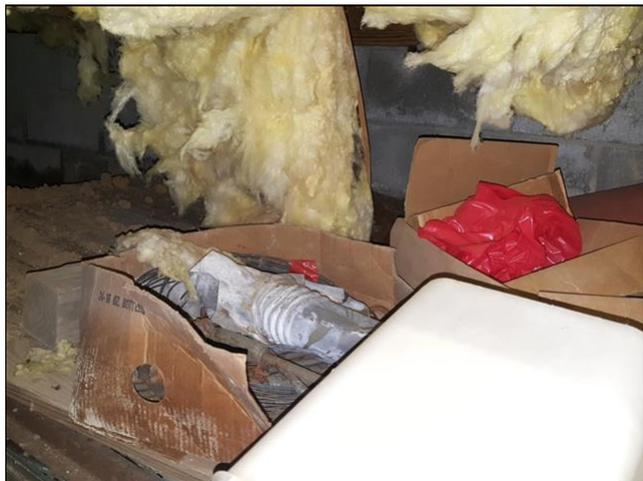
1.2 Item 6(Picture)

1.2 (1) All wood, insulation, unused building materials and junk should be removed from the crawlspace floor. The insulation will hold moisture creating condensation and possible mold growth on the wooden structure in the crawlspace. Wood debris risks rotting and can attract wood eating insects into the crawlspace which can lead to more costly repairs later. Recommend all types of debris resting on the crawlspace floor be removed to prevent damage to the wood/floor structure of the home.

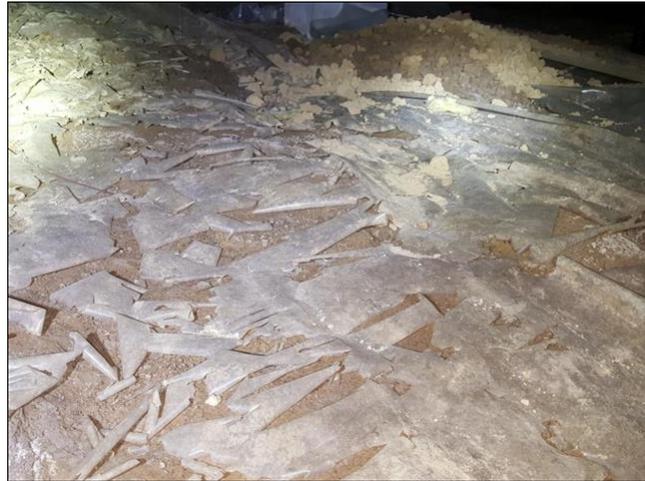
1.2 Item 7(Picture)

1.2 (2) The vapor barrier (plastic) on the crawlspace ground is deteriorated in various areas and is less than 9 mill thick. A vapor barrier provides added protection to the floor system from moisture or dampness that can enter from the ground. If this is not corrected wood rot, condensation and/or mold could develop in the crawlspace. Recommend a qualified contractor replace as needed prior to moving in.

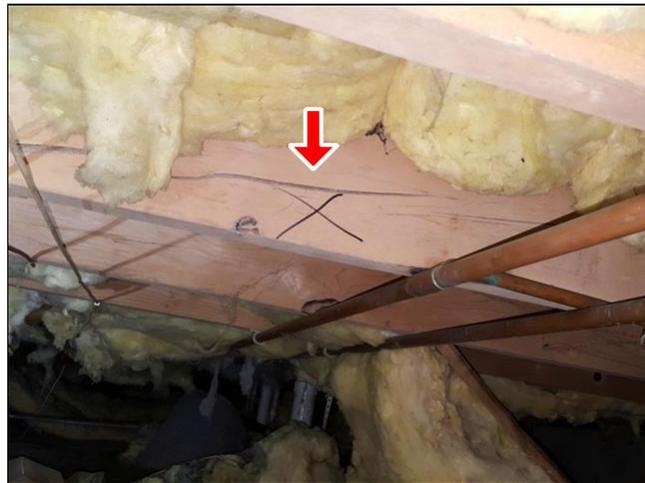
1.4 Item 2(Picture)

1.4 (1) One floor joist is severely split or cracked in the crawlspace under the master bathroom area. There may be more but due to the access and conditions in the crawlspace others may have been unnoticed at the time of inspection. Repairs are needed. Cracked joists are repaired by replacement , "sister" joists installed along side or additional support. Recommend a qualified licensed building contractor repair as needed and further access the floor structure under the living room and kitchen area once access is granted.

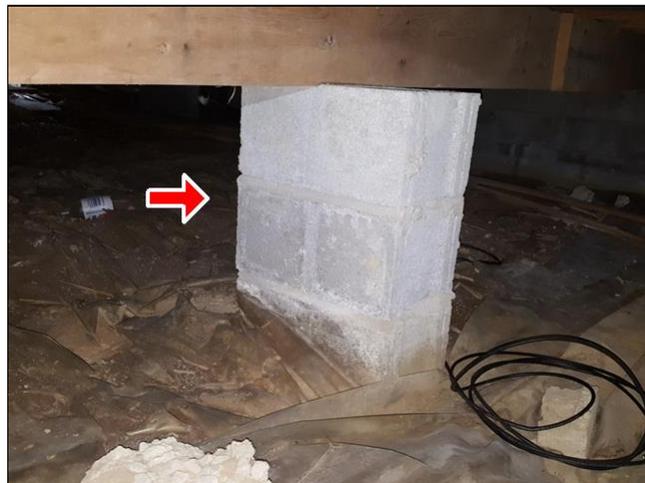
1.6 Item 2(Picture)

1.6 (1) All the piers that are supporting the main beam in the crawlspace maybe undersized and may not provide proper support for the beam. Normal building practices use a minimum sizing of 12 inch wide piers. The installed piers in question are 8x8x16 single pile piers. The floor is an integral part of the foundation system. Because of the various repairs to joists, additional steel screw posts installed in the crawl and issues found with exterior brick walls and foundation walls it is recommended prior to closing to have a structural engineer further evaluate to determine if corrections are needed.

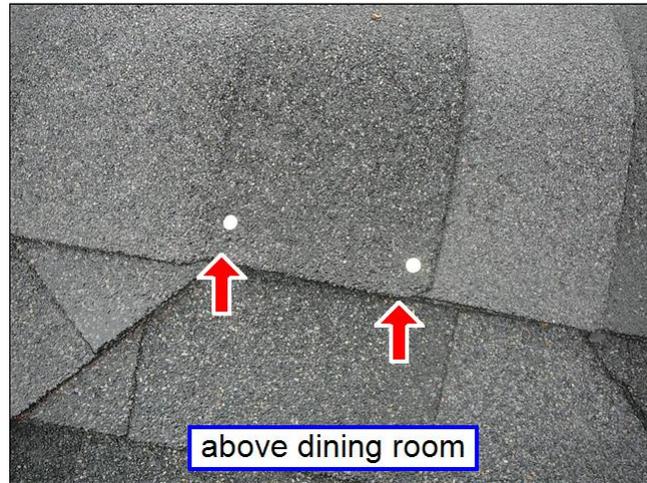
2.0 Item 4(Picture)

2.0 (2) Exposed nail heads were seen above the garage and dining room area at the roof. All exposed nails should be properly sealed by a qualified roofing contractor. A sealant compatible with the roofing or flashing material should be applied to the nail. This will prevent and reduce future water entry and/or leaks into the attic.

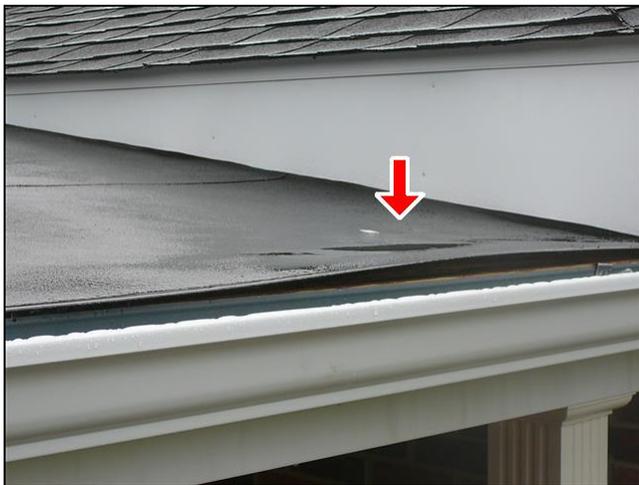
2.1 Item 1(Picture)

2.1 The flat roof roof covering is lifting at the front of the home above the covered porch right side. Unable to determine if this area will leak. However this needs to be repaired to prevent the wood sheathing from being damaged via water intrusion and to prevent possible water pooling in this area which could result in roof leakage. Recommend qualified roofing contractor should inspect further and correct/repair as needed

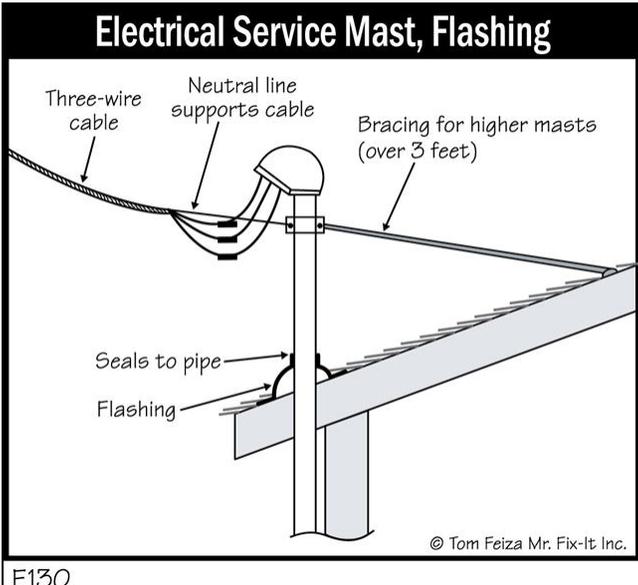
2.3 Item 3(Picture)

2.3 The rubber boot below the electric mast is starting to deteriorate and may be prone to leaks because it is split/cracked at the rear of the home. This may allow water to enter into the attic which may lead to deterioration of the roof and ceiling structure which can lead to mold within the attic. Sealing or replacing the rubber boot is recommended. Recommend a roofing contractor repair or replace as needed.

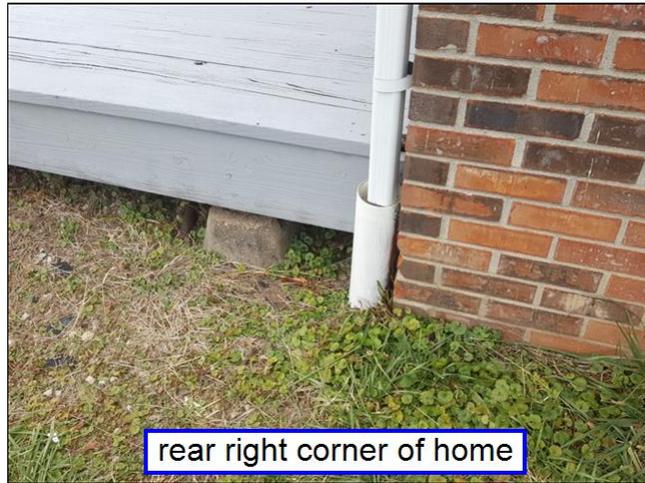
2.4 Item 3(Picture)

2.4 (2) Downspouts that discharge below grade level should be monitored. If they are ever suspected to be clogged or disconnected below grade, they should be redirected to discharge at least 10 feet from the building or into a storm sewer system. Foundation leakage adjacent to a downspout is an indication of a problem below grade.

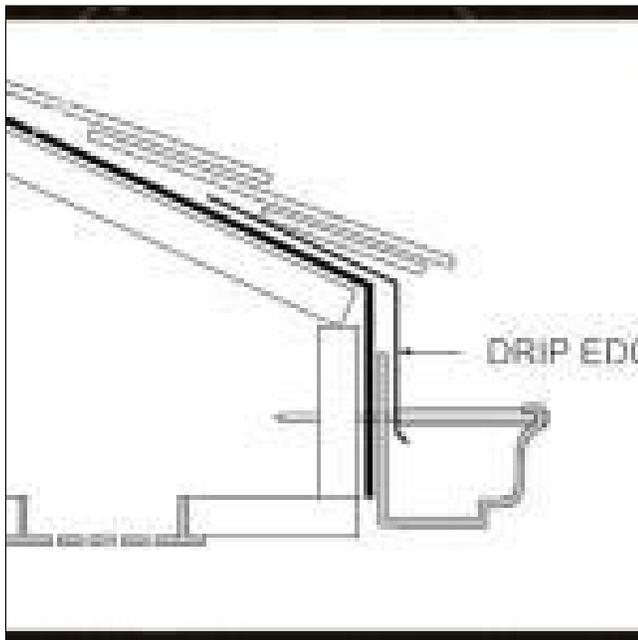
2.4 Item 16(Picture)

2.4 (5) The drip edge/flashing is missing at the front porch roof of the home. The drip edge/flashing protects the roof edge of the wood sheathing from water intrusion. Repairs are needed to prevent deterioration of the roof sheathing. Recommend a qualified roofing contractor repair as needed.

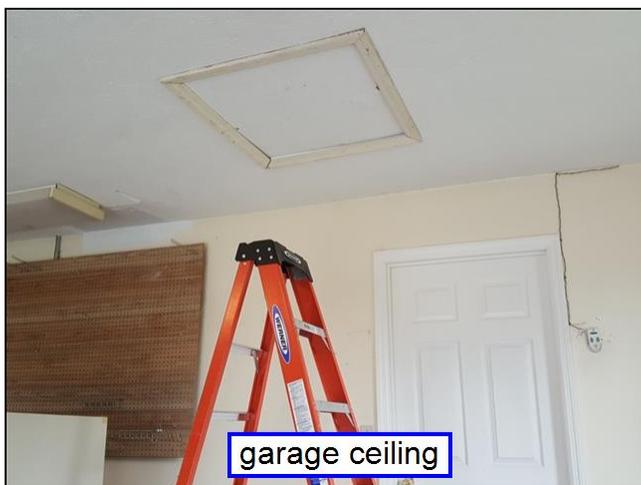
2.5 Item 1(Picture)

2.5 (1) Attic access location (see photo)

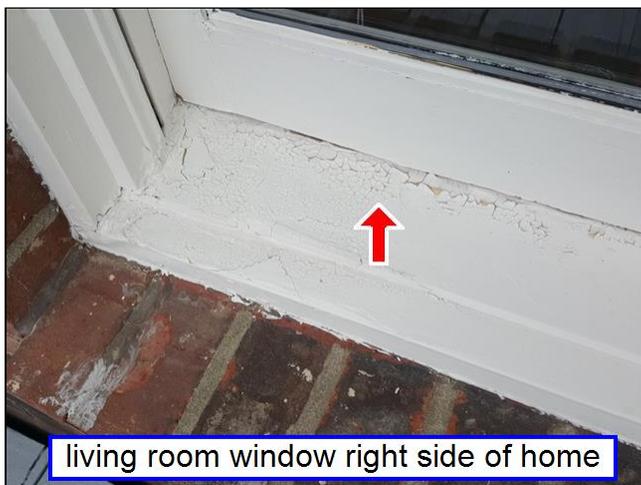
3.3 Item 1(Picture)

3.3 (1) Signs of peeling paint was observed around some of the window sills around the home. Deterioration of the wooden frames will occur if not sealed and painted via water intrusion. Recommend painting after repairs to windows have been performed. You may wish to consider installing a metal flashing around the frames to eliminate maintenance of the frames.

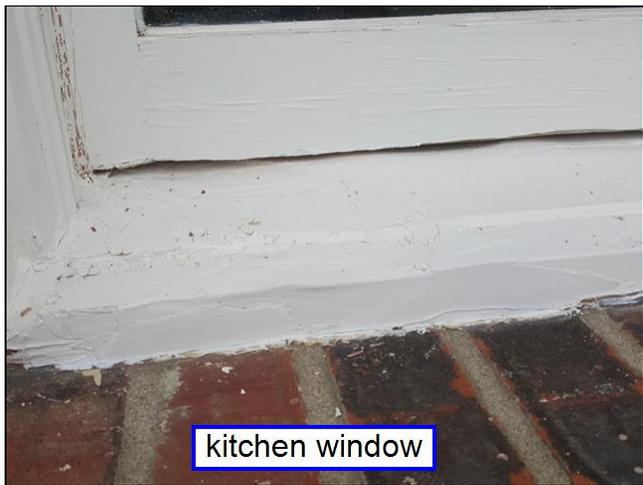
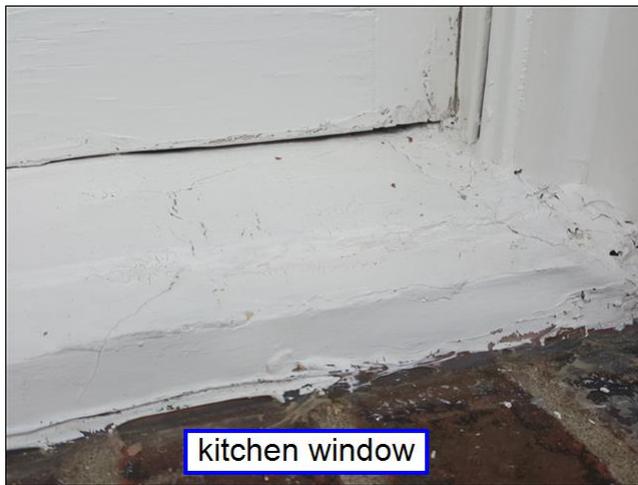
3.3 Item 4(Picture)

3.3 (3) The bottom of some of the window sills around the home are warped/buckled and show signs of previous repairs. The sills should be flat and sloped to ensure water drains away from the home. The openings may allow water to enter and cause poor seals allowing the outside air to enter if not sealed correctly. Recommend a qualified window contractor repair as needed.

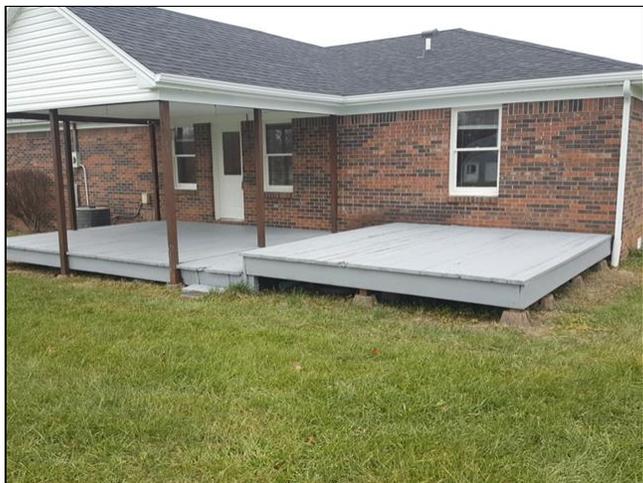
3.5 Item 1(Picture)

3.5 (1) The deck is built on/near grade and the sides extend to the ground. I was unable to completely inspect the underside. The area under the deck was limited. Some areas could not be viewed.

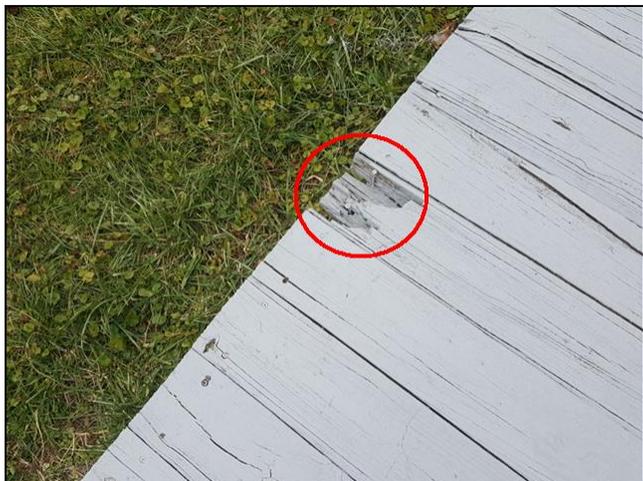
3.5 Item 2(Picture)

3.5 (2) The deck board at the some of the ends on the deck at the rear of the home have deteriorated at the end cuts. Further erosion or deterioration can occur if not corrected via water intrusion. Recommend repair or replace as needed.

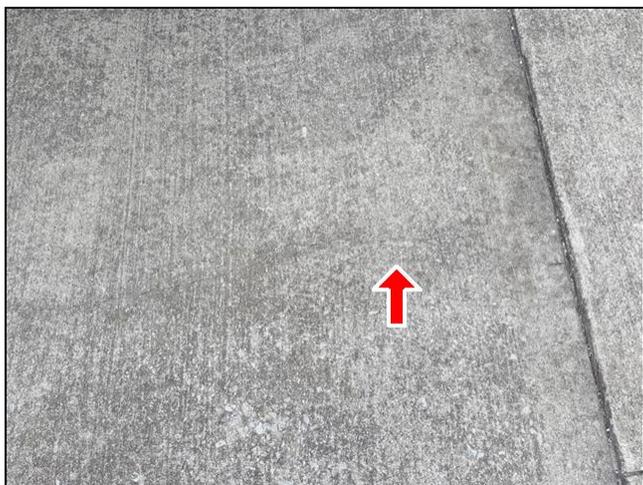
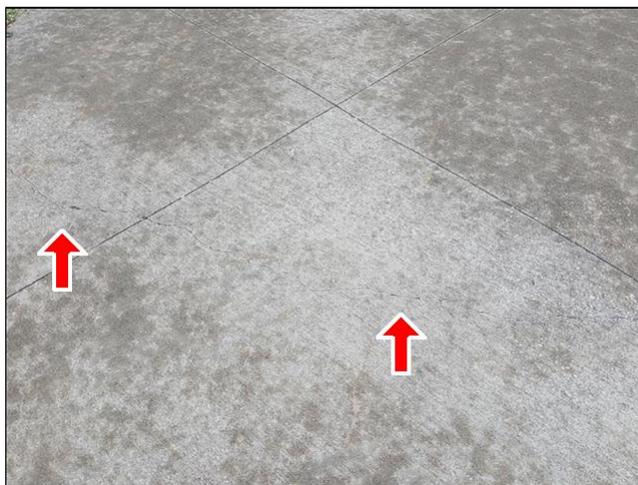
3.6 The concrete driveway has shrinkage cracks on the surface where indicated in the photos. Shrinkage cracking is the result of moisture in the concrete evaporating and shrinking. This generally is not a cause for concern as all concrete shrinks. The size, pattern and location of these cracks do not suggest a serious problem and is of no concern at present. Due to freeze/thaw, the cracks should be sealed to minimize further cracking and settlement via water intrusion. This is for your information. [Caulk for Concrete Cracks](#)

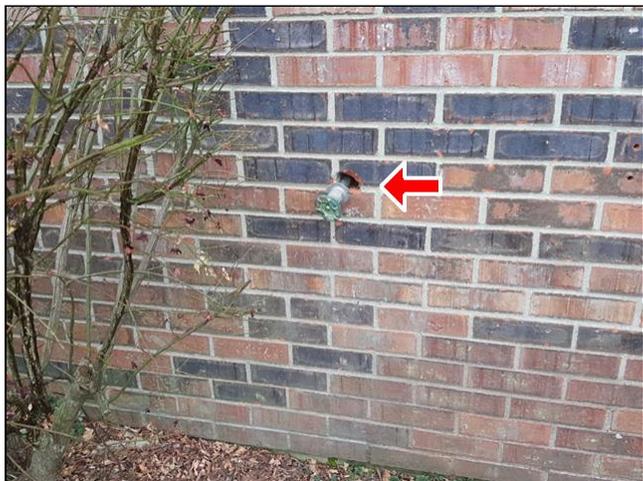
3.9 Item 1(Picture)

3.9 (2) The outside water faucet has an opening where the pipe protrudes the wall at the right side of the home. The opening can allow insects or water to enter which can cause deterioration of the wall structure. Recommend a general contractor repair as needed.

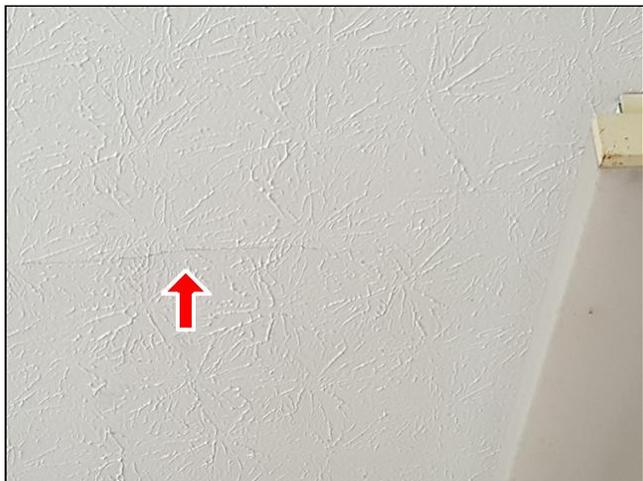
4.0 Item 1(Picture)

4.0 (1) The drywall has a vertical shrinkage/settlement crack(s) where the ceiling meets on the ceiling in the garage. Most minor cracking is due to shrinkage of construction materials. The crack is considered to be cosmetic and a small repair issue for your information. Recommend prep prime and paint as needed.

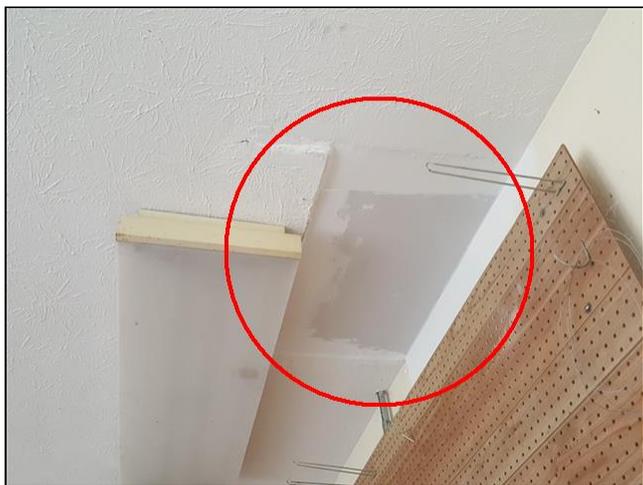
4.0 Item 2(Picture)

4.0 (2) Previous repair was noted at the ceiling in the garage. Recommend contacting the owner of the home for possible explanation. This is for your information.

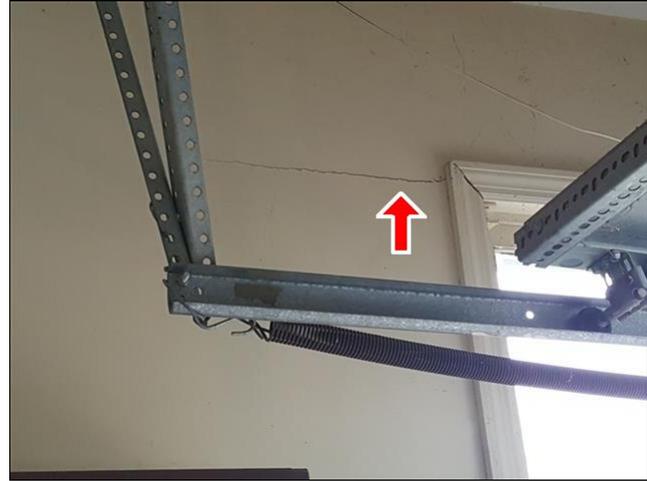
4.1 Item 5(Picture)

4.1 (2) The horizontal cracks in the walls in the garage at the right wall above the windows (see photos for location) appear to be common settlement cracks. Cracks larger than 1/8" are of concern only. Minor settlement of the home has occurred due to the age of the home and from perhaps framing shrinkage. Cracks of this nature are also caused by moisture and changing temperature. Recommend repairing cracks then paint and monitor. If cracks reappear and become larger than 1/8" then would recommend a structural engineer further investigate to determine cause and suggest repairs.

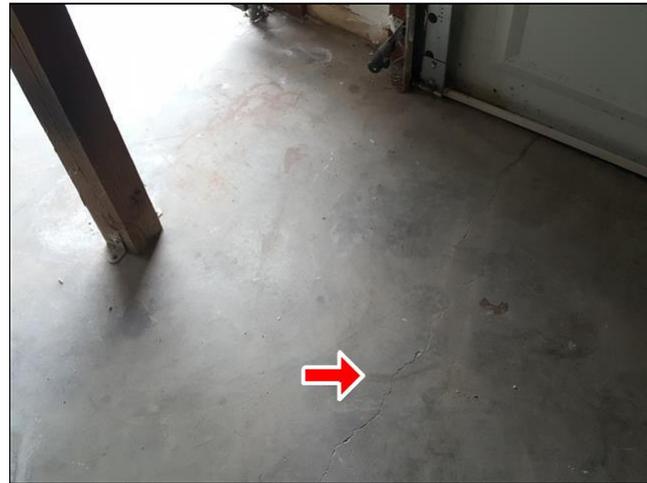
4.2 Item 1(Picture)

4.2 There are no control joints in the garage floor. All concrete cracks. Control joints allow poured concrete to crack at the joint to prevent large running cracks. The garage flooring has typical cracks in areas highlighted in photos. These cracks do not appear significant and seem typical. Cracks that are usually 1/8 inch or wider are need for concern. The cracks are usually the result of shrinkage and/or settling of the slab. Recommend these cracks be sealed then apply an epoxy coating on the floor to ensure water intrusion does not occur. It is recommended that you monitor annually after repairs. If these cracks should reoccur a masonry contractor who is familiar with foundation repair should be consulted. [Caulk for Concrete Cracks](#) This is for your information.

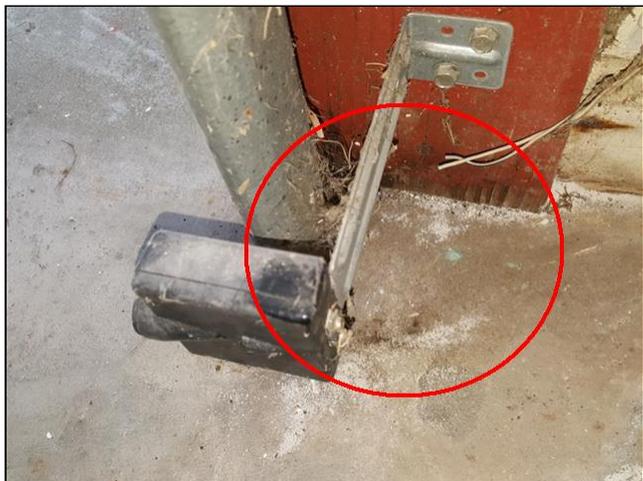
4.3 Item 4(Picture)

4.3 (2) The eye sensors for the garage "right" door (from outside) are not connected, hence possible reason why the door button needs to be depressed and held in order for the door to be closed. The sensors do not function. This is a safety issue. Recommend a qualified garage installer repair as needed prior to moving in.

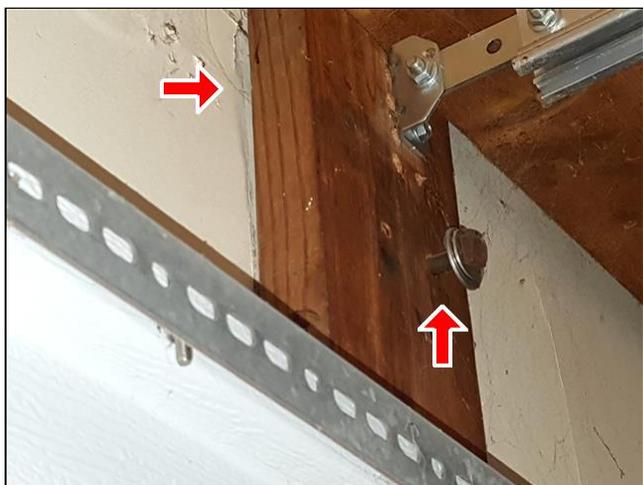
4.3 Item 6(Picture)

4.3 (4) The header block is pulling away from the wall and the bolt is not fastened correctly which may result in the garage "right" door (from outside) opener to fail. The header block should be mounted and secured to support the operation of the garage door opening and closing and to not place strain on the moving and supporting parts. Recommend a qualified garage door installer make the needed repairs and adjustments prior to moving in.

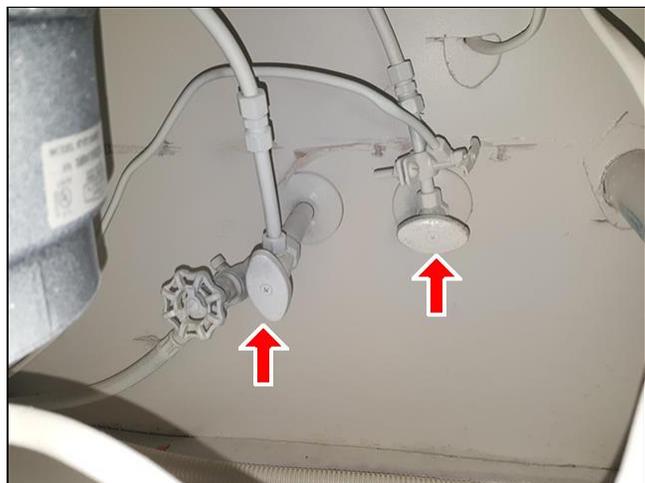
5.0 Item 1(Picture)

5.0 The faucets are turned off at the supply lines under the sink at time of the inspection in the kitchen. I cannot determine if any problems will arise after water supply is restored. Our company prohibits an inspector from turning on any water supply valves due to it may cause harm or damage to the building via a possible water leak(s). Recommend checking with owner to verify operation of the faucets and for reason why the water supply has been turned off prior to closing.

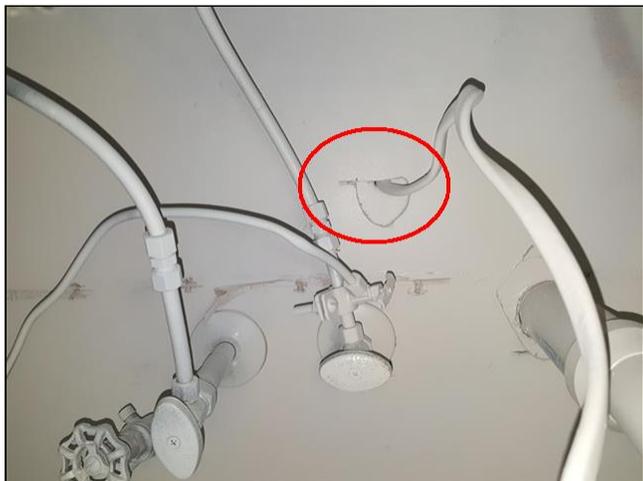
5.3 Item 1(Picture)

5.3 (1) The outlet is obstructed by the panelling under the kitchen sink. Could not determine how the disposer is connected. This is hazardous if repair work is needed on the disposer. The only easy means of cutting power to the disposer is via the electrical panel box. Recommend a qualified electrician repair as needed for your safety.

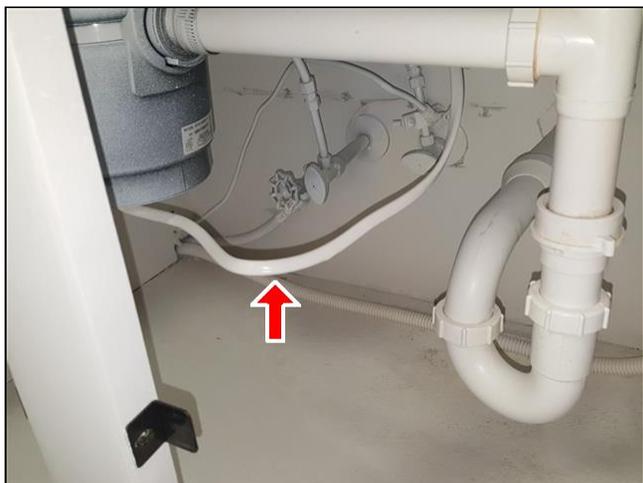
5.3 Item 2(Picture)

5.3 (2) Unprotected electrical wiring under the kitchen sink for the disposer is susceptible to being damage and should be relocated or protected by a rigid conduit. Recommend a qualified electrician repair as needed for safety of the occupants.

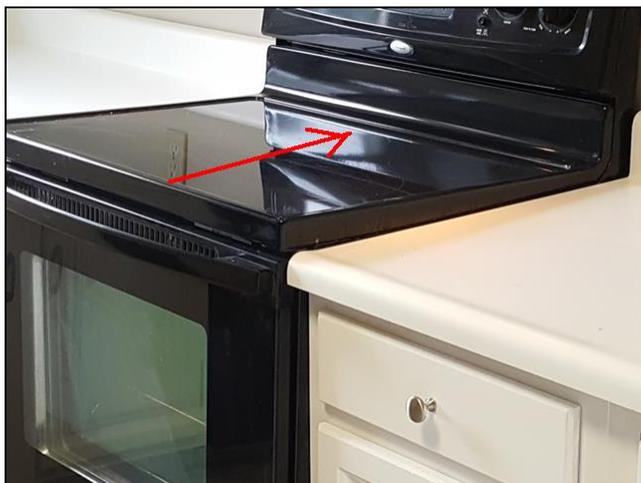
5.4 Item 2(Picture)

5.4 (2) The stove needs to be adjusted at the feet at the front. The stove top slopes severely to the back. Recommend adjusting the bottom feet to ensure stove top is stable and level on the floor. This can be a safety issue when boiling water on the stove top.

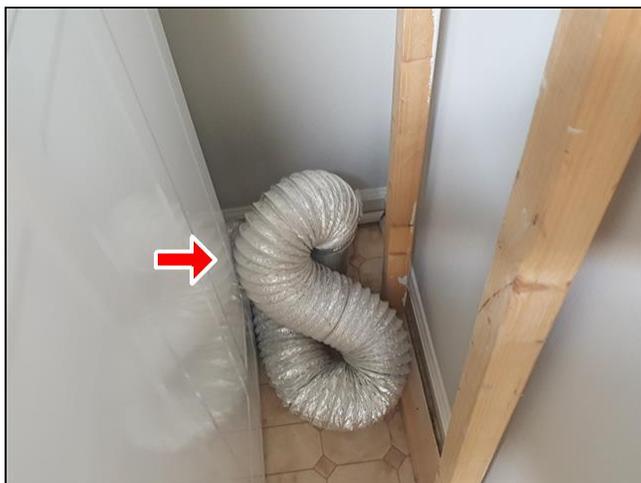
5.9 Item 1(Picture)

5.9 (1) A pleated Foil flex pipe is currently installed from the dryer to the exhaust vent. The current recommendations are for dryer vents to be heavy flexible or solid metal to help prevent crushing and damage from fires. Dryer lint fires are reported to be the third leading cause of fires. Exhaust ducts should be constructed of minimum 0.016 inch thick rigid metal ducts, having smooth interior surfaces with joints running in the direction of air flow. Exhaust ducts shall not be connected with sheet metal screws or fastening means which extend into the duct. All dryer vents should be disconnected and cleaned twice a year. This is a very common cause of fires. Recommend replacing duct for proper operation and for your safety using a qualified contractor.

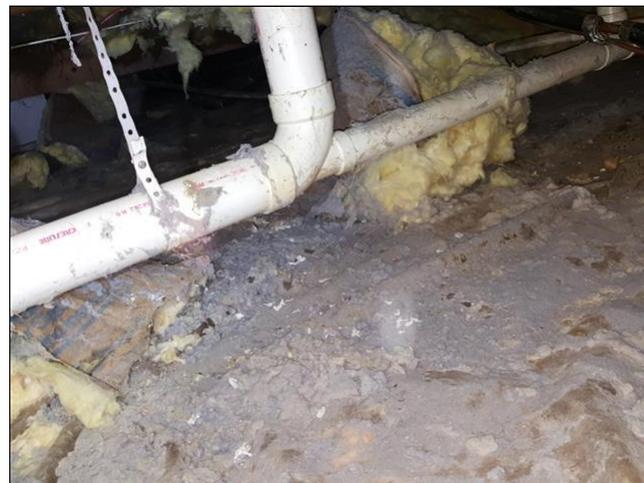
5.9 Item 5(Picture)

5.9 (2) The dryer is currently venting into the crawlspace which can result in various problems. Venting a dryer in a crawlspace can result in moisture problems which could lead to rot or mold in your crawl space, lint buildup on insulation, and damage to floor framing. The dryer should vent to the exterior. Recommend a qualified contractor correct as needed.

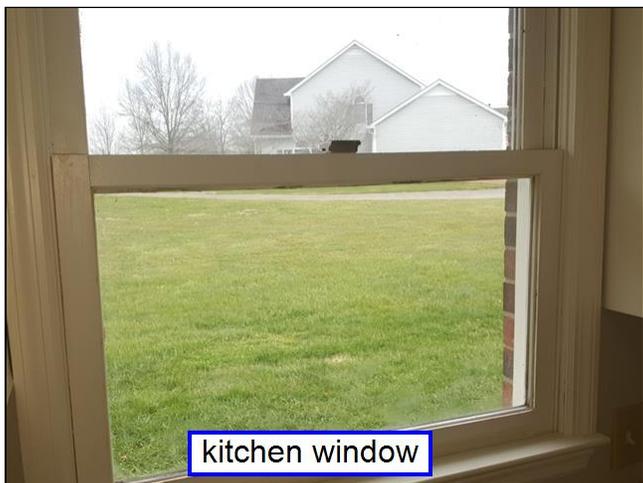
6.5 Item 6(Picture)

6.5 (2) The majority of the windows in the home will not open, see photos for location. These may be stuck or painted shut and/or may involve repair to sash cords. In the event a fire was to develop in the hallway in the home, person(s) or children have no means of exiting the master bedroom. This is a serious safety issue. Strongly recommend this be corrected prior to moving into home. Recommend unsticking the other window(s) to determine there functionality. If the problem persists, recommend either installing new windows or have a qualified window installer further investigate and repair as needed, which ever is cheaper.

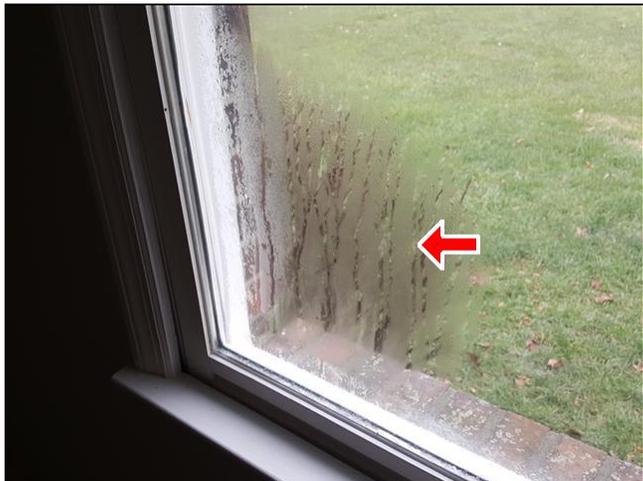
6.5 Item 12(Picture)

6.5 (3) The 2nd Bedroom window, left side at the home has deterioration at the seals between the panes of glass due to condensation was evident between the panes of glass. This can cause fogging between the window and the insulation/ thermal ability of the window may be compromised. This can cause heat/cooling loss. Recommend a qualified window installer further investigate and repair or replace as needed to ensure efficiency of windows. Some windows with lost seals may not have been evident at the time of this inspection. The windows were checked for condensation.

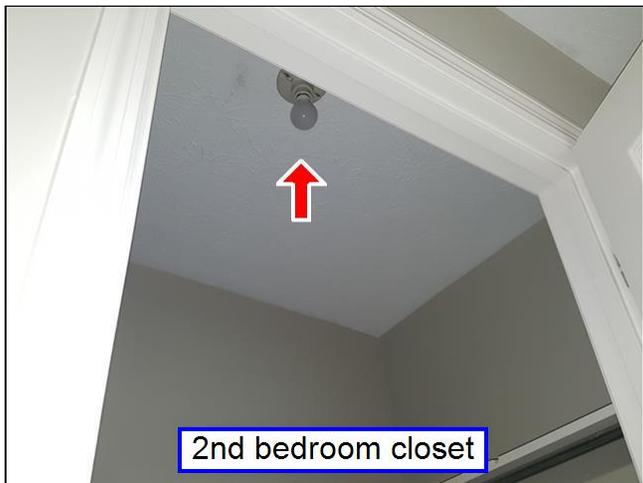
6.6 Item 1(Picture)

6.6 The light in the Master Bedroom and the 2nd Bedroom closet room is missing a fixture. Light bulbs in closets should have fixtures or be replaced with fluorescent bulbs to prevent fires from bulbs being in contact with clothing or storage items. This is a safety issue. Recommend correcting as needed.

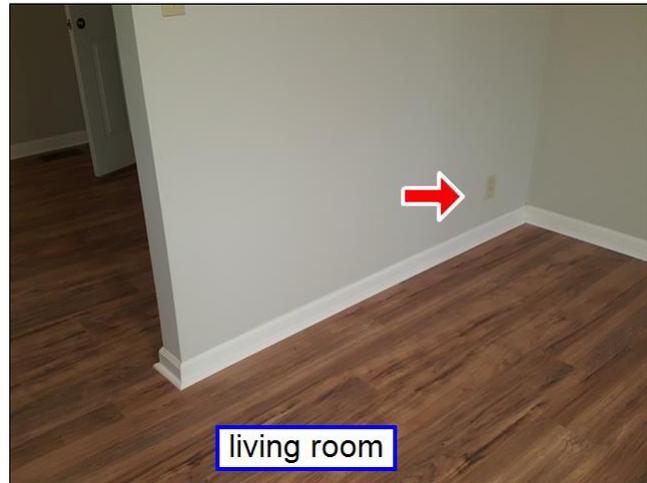
6.7 Item 1(Picture)

6.7 (1) The outlet(s) where indicated in the photo(s) are loose at the wall or in the outlet box. Electrical issues are considered a hazard until repaired. This is a safety issue that needs to be corrected due to an electric shock or fire from loose connections could occur if not repaired. Recommend a qualified licensed electrical contractor correct as needed.

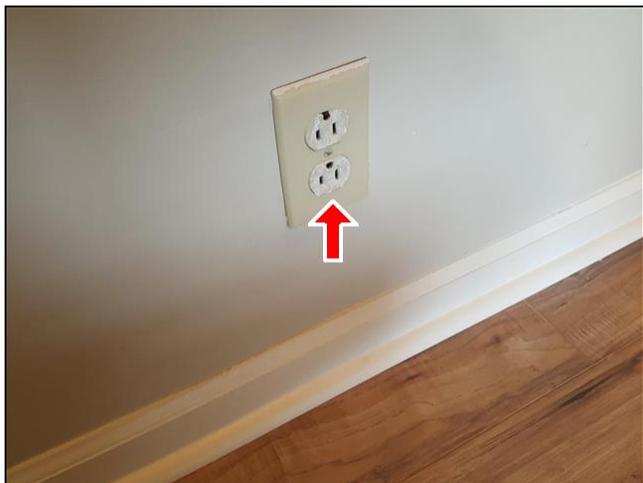
6.7 Item 4(Picture)

6.7 (3) The outlet in the hallway have been painted. Paint clumps in crevices can clog the openings in the outlet, making it difficult to insert the blades from the plug. Forcing the blades in may damage them and/or lead to a poor connection with the internal contacts creating a hazardous condition causing a fire. Additionally, paint chips can fall off the outlet or switch after repeated use creating a health hazard for young children and pets. Recommend replacing outlets and covers where necessary for safety by an electrician.

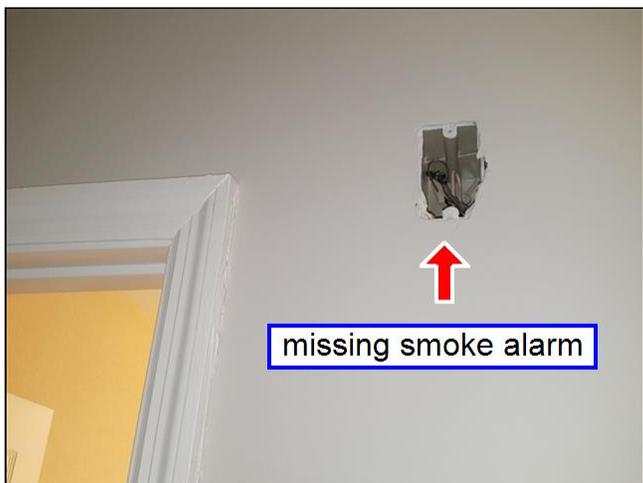
6.8 (2) The smoke detector has been disconnected intentionally and removed at the hallway. Without a working smoke detector in your home you have no first alert to a possible fire. This is a safety issue. Strongly recommend installing or replace the smoke detector for your safety in the home. Recommend a qualified contractor install one before closing and moving in. Note: Ensure the smoke alarm is a photoelectric type. Here is a link explaining type of alarm to use by the [Dept. of Fire and Emergency Services](#)

6.8 Item 1(Picture) hallway wall

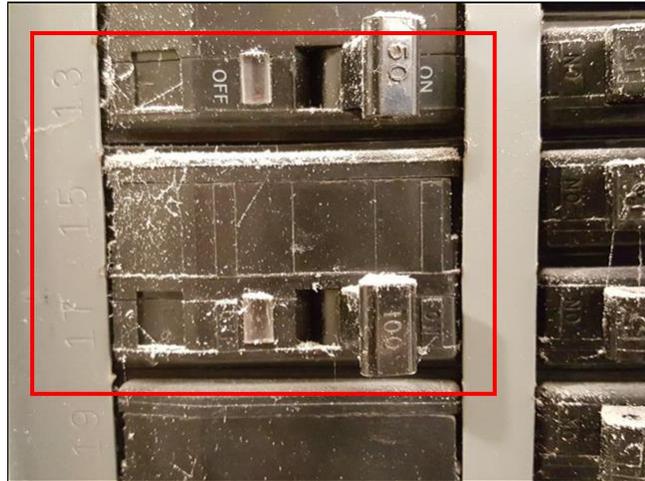
9.2 Item 2(Picture)

9.2 (2) The circuit breakers are not correctly labelled on the cover of the main electrical panel in the master bathroom. This is a safety issue. The panel indicates that the 100 amp breaker is for the furnace. The electrical panel should be indexed correctly, identifying each circuit breaker. This will allow for quick de-energizing of a circuit under emergency situations. Recommend the panel be correctly labelled to facilitate turning off breakers to circuits prior to moving in. A licensed electrician is recommended for this correction for safety.

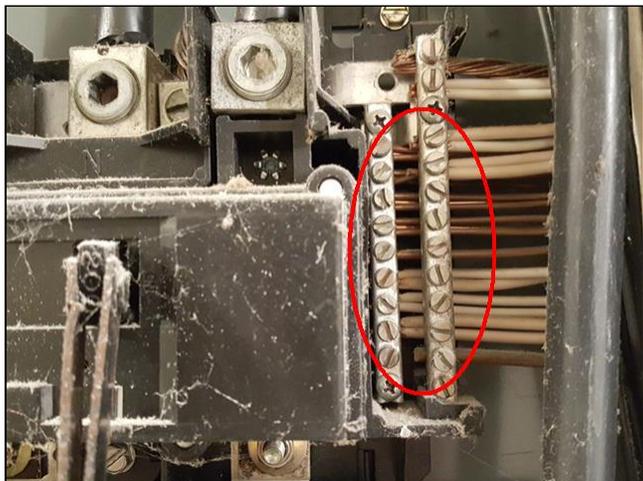
9.3 Item 1(Picture)

9.3 (1) More than one common (white wires) on a single lug of the neutral bar is not recommended but was found in the main panel in the master bathroom. Separation of these commons is recommended when any other electrical work is done by a qualified licensed electrician.

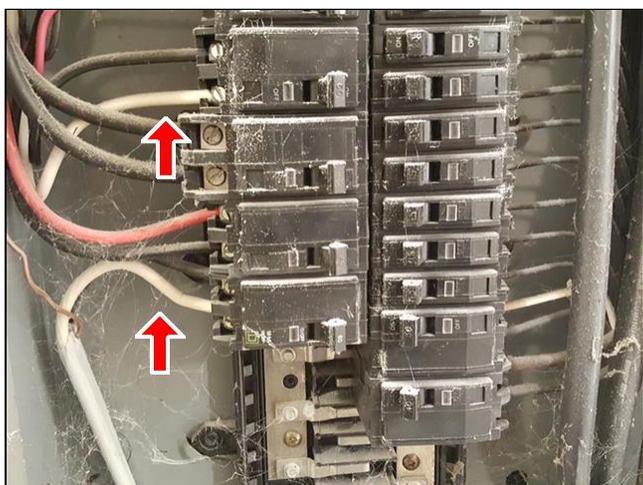
9.3 Item 2(Picture)

9.3 (2) The white wire(s) that are connected to the circuit breaker(s) in the main panel at the master bathroom should be marked black to indicate that they are live (hot wires) and are being used for the flow of electricity to travel. Recommend an electrician correct due to safety.

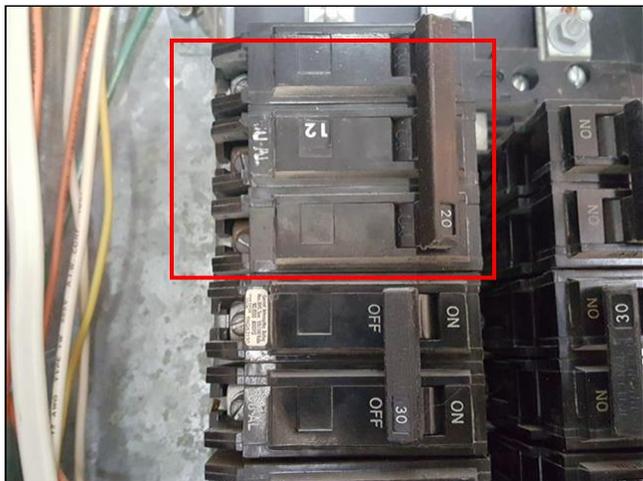
9.3 Item 3(Picture)

9.3 (3) There were no wires connected to the breaker at the sub panel in the garage yet the breaker is in the on position. Recommend the breaker be turned off and for a qualified electrician to perhaps remove the breaker from the panel box and install a knock out cover to cover opening when the breaker is removed.

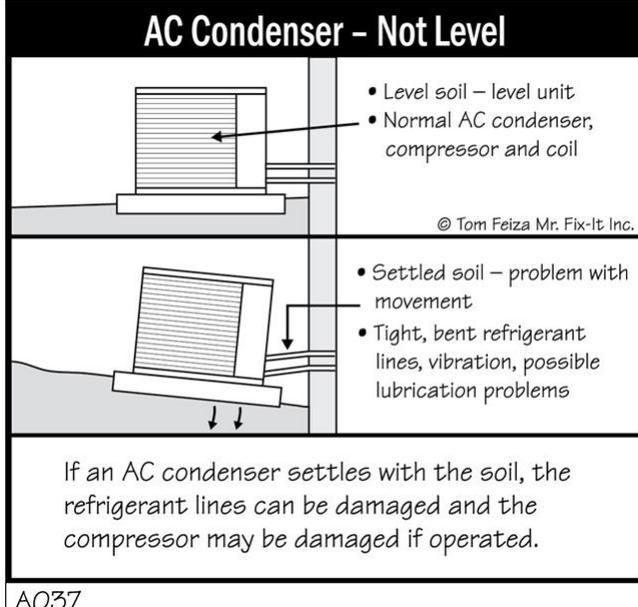
10.3 Item 5(Picture)

10.3 (3) Recommend the discharge for the condensate drain line be improved via installing a splash block and extending the drain line at the rear of the home. This will prevent water pooling near the foundation which could cause settlement of the foundation wall, soil erosion and water leakage into the crawlspace. Also to prevent possible settling of the platform for the Heat Pump. A qualified HVAC contractor is recommended for these repairs.

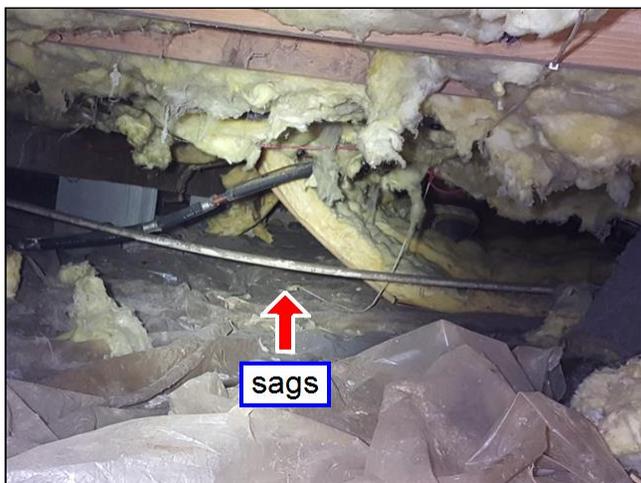
10.3 Item 7(Picture)

10.3 (5) The condensate drain line is not supported and sags leading to the exterior in the crawlspace. It also has an improper pitch for ease of draining. Poor drainage can lead to leakage or damage to the unit. Recommend a qualified contractor or HVAC contractor correct as needed.

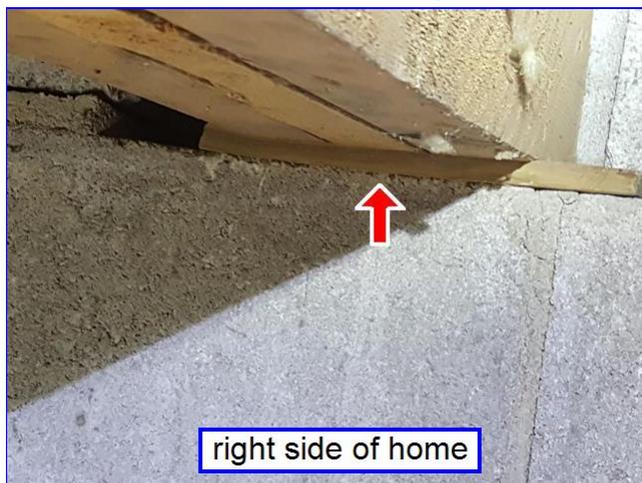
1.4 Item 3(Picture)

(2) Wood shims were placed under the beam (under 2nd bedroom area) to support and level beam resting on the masonry block wall foundation. Steel shims are recommended for this purpose. Wood will compress and allow the beam to sag resulting in the floor sloping and cracks in the drywall of the walls and ceilings. See note 6.1 Photo 1. Recommend a qualified structural engineer further evaluate to determine if corrections are needed.
