Report: 3443

Confidential Inspection Report

[REDACTED]
[REDACTED]
August 4, 2023

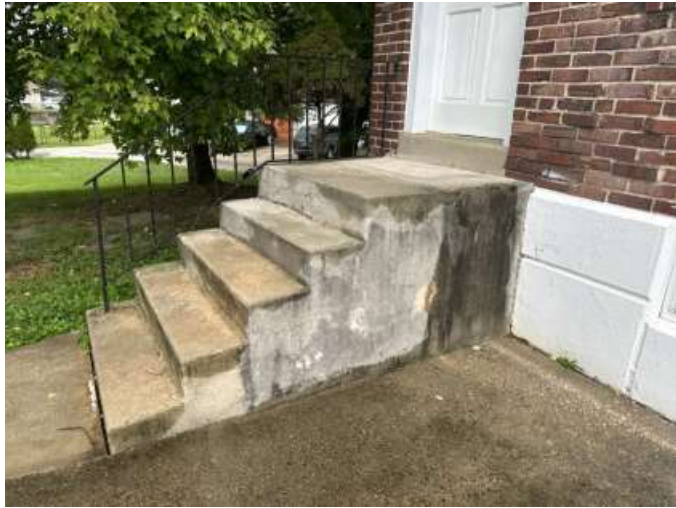
- Driveway:* Concrete.
- Walks:* Concrete, Public sidewalk.
- Exterior Steps:* Concrete.
- Handrails:* ⚠ Metal. Handrails missing at right side of front steps. Recommend installation as needed for safety.

Metal. Handrails missing at right side of front steps. Recommend installation as needed for safety.

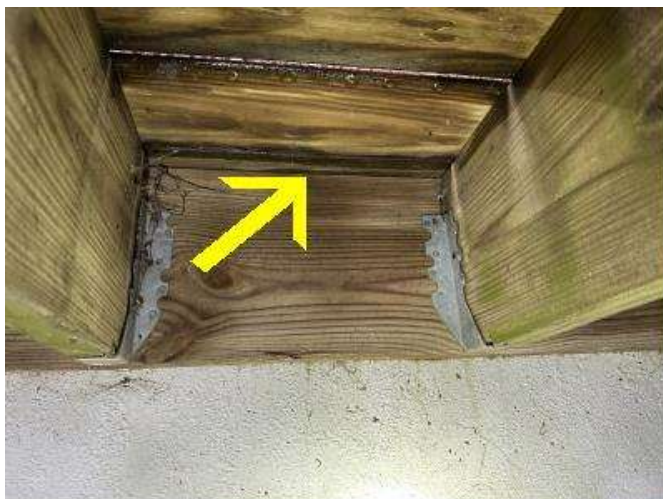
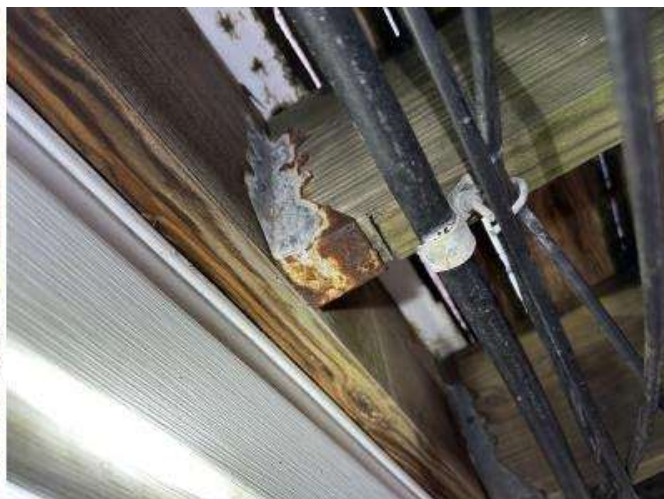
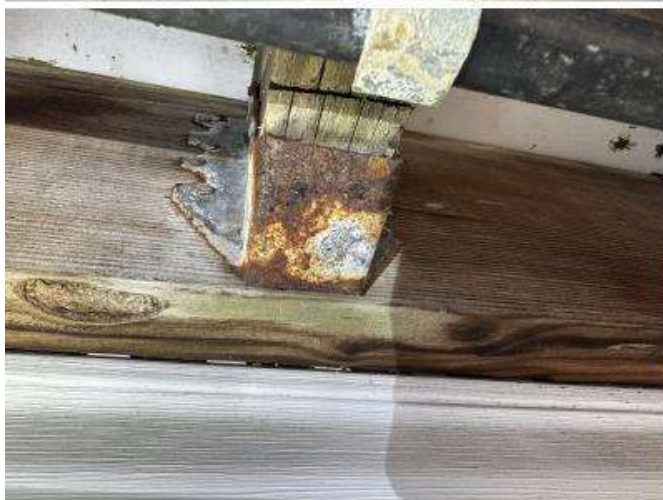
Wood, Missing flashing noted at deck ledger board. Proper flashing prevent water entry between the ledger and the house which can cause wood rot and fastener corrosion. Two deck brackets to the left of the rear door are rusted and required replacement. Recommend evaluation by qualified contractor for repair as needed.

- Deck:* ⚠ Wood, Missing flashing noted at deck ledger board. Proper flashing prevent water entry between the ledger and the house which can cause wood rot and fastener corrosion. Two deck brackets to the left of the rear door are rusted and required replacement. Recommend evaluation by qualified contractor for repair as needed.

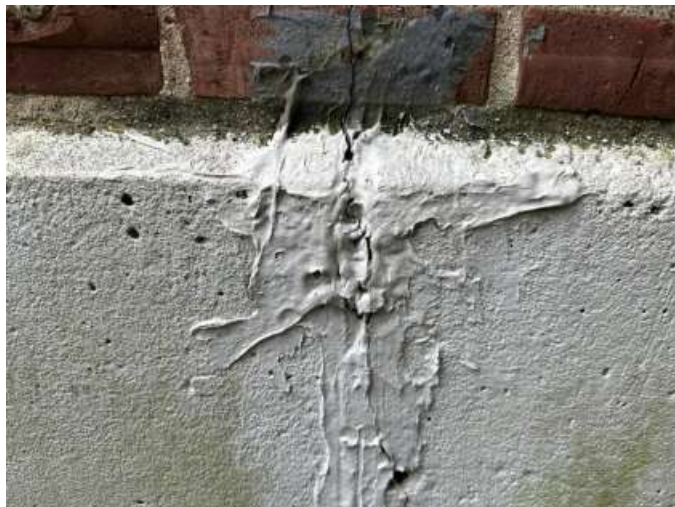
Poured concrete, Shrinkage cracks are hairline cracks that are caused by the evaporation of water in the concrete mix. This is a normal condition. Seventy-five percent of all shrinkage cracks appear in the first year.

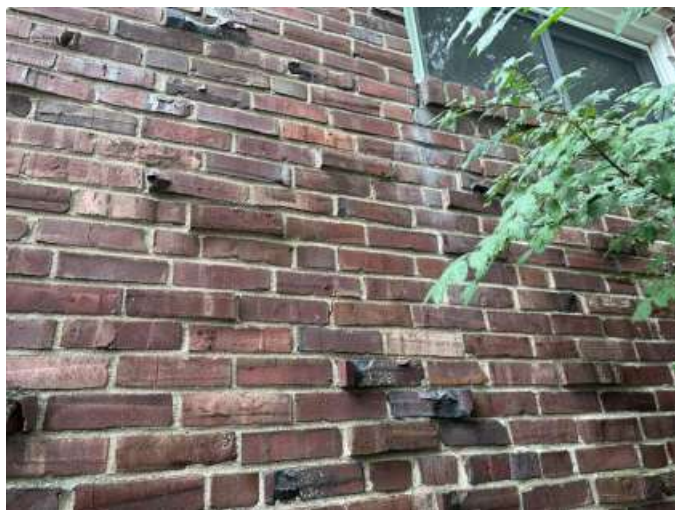
Brick. Settling cracks noted at middle side first floor exterior wall. Cracks extend through bricks indicating stress on the structure, however it appears to older. Monitor for widening or new cracks over time. If further review is desired, contact a foundation expert or structural engineer as desired.

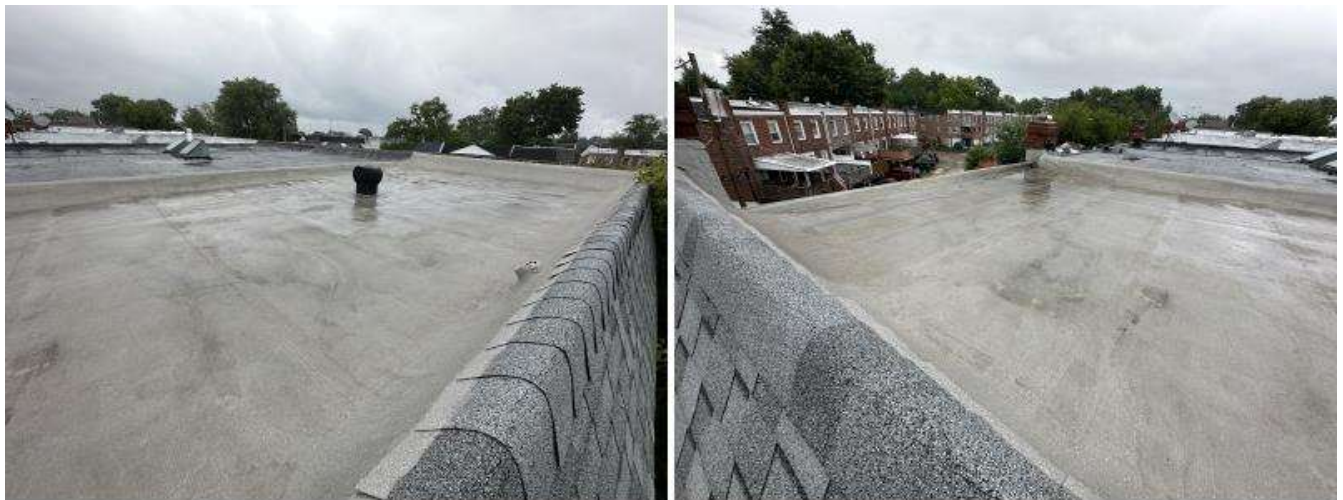
Roof Covering: ! Modified bituminous membrane, often referred to as rubber roofing noted. Recommend recoat with silver aluminized coating every 2 to 4 years to prolong life.

Roof Covering Condition: Roofing material appears to be in good condition for its age and nature. Monitor for future wear and leakage.

Modified bituminous membrane, often referred to as rubber roofing noted. Recommend recoat with silver aluminized coating every 2 to 4 years to prolong life.

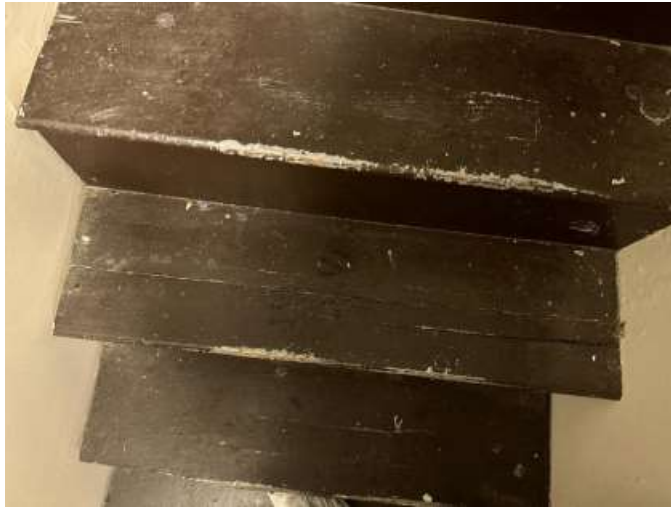
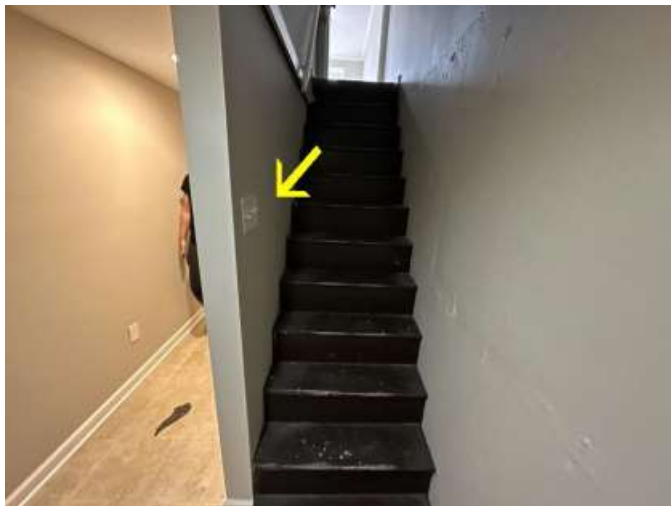
Wood. Damaged/cracked steps towards the bottom. Recommend repair prior to worsening conditions.

Missing handrail noted at base of basement stairs. Install for safety.100.

- Access: Partially finished; Limited access to structure.
- Basement Stairs: ⚠ Wood. Damaged/cracked steps towards the bottom. Recommend repair prior to worsening conditions.
- ⚠ Missing handrail noted at base of basement stairs. Install for safety.100.

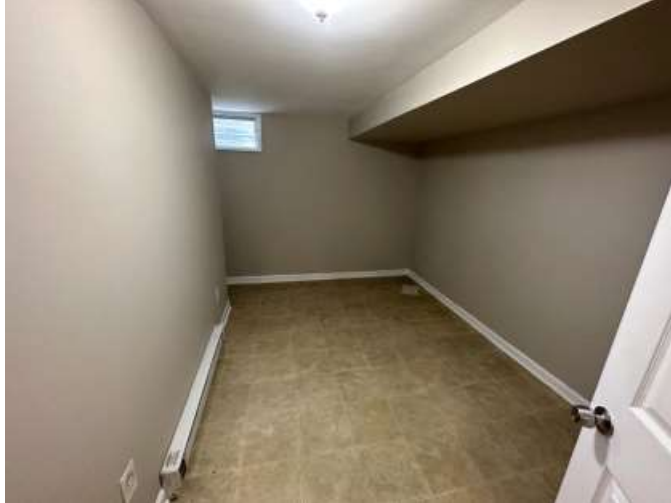
The windows as installed appear to be satisfactory. Difficult operation is typical of basement windows. The windows as installed are not egress accessible. As a result of the lack of egress, the areas should not be considered as living space nor used as a sleeping area for safety reasons. In Pennsylvania, finished basements have required egress for many years. Consult the local authority having jurisdiction for more info as needed.

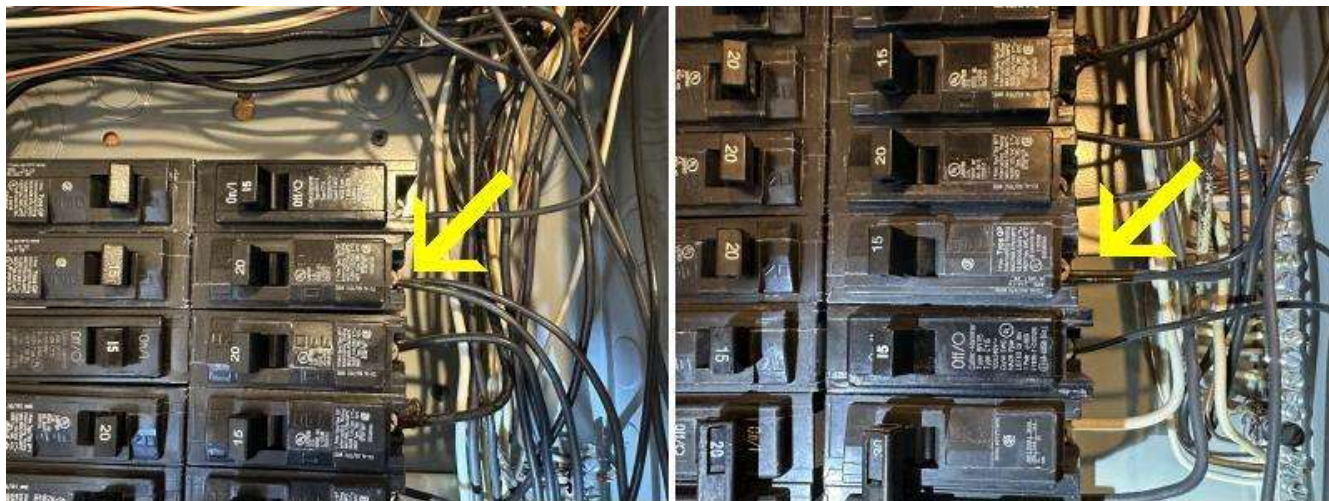
Multiple double taps noted. Panel is full. Multiple circuit wires noted at breaker(s) rated for a single circuit wire. This can cause an overload or burned wire. Recommend evaluation by qualified electrician to separate double taps for safety. This may require replacement to a larger panel or the addition of a sub-panel.

Main Panel Observations: ⚠ Multiple double taps noted. Panel is full. Multiple circuit wires noted at breaker(s) rated for a single circuit wire. This can cause an overload or burned wire. Recommend evaluation by qualified electrician to separate double taps for safety. This may require replacement to a larger panel or the addition of a sub-panel.

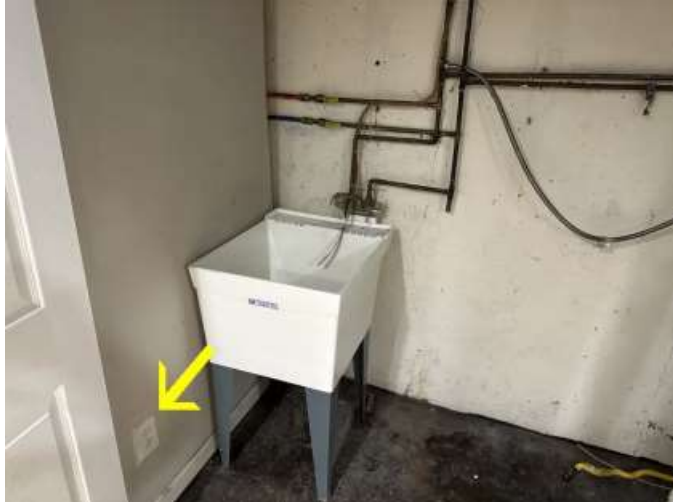
Ground Fault Circuit Interrupter (GFCI) protection is required at left of tub sink. Recommend evaluation for installation or repair as needed by qualified electrician for safety.

Laundry: ⚠ Ground Fault Circuit Interrupter (GFCI) protection is required at left of tub sink. Recommend evaluation for installation or repair as needed by qualified electrician for safety.

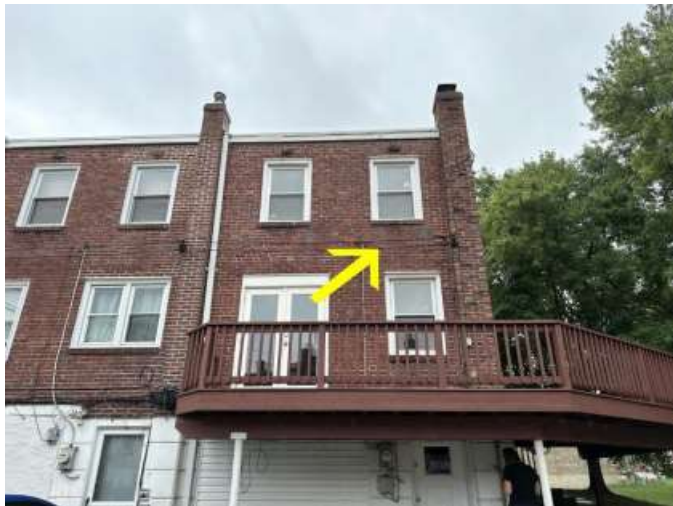
Overhead, Aluminum, 110/220 Volt, Circuit breakers, Overhead wires are too close to ground (should be 10' off ground at walking areas and 14' above driven areas) Recommend evaluation to raise wires by qualified electrician or local power company.

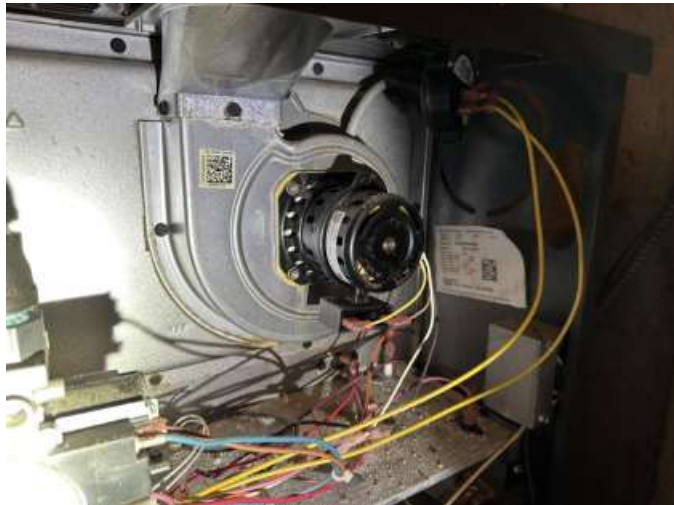
Heating system did not respond to controls. The induction fan is cycling on and off and the flames are not lighting. See video clip here for review of the induction fan. [www.https://youtu.be/0GEenKT2vn0](https://youtu.be/0GEenKT2vn0)

Heating system did not respond to controls. The induction fan is cycling on and off and the flames are not lighting. See video clip here for review of the induction fan. www.https://youtu.be/0GEenKT2vn0
		Recommend evaluation for service or repair as needed by qualified technician.

Recommend evaluation for service or repair as needed by qualified technician.

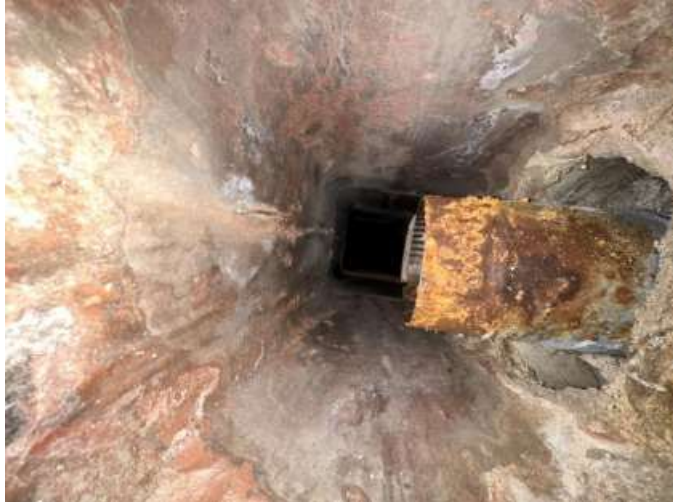
There is a raised efficiency furnace installed connected to an older terra cotta clay lined chimney without the appropriate stainless steel liner installed to accommodate the cooler exhaust gas temperature. Recommend evaluation by qualified chimney professional for stainless steel liner installation to protect structure and for health safety.

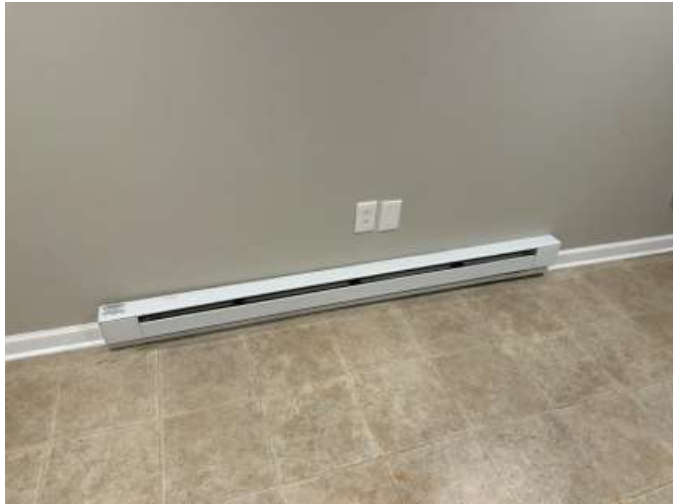
Outlets noted above base board electric heat. This is a fire risk as a wire could enter the unit and burn and is not allowed. Recommend evaluation by qualified electrician for outlet or heater relocation for safety.

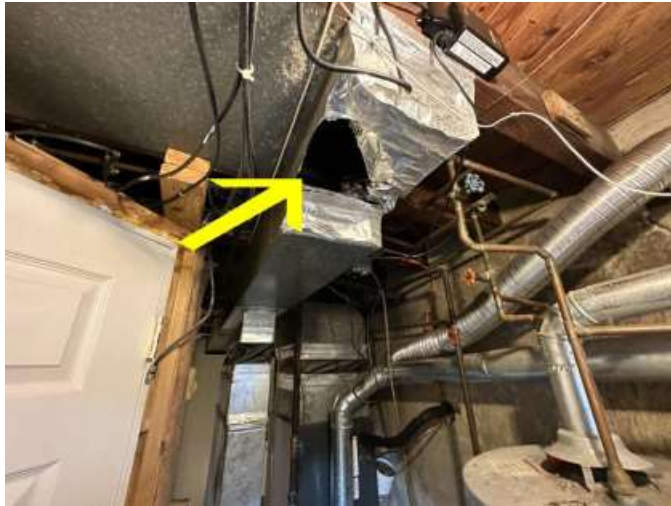
Open return duct noted in the basement utility room ceiling. This is drawing in return air from the basement and lessening the return air being drawn from the living areas of the home. Recommend sealing.

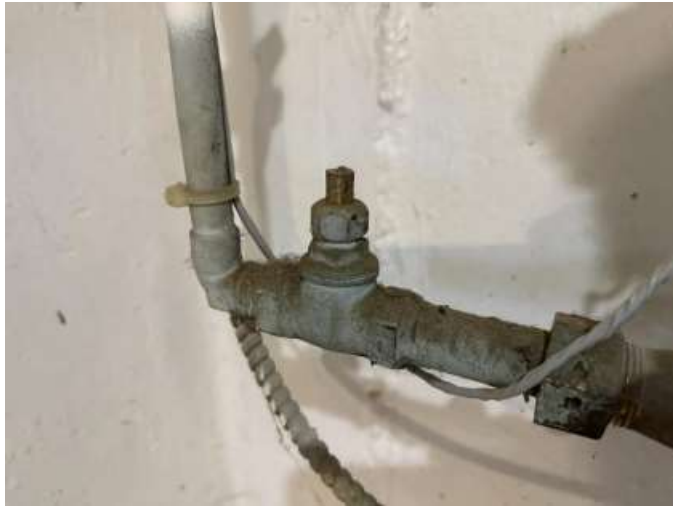
Public water, Meter located in basement, Main shutoff is located at meter. Maintain clear access. Shut off valve handle after the meter is missing. Replace as needed.

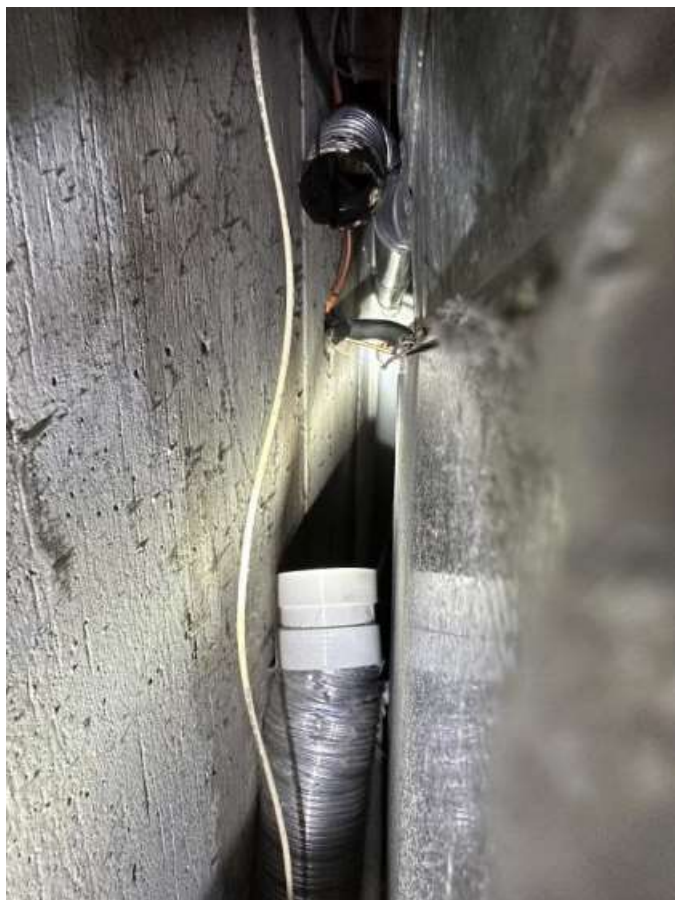
The clothes dryer is disconnected from the exterior vent duct. Repair as needed. Clean dryer vent of lint annually.

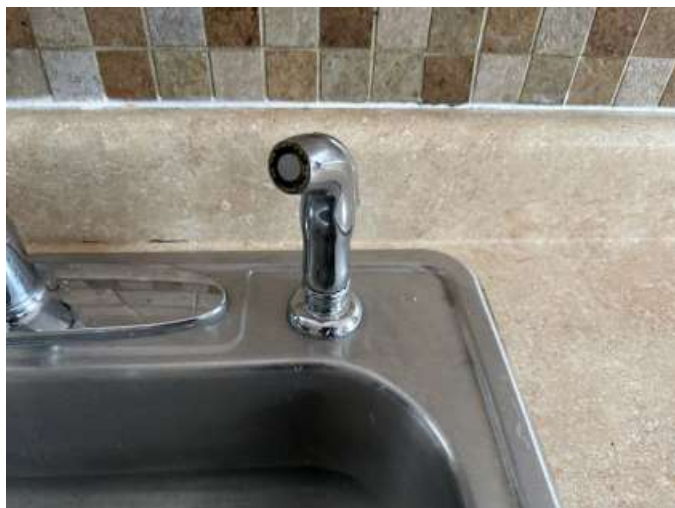
Sprayer is not functional. Replace as needed. Typically the entire faucet assembly would be replaced.

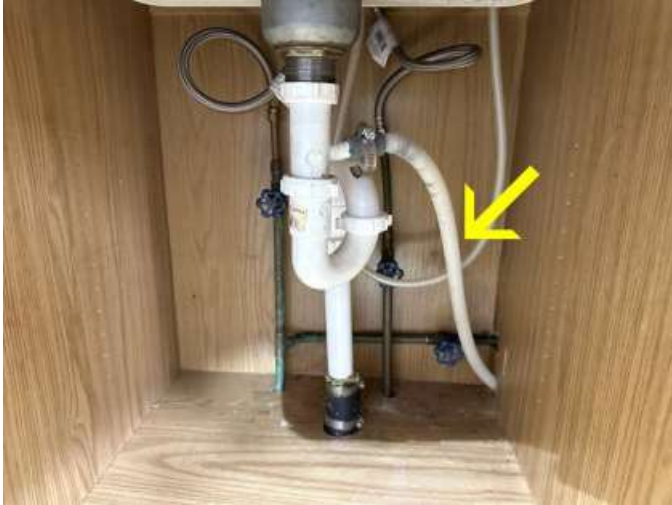
Dishwasher was tested through one cycle. Unit appears to be functional. Dishwasher hoses should have a high loop at least 20 inches above the finished floor to prevent wastewater from entering the appliance if the drain clogs.

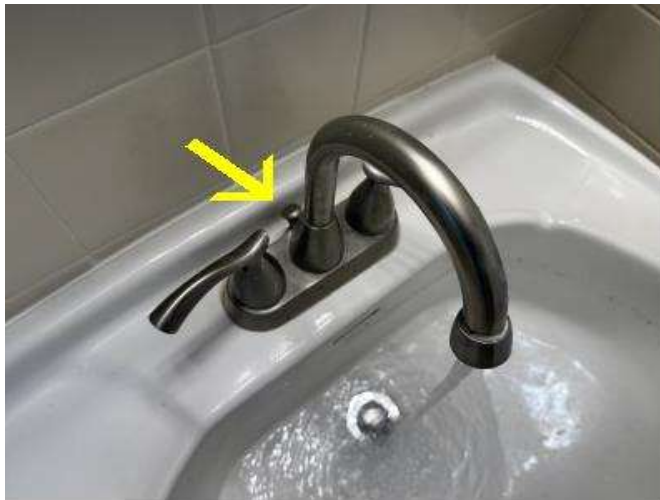
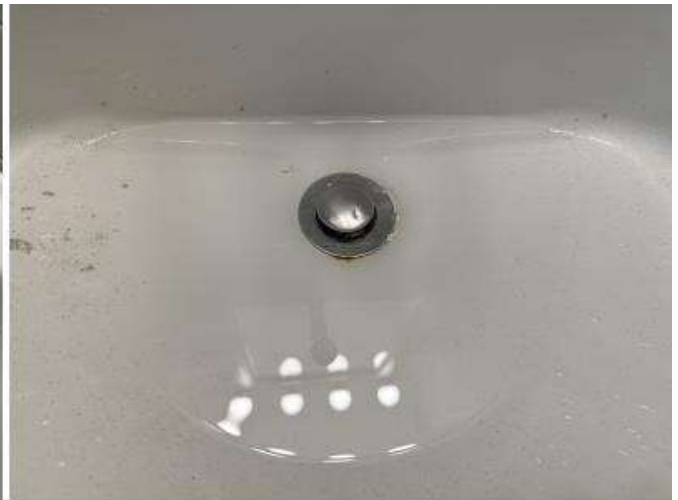
Sink stopper inoperative at 2nd floor bathroom sink. Repair as needed for proper operation. Slow drain noted at same sink. Repair as needed with a drano type product or seek assistance of a qualified plumber for proper water drainage.

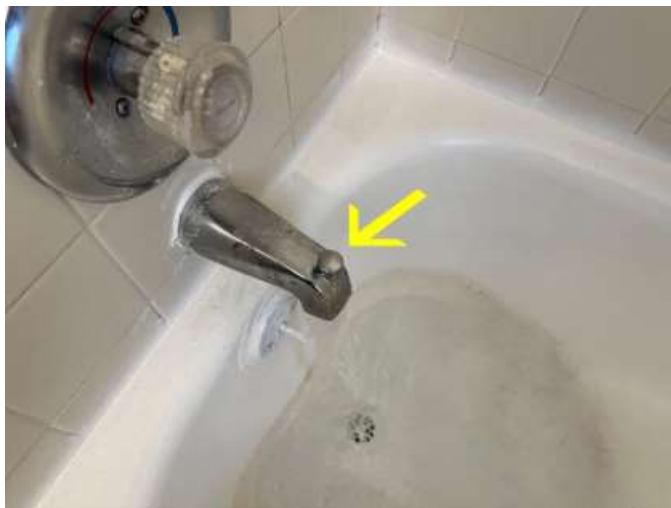
Diverter does not fully engage at tub . Recommend adjustment or replacement as needed by qualified plumber for proper operation.

Diverter does not fully engage at tub. Recommend adjustment or replacement as needed by qualified plumber for proper operation.

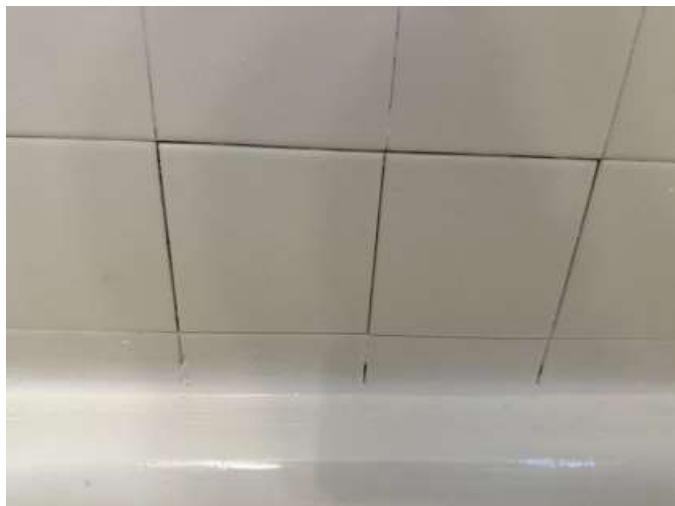
Ceramic Tile. Missing grout noted. Recommend grout repair as needed by qualified contractor. Caulk and seal all tub and shower areas as a precaution.

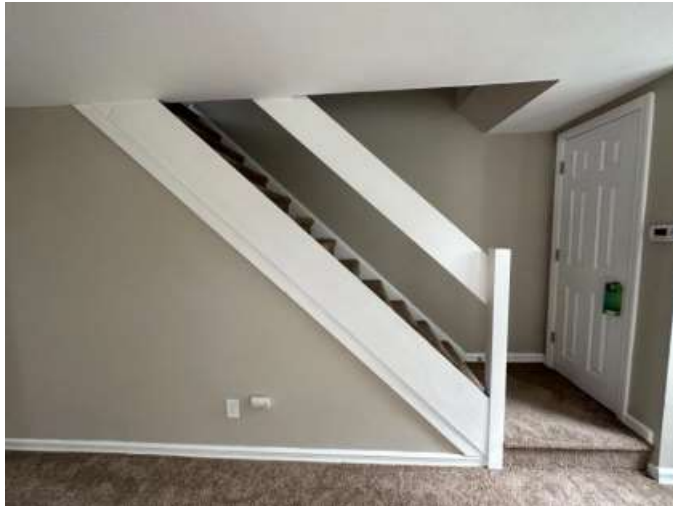
Openings noted at guardrail large enough for a child to pass through. Modern standard is vertical spindles, 4 to 6 inch spacing. Recommend repairs as needed for safety.

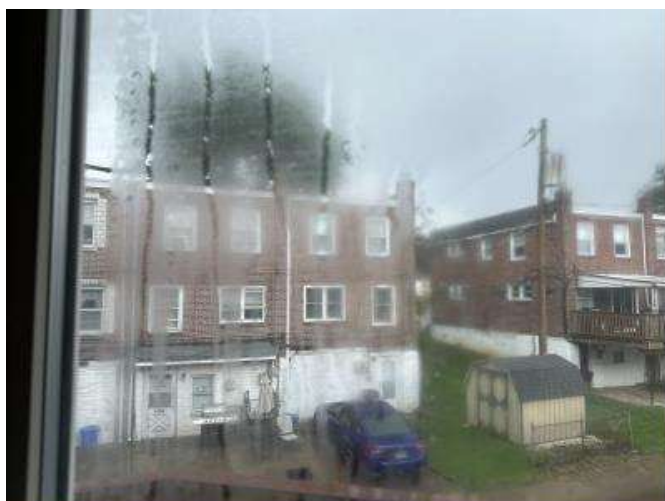
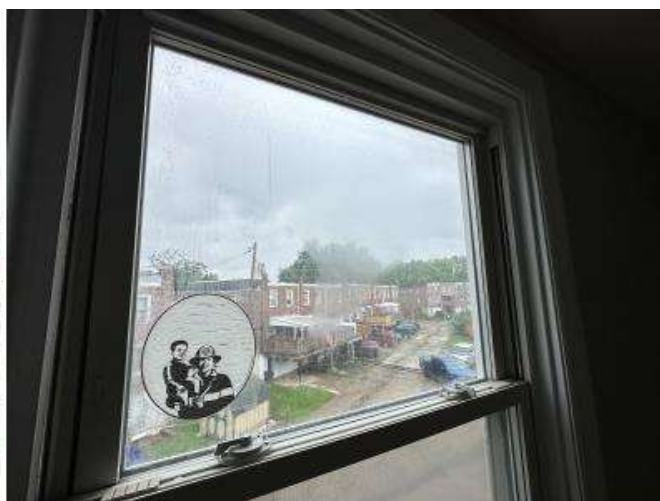
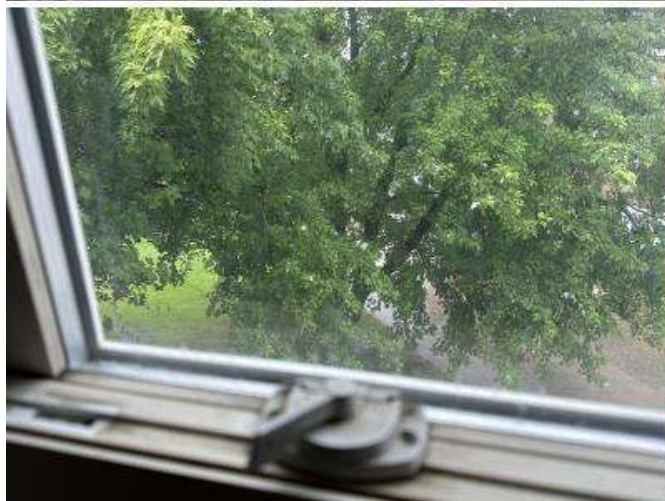
Type: Vinyl frame / vinyl clad, Double glazed insulated, Most windows were tested where accessible and found operable with only minor sticking noted. Windows require seasonal attention to remain operable. Fogged window, blown thermal seal noted at kitchen and two bedroom windows. Seal at double pane insulated window has failed, allowing moisture between the panes. Not all blown seals are visible in all seasons and visibility can vary with other factors such as temperature. This inspection can only mention those that are clearly visible at time of inspection. Repair typically is the replacement of the glass unit. Recommend evaluation for repair as needed by qualified window contractor.
