SAGUACHE CREEK DIVERSION INFRASTRUCTURE INVENTORY

Structure Name: MUNRO D 1

Date: April 11, 2019

Saguache Creek Stream Management Plan

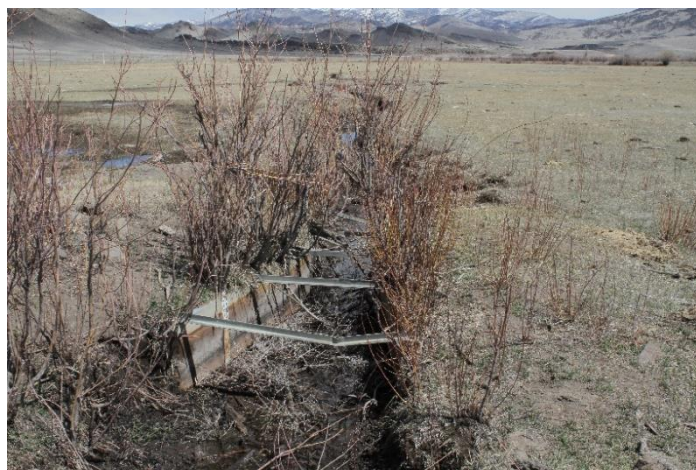
Flume looking downstream

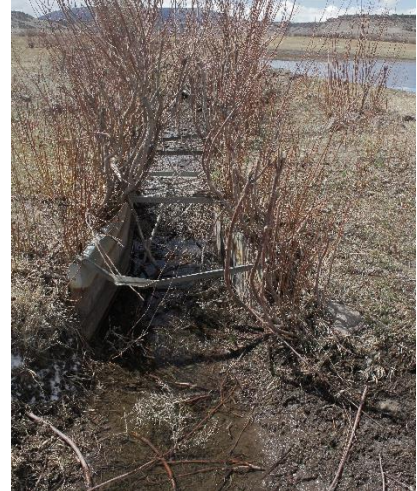
Flume looking upstream
