SAGUACHE CREEK DIVERSION INFRASTRUCTURE INVENTORY

Structure Name: MUNRO D 1

Saguache Creek Stream Management Plan

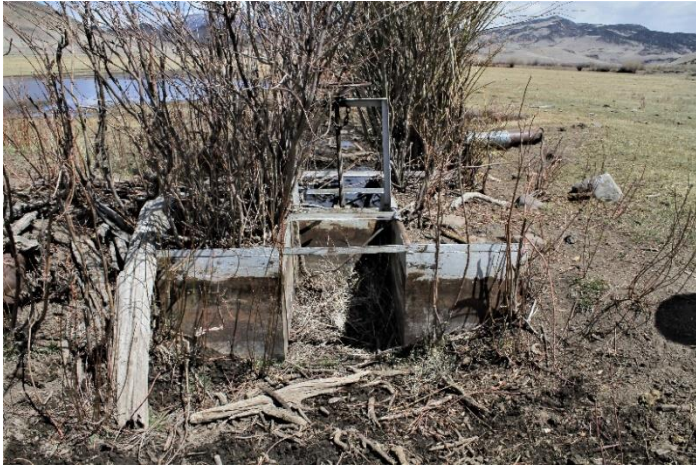
Structure Description: This ditch is located at the apex of a meander in the stream. A stacked boulder diversion dam directs water to the headgate, which is located on the north bank of the river. The headgate is tilted, presumably due to willow growth. The flume is sunken and is partially collapsed due to willows.

Headgate looking downstream

Repair(s) or Improvement(s) Currently Needed: The headgate should be reset to improve its function. The flume should be reset and some vegetation removed to improve administration of this ditch. Fish passage and riparian restoration should be considered as part of any future repairs or improvements.

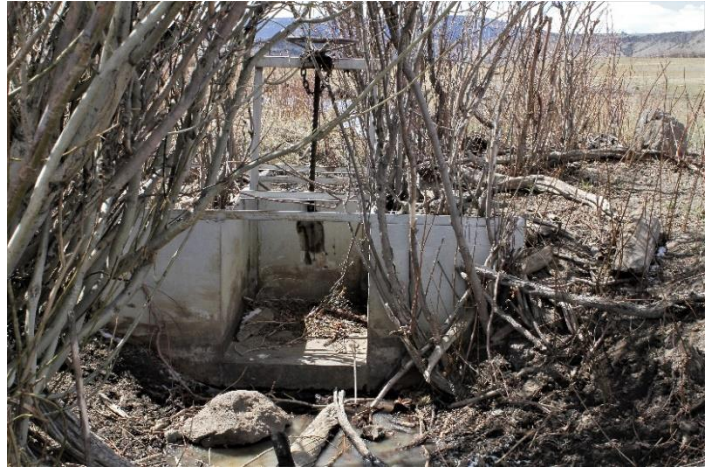
Headgate outlet

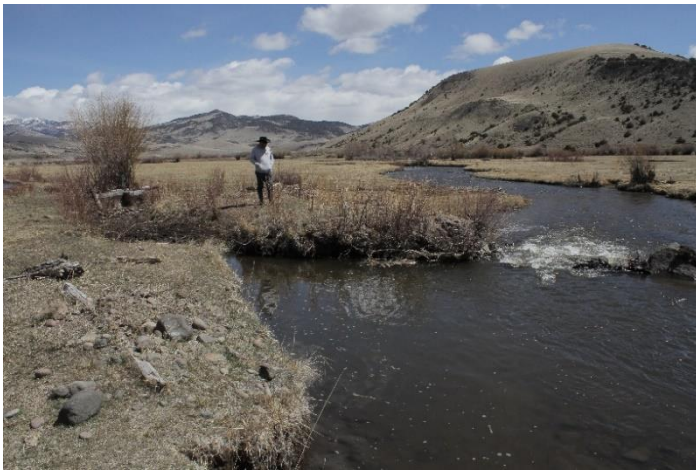
Headgate and diversion dam

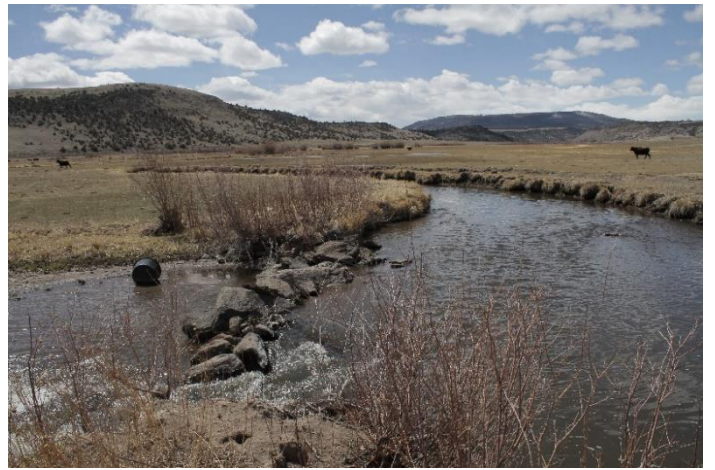
Diversion dam

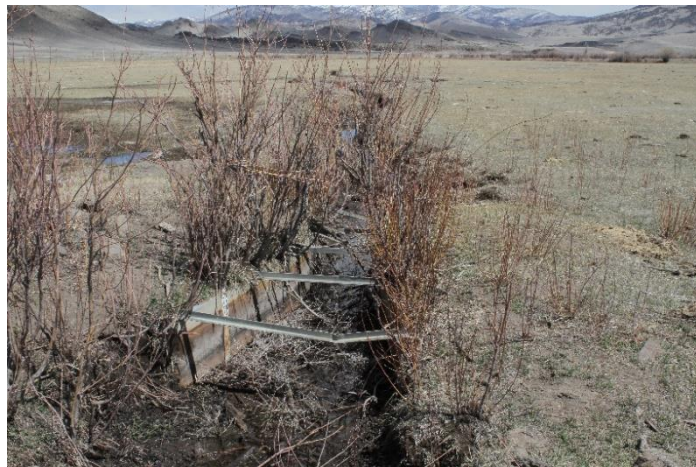
Flume looking downstream

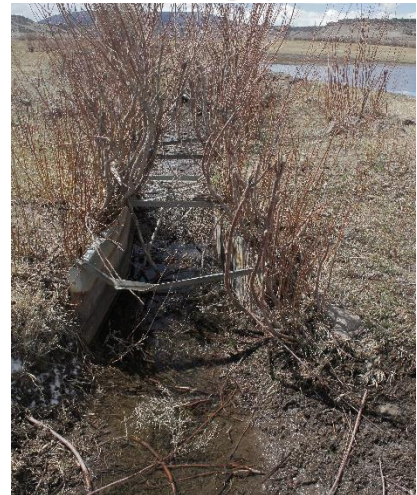
Flume looking upstream
