MINIMUM INSPECTION PROCEDURAL GUIDELINES  
FOR BUILDING ELECTRICAL RECERTIFICATION

INSPECTION MADE BY: FLORIN FLOREA P.E.

a. Name on Title: Village at Dadeland Condominiums (G)

b. Street Address: 7500 SW 82nd St. Miami, Florida 33143

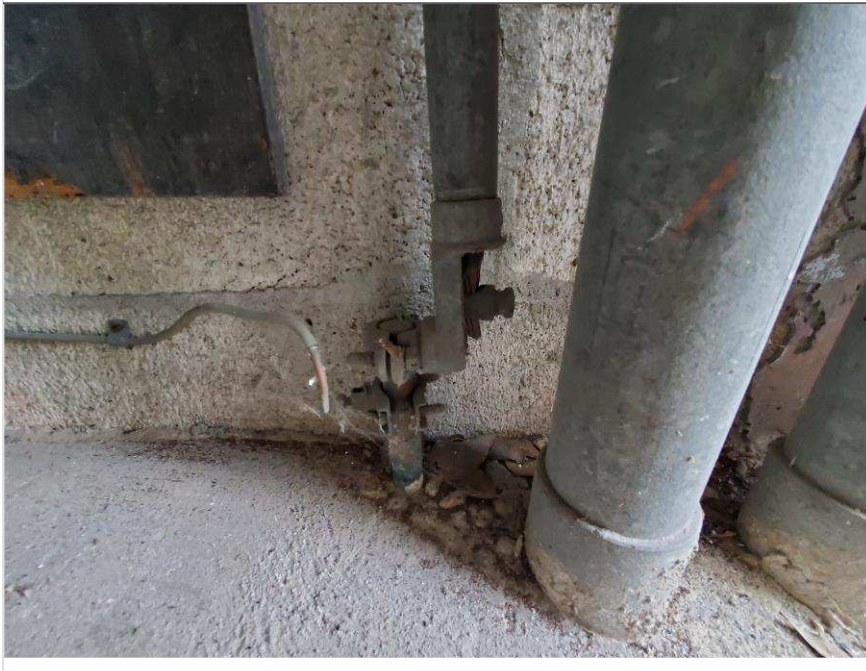
Photo 12 – Village of Dadeland Condominium Association

Existing Electrical Room - 1st FL  
Main Service - Grounding

Grounding resistance to be tested to determine if repairs and/or maintenance are required.

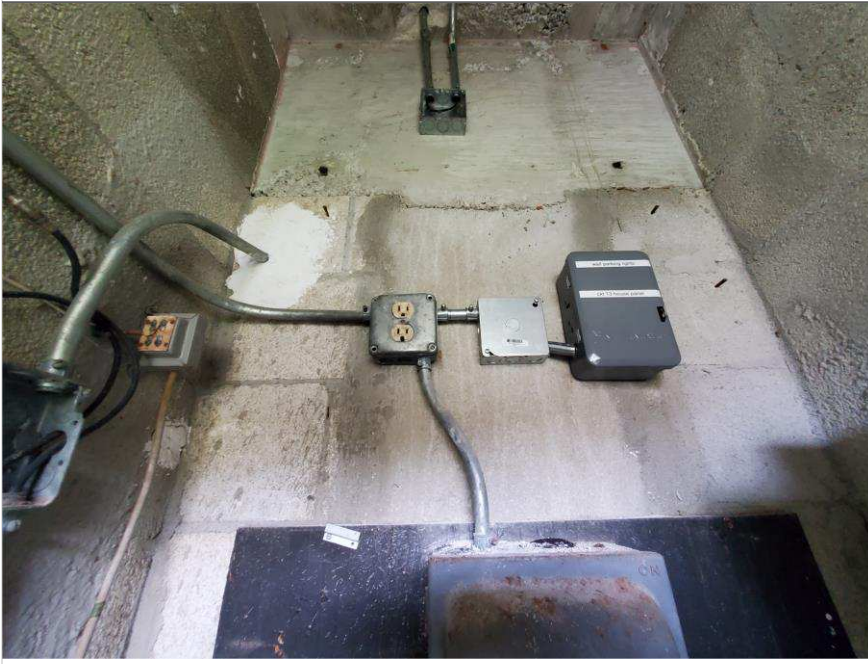
Photo 13 – Village of Dadeland Condominium Association

Existing Electrical Room - 1st FL

All wall penetrations to be fire caulked.

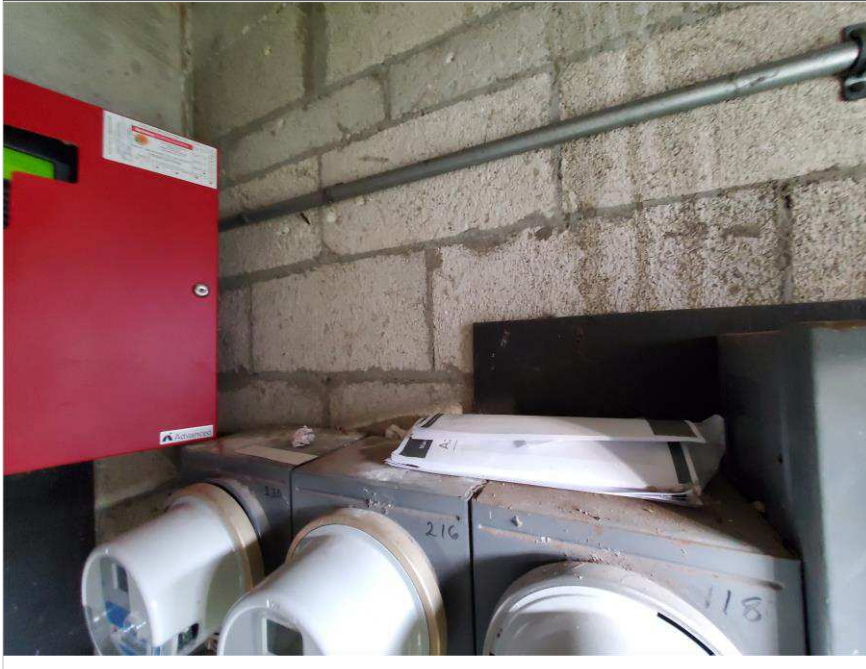
Photo 9 – Village of Dadeland Condominium Association

Existing Electrical Room - 1st FL  
Meter stacks are corroded.  
50 year old electrical  
component.

Old and corroded meter stacks.

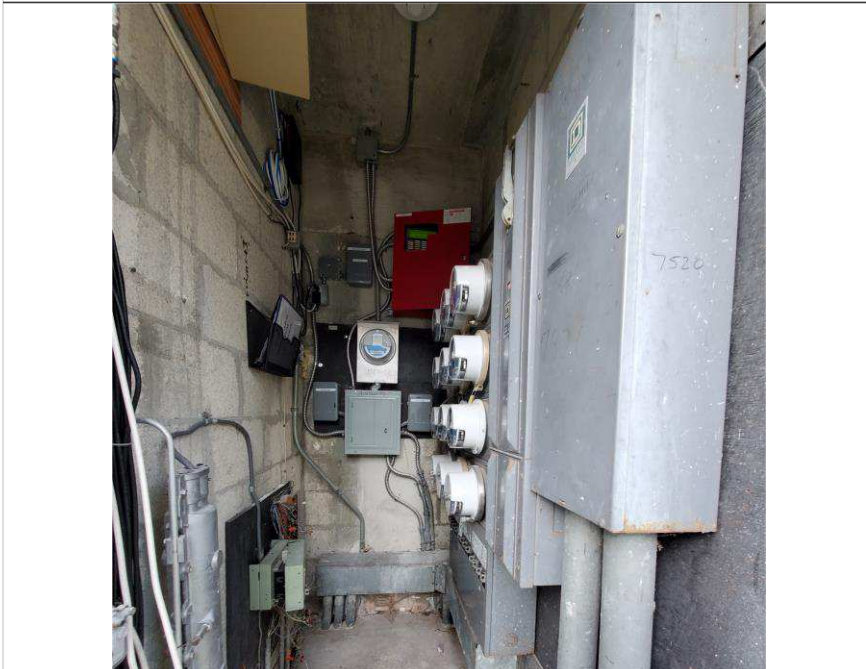
Photo 10 – Village of Dadeland Condominium Association

Existing Electric Room - 1<sup>st</sup> FL

Insufficient clearance at  
electrical components.

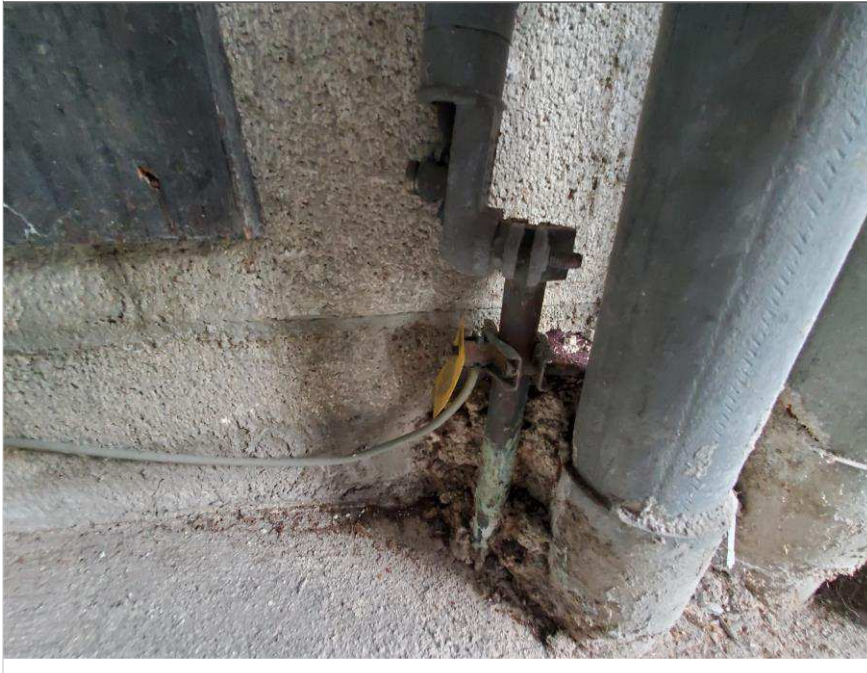
Photo 11 – Village of Dadeland Condominium Association

Existing Electrical Room - 1st FL  
Main Service - Grounding

Grounding resistance to be tested to determine if repairs and/or maintenance are required.

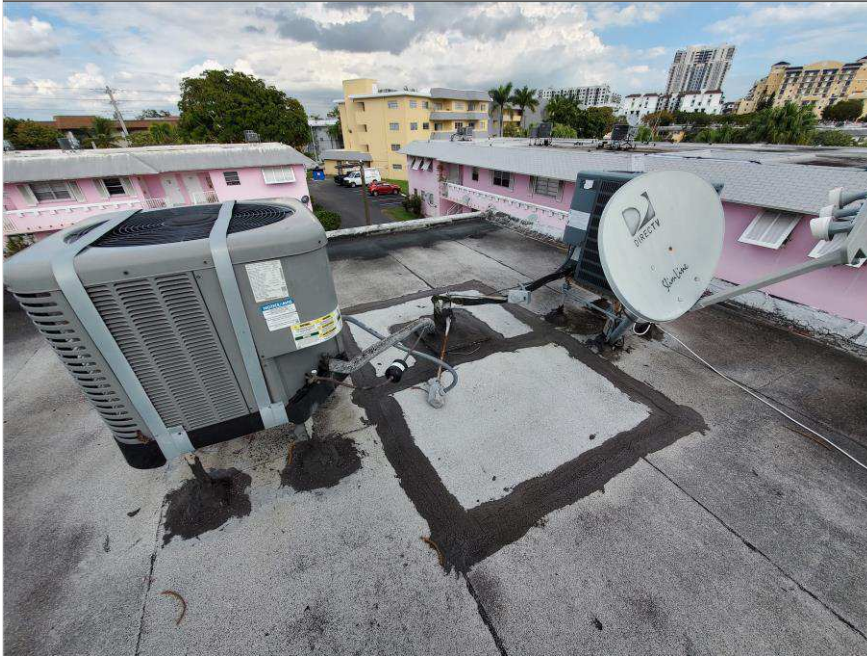
Photo 12 – Village of Dadeland Condominium Association

Rooftop -  
Rooftop Condenser Units

Junction boxes not properly supported.

Corroded conduits

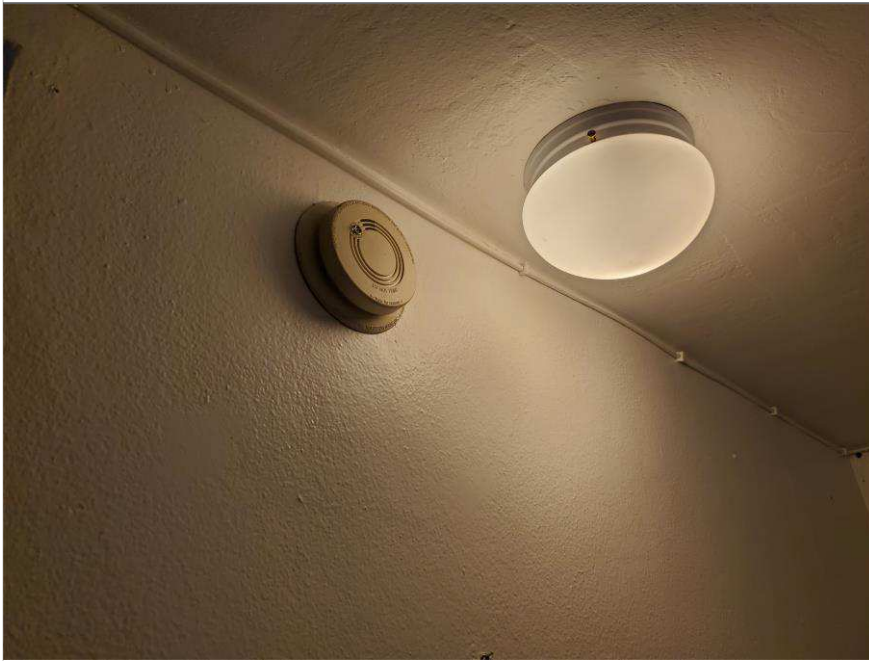
Photo 24 – Village of Dadeland Condominium Association

Apartments - Old Smoke Detectors

Old Smoke Detectors to be replaced.

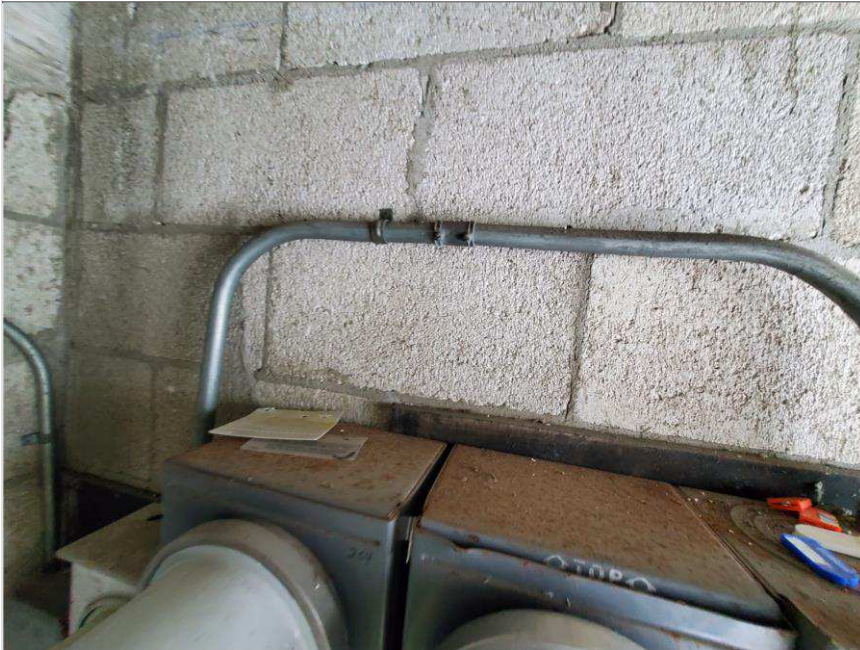
Photo 8 – Village of Dadeland Condominium Association

Existing Electrical Room - 1st FL  
Apartment Meters - Top View

Old and corroded meter stacks.

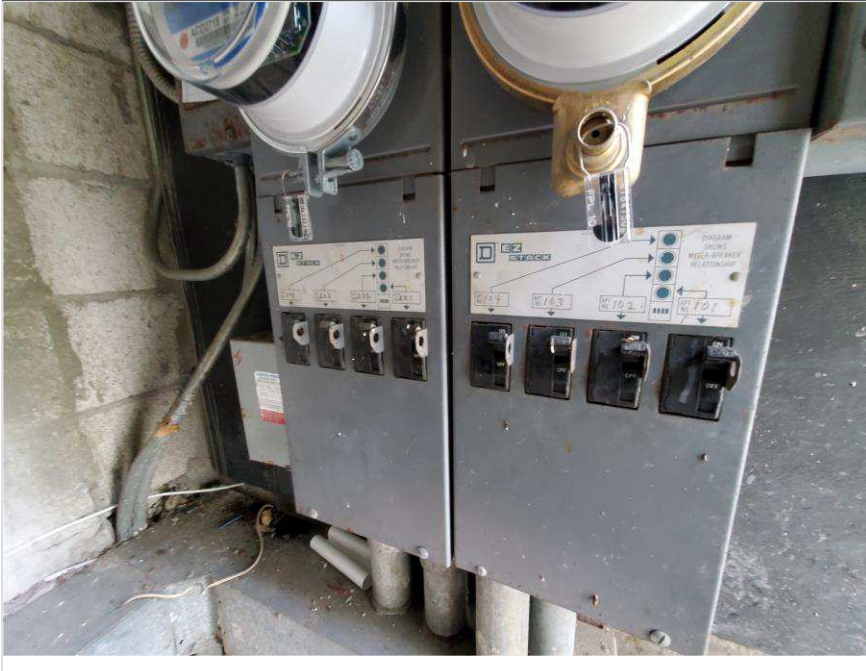
Photo 9 – Village of Dadeland Condominium Association

Existing Electrical Room - 1st FL  
Apartment Meters and Main  
Switches

Insufficient clearance at  
electrical components.

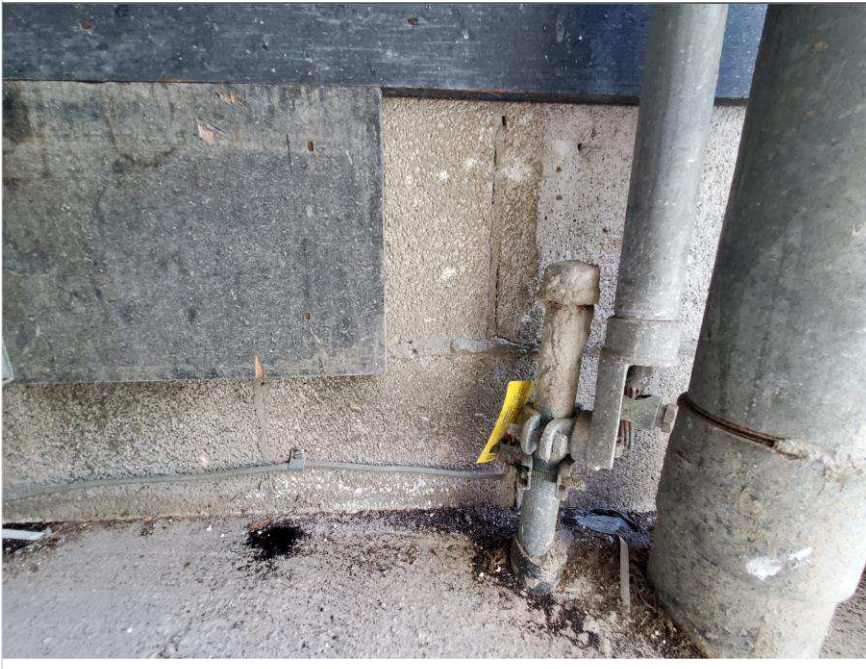
Photo 10 – Village of Dadeland Condominium Association

Existing Electrical Room - 1st FL  
Main Service - Grounding

Grounding resistance to be  
tested to determine if repairs  
and/or maintenance are  
required.

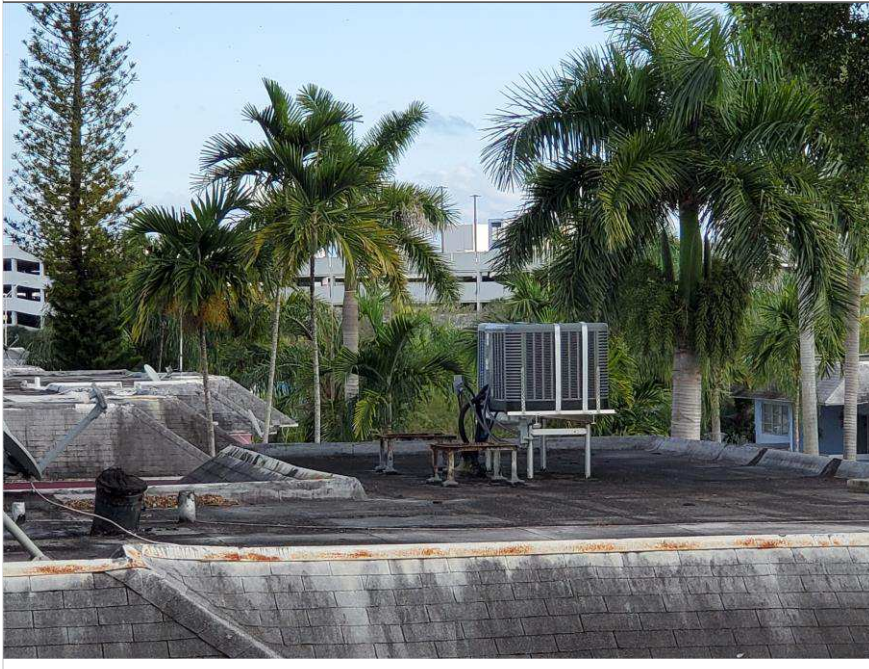
Photo 11 – Village of Dadeland Condominium Association

Rooftop Condenser Units -

Missing or improperly installed disconnect switches.

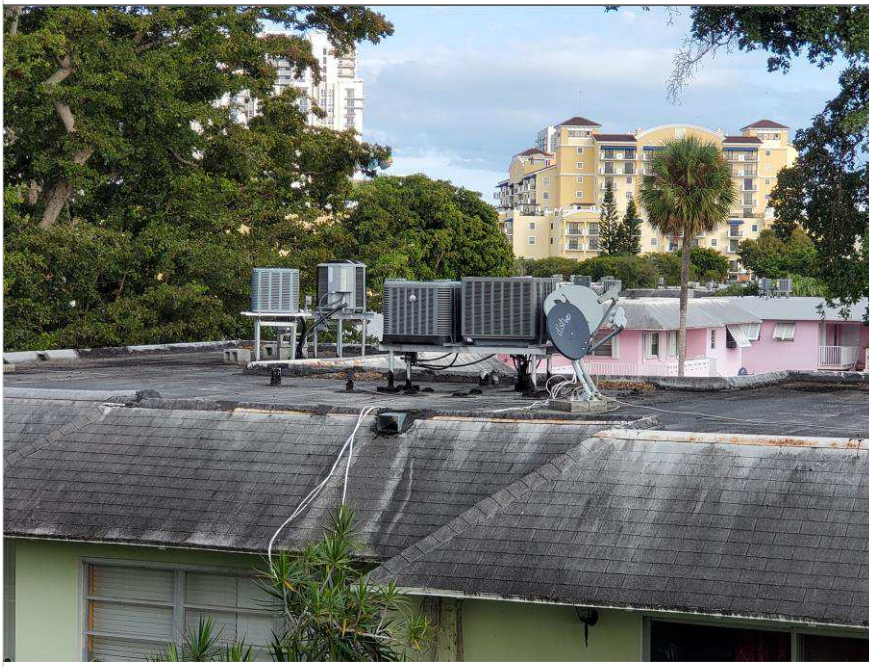
Photo 12 – Village of Dadeland Condominium Association

Rooftop Condenser Units -  
Corroded junction boxes and  
conduits.

Improperly installed switches.

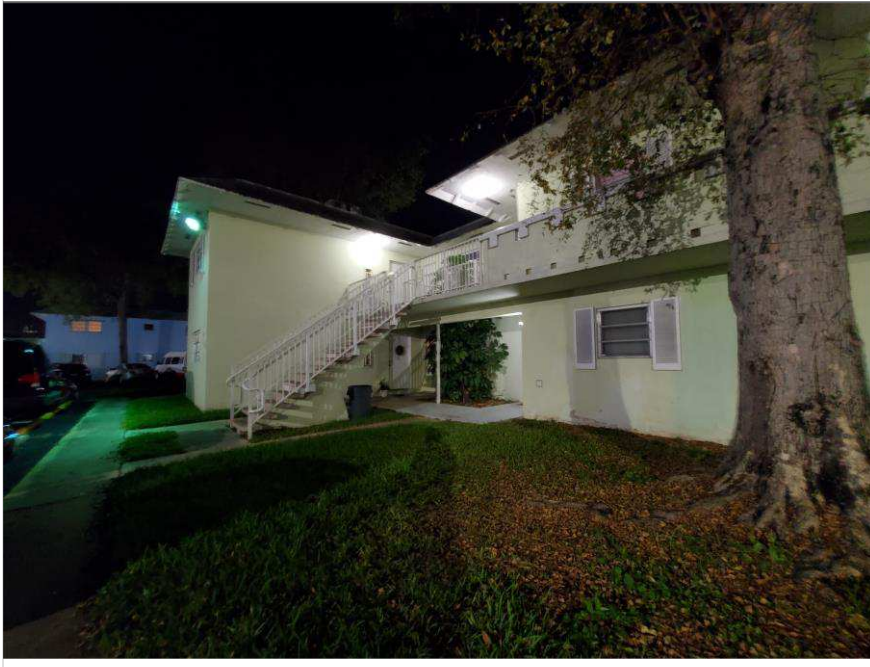
Photo 13 – Village of Dadeland Condominium Association

Points of Egress -  
Poorly illuminated sidewalks and  
stairs.  
Exterior lights not functional.

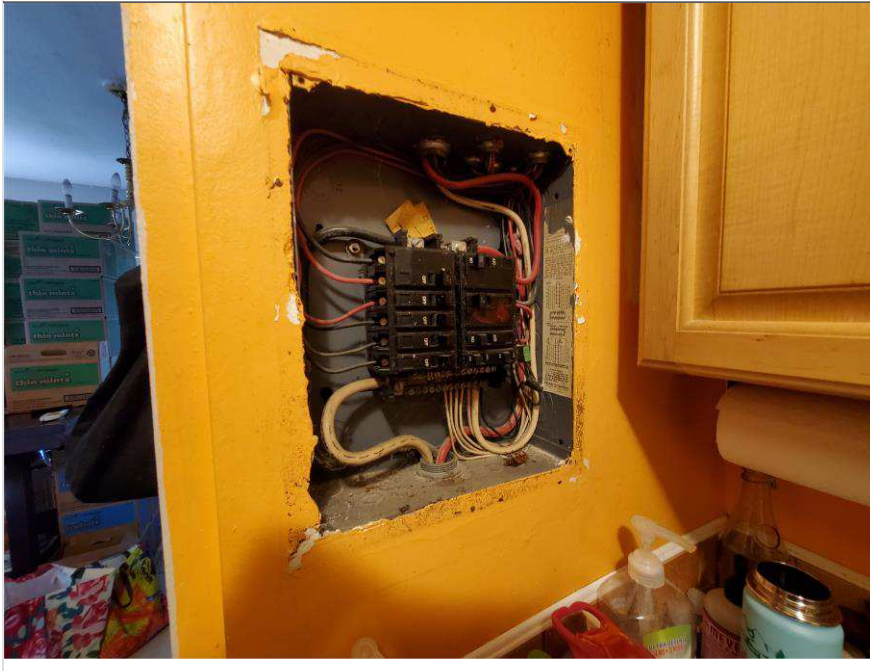
Photo 15 – Village of Dadeland Condominium Association

Apartments - Electrical Panels

Missing panel directory.

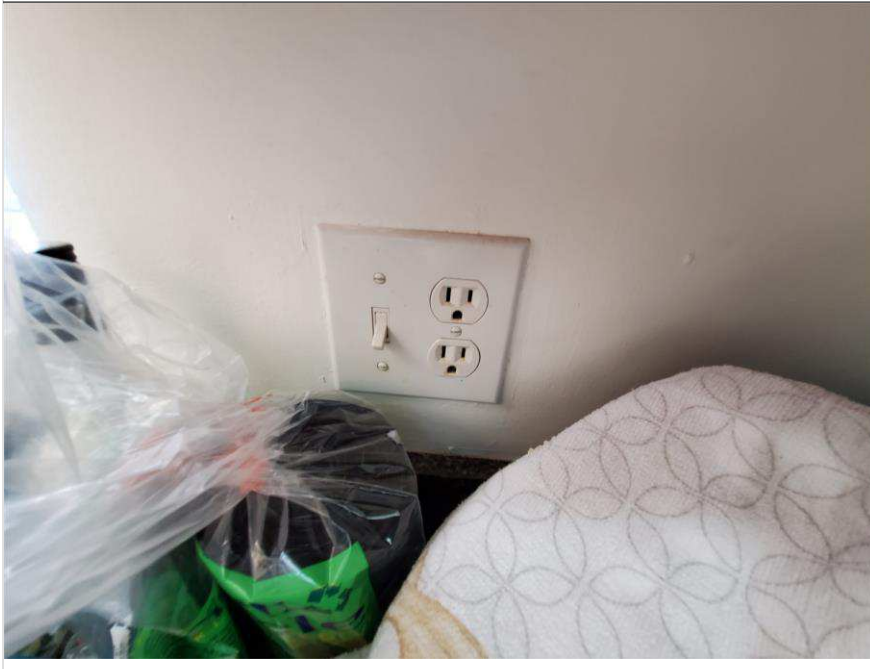
Photo 16 – Village of Dadeland Condominium Association

Apartments - Kitchen outlets are not GFCI type.

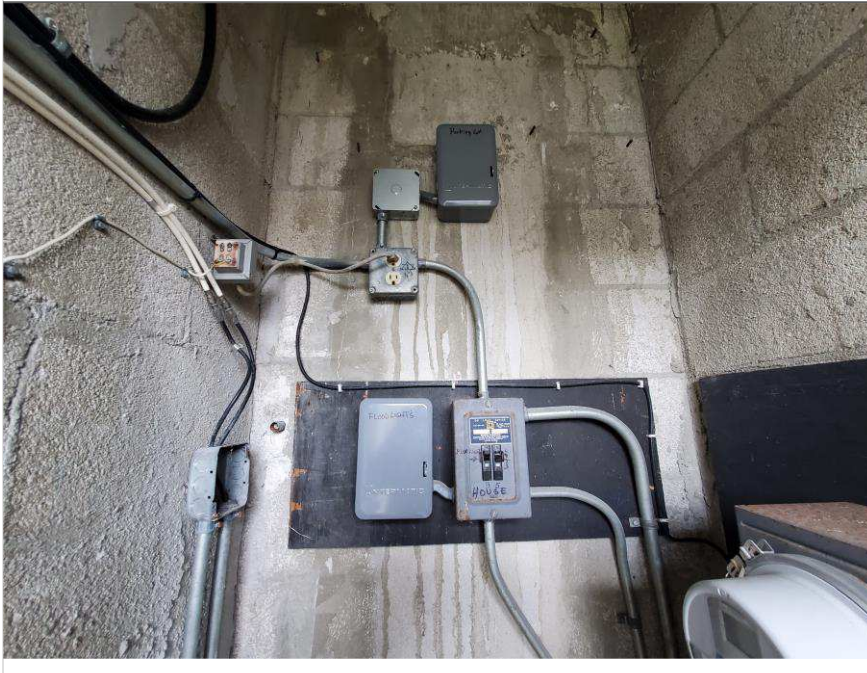
Photo 5 – Village of Dadeland Condominium Association

Existing Electrical Room - 1st FL  
House Panel Board and Meter

Open junction boxes to be  
closed.

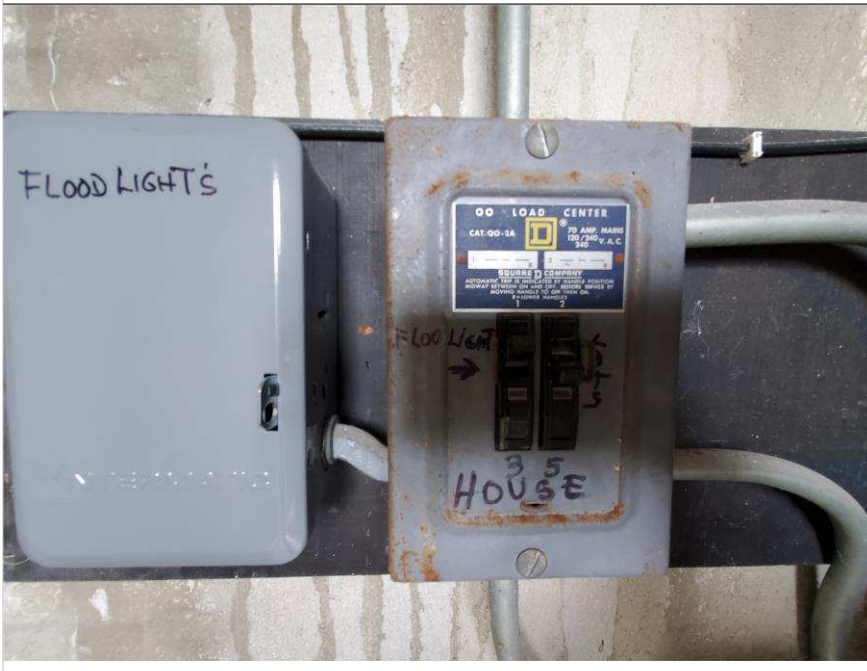
Photo 6 – Village of Dadeland Condominium Association

Existing Electrical Room - 1st FL  
House Panel Board and  
breakers.

Corroded panel and old circuit  
breakers.

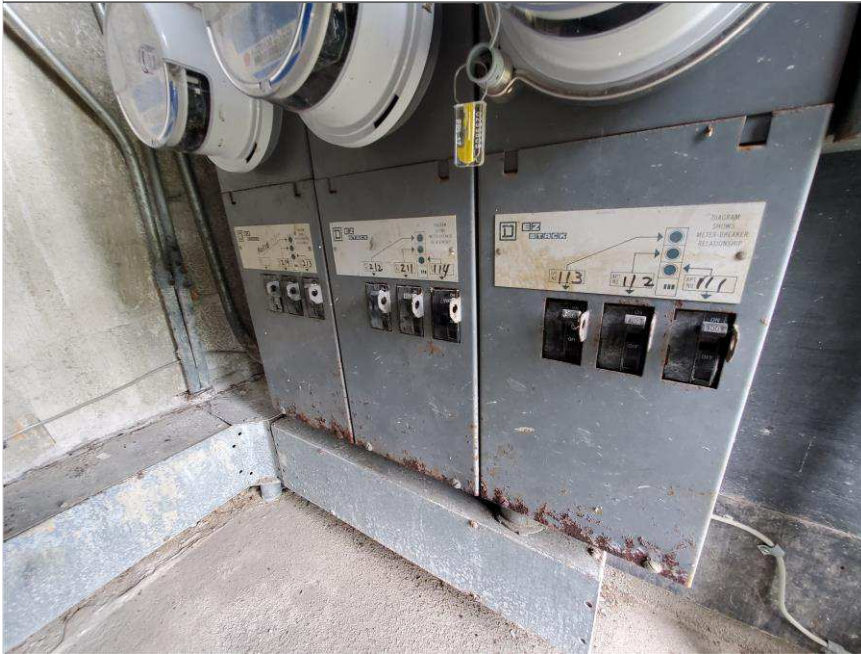
Photo 7 – Village of Dadeland Condominium Association

Existing Electrical Room - 1st FL  
Main Switches for Apartments,  
Meters, and Gutter.

Old and corroded meter stacks.

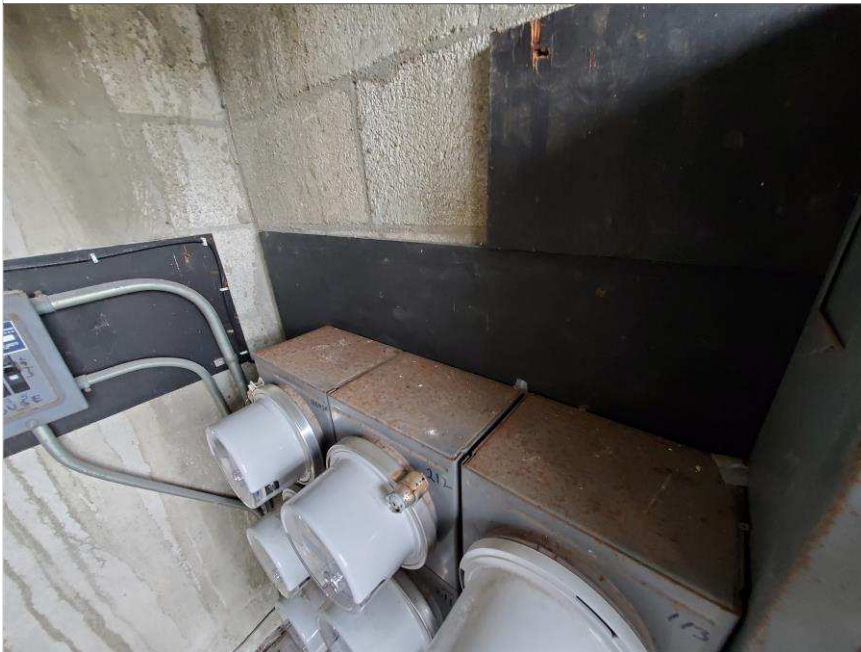
Photo 8 – Village of Dadeland Condominium Association

Existing Electrical Room - 1st FL  
Apartment Meters - Top View

Old and corroded meter stacks.

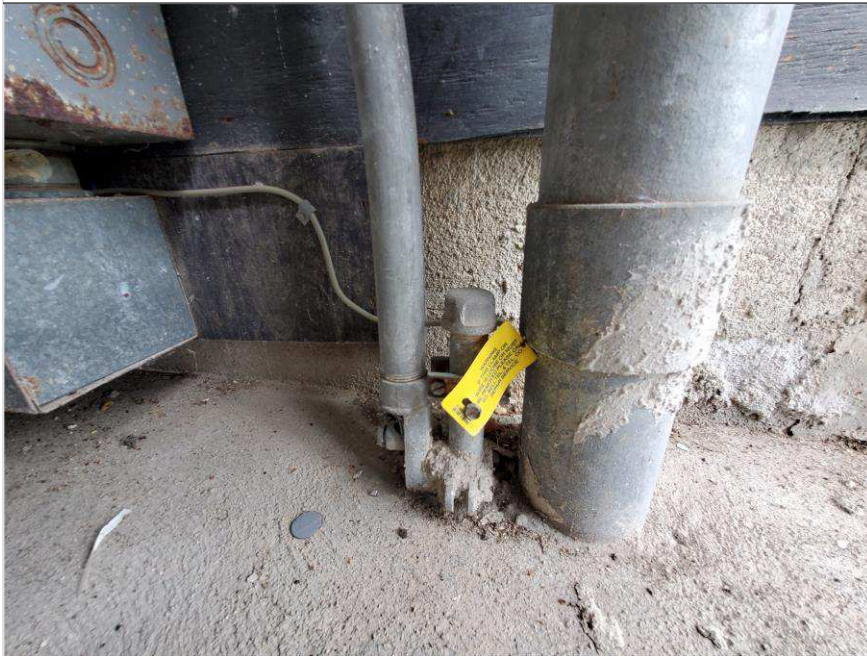
Photo 10 – Village of Dadeland Condominium Association

Existing Electrical Room - 1st FL  
Main Service - Grounding

Grounding resistance to be  
tested to determine if repairs  
and/or maintenance are  
required.

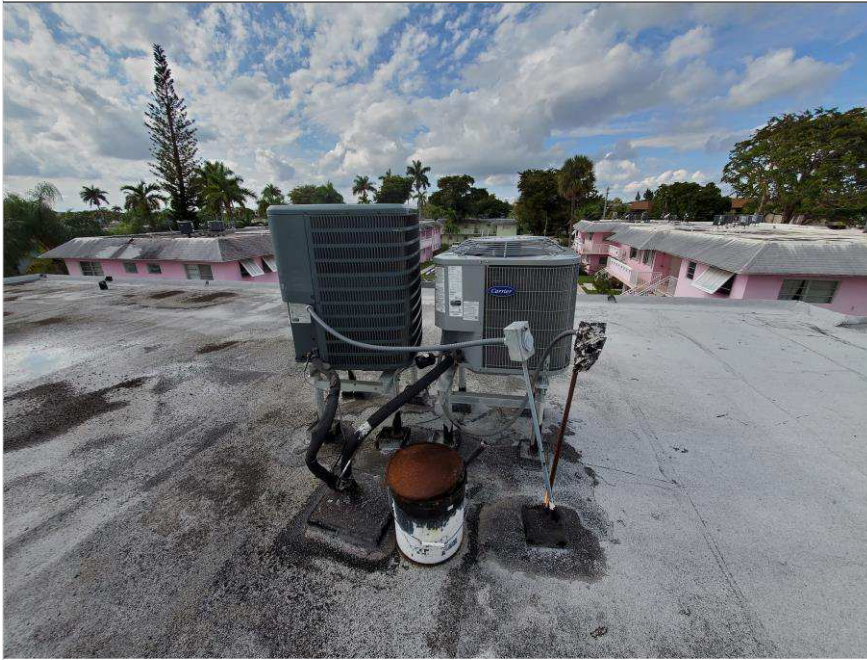
Photo 11 – Village of Dadeland Condominium Association

Rooftop Condenser Units -

Improperly supported switches.

Missing or non-compliant method of providing disconnect switches.

Corroded conduits and boxes.

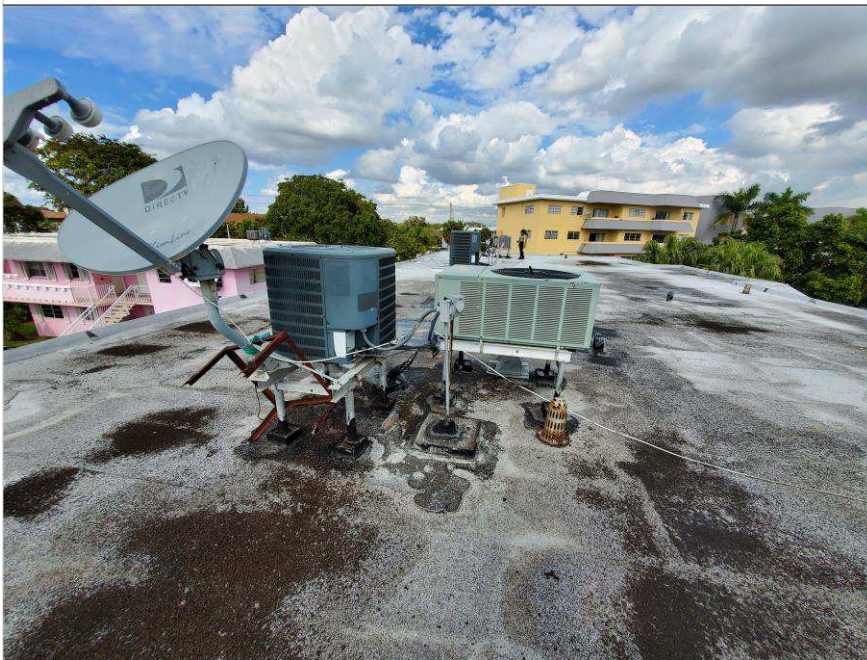
Photo 12 – Village of Dadeland Condominium Association

Rooftop Condenser Units -

Corroded junction boxes and conduits.

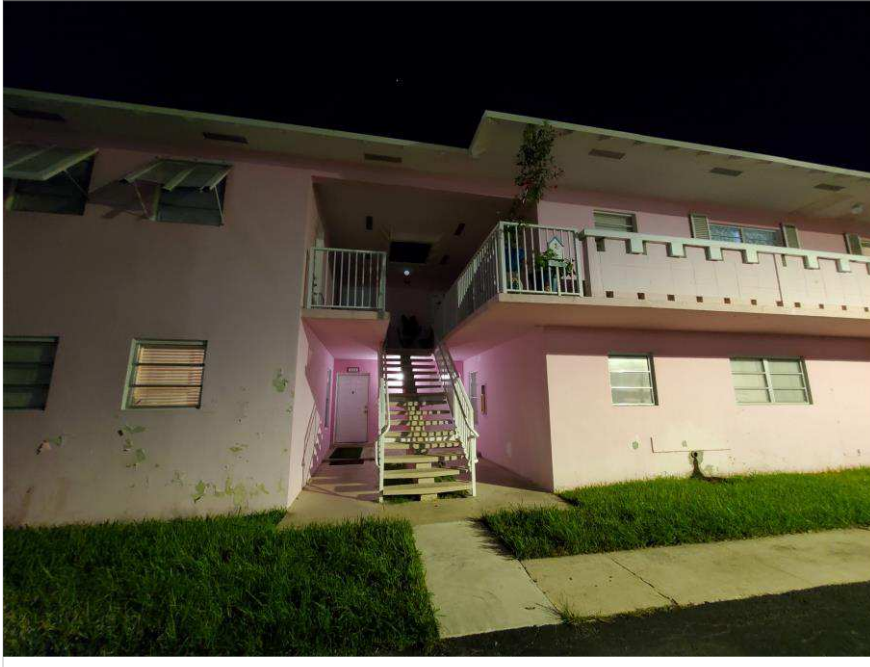
Photo 13 – Village of Dadeland Condominium Association

Points of Egress -  
Insufficient illumination at  
catwalks, stairs, and sidewalks.  
Exterior lights not functional.

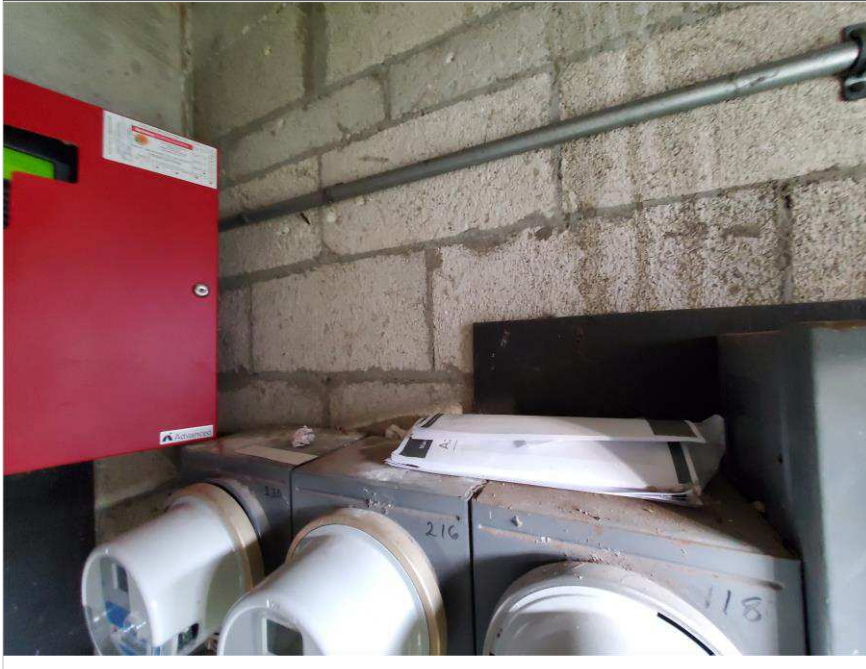
Photo 9 – Village of Dadeland Condominium Association

Existing Electrical Room - 1st FL  
Meter stacks are corroded.  
50 year old electrical  
component.

Old and corroded meter stacks.

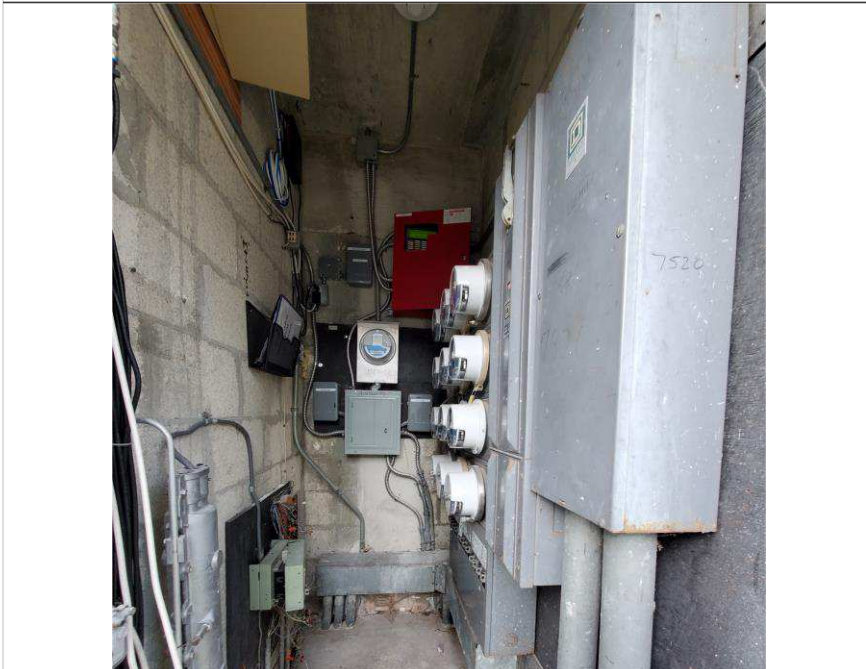
Photo 10 – Village of Dadeland Condominium Association

Existing Electric Room - 1<sup>st</sup> FL

Insufficient clearance at  
electrical components.

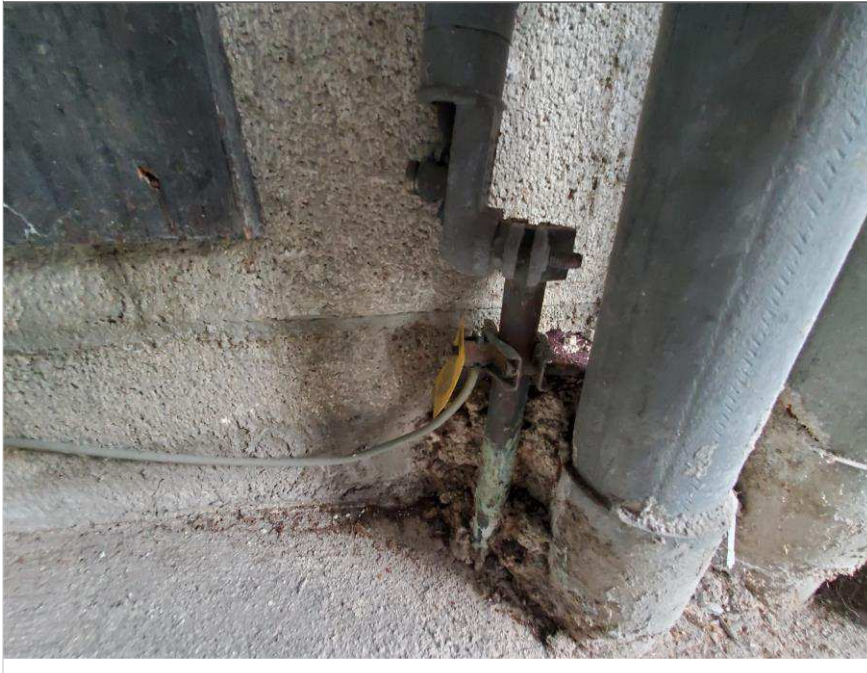
Photo 11 – Village of Dadeland Condominium Association

Existing Electrical Room - 1st FL  
Main Service - Grounding

Grounding resistance to be tested to determine if repairs and/or maintenance are required.

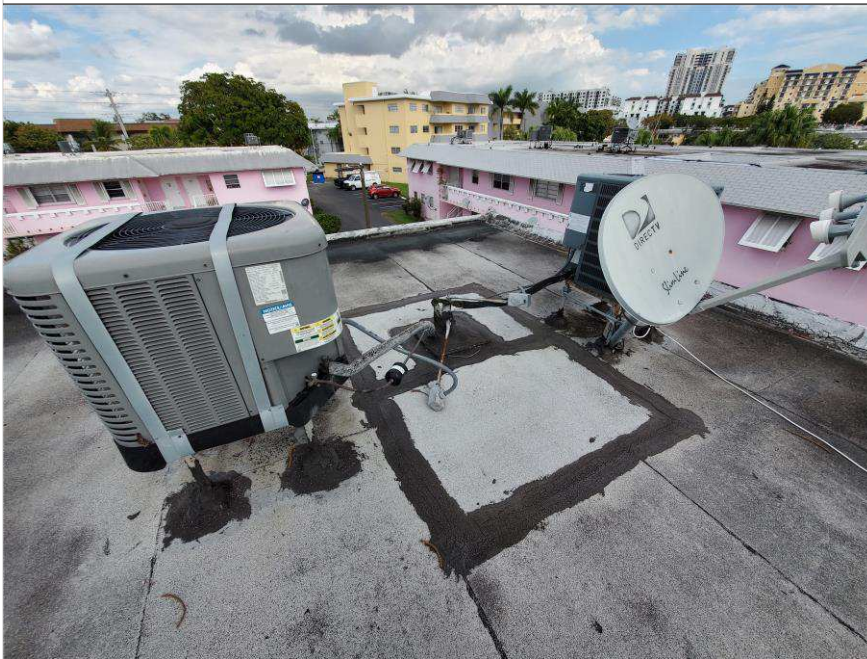
Photo 12 – Village of Dadeland Condominium Association

Rooftop -  
Rooftop Condenser Units

Junction boxes not properly supported.

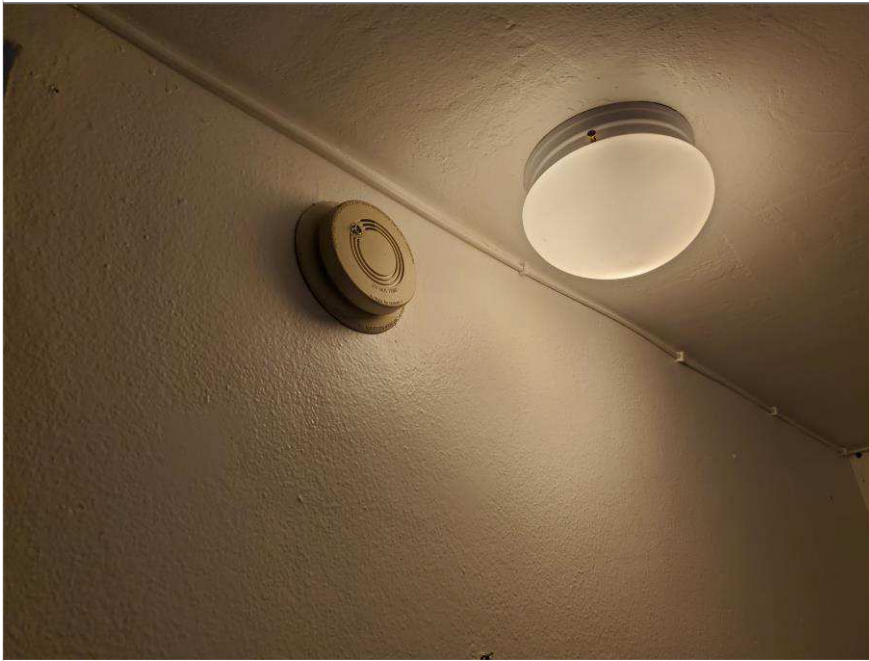
Photo 24 – Village of Dadeland Condominium Association

Apartments - Old Smoke Detectors

Old Smoke Detectors to be replaced.

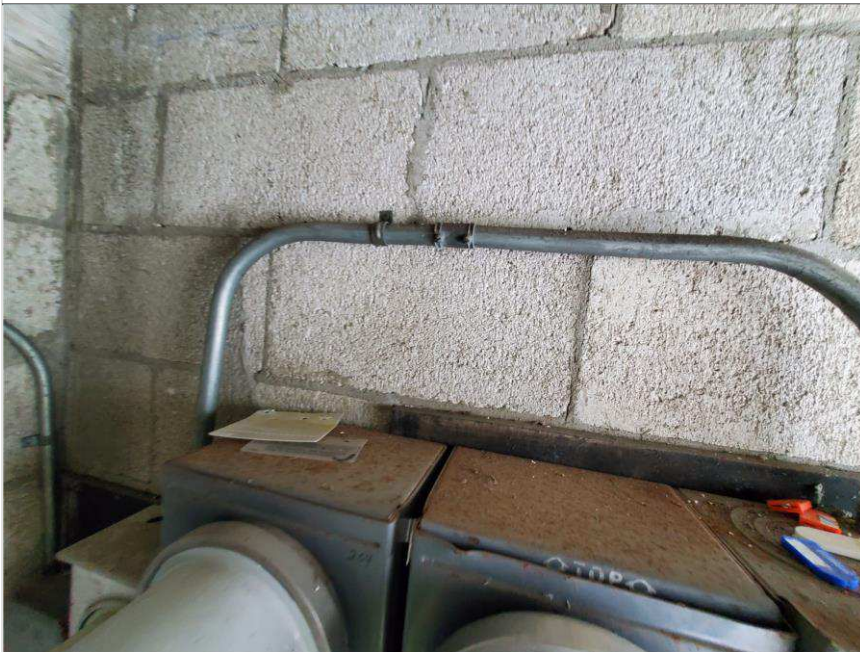
Photo 8 – Village of Dadeland Condominium Association

Existing Electrical Room - 1st FL  
Apartment Meters - Top View

Old and corroded meter stacks.

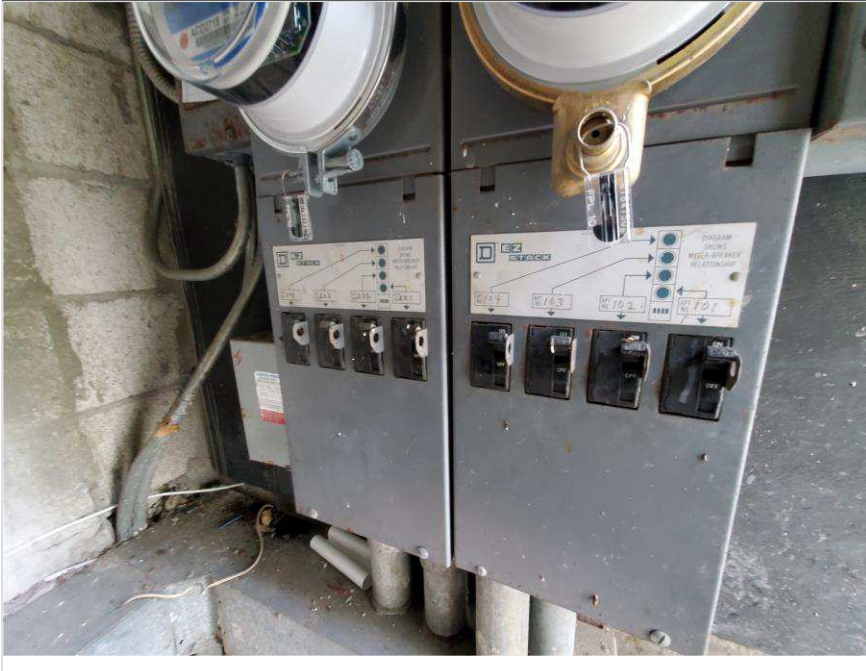
Photo 9 – Village of Dadeland Condominium Association

Existing Electrical Room - 1st FL  
Apartment Meters and Main  
Switches

Insufficient clearance at  
electrical components.

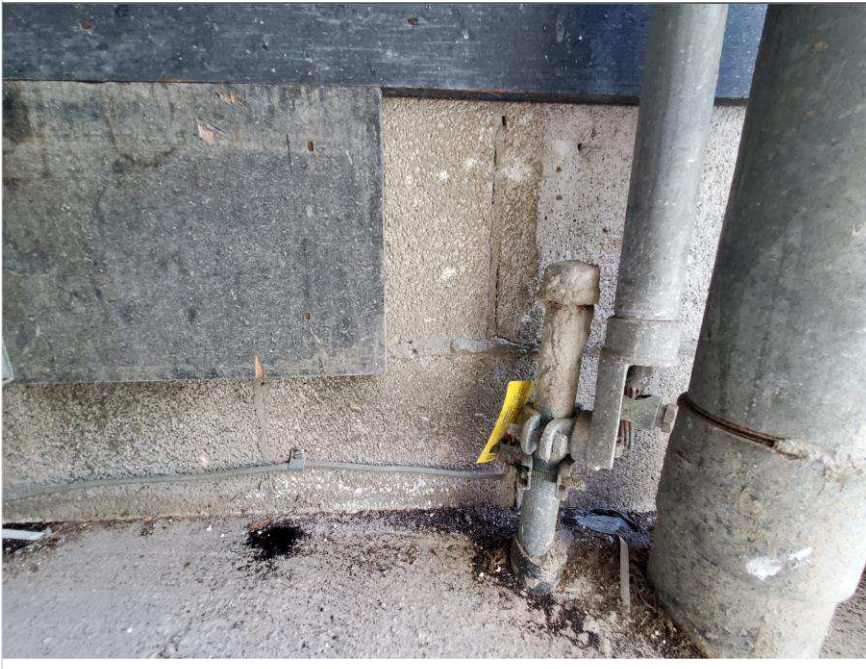
Photo 10 – Village of Dadeland Condominium Association

Existing Electrical Room - 1st FL  
Main Service - Grounding

Grounding resistance to be  
tested to determine if repairs  
and/or maintenance are  
required.

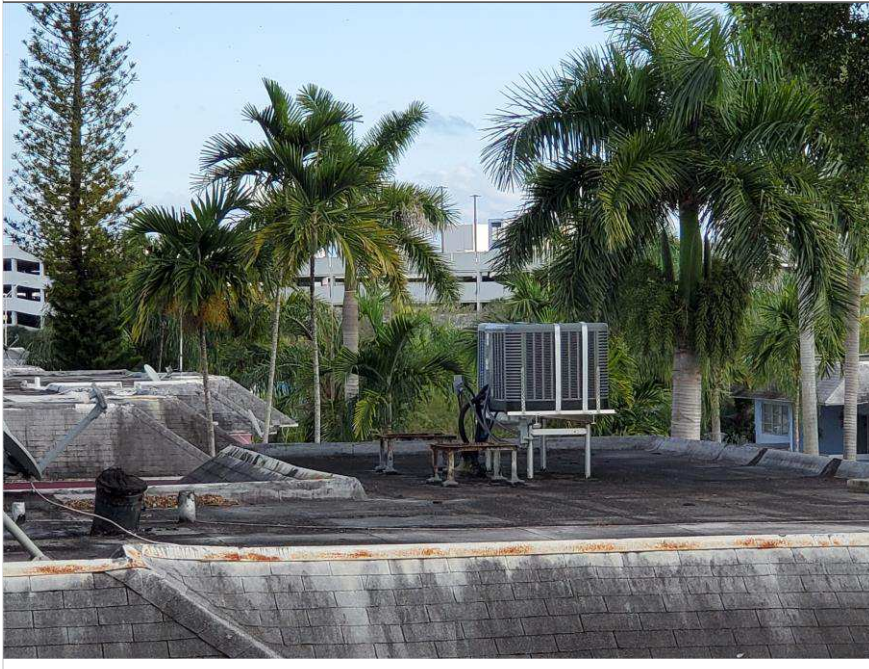
Photo 11 – Village of Dadeland Condominium Association

Rooftop Condenser Units -

Missing or improperly installed disconnect switches.

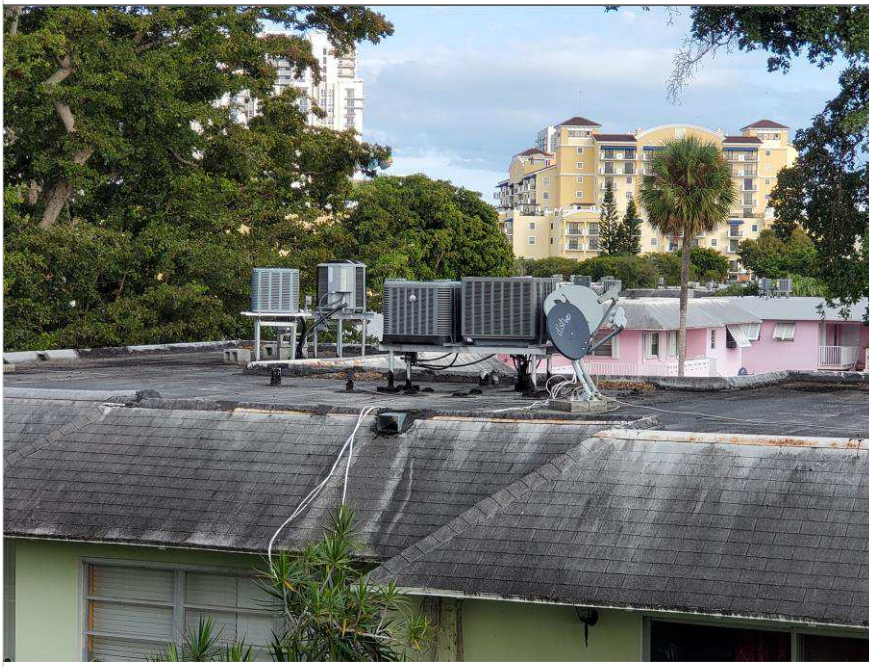
Photo 12 – Village of Dadeland Condominium Association

Rooftop Condenser Units -  
Corroded junction boxes and  
conduits.

Improperly installed switches.

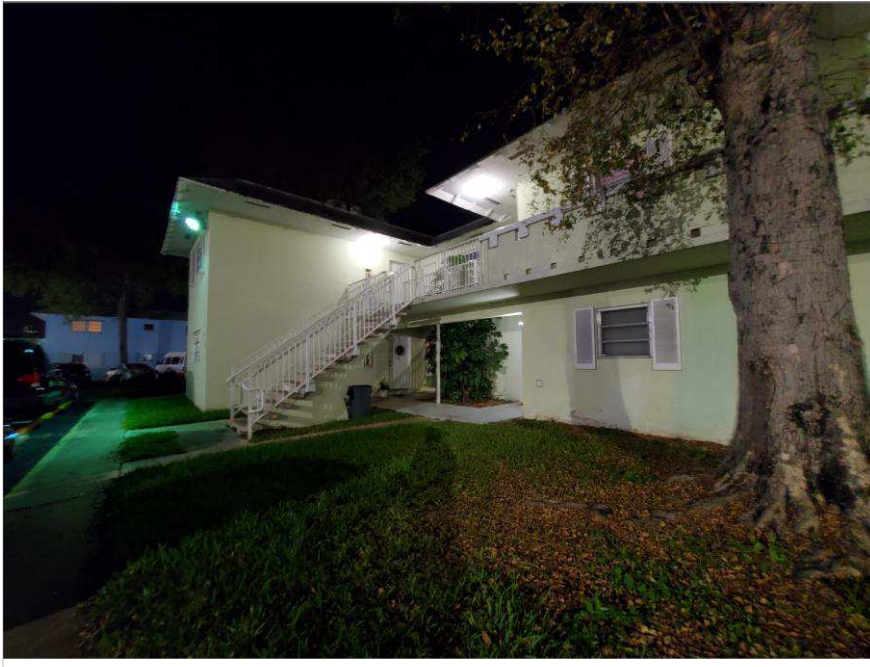
Photo 13 – Village of Dadeland Condominium Association

Points of Egress -  
Poorly illuminated sidewalks and  
stairs.  
Exterior lights not functional.

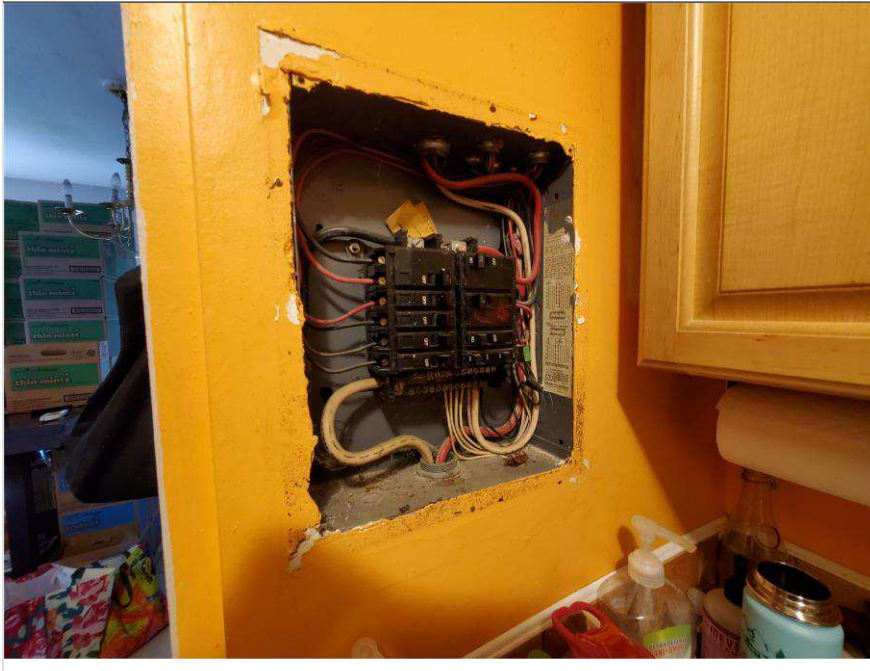
Photo 15 – Village of Dadeland Condominium Association

Apartments - Electrical Panels

Missing panel directory.

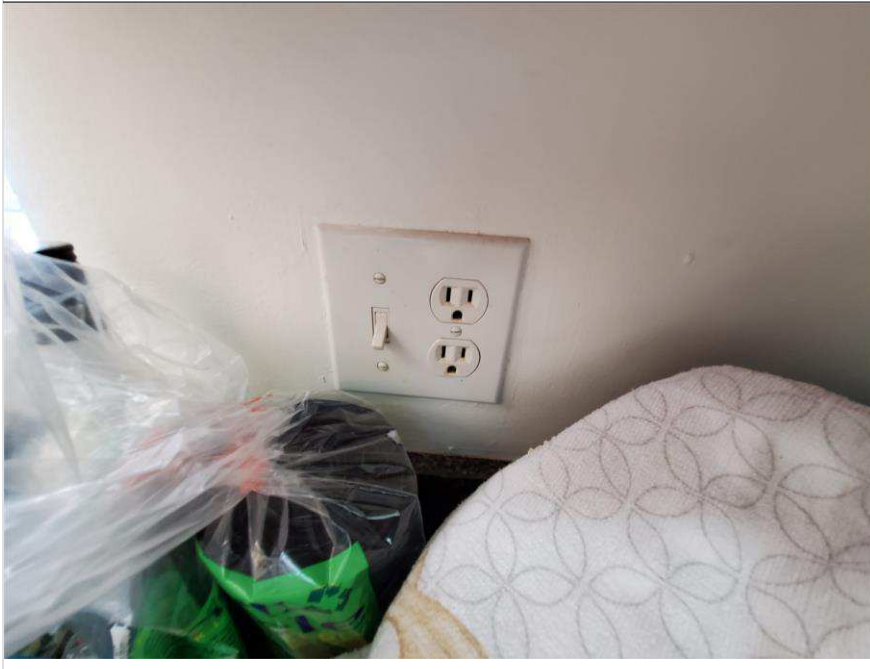
Photo 16 – Village of Dadeland Condominium Association

Apartments - Kitchen outlets are not GFCI type.

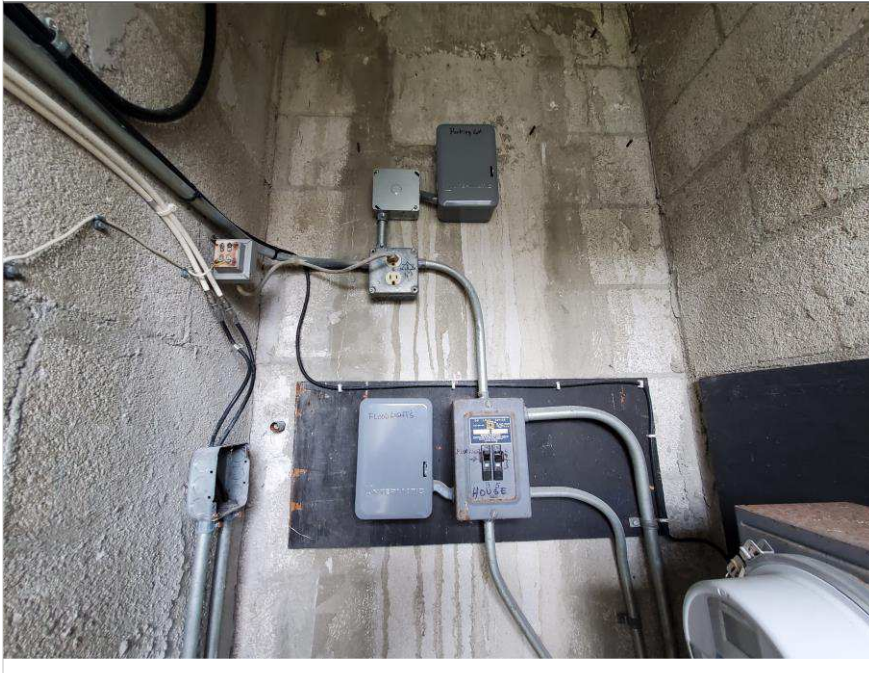
Photo 5 – Village of Dadeland Condominium Association

Existing Electrical Room - 1st FL  
House Panel Board and Meter

Open junction boxes to be  
closed.
