MINIMUM INSPECTION PROCEDURAL GUIDELINES  
FOR BUILDING ELECTRICAL RECERTIFICATION

INSPECTION MADE BY: FLORIN FLOREA P.E.

a. Name on Title: Village at Dadeland Condominiums (G)

b. Street Address: 7500 SW 82nd St. Miami, Florida 33143

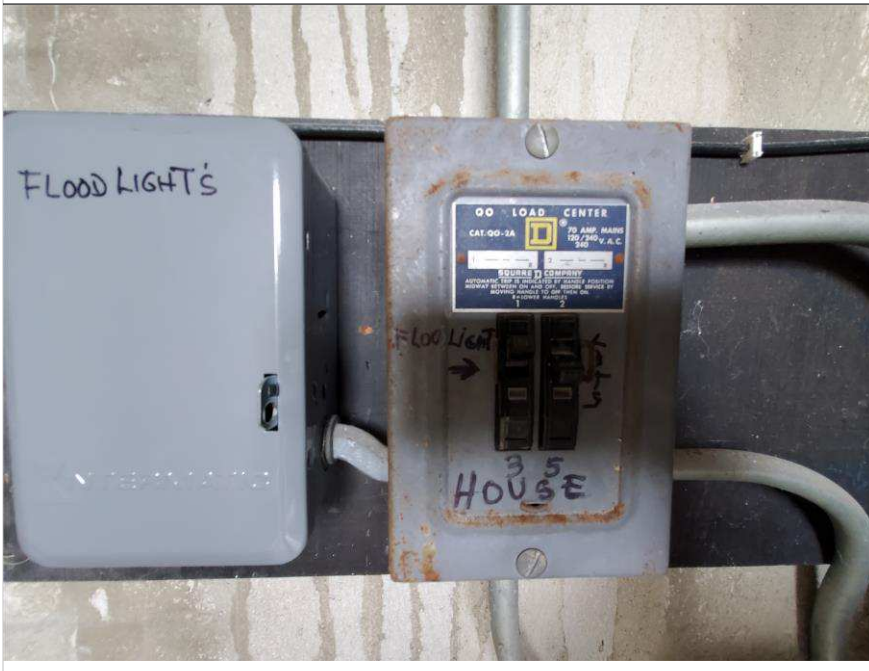
Photo 6 – Village of Dadeland Condominium Association

Existing Electrical Room - 1st FL  
House Panel Board and  
breakers.

Corroded panel and old circuit  
breakers.

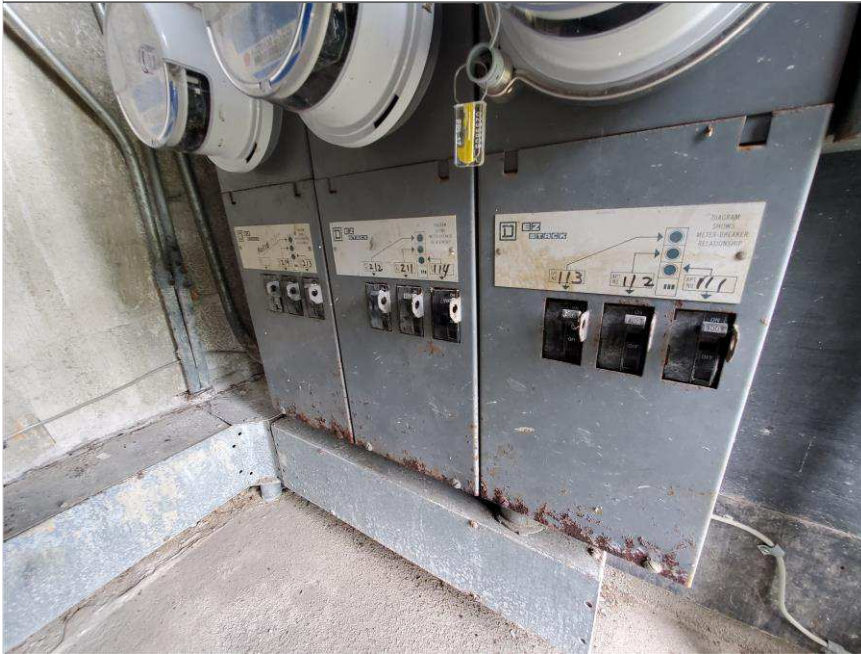
Photo 7 – Village of Dadeland Condominium Association

Existing Electrical Room - 1st FL  
Main Switches for Apartments,  
Meters, and Gutter.

Old and corroded meter stacks.

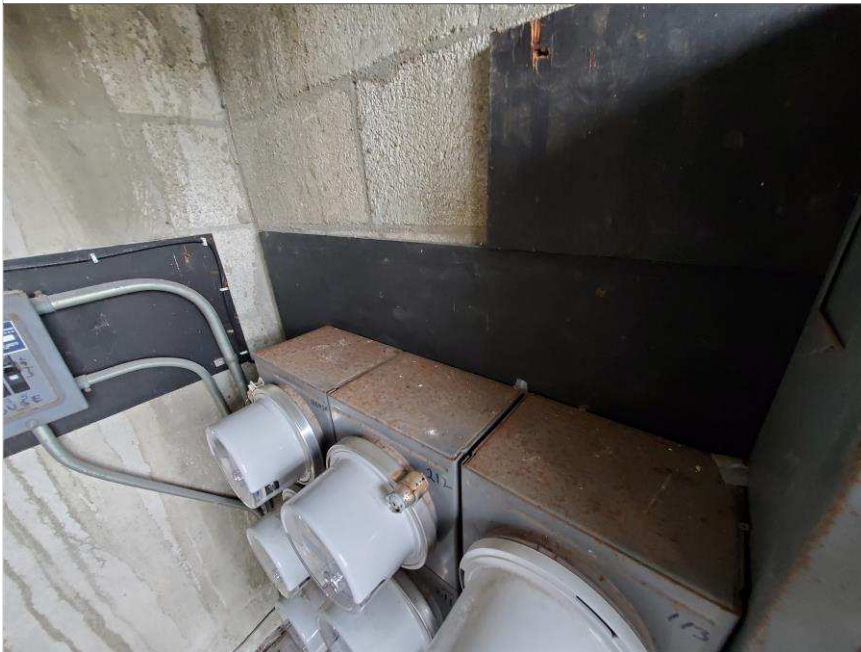
Photo 8 – Village of Dadeland Condominium Association

Existing Electrical Room - 1st FL  
Apartment Meters - Top View

Old and corroded meter stacks.

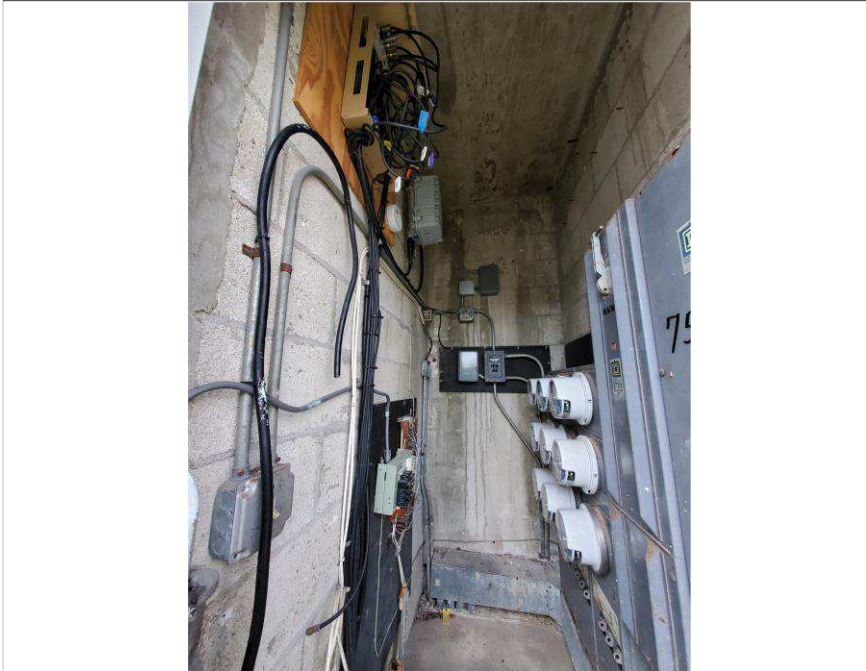
Photo 9 – Village of Dadeland Condominium Association

Existing Electrical Room - 1st FL  
Apartment Meters, Gutter and  
Main Disconnect Switch

Insufficient clearance at  
electrical components.

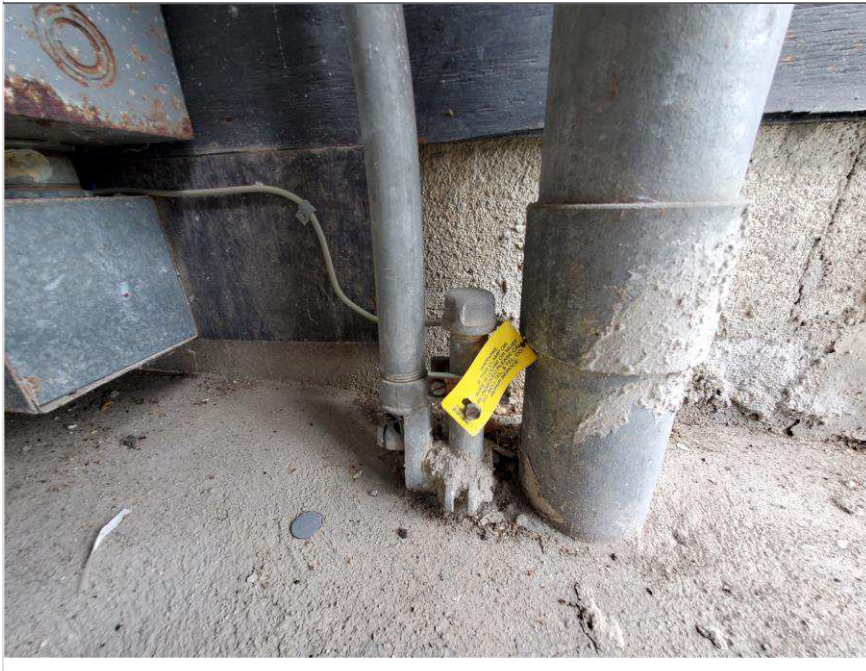
Photo 10 – Village of Dadeland Condominium Association

Existing Electrical Room - 1st FL  
Main Service - Grounding

Grounding resistance to be  
tested to determine if repairs  
and/or maintenance are  
required.

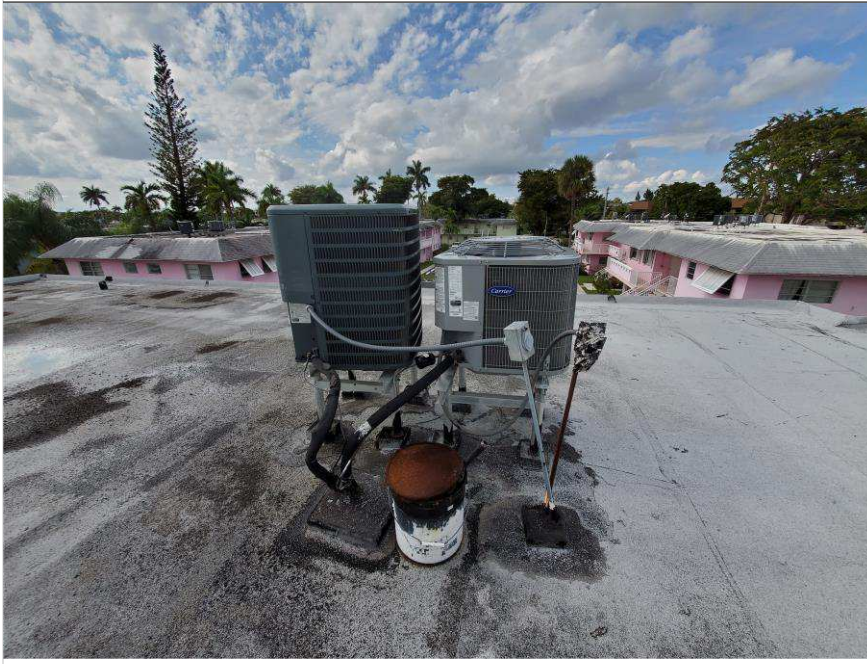
Photo 11 – Village of Dadeland Condominium Association

Rooftop Condenser Units -

Improperly supported switches.

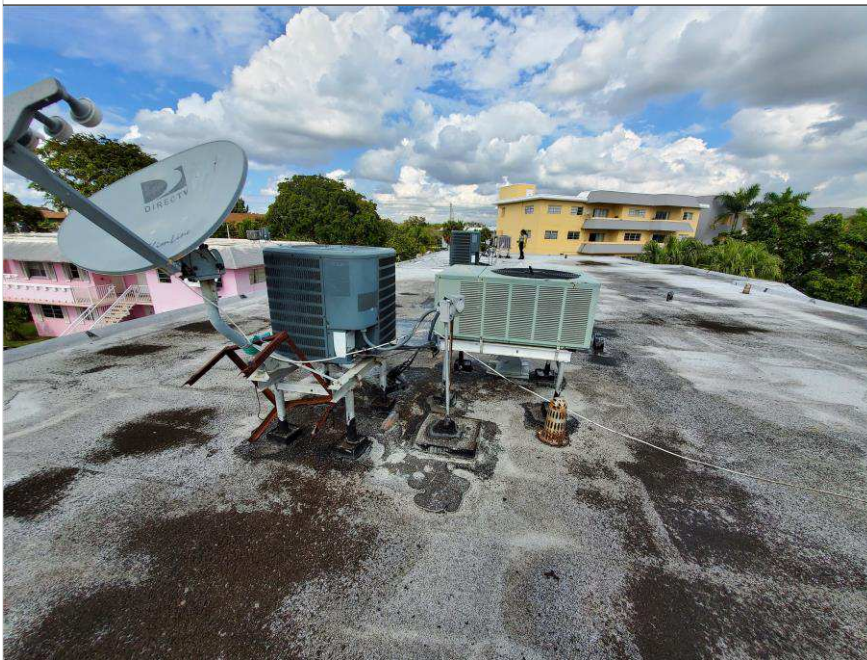
Photo 12 – Village of Dadeland Condominium Association

Rooftop Condenser Units -

Corroded junction boxes and conduits.

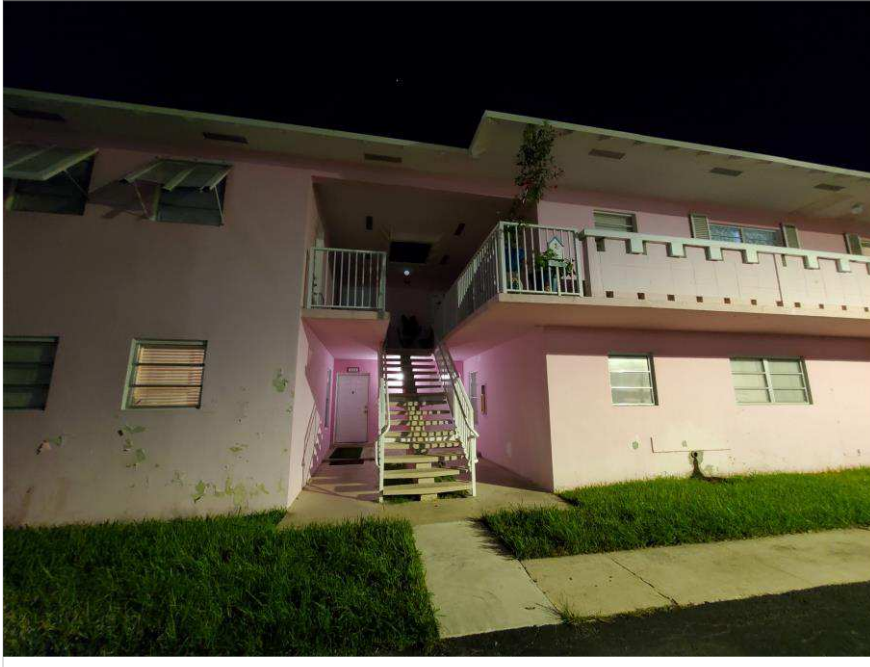
Photo 13 – Village of Dadeland Condominium Association

Points of Egress -  
Insufficient illumination at  
catwalks, stairs, and sidewalks.  
Exterior lights not functional.

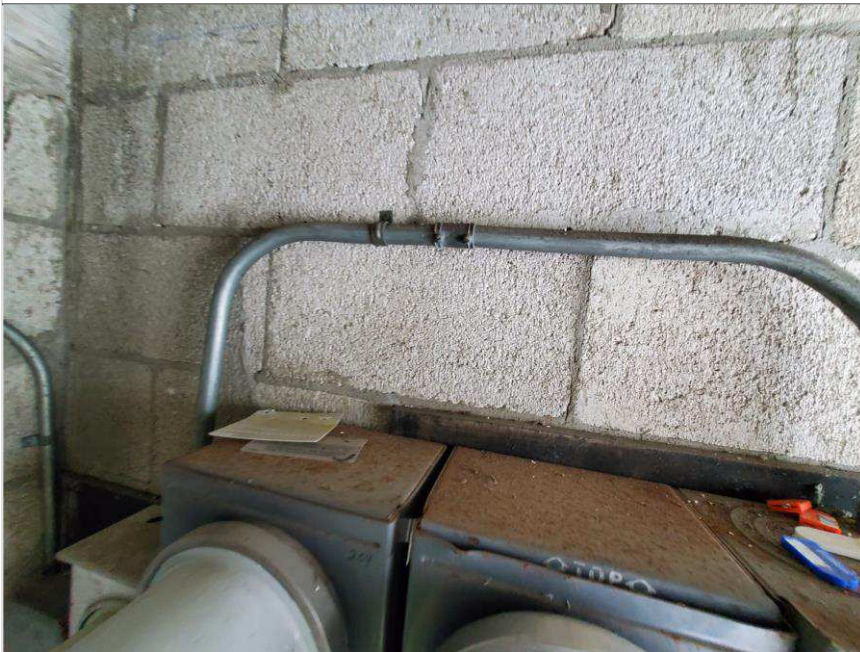
Photo 8 – Village of Dadeland Condominium Association

Existing Electrical Room - 1st FL  
Apartment Meters - Top View

Old and corroded meter stacks.

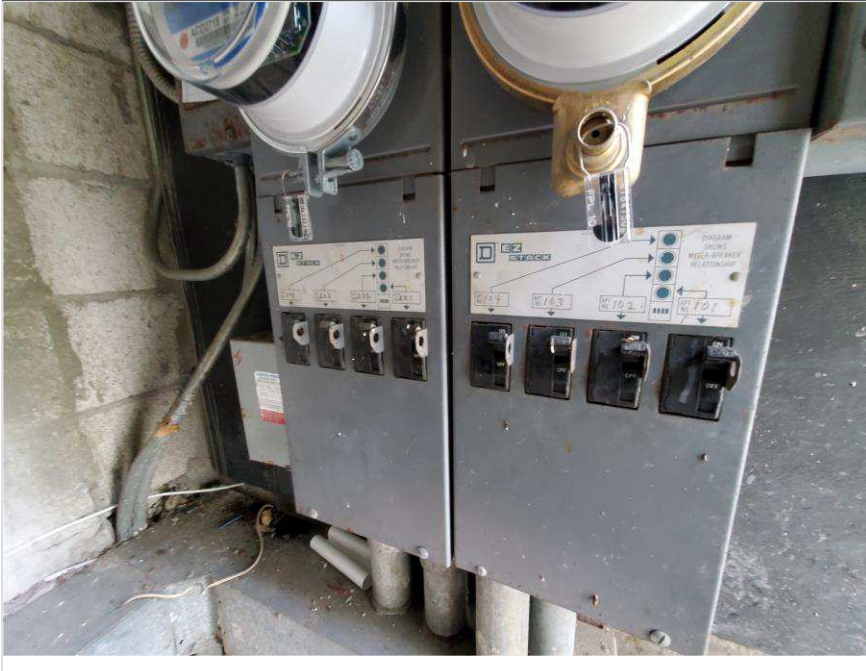
Photo 9 – Village of Dadeland Condominium Association

Existing Electrical Room - 1st FL  
Apartment Meters and Main  
Switches

Insufficient clearance at  
electrical components.

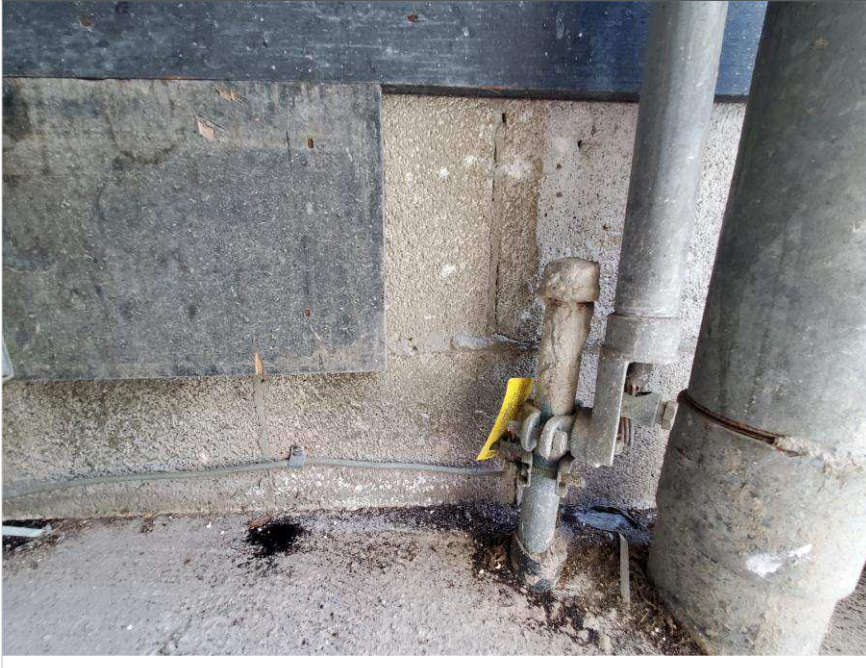
Photo 10 – Village of Dadeland Condominium Association

Existing Electrical Room - 1st FL  
Main Service - Grounding

Grounding resistance to be  
tested to determine if repairs  
and/or maintenance are  
required.

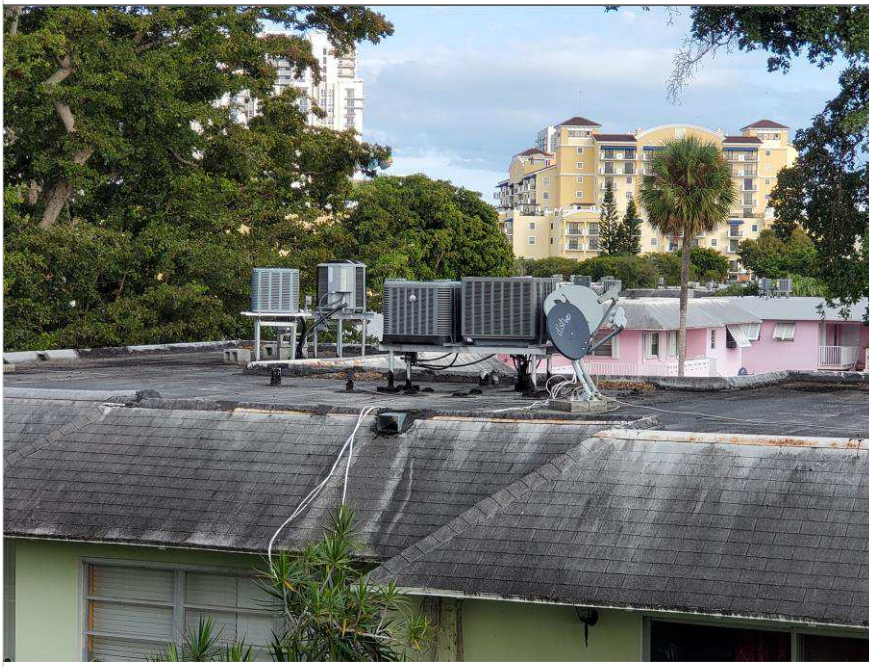
Photo 12 – Village of Dadeland Condominium Association

Rooftop Condenser Units -  
Corroded junction boxes and  
conduits.

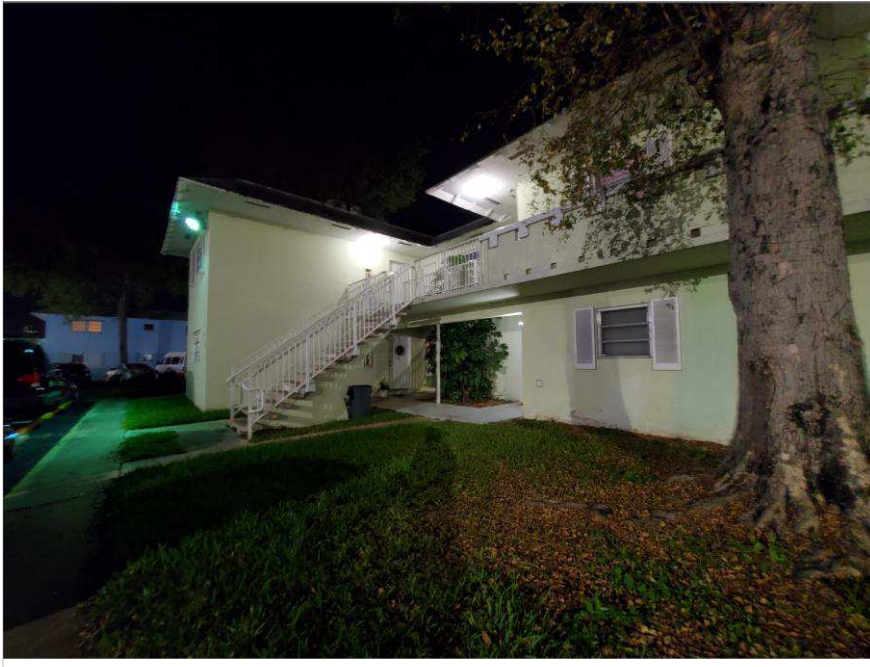
Photo 13 – Village of Dadeland Condominium Association

Points of Egress -  
Poorly illuminated sidewalks and  
stairs.  
Exterior lights not functional.

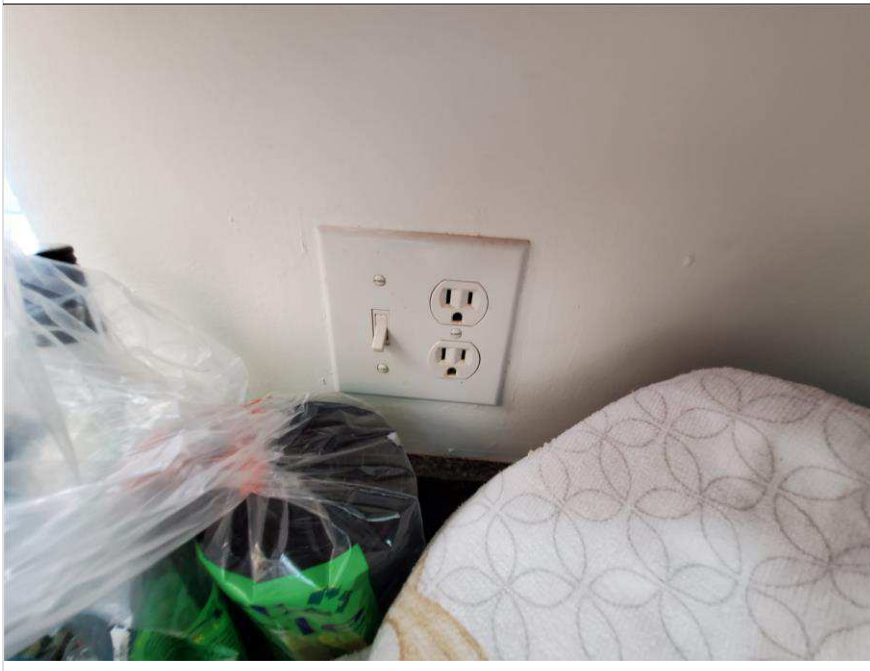
Photo 16 – Village of Dadeland Condominium Association

Apartments - Kitchen outlets are not GFCI type.

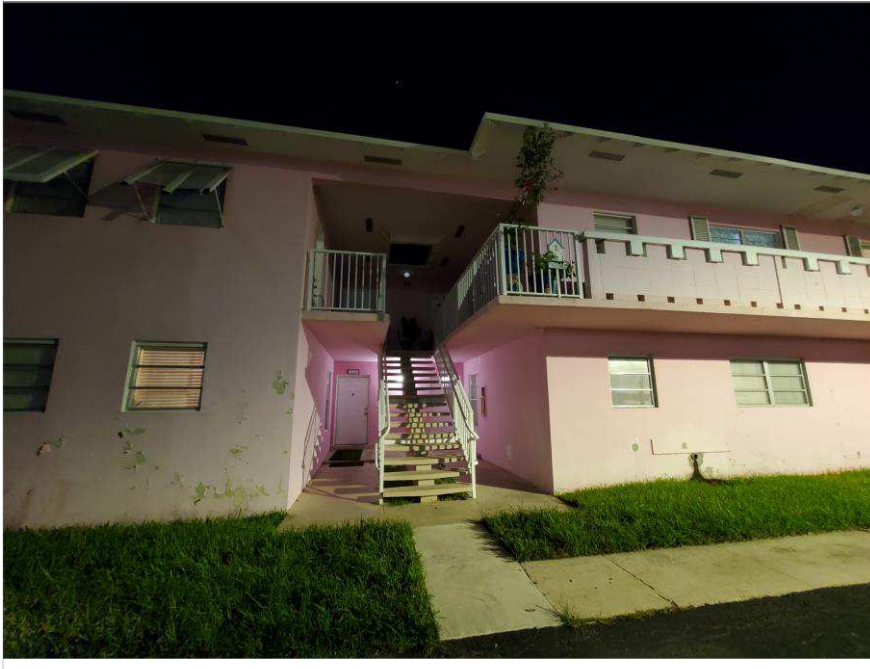
Photo 13 – Village of Dadeland Condominium Association

Points of Egress -  
Insufficient illumination at  
catwalks, stairs, and sidewalks.  
Exterior lights not functional.

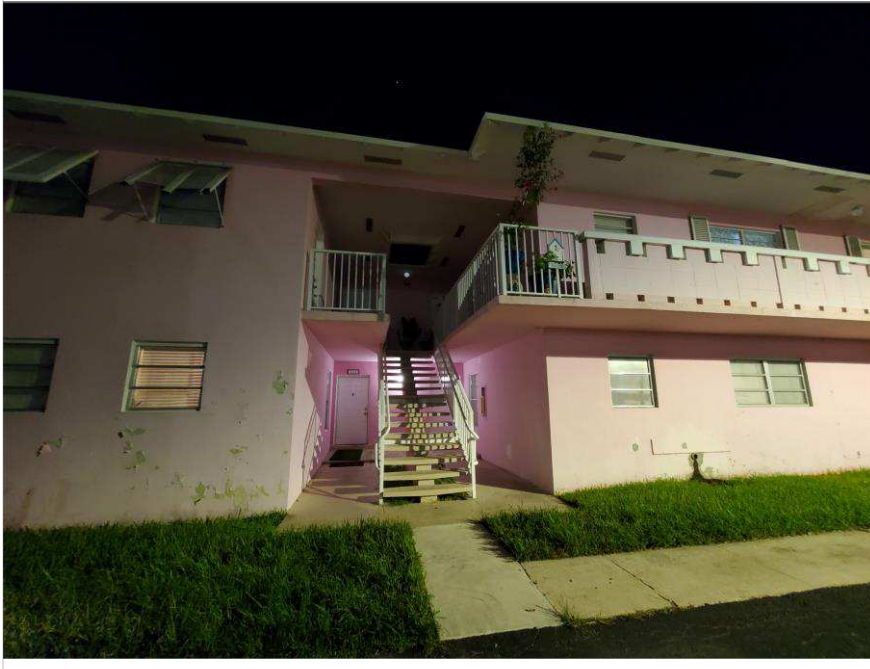
Photo 13 – Village of Dadeland Condominium Association

Points of Egress -  
Insufficient illumination at  
catwalks, stairs, and sidewalks.  
Exterior lights not functional.
