RIO GRANDE DIVERSION INFRASTRUCTURE INVENTORY

Structure Name: PACE D

Date: April 1, 2019

Rio Grande Stream
Management Plan

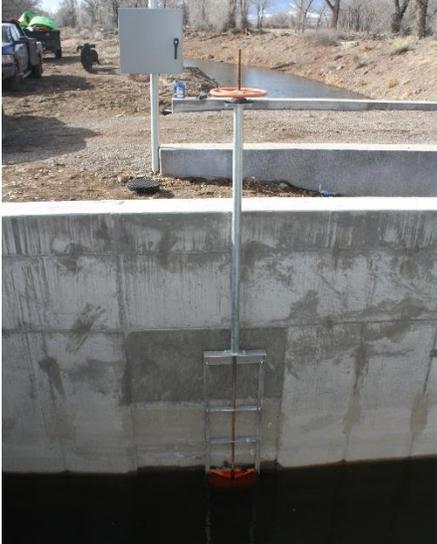
Headgate looking downstream

Repair(s) or Improvement(s) Currently Needed: Debris accumulation at the headgate needs to be addressed. One possible solution is to install rock barbs to redirect debris to the middle of the river channel rather than the headgate. The flume is often submerged and should be reset. If the ditch upstream of flume had some elevation drop, it would function significantly better.

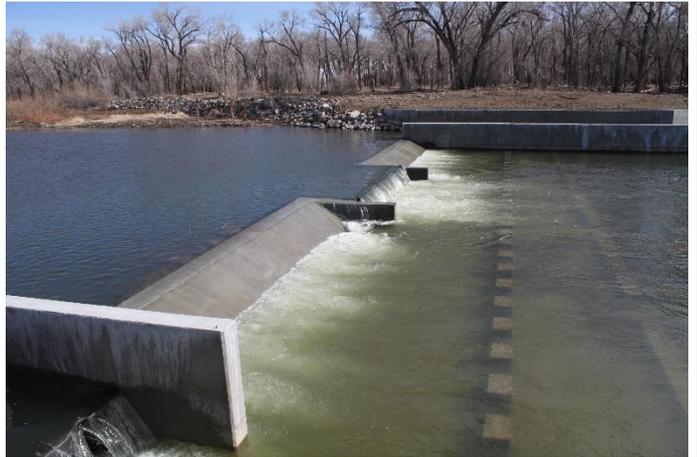
Diversion dam

Structure Description: Within the last 35 years, the river has migrated significantly in this area, especially upstream of the diversion dam. The two meanders upstream of the diversion have been growing and changing the orientation of the river where it meets the diversion dam. This ditch shares the diversion dam and headwall with the Consolidated Ditch. A brand new large concrete diversion dam spans the river and directs water to the headgate. On the south bank of the river, a radial sluice gate was installed that can be adjusted using an air bladder. On the north side of the diversion, a large fish ladder was installed. In the center of the diversion sits an additional adjustable Obermeyer gate. A substantial trash rack is at the entrance to the ditch, with the headgate located just below. All of the infrastructure is laid in concrete. This structure allows for boat and fish passage and, after construction was completed, bank and riparian habitat was restored using rock structures and riparian vegetation plantings. This structure serves eight ditches, including Marajo Ditch, John Anderson Ditch, Star Ditch, Rio Grande San Luis Ditch, Rio Grande Lariat Ditch, Anderson Ditch, Atencio Ditch, and Horner Ydren Ditch.

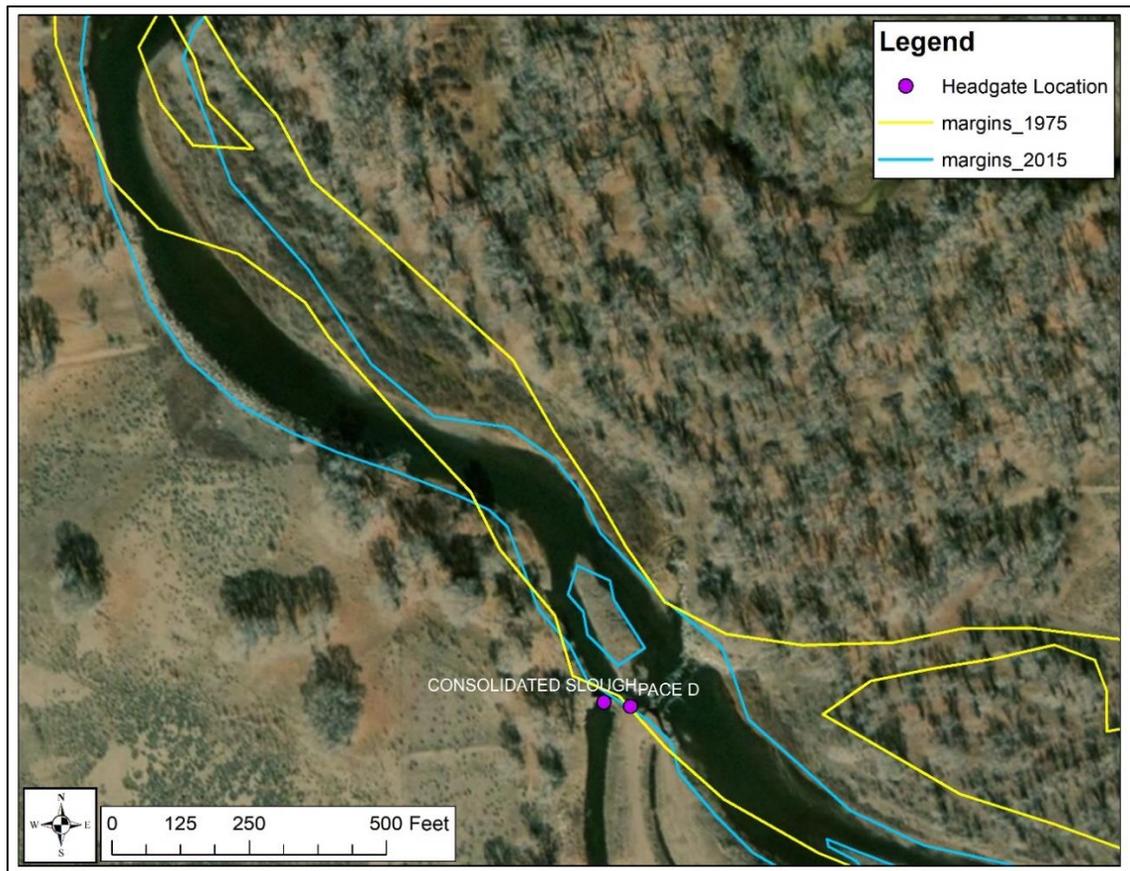
Map showing Consolidated Ditch diversion dam with 1975 to 2015 channel margins overlaid.

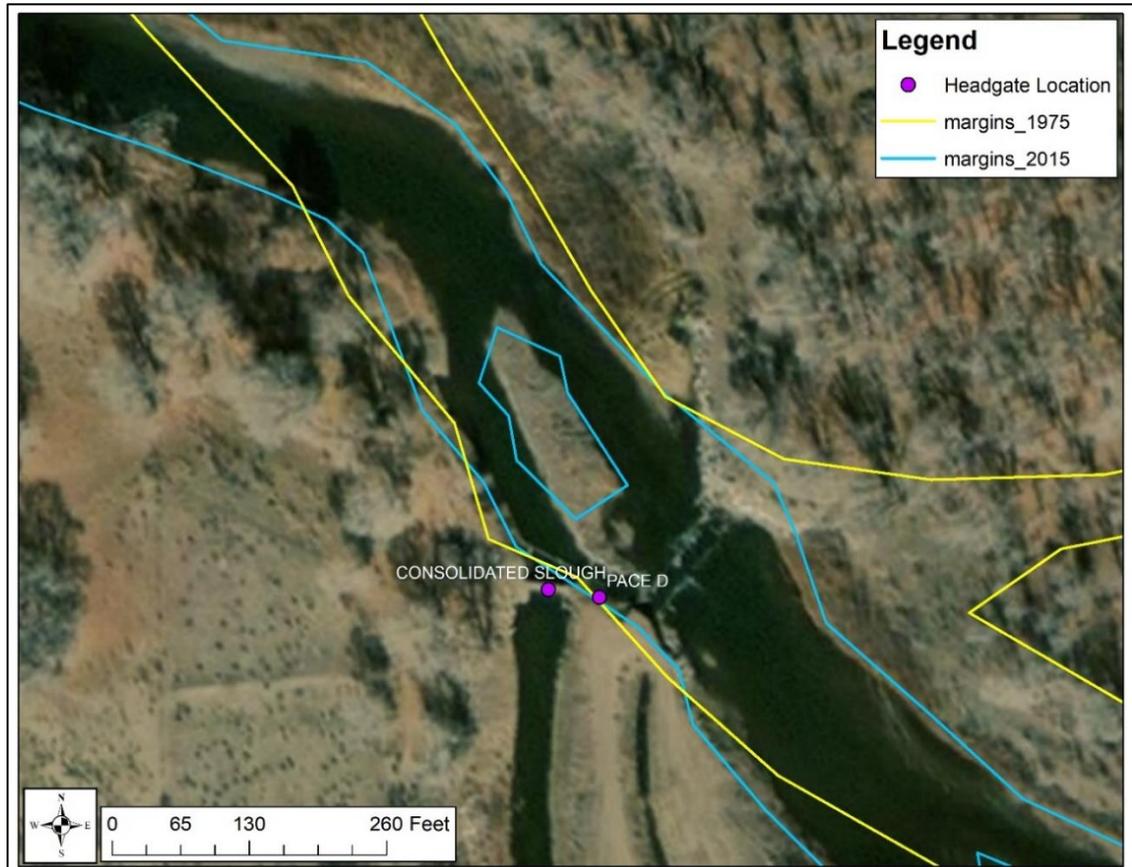
Close-up of Consolidated Ditch diversion dam with 1975 to 2015 channel margins overlaid.
