# RIO GRANDE DIVERSION INFRASTRUCTURE INVENTORY

**Structure Name:** EXCELSIOR D

**Date:** April 10, 2019

**EXCELSIOR DITCH**

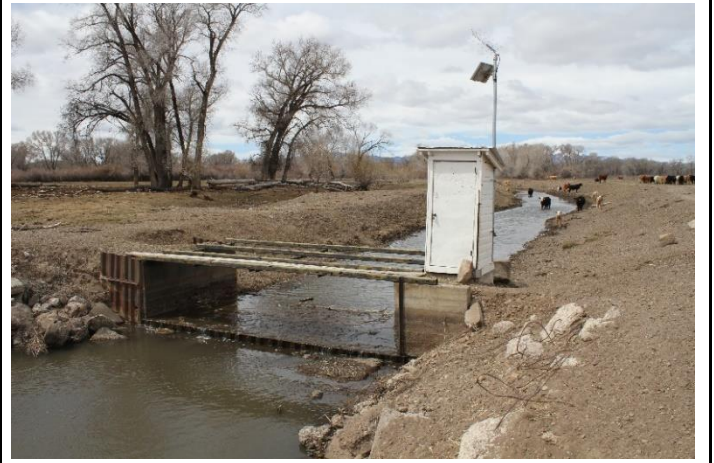
Flume looking upstream

**Comments:** The flume functions well and is rated B. This ditch uses the Costilla Canal as a carrier ditch. This structure includes priorities 74, 163, 249, and 262.
