***INSPECTION AND CLEANING (SEDIMENT REMOVAL) OF THE
120,000-GALLON ELEVATED RIVETED STEEL WATER STORAGE TANK***

***VILLAGE OF INTERLAKEN D.P.W.
INTERLAKEN, NEW YORK***

NOVEMBER 10, 2015

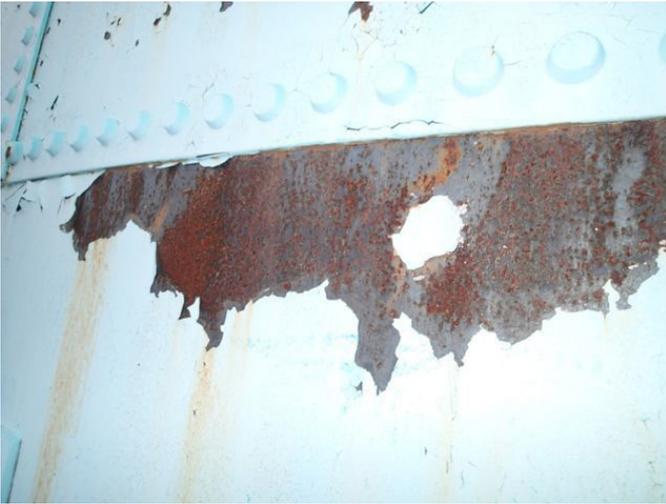
The protective coating applied to the exterior steel sidewalls was found having poor adhesion value and is nearing expiration. Cracking, lifting and peeling of the coating applied to the tank walls has resulted in exposure of the primary coating throughout approximately 20% of these wall surfaces, while complete coating loss and steel exposure exists throughout approximately 20% of these walls at this time.

1 *Exterior Wall With Coating Loss/Cracking/Lifting/Peeling, Exposed Primary Coating, Exposed Steel And Mild To Moderate Surface Corrosion (Nearing Expiration)*

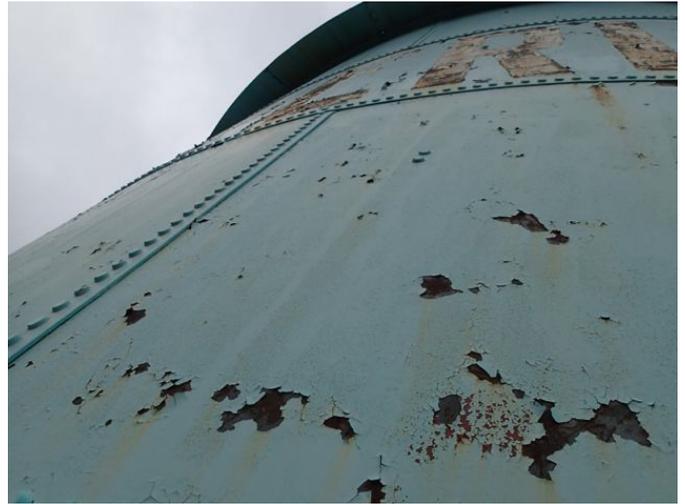
2 *Exterior Wall With Coating Loss/Cracking/Lifting/Peeling, Exposed Primary Coating, Exposed Steel And Mild To Moderate Surface Corrosion (Nearing Expiration)*

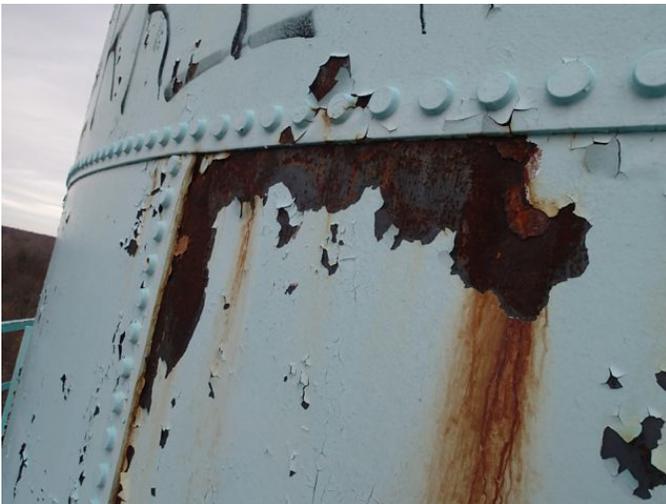
3 *Exterior Wall With Coating Loss/Cracking/Lifting/Peeling, Exposed Primary Coating, Exposed Steel And Mild To Moderate Surface Corrosion (Nearing Expiration)*

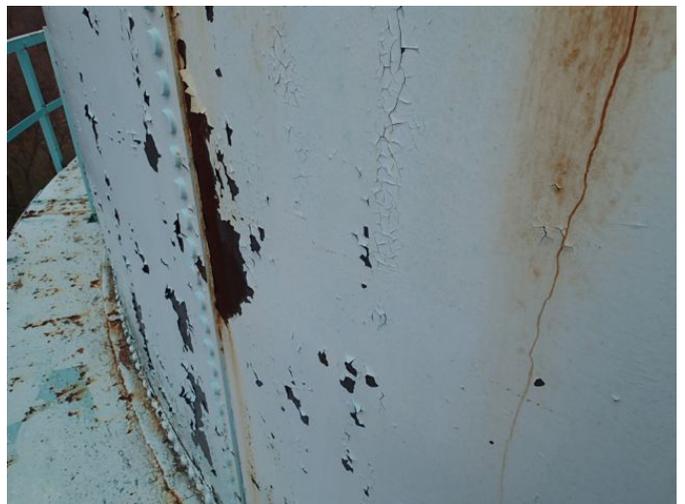
4 *Exterior Wall With Coating Loss/Cracking/Lifting/Peeling, Exposed Primary Coating, Exposed Steel And Mild To Moderate Surface Corrosion (Nearing Expiration)*

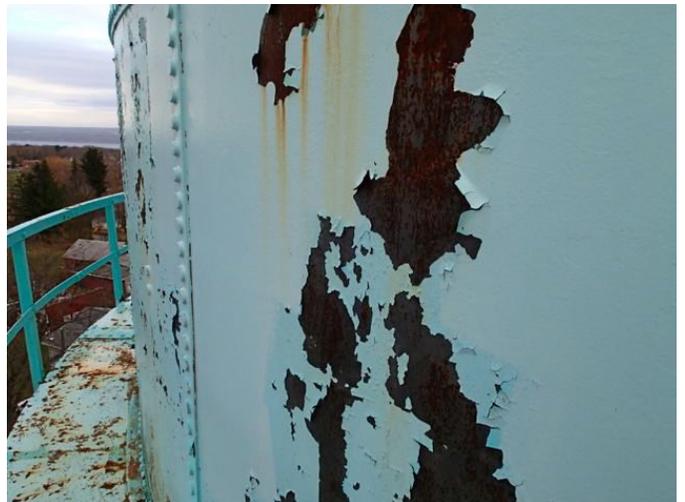
6 *Exterior Wall With Coating Loss/Cracking/Lifting/Peeling, Exposed Primary Coating, Exposed Steel And Mild To Moderate Surface Corrosion (Nearing Expiration)*

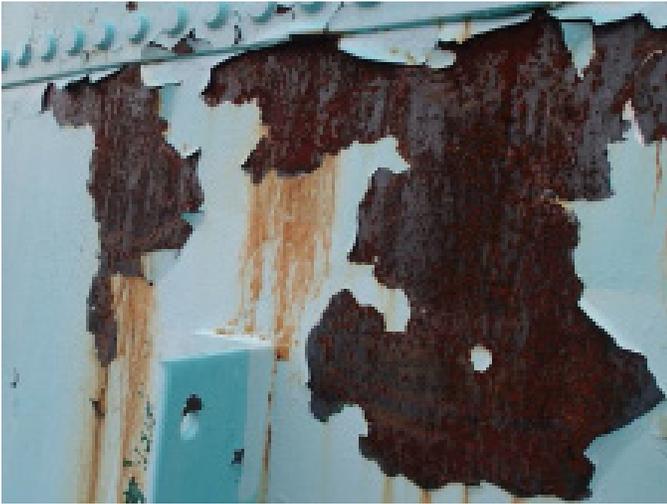
7 *Exterior Wall With Coating Loss/Cracking/Lifting/Peeling, Exposed Primary Coating, Exposed Steel And Mild To Moderate Surface Corrosion (Nearing Expiration)*

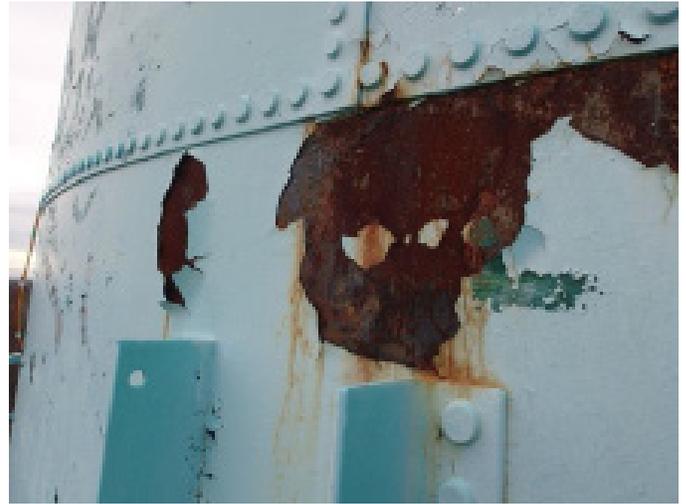
8 *Exterior Wall With Coating Loss/Cracking/Lifting/Peeling, Exposed Primary Coating, Exposed Steel And Mild To Moderate Surface Corrosion (Nearing Expiration)*

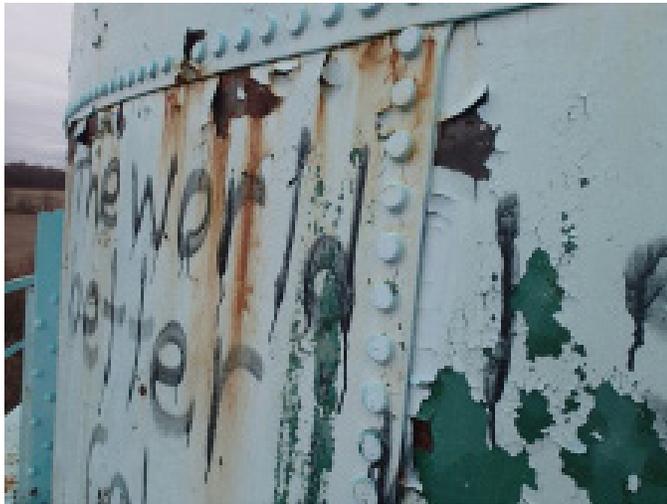
9 *Exterior Wall With Coating Loss/Cracking/Lifting/Peeling, Exposed Primary Coating, Exposed Steel And Mild To Moderate Surface Corrosion (Nearing Expiration)*

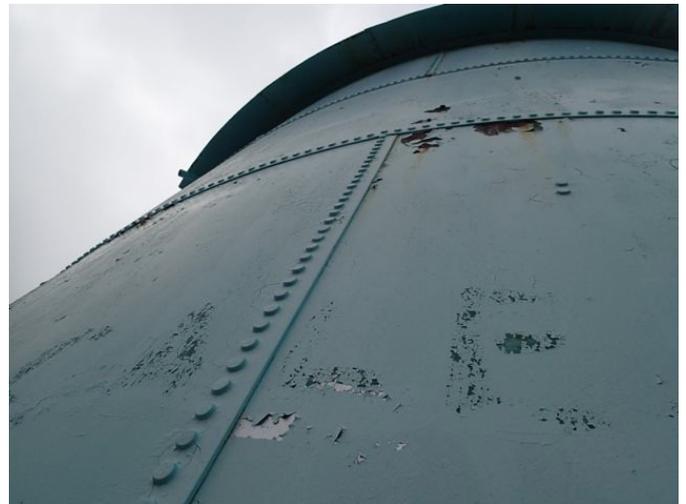
10 *Exterior Wall With Coating Loss/Cracking/Lifting/Peeling, Exposed Primary Coating, Exposed Steel And Mild To Moderate Surface Corrosion (Nearing Expiration)*

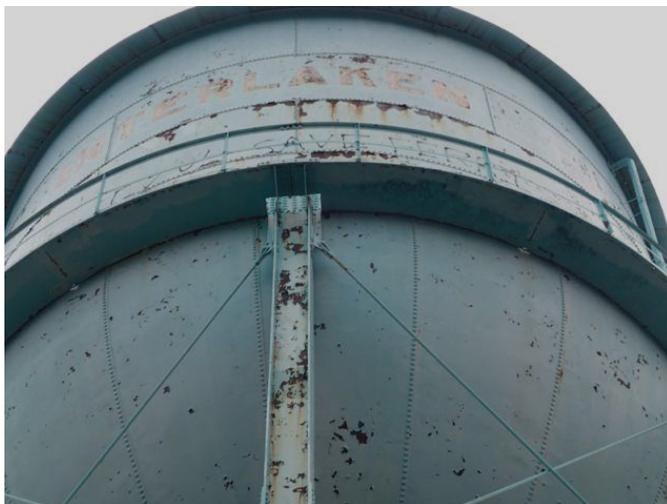
The protective coating applied to the bowl base was also found having poor adhesion value and is nearing expiration. Peeling of the coating has resulted in exposure of the underlying steel throughout approximately 10% of these surfaces at this time. No obvious fatigue (pitting) of these steel panels was evident, rather mild to moderate corrosion exists at this time.

11 *Exterior Tank Bowl With Coating Loss/Cracking/Lifting/Peeling, Exposed Primary Coating, Exposed Steel And Mild To Moderate Surface Corrosion (Nearing Expiration)*

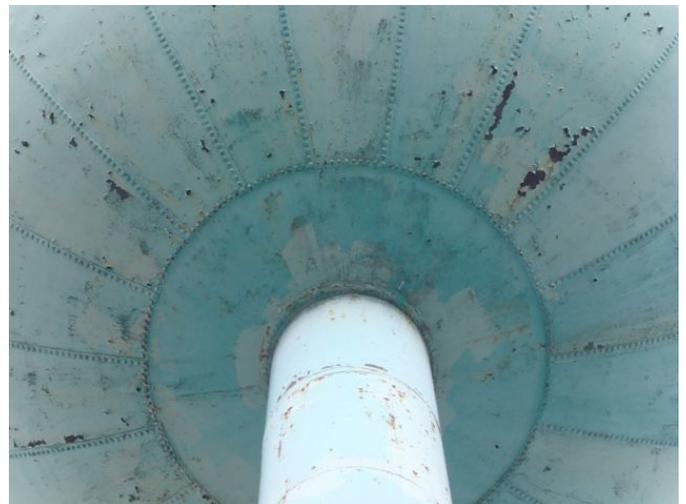
12 *Exterior Tank Bowl With Coating Loss/Cracking/Lifting/Peeling, Exposed Primary Coating, Exposed Steel And Mild To Moderate Surface Corrosion (Nearing Expiration)*

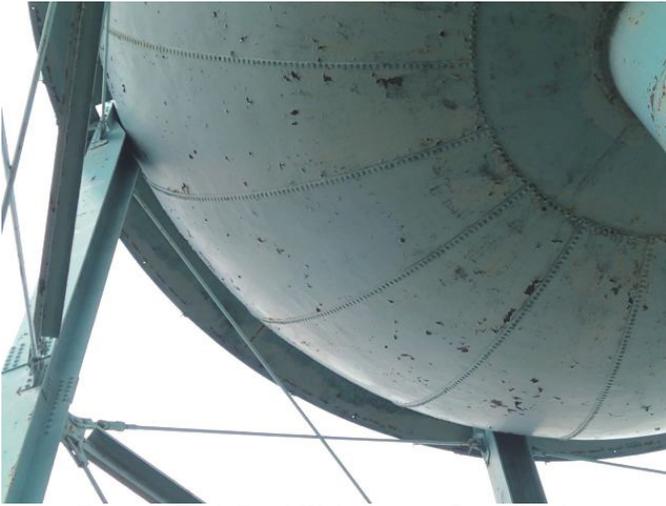
13 *Exterior Tank Bowl With Coating Loss/Cracking/
Lifting/Peeling, Exposed Primary Coating, Exposed
Steel And Mild To Moderate Surface Corrosion
(Nearing Expiration)*

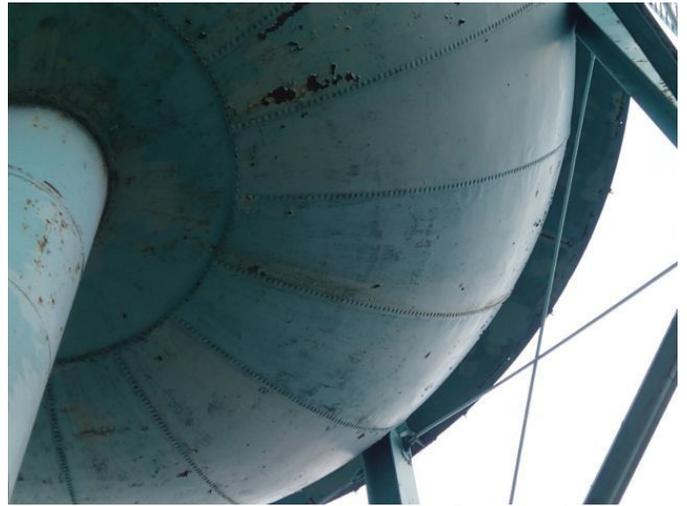
14 *Exterior Tank Bowl With Coating Loss/Cracking/
Lifting/Peeling, Exposed Primary Coating, Exposed
Steel And Mild To Moderate Surface Corrosion
(Nearing Expiration)*

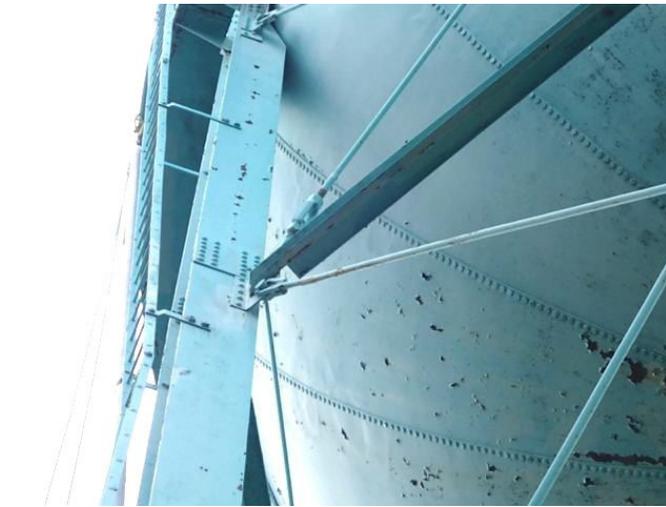
15 *Exterior Tank Bowl With Coating Loss/Cracking/
Lifting/Peeling, Exposed Primary Coating, Exposed
Steel And Mild To Moderate Surface Corrosion
(Nearing Expiration)*

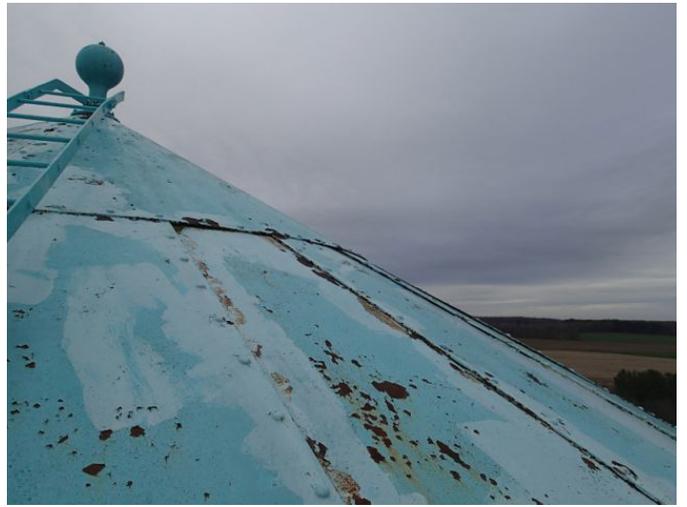
16 *Roof Panels With Coating Loss/Peeling/Lifting,
Exposed Primary Coating, Exposed Underlying Steel
And Mild To Moderate Corrosion
(Nearing Expiration)*

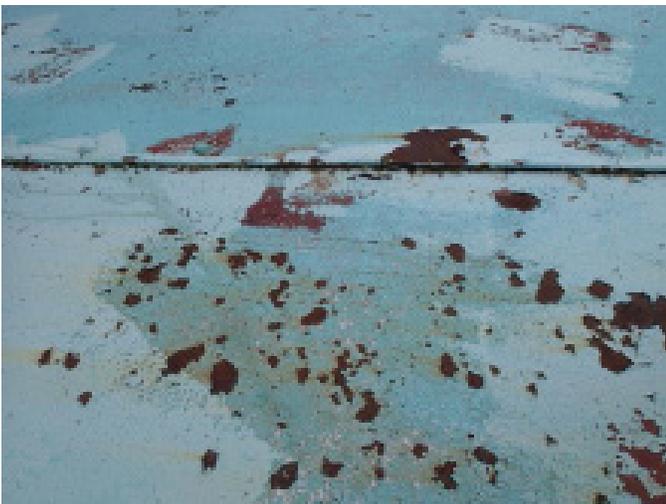
17 *Roof Panels With Coating Loss/Peeling/Lifting,
Exposed Primary Coating, Exposed Underlying Steel
And Mild To Moderate Corrosion
(Nearing Expiration)*

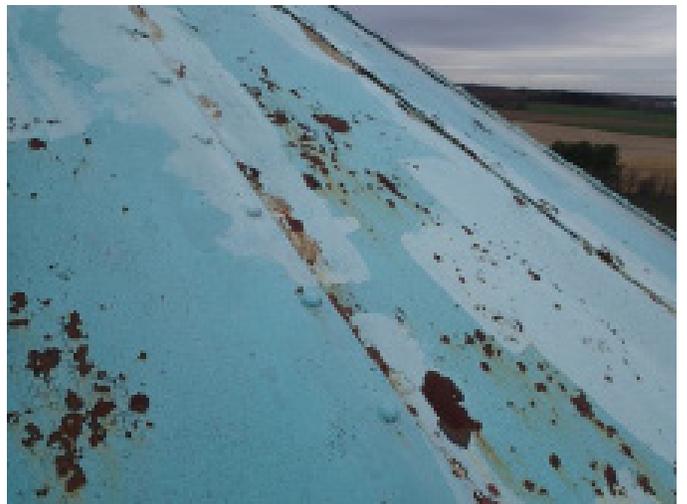
18 *Roof Panels With Coating Loss/Peeling/Lifting,
Exposed Primary Coating, Exposed Underlying Steel
And Mild To Moderate Corrosion
(Nearing Expiration)*

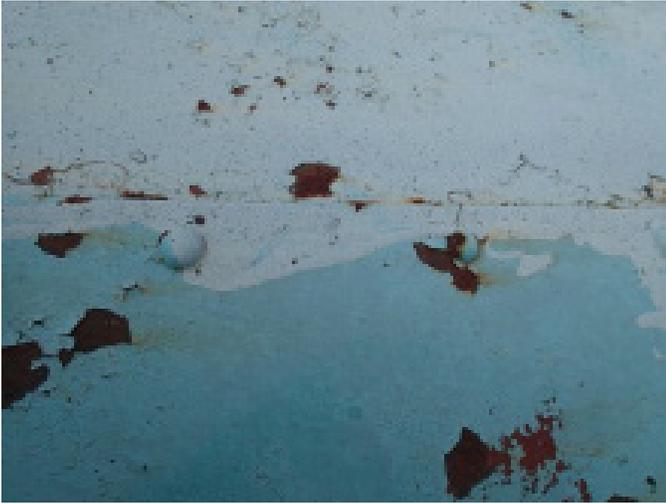
19 *Roof Panels With Coating Loss/Peeling/Lifting, Exposed Primary Coating, Exposed Underlying Steel And Mild To Moderate Corrosion (Nearing Expiration)*

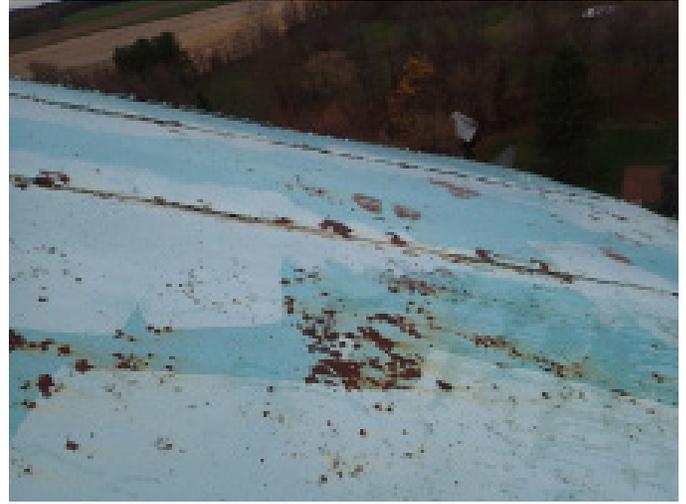
20 *Roof Panels With Coating Loss/Peeling/Lifting, Exposed Primary Coating, Exposed Underlying Steel And Mild To Moderate Corrosion (Nearing Expiration)*

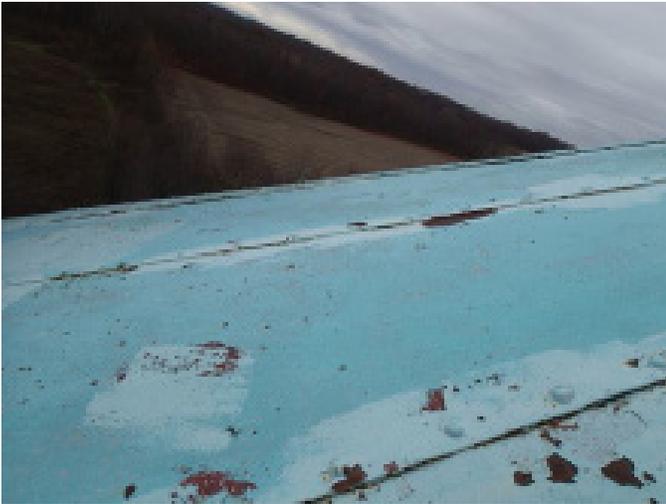
21 *Roof Panels With Coating Loss/Peeling/Lifting, Exposed Primary Coating, Exposed Underlying Steel And Mild To Moderate Corrosion (Nearing Expiration)*

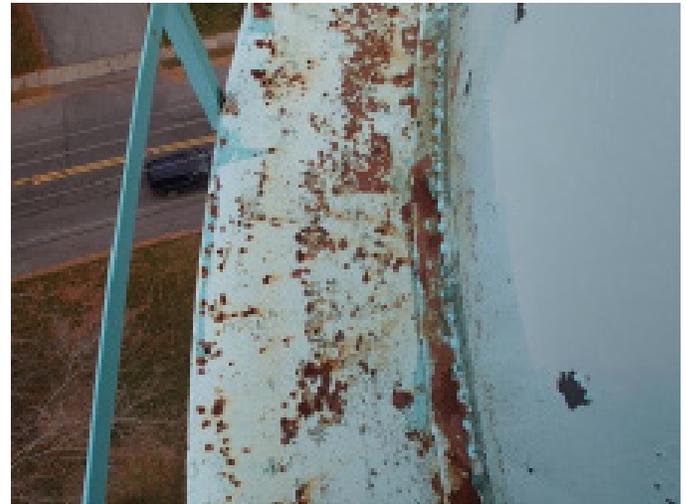
22 *Catwalk And Safety Railing With Coating Loss/Peeling, Exposed Underlying Steel And Mild To Moderate (Nearing Expiration)*

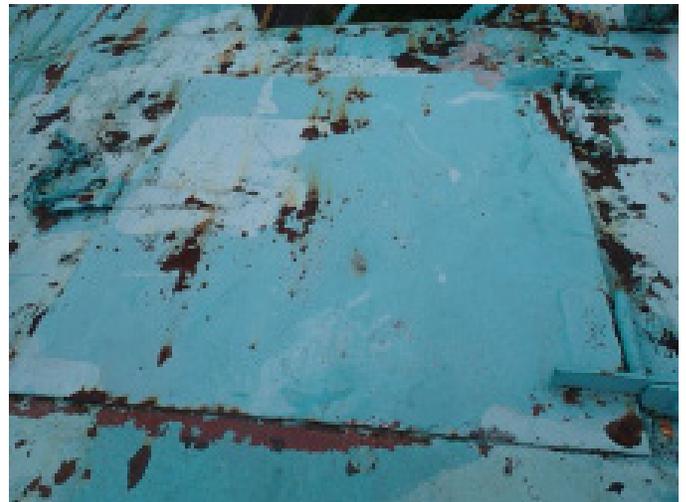
The protective coating applied to the interior and exterior surfaces of this steel hatch was found having poor adhesion value and is peeling. This condition has resulted in exposure of the underlying steel throughout approximately 10% of all surfaces of this hatch.

30 *Closed Hatch With Coating Loss/Peeling, Exposed Underlying Steel And Mild To Moderate Corrosion*

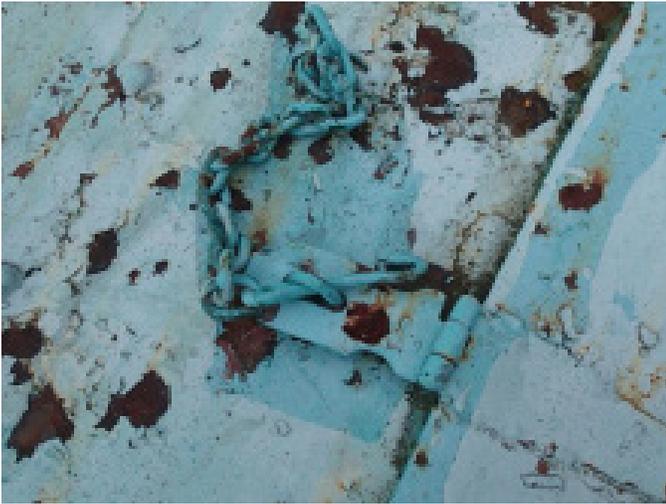
31 *Secure Hatch*

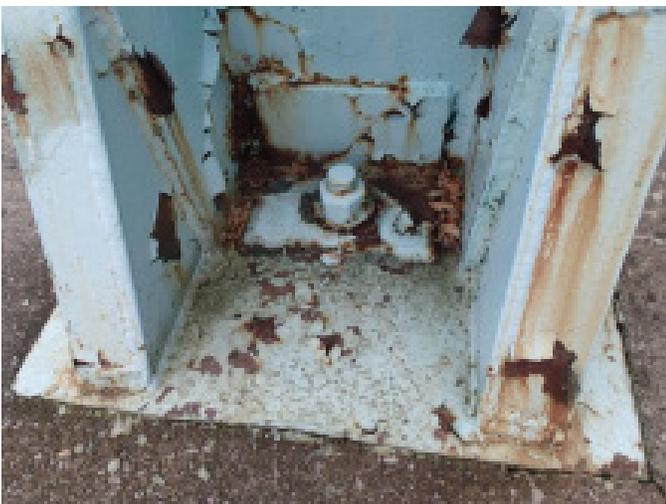
The protective coating applied to this steel hardware was found showing a decline in film thickness, causing mild blotch rusting. Coating loss throughout less than 5% of the surfaces of each anchor bolt and associated nut has resulted in exposure of the underlying steel of this hardware.

35 *Anchor Bolt With Coating Loss, Mild Blotch Rusting, Exposed Underlying Steel And Mild To Moderate Corrosion*

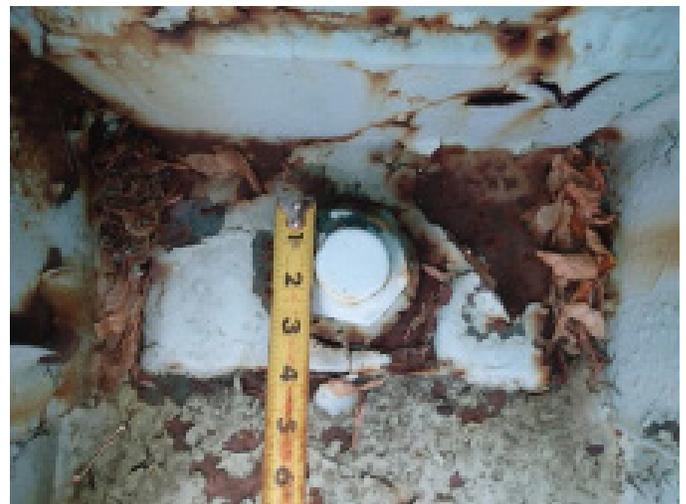
36 *Anchor Bolt With Coating Loss, Mild Blotch Rusting, Exposed Underlying Steel And Mild To Moderate Corrosion*

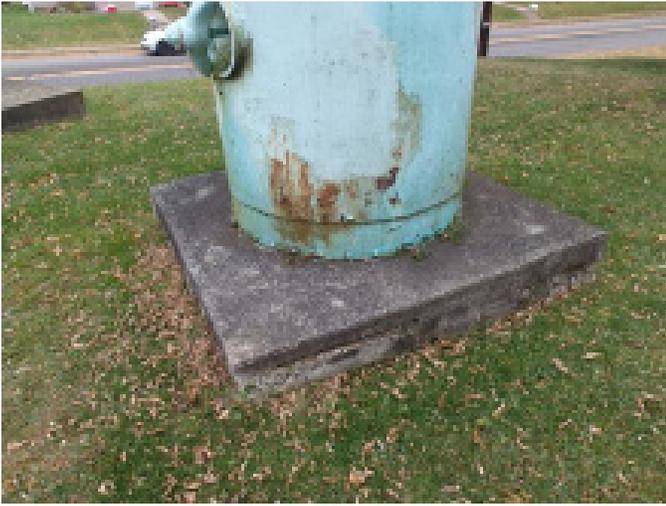
Peeling of the coating was observed throughout approximately 10% of the length of this riser column, resulting in exposure of the underlying steel. No obvious fatigue (pitting) of the steel was evident within these areas of steel exposure, rather mild to moderate corrosion exists at this time.

37 *Center Riser Column With Coating Loss/Peeling, Exposed Underlying Steel, Mild To Moderate Corrosion And Mildew (Nearing Expiration)*

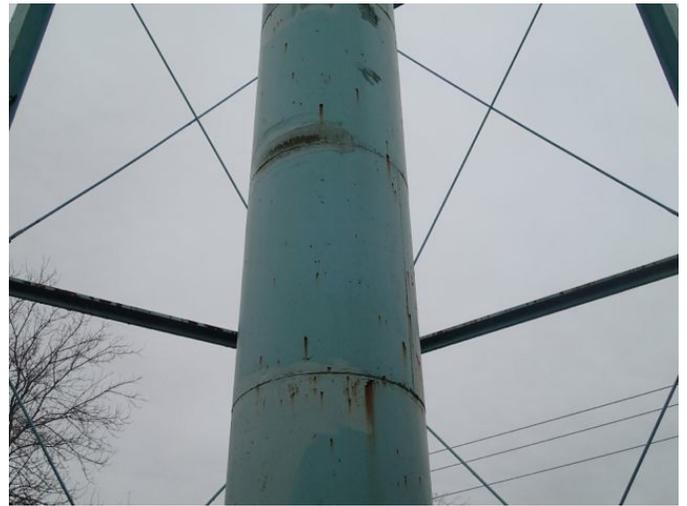
38 *Center Riser Column With Coating Loss/Peeling, Exposed Underlying Steel, Mild To Moderate Corrosion And Mildew (Nearing Expiration)*

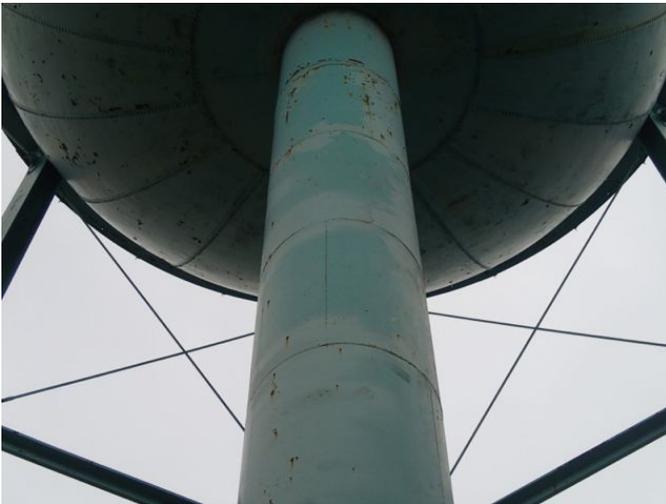
39 *Center Riser Column With Coating Loss/Peeling, Exposed Underlying Steel, Mild To Moderate Corrosion And Mildew (Nearing Expiration)*

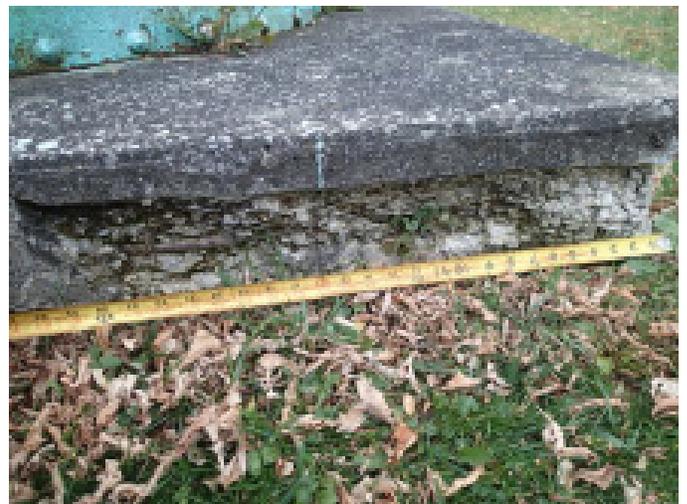
The 72" by 72" by 10" tall concrete support footer located at the base of the center riser column was found having an area of concrete spall measuring approximately 36" in length by 4" in width and with an average maximum depth of 1-1/2" and has resulted in exposure of the reinforcement steel. The surrounding and underlying concrete within this area of spall remains sound, and although mild surface corrosion exists on the surfaces of the exposed reinforcement steel, no obvious fatigue or deterioration of this reinforcement steel was evident at this time.

40 *Concrete Support Footer With Spall, Exposed Reinforcement Steel And Mild Surface Corrosion*

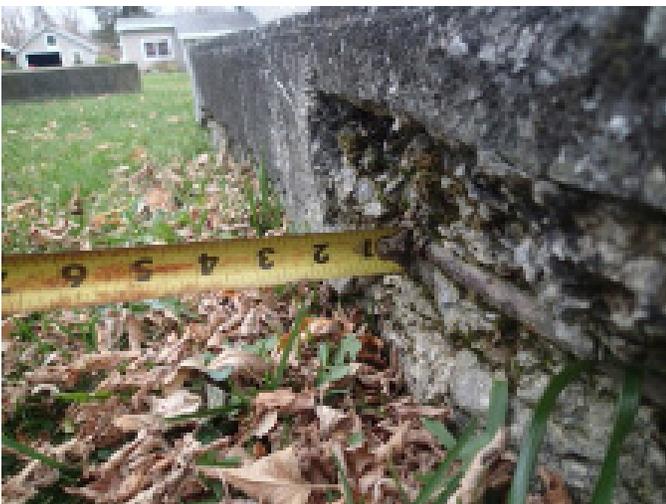
41 *Concrete Support Footer With Spall, Exposed Reinforcement Steel And Mild Surface Corrosion*

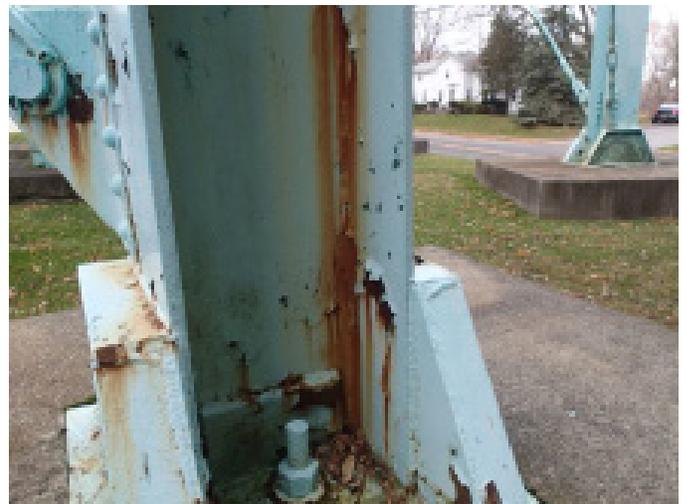
The protective coating applied to each support leg was found having poor adhesion value and is peeling throughout approximately 10% of the surfaces of each support leg, resulting in exposure of the underlying steel.

42 *Support Leg With Coating Loss/Peeling, Exposed Underlying Steel And Mild To Moderate Corrosion (Nearing Expiration)*

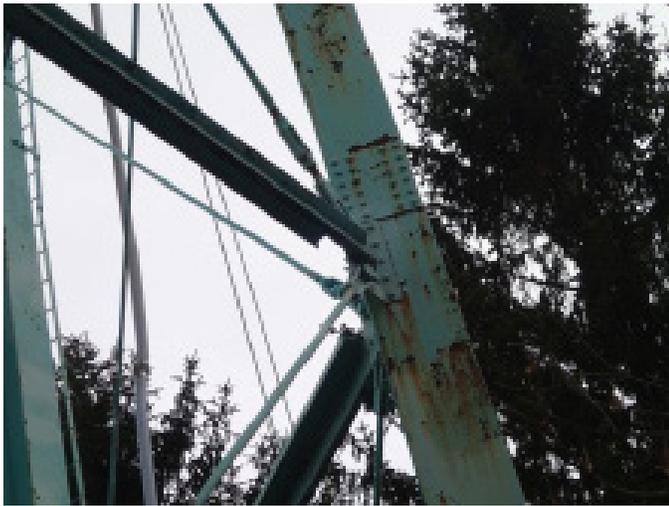
43 *Support Leg With Coating Loss/Peeling, Exposed Underlying Steel And Mild To Moderate Corrosion (Nearing Expiration)*

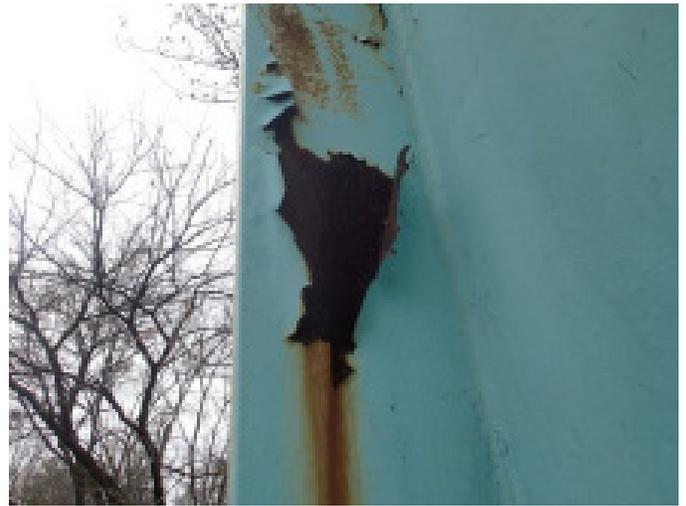
44 *Support Leg With Coating Loss/Peeling, Exposed Underlying Steel And Mild To Moderate Corrosion (Nearing Expiration)*

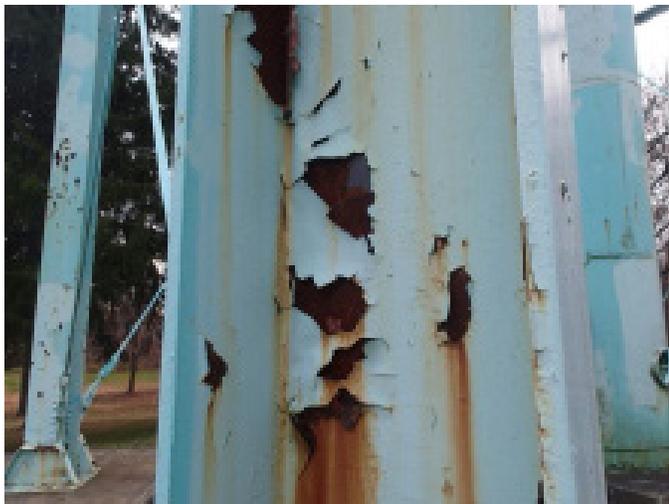
45 *Support Leg With Coating Loss/Peeling, Exposed Underlying Steel And Mild To Moderate Corrosion (Nearing Expiration)*

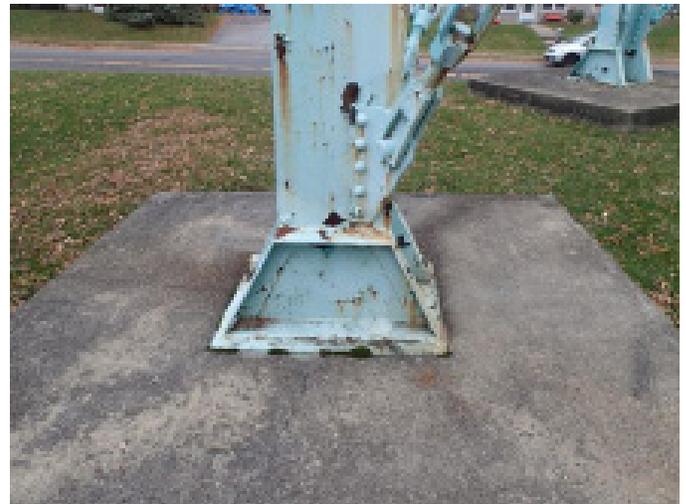
46 *Support Leg With Coating Loss/Peeling, Exposed Underlying Steel And Mild To Moderate Corrosion (Nearing Expiration)*

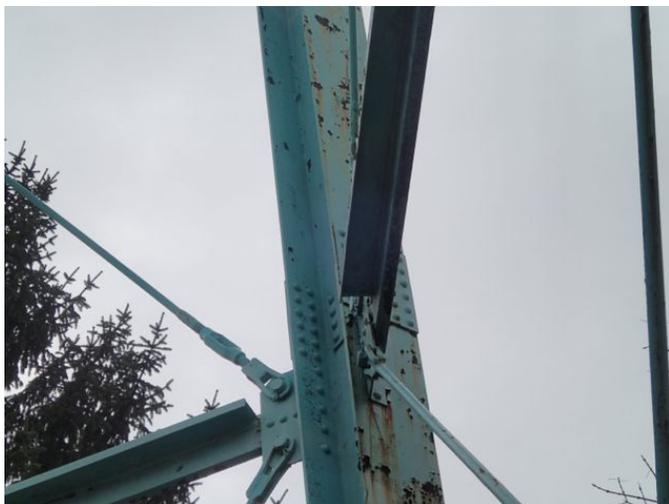
47 *Support Leg With Coating Loss/Peeling, Exposed Underlying Steel And Mild To Moderate Corrosion (Nearing Expiration)*

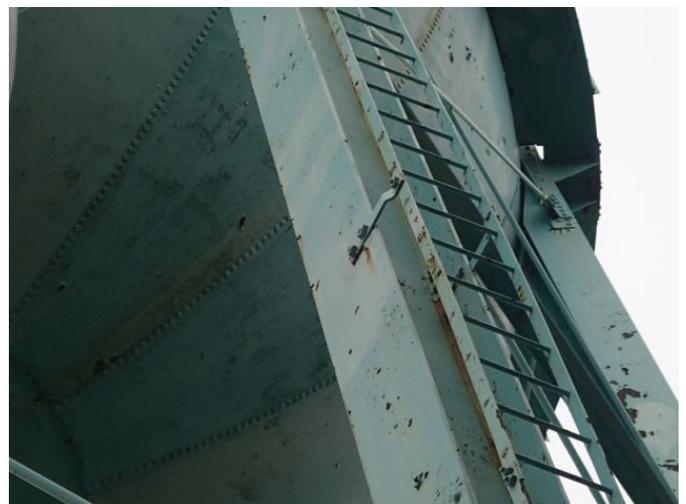
48 *Support Leg With Coating Loss/Peeling, Exposed Underlying Steel And Mild To Moderate Corrosion (Nearing Expiration)*

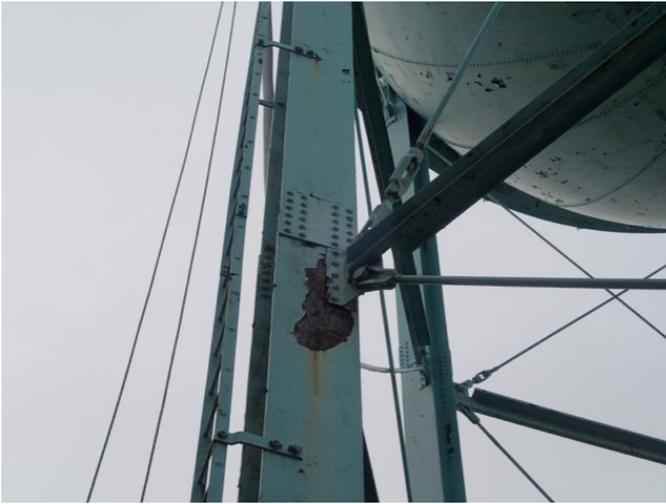
49 *Support Leg With Coating Loss/Peeling, Exposed Underlying Steel And Mild To Moderate Corrosion (Nearing Expiration)*

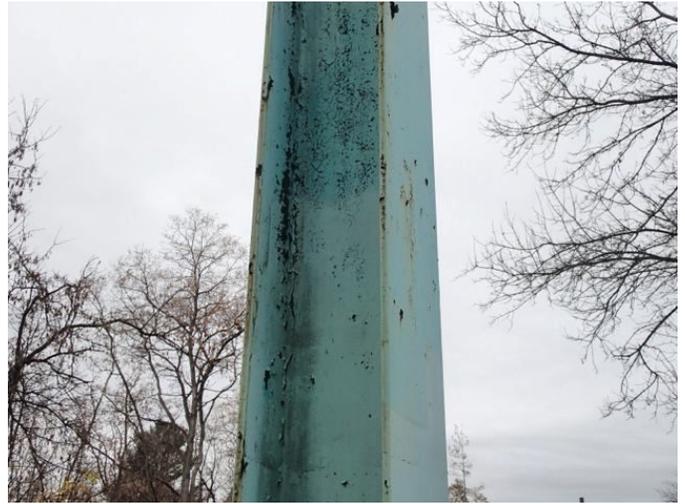
50 *Support Leg With Coating Loss/Peeling, Exposed Underlying Steel And Mild To Moderate Corrosion (Nearing Expiration)*

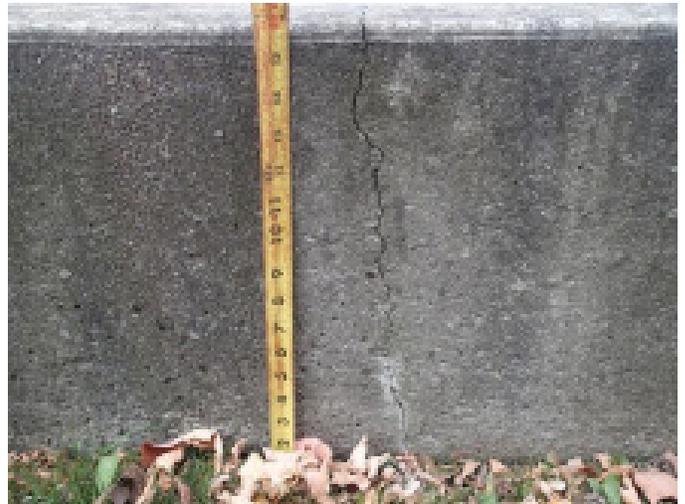
The 96" by 96" by 12" tall concrete support footer located at the base of each support leg were found having cracks throughout less than 5% of their surfaces. These cracks were found having an average length of 31" and having a maximum width 1/2" at this time. These cracks were sounded and found free of obvious voids or spalls at this time.

52 *Concrete Support Footer With Cracking*

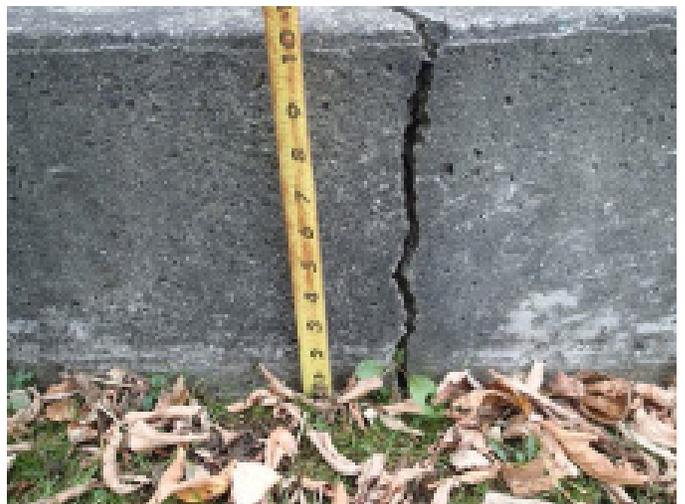
54 *Concrete Support Footer With Cracking*

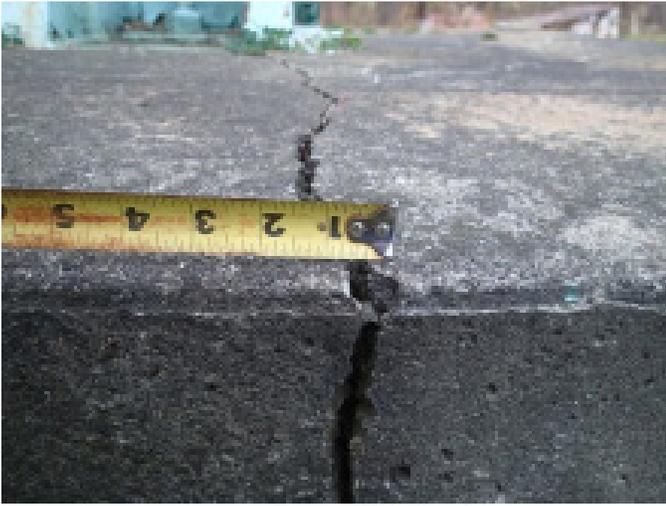
55 *Concrete Support Footer With Cracking*

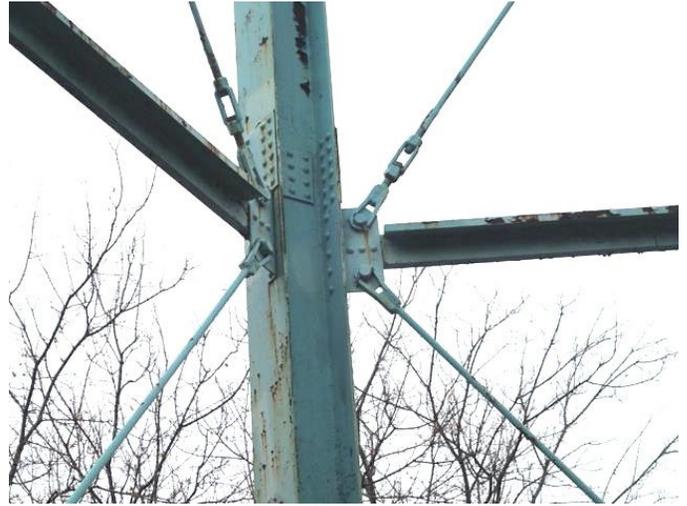
The protective coating applied to the steel cross member struts was found having poor adhesion value and is peeling, resulting in exposure of the underlying steel throughout approximately 5% of the surfaces of each cross member, to include the hardware that secures these cross members to the tower support legs.

56 *Cross Member With Coating Loss/Peeling, Exposed Underlying Steel And Mild Surface Corrosion (Nearing Expiration)*

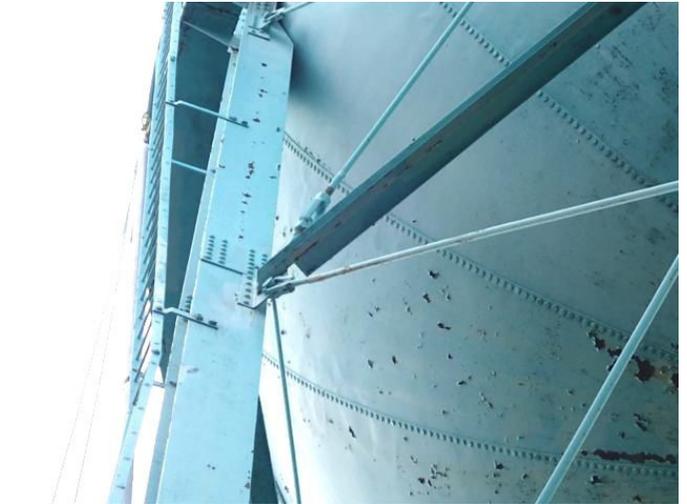
58 *Cross Member With Coating Loss/Peeling, Exposed Underlying Steel And Mild Surface Corrosion (Nearing Expiration)*

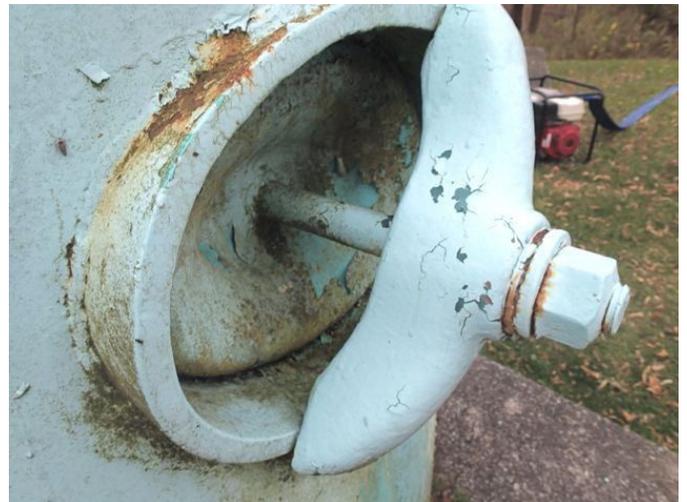
Secondary coating adhesion loss throughout approximately 10% the surfaces of the manway lid and securing bar has resulted in exposure of the underlying primary coating, while complete coating loss and steel exposure was observed throughout less than 5% of the 3" deep by 1" thick steel manway trunk, resulting in exposure of the underlying steel.

60 *Manway With Secondary Coating Loss, Exposed Underlying Primary Coating, Exposed Underlying Steel And Mild To Moderate Corrosion*

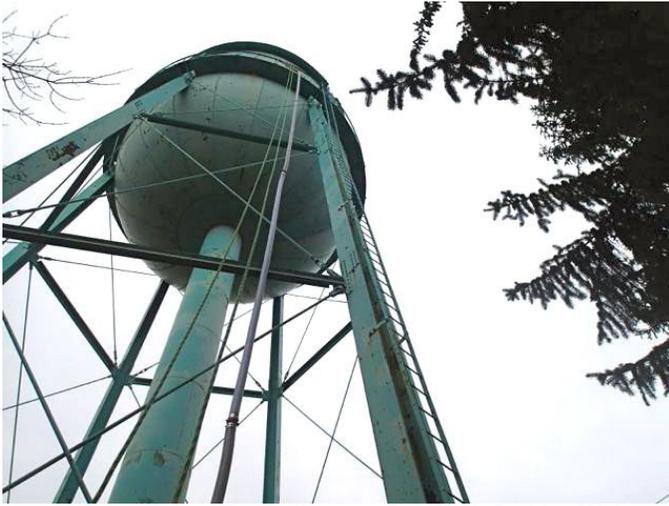
61 *Easternmost Tower Support Leg With Ladder With Coating Loss/Cracking/Peeling, Exposed Underlying Steel And Mild Surface Corrosion*

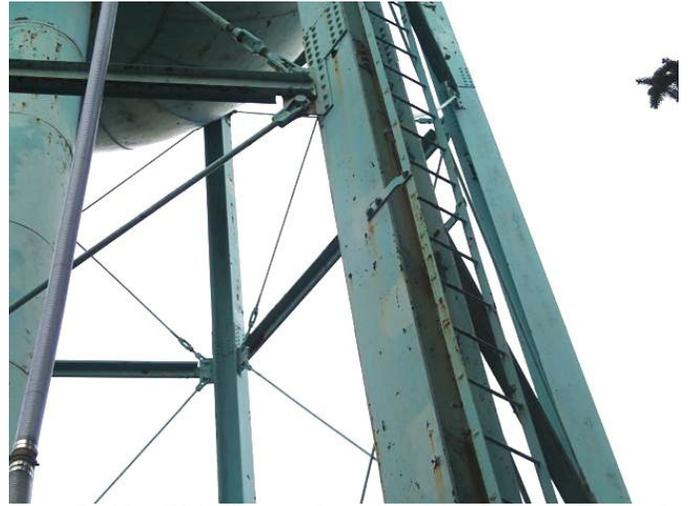
62 *Ladder With Coating Loss/Cracking/Peeling, Exposed Underlying Steel And Mild Surface Corrosion*

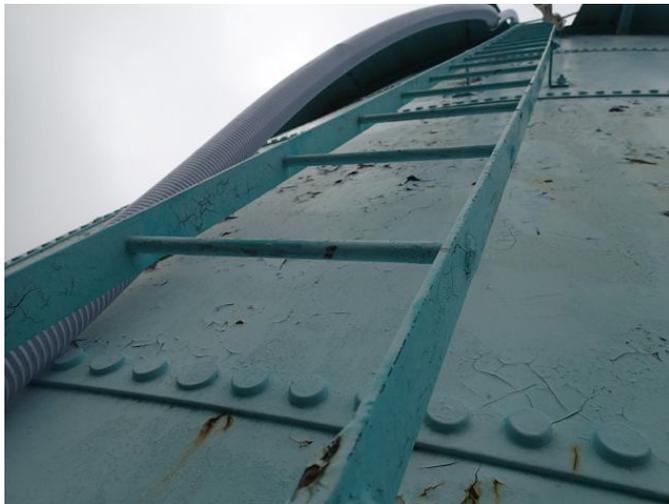
63 *Ladder With Coating Loss/Cracking/Peeling, Exposed Underlying Steel And Mild Surface Corrosion*

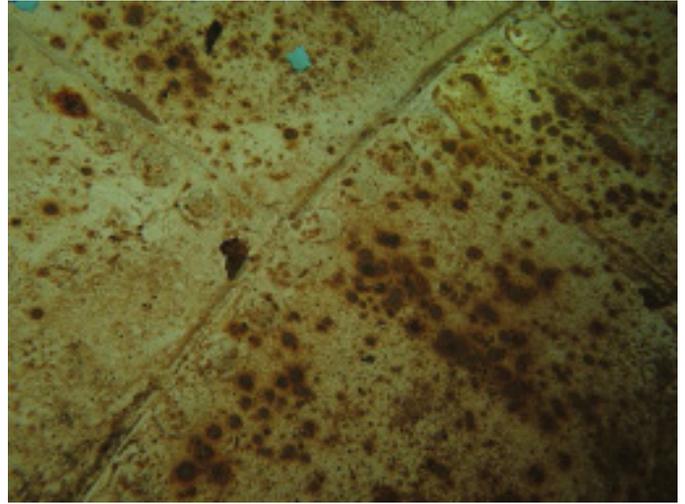
68 *Floor With Coating Loss, Ruptured Coating Blisters, Exposed Underlying Steel, Moderate To Heavy Corrosion And Mild Staining(Expired)*

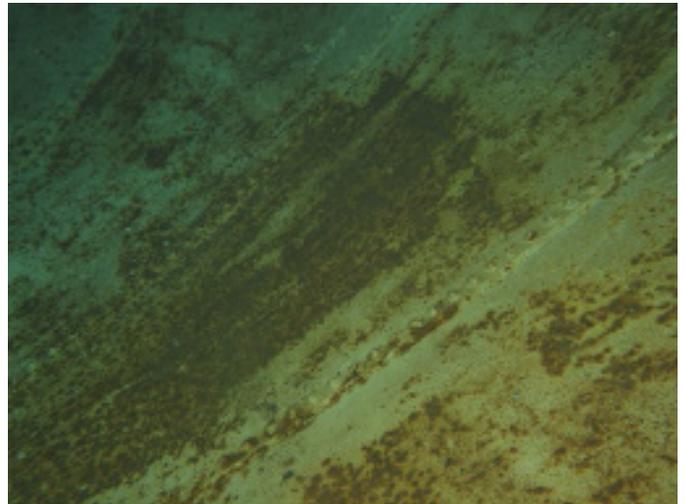
70 *Floor With Coating Loss, Ruptured Coating Blisters, Exposed Underlying Steel, Moderate To Heavy Corrosion And Mild Staining(Expired)*

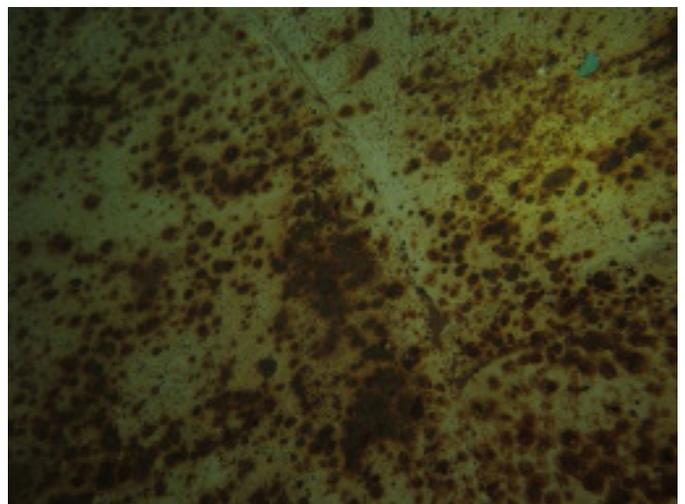
72 *Floor With Coating Loss, Ruptured Coating Blisters, Exposed Underlying Steel, Moderate To Heavy Corrosion And Mild Staining(Expired)*

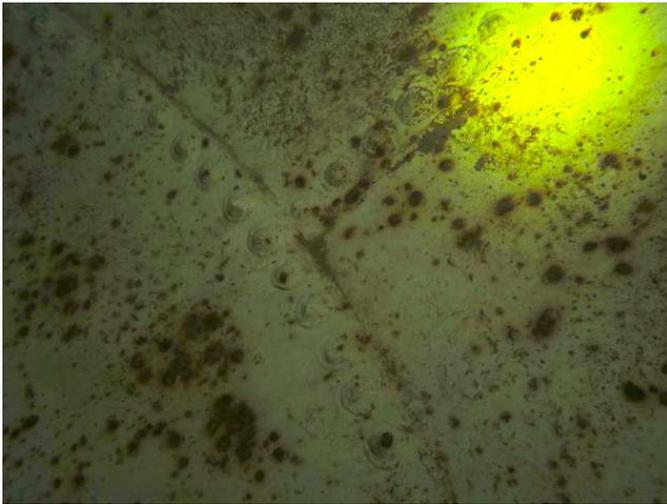
73 *Floor With Coating Loss, Ruptured Coating Blisters, Exposed Underlying Steel, Moderate To Heavy Corrosion And Mild Staining(Expired)*

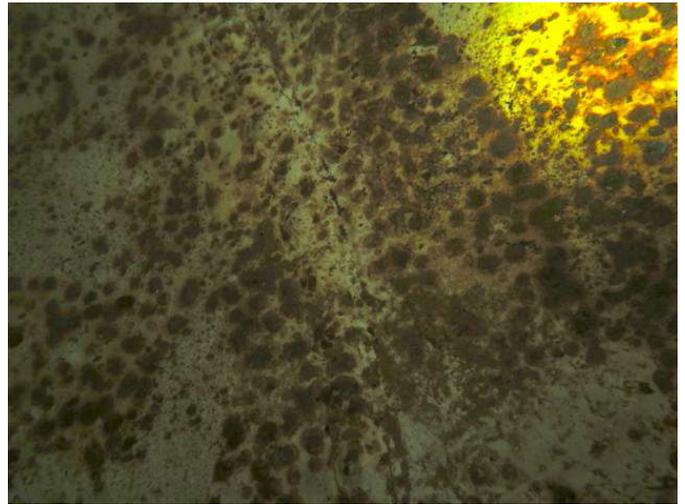
74 *Floor With Coating Loss, Ruptured Coating Blisters, Exposed Underlying Steel, Moderate To Heavy Corrosion And Mild Staining(Expired)*

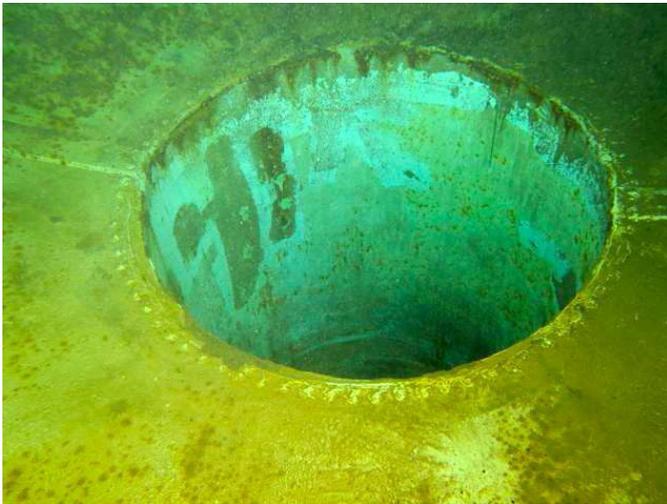
75 *Flush Pipe With Coating Loss/Blisters, Exposed Underlying Steel And Mild To Moderate Corrosion*

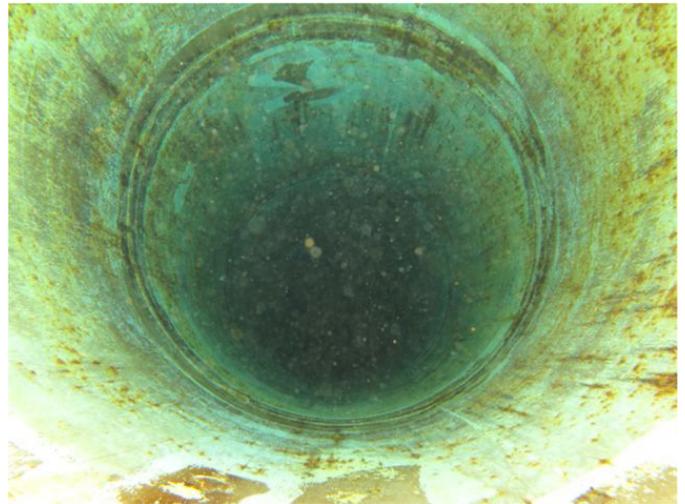
76 *Flush Pipe With Coating Loss/Blisters, Exposed Underlying Steel And Mild To Moderate Corrosion*

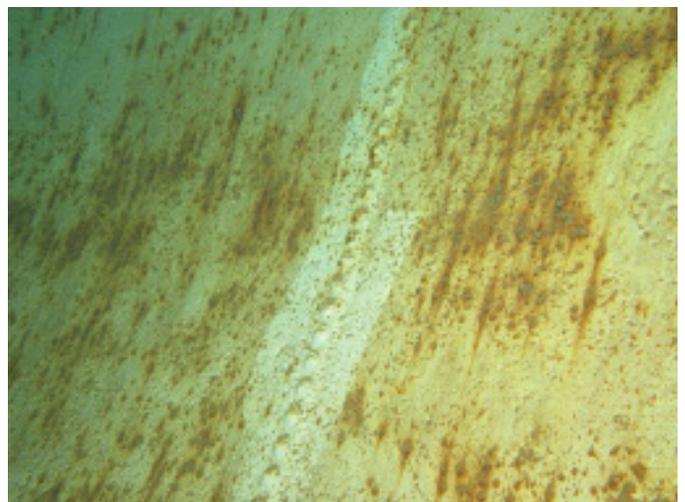
78 *Interior Wall With Coating Loss/Blistering/Peeling, Exposed Underlying Steel, Mild To Moderate Corrosion And Mild Staining (Expired)*

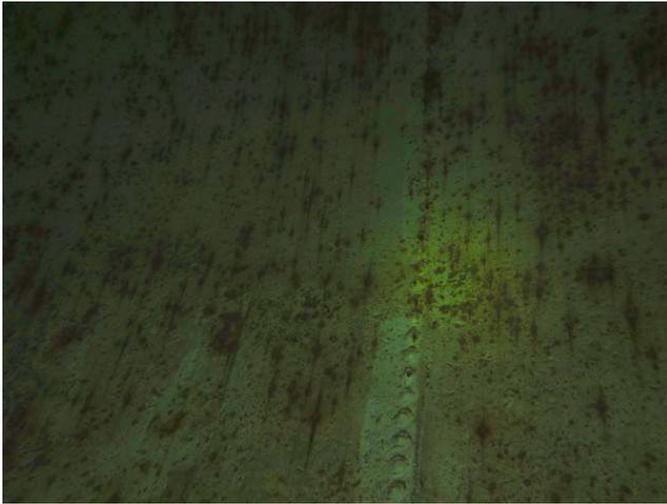
79 *Interior Wall With Coating Loss/Blistering/Peeling, Exposed Underlying Steel, Mild To Moderate Corrosion And Mild Staining (Expired)*

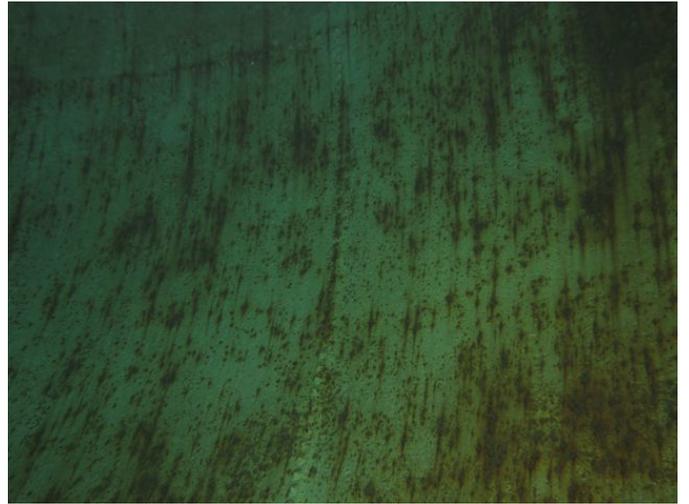
80 *Interior Wall With Coating Loss/Blistering/Peeling, Exposed Underlying Steel, Mild To Moderate Corrosion And Mild Staining (Expired)*
