***INSPECTION AND CLEANING (SEDIMENT REMOVAL) OF THE
120,000-GALLON ELEVATED RIVETED STEEL WATER STORAGE TANK***

***VILLAGE OF INTERLAKEN D.P.W.
INTERLAKEN, NEW YORK***

NOVEMBER 10, 2015

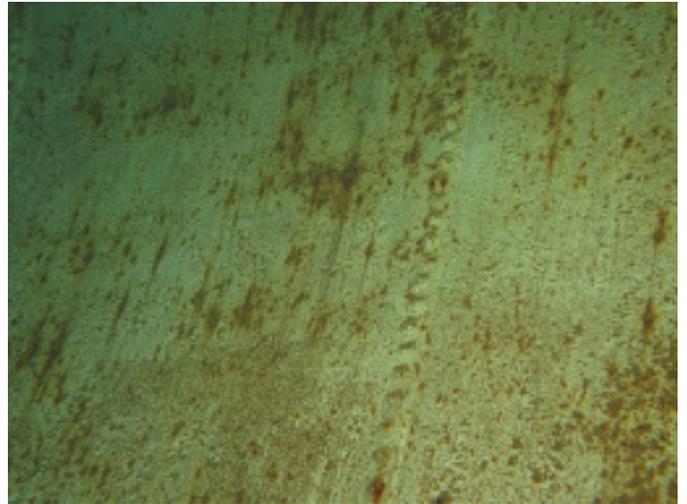
82 *Interior Wall With Coating Loss/Blistering/Peeling, Exposed Underlying Steel, Mild To Moderate Corrosion And Mild Staining (Expired)*

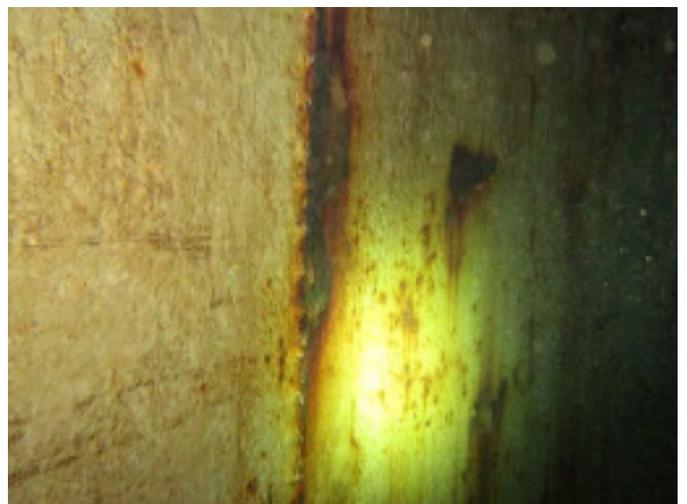
84 *Interior Wall With Coating Loss/Blistering/Peeling, Exposed Underlying Steel, Mild To Moderate Corrosion And Mild Staining (Expired)*

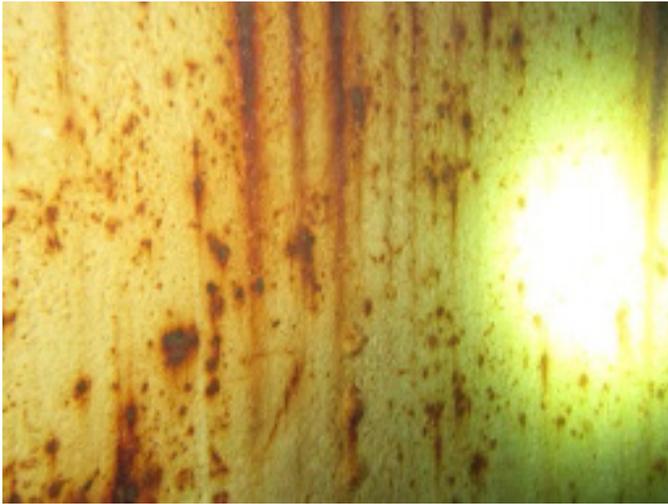
85 *Interior Wall With Coating Loss/Blistering/Peeling, Exposed Underlying Steel, Mild To Moderate Corrosion And Mild Staining (Expired)*

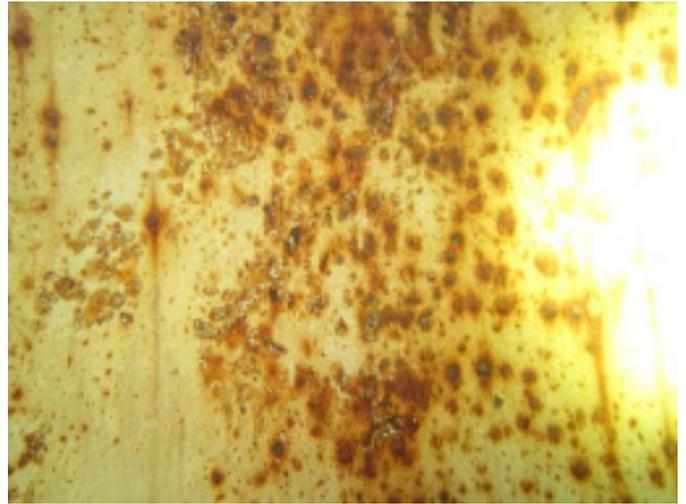
86 *Interior Wall With Coating Loss/Blistering/Peeling, Exposed Underlying Steel, Mild To Moderate Corrosion And Mild Staining (Expired)*

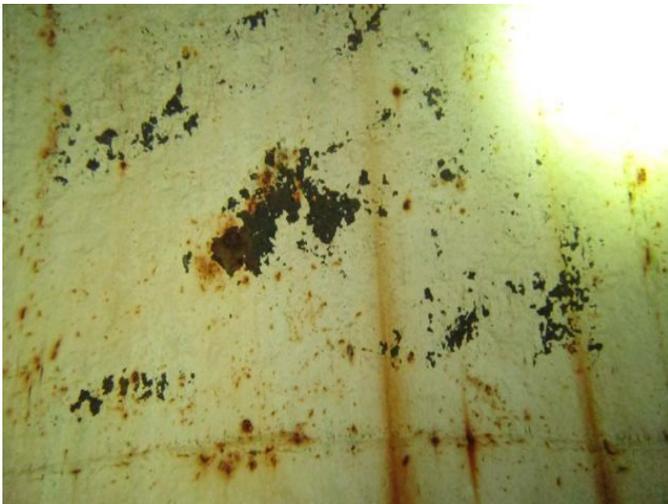
87 *Interior Wall With Coating Loss/Blistering/Peeling, Exposed Underlying Steel, Mild To Moderate Corrosion And Mild Staining (Expired)*

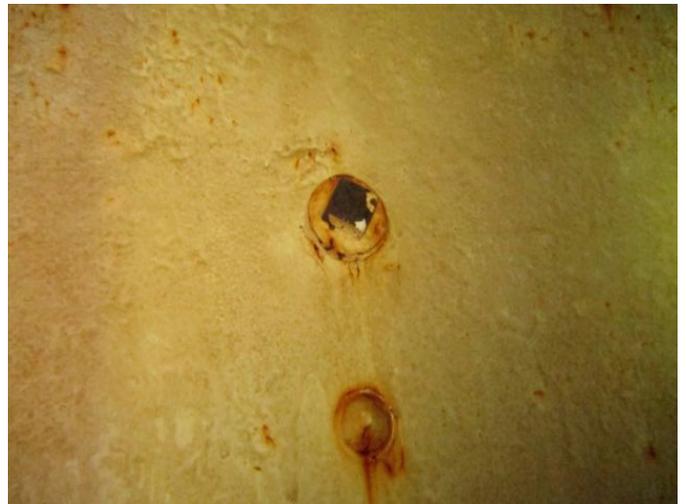
88 *Interior Wall With Coating Loss/Blistering/Peeling, Exposed Underlying Steel, Mild To Moderate Corrosion And Mild Staining (Expired)*

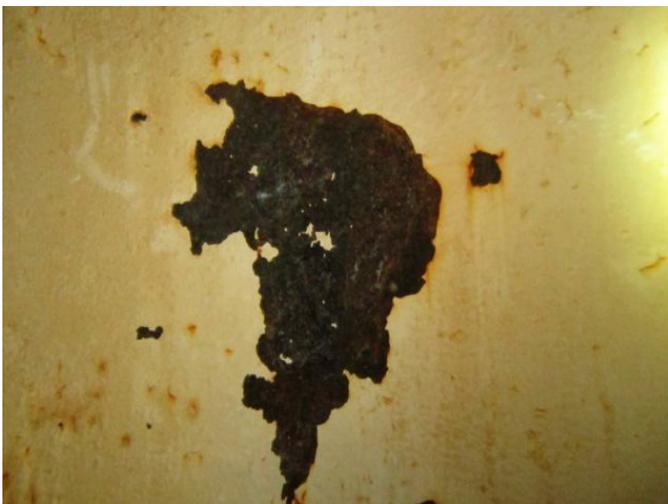
89 *Interior Wall With Coating Loss/Blistering/Peeling, Exposed Underlying Steel, Mild To Moderate Corrosion And Mild Staining (Expired)*

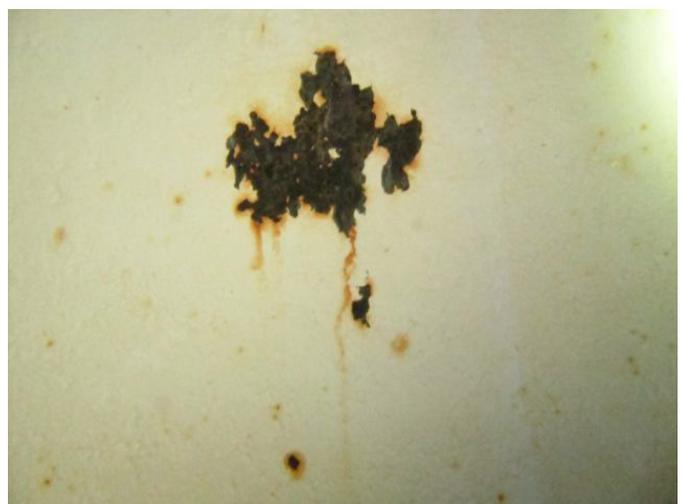
90 *Interior Wall With Coating Loss/Blistering/Peeling, Exposed Underlying Steel, Mild To Moderate Corrosion And Mild Staining (Expired)*

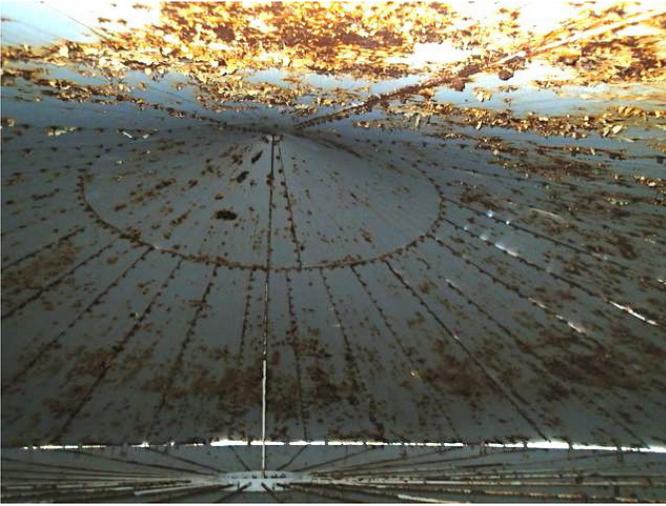
91 *Overhead With Coating Loss/Peeling, Exposed Underlying Steel, Blotch Rusting And Mild To Moderate Corrosion And Staining*

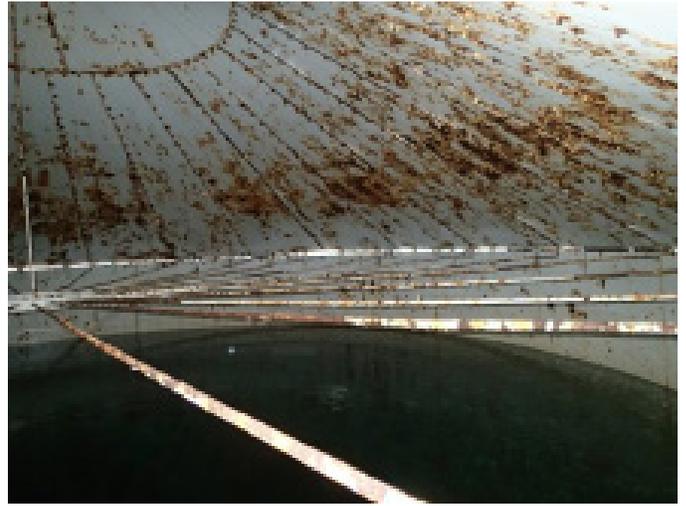
92 *Overhead With Coating Loss/Peeling, Exposed Underlying Steel, Blotch Rusting And Mild To Moderate Corrosion And Staining*

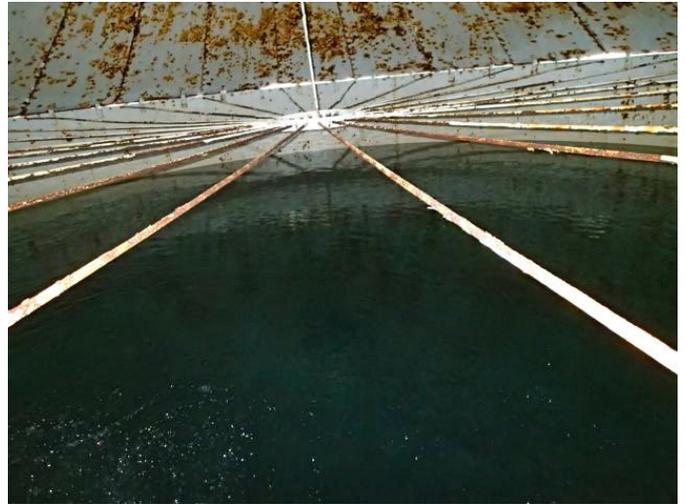
94 *Overhead Steel Spider With Coating Loss/Peeling, Exposed Underlying Steel, Blotch Rusting And Mild To Moderate Corrosion And Staining*
